Entiat River Upper Stillwaters Reach Stream Corridor Assessment & Habitat Restoration Strategy

SUBMITTED TO
Yakama Nation Fisheries Program

OCTOBER 2013

PREPARED BY
Inter-Fluve, Inc.
501 Portway Ave, Suite 101
Hood River, OR 97031
(541) 386-9003

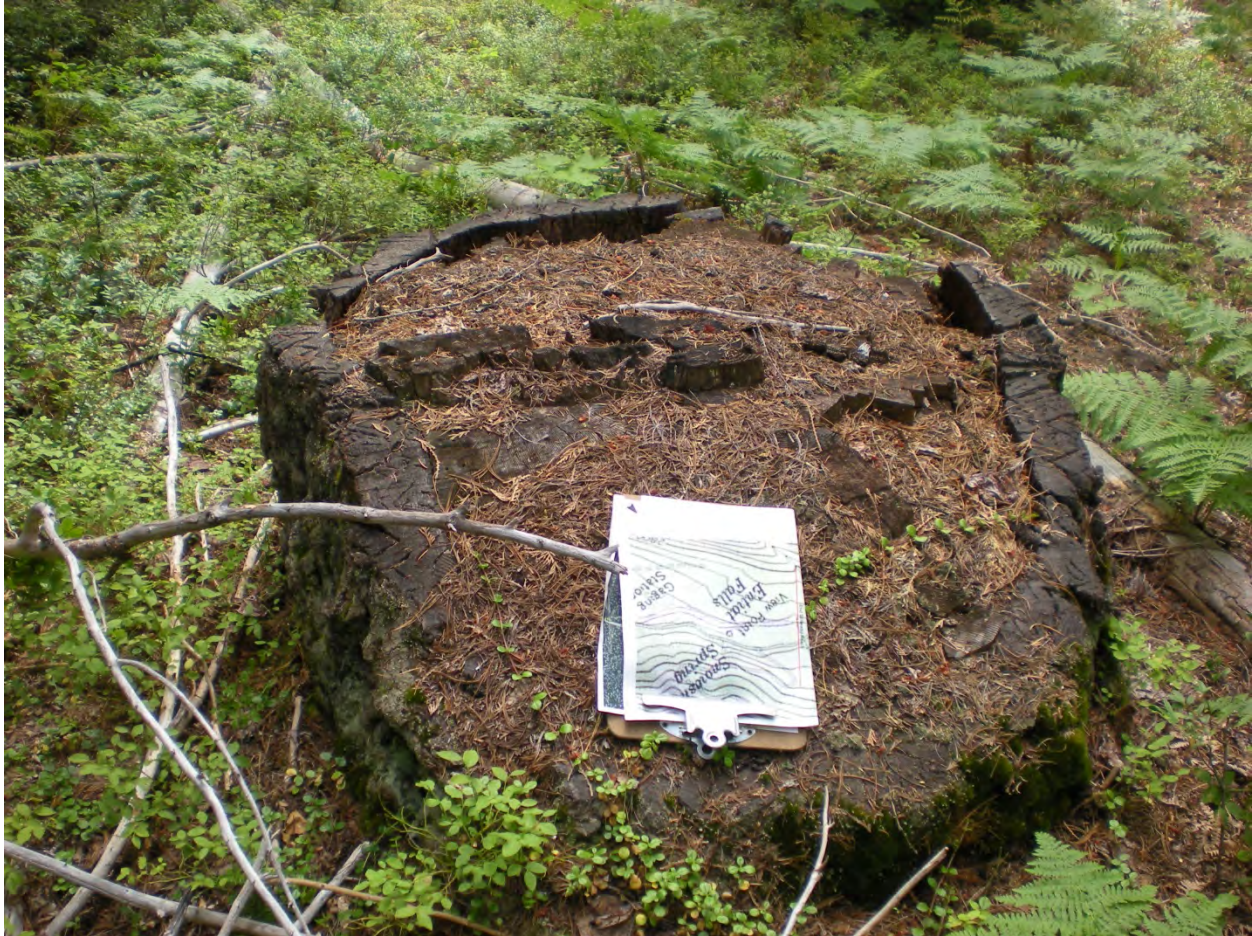
Figure 5. Stump of logged riparian tree measuring 42" in diameter.

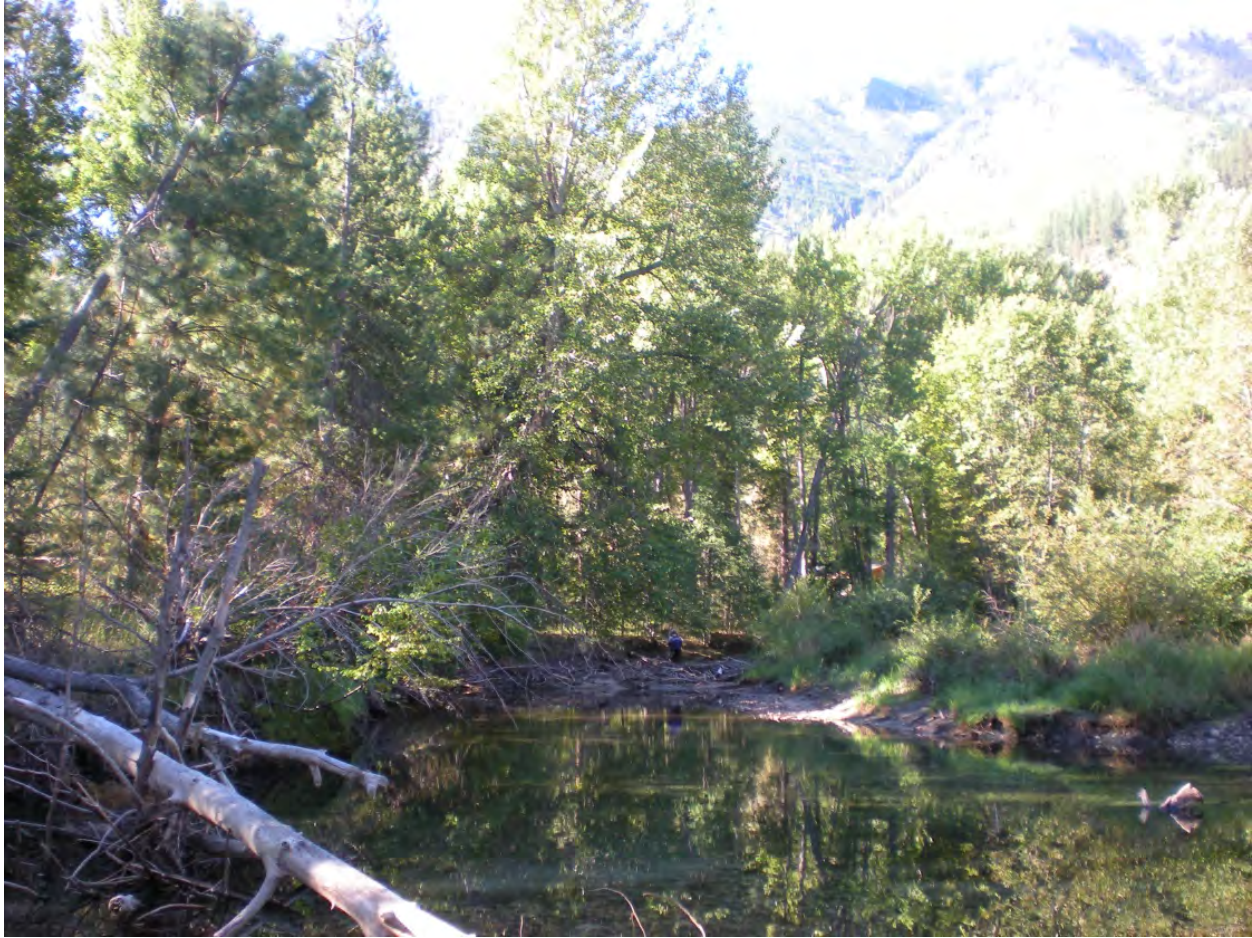
There is very little sediment storage occurring in the middle portion of the reach, which is composed of a long, straight, and uniform glide with little complexity available to store wood or sediment. Of any section of channel within the study area, this section appears most likely to have experienced stream channel incision and channel simplification associated with human activities. Signs of incision include low gradient, with bank heights increasing in the upstream direction; as well as low sinuosity and flows confined within the channel at the 2-year event. Vertical control is provided at the downstream end by the fan/bridge constriction, which has increased local sediment deposition and side channel development upstream of the bridge; but this influence has not extended into the upstream glide, possibly due to the effects of incision and straightening on increasing sediment transport. Log drives have been documented up to RM 24, which is near this area. There has also been residential development activity along this reach. These impacts may have contributed to channel incision and simplification that have affected habitat quantity and quality in the reach.

Figure 31. Side channel habitat upstream of the bridge in Reach 0.

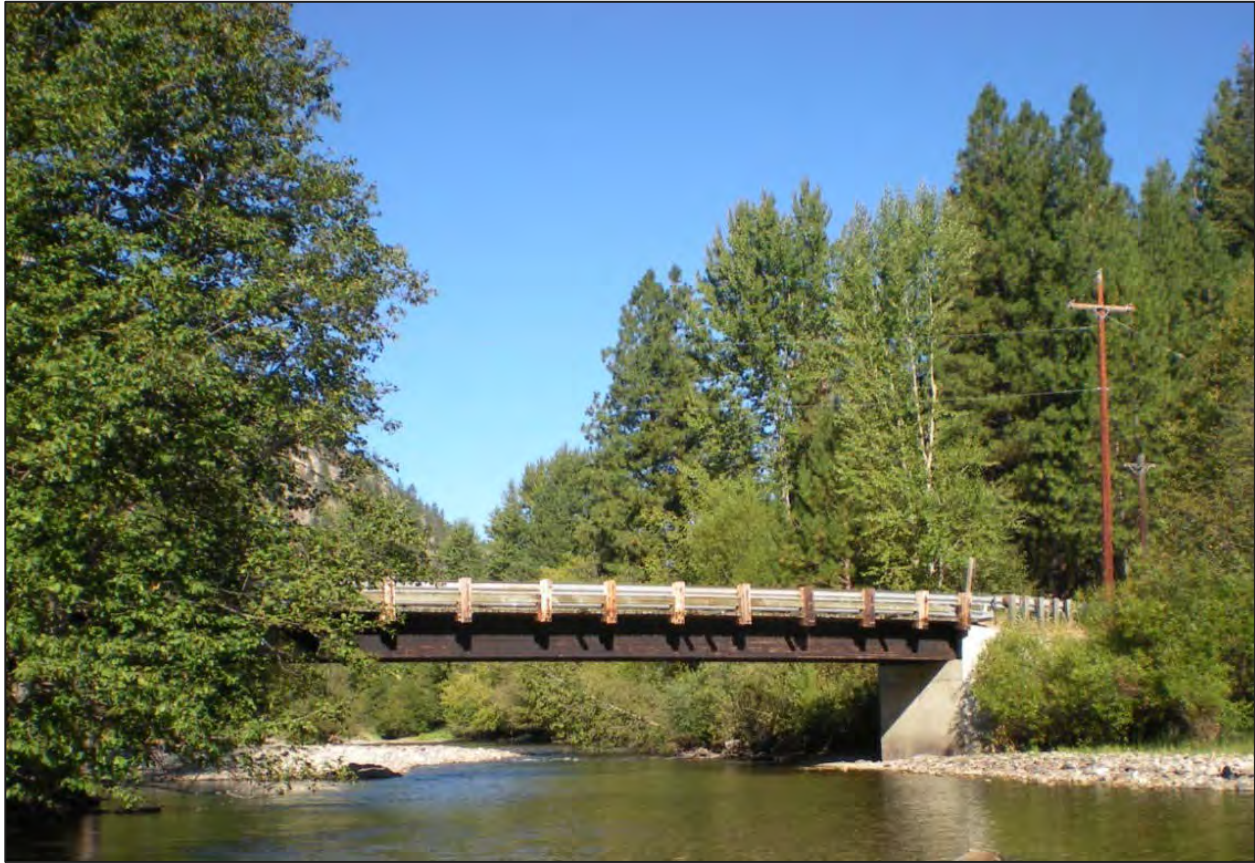
hydraulic contraction and expansion processes have also been impacted by the bridge and its associated abutments at RM 23.45 (Figure 32).

Figure 32. View looking upstream at the bridge crossing at RM 23.45. Bedload deposition (gravel bar) caused by backwater effects of the constriction, can be seen upstream of the bridge.

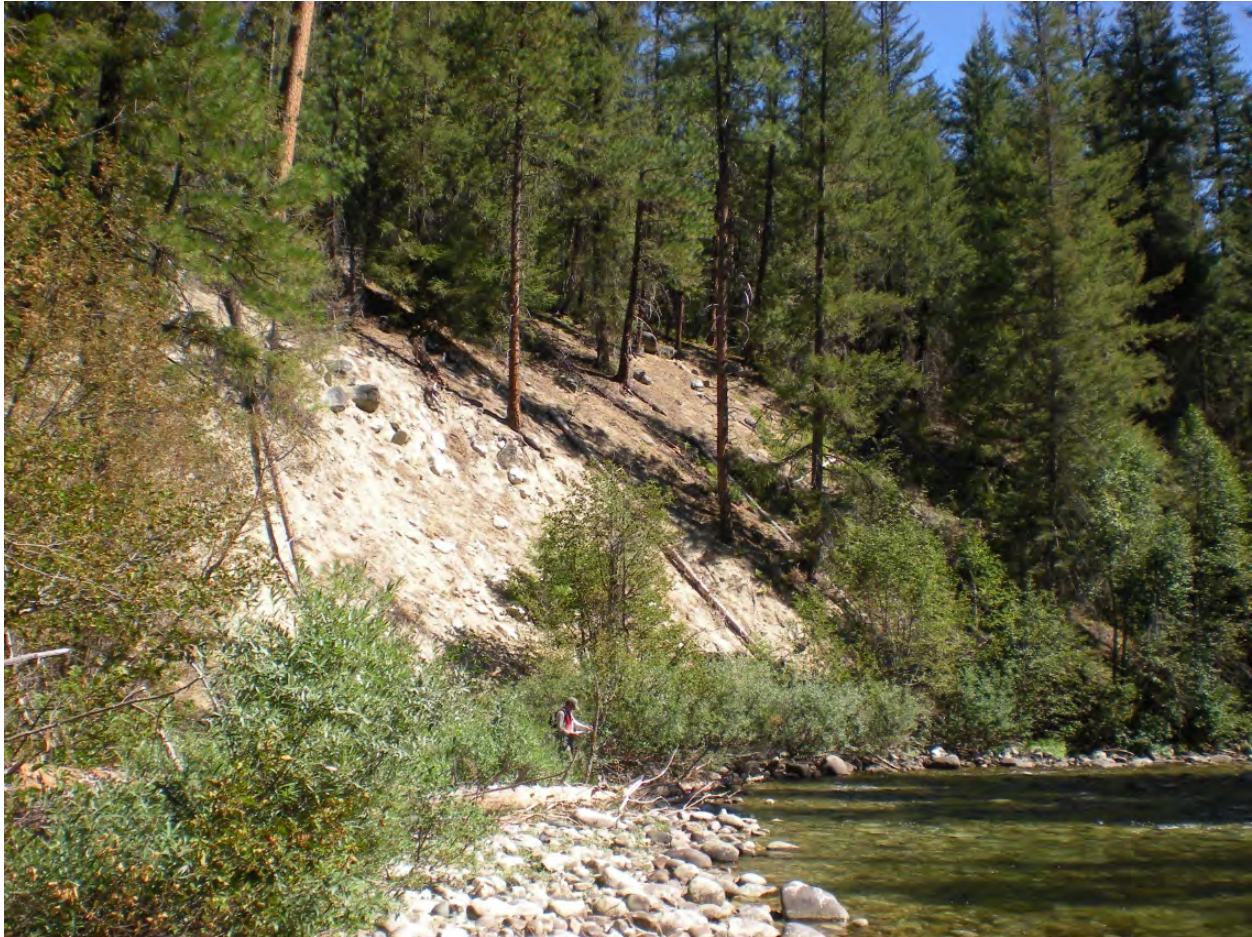
terrace scarps at several locations in the reach (Figure 47). Bank toes and bar surfaces within the study reach are armored by winnowing of smaller material during floods.

Figure 47. Fine sediment source within Reach 7.

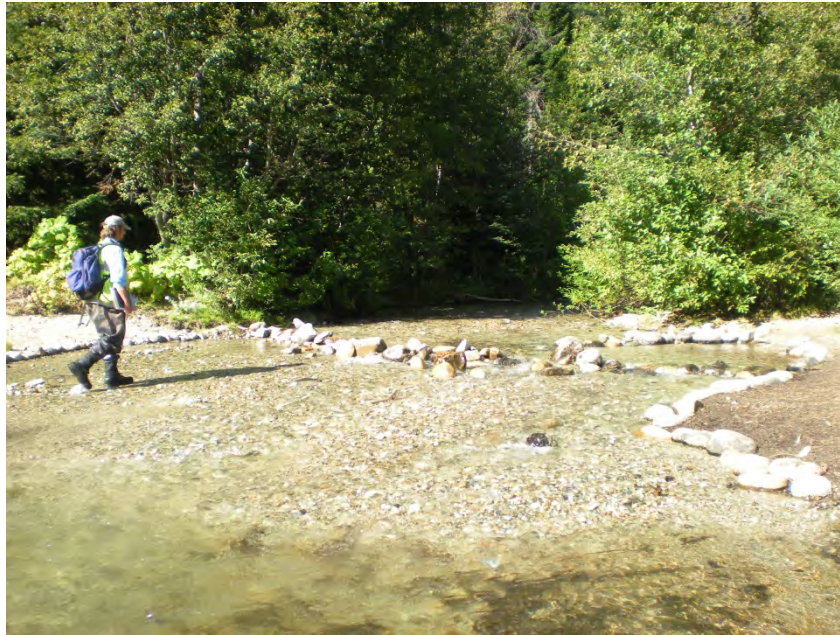
Figure 73. View of the mouth of Silver Creek where recreational river users have constructed a dam using large cobble.

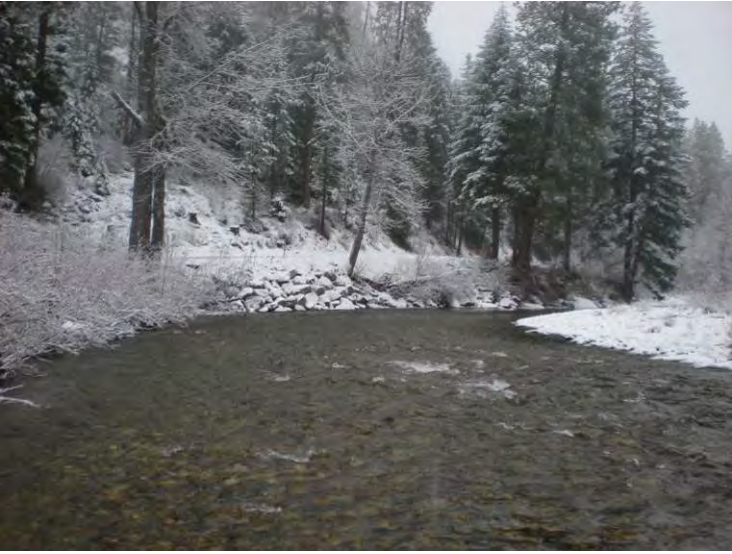
View looking downstream at riprap bank at RM 25.8. November 2012.

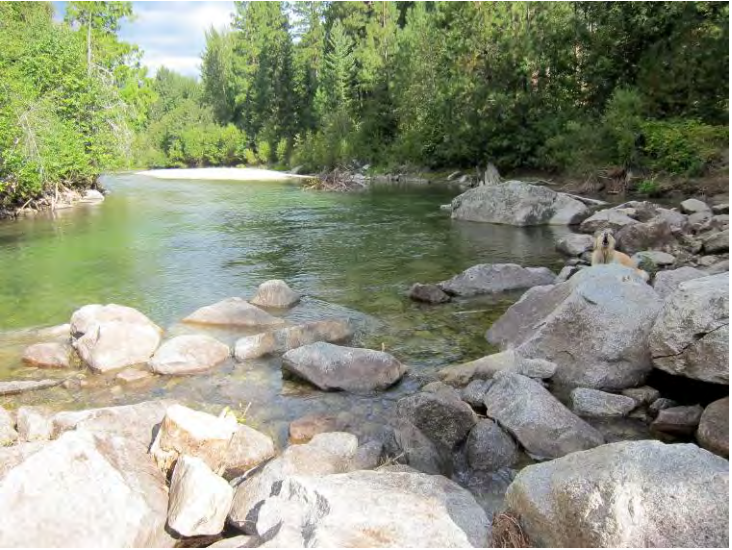
View looking upstream at pool at RM 25.53. August 2012.

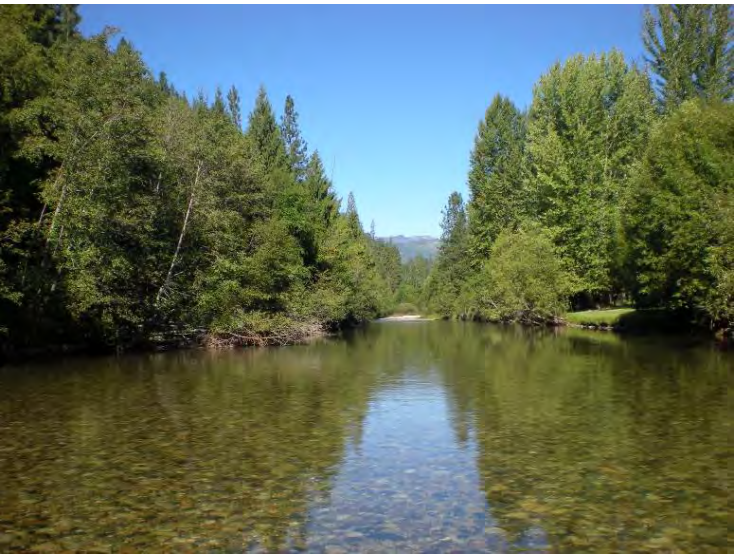
View looking upstream at straight, uniform channel from near RM 23.7. September 2012.
0	Project RM 23.65L	Reach 0 LB Riparian Restoration and Protection	Riparian restoration Protection	The left bank riparian area and floodplain from the bridge (RM 23.45) up to RM 23.8 lies within a residentially developed area where riparian clearing (lawns) and past grading has impacted riparian and floodplain processes. This area is privately-owned and continued clearing and other impacts are possible. Plant cleared areas to provide long-term riparian and floodplain function.

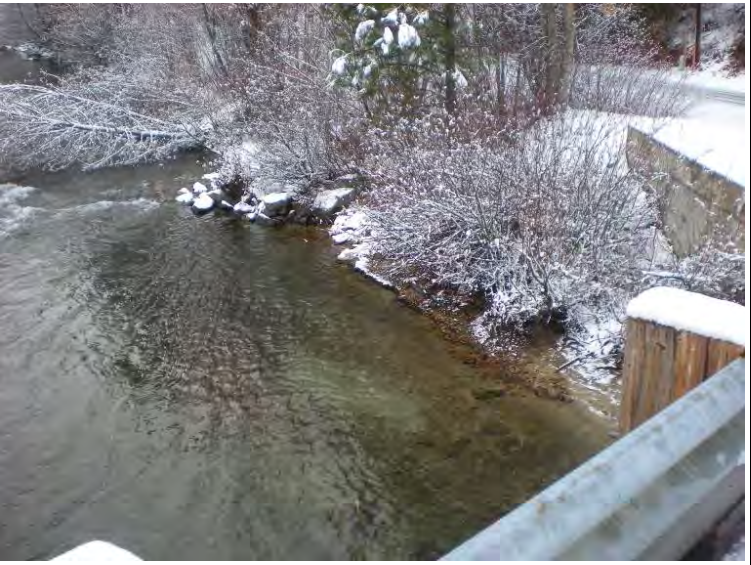
View looking upstream from bridge at river left bank and rock barb near RM 23.45. November 2012.

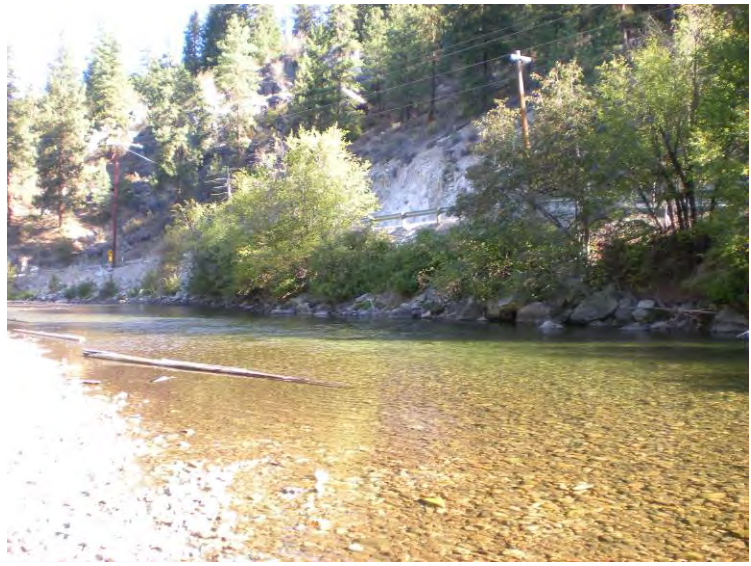
View looking upstream at riprap bank near RM 23.4. September 2012.
0	Project RM 23.3	Zerrener LW Enhancement	Off-channel habitat enhancement Placement of structural habitat elements	From 23.3 to 23.35 there is a depositional area where logjams would naturally form. There is some bar formation and split flow conditions at low flows. Apex and meander bend jams could be used to enhance cover, complexity, and lateral channel dynamics. Houses nearby.
