**LOWER PESHASTIN TRIBUTARY AND REACH ASSESSMENT**

**APPENDIX A    STREAM HABITAT REACH REPORTS**

**A-1 REACH 1**

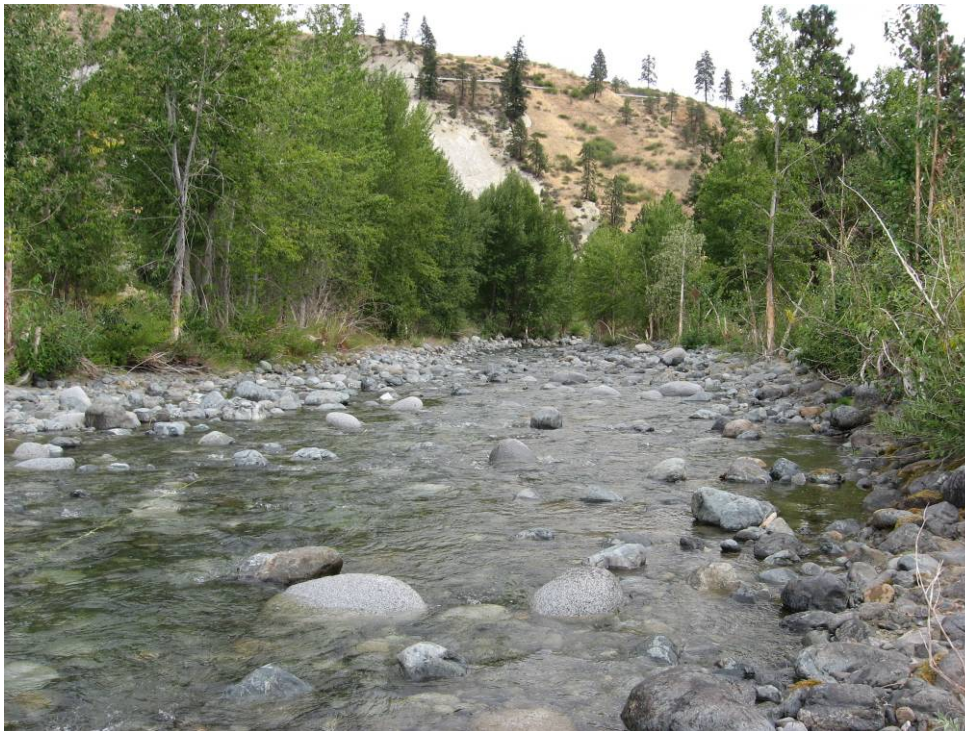
Channel morphology in Reach 1 is dominated by plane-bed segments with infrequent pool-riffle sequences (Figure 3). Although the valley is unconfined, the channel itself is confined due to hydromodifications and incision into glacial outwash material. Bed gradients range from 1% to 2%. In some areas, steep bed slopes may be attributed to historical channel straightening in this reach. Average channel widths are approximately 35 feet (wetted width at time of survey); bankfull widths are more than twice as wide (73.5 ft). The average floodprone width exceeds 400 feet and is the largest relative to the other 4 reaches.

Figure 3. Downstream view in Reach 1 of Peshastin Creek. Approximate river mile 0.2.

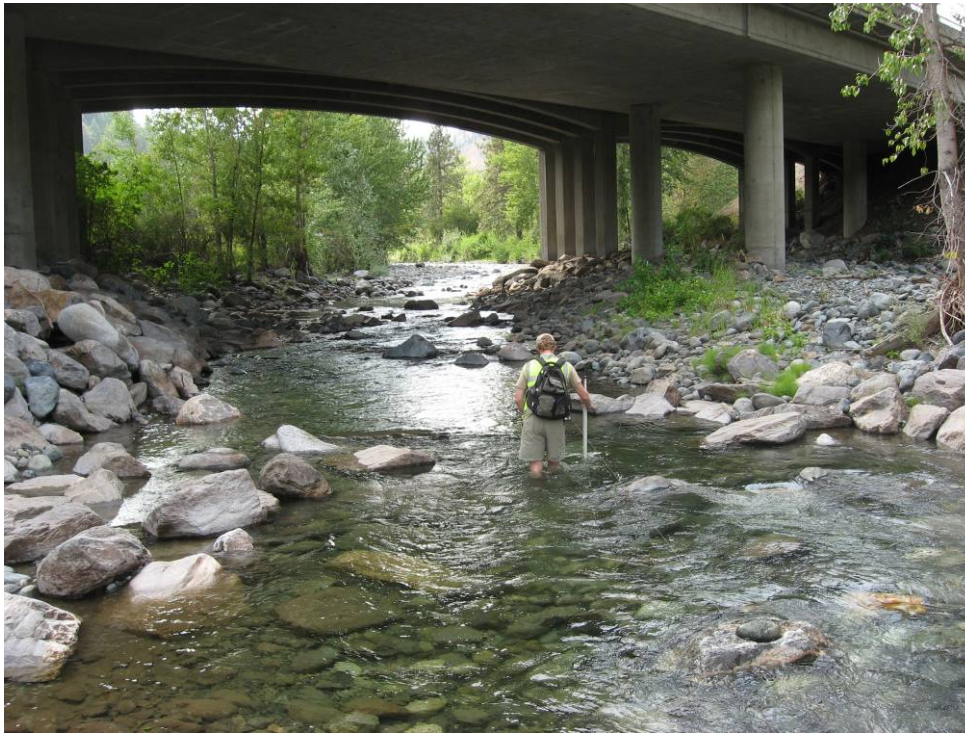
Human activities have modified the channel and associated riparian corridor within this reach. There are levees/road embankments where Highway 97 or other roadways abut the channel. The channel is constricted at two bridge crossings (RM 0.4 and 0.7) (Figure 9); and the lower 0.4 mile has been straightened and is currently incised and disconnected from the floodplain.

Figure 9. Hwy 97 Bridge at river mile 0.65.

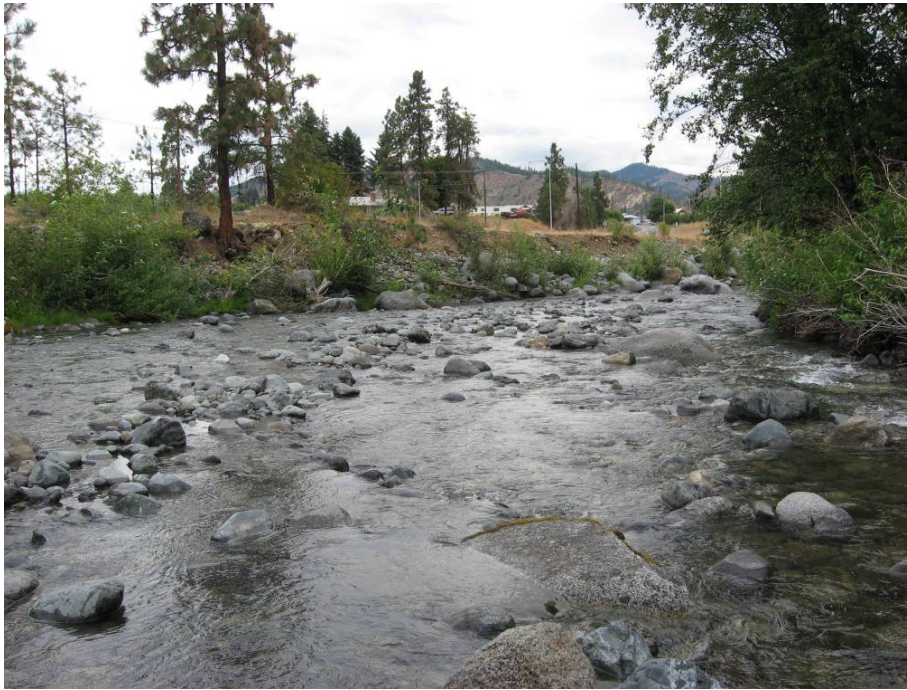
Vegetation in the riparian zone is heavily modified with few large trees in either the inner (near-channel) or outer zones (Figure 10 and Figure 11). The riparian corridor is confined to a narrow buffer through most of the reach. Roadways, residential development, and orchards lie adjacent to the reach and have impacted the width and species composition of the riparian corridor (Figure 12). There is very little shade provided by riparian vegetation and the potential for large woody debris recruitment in this reach is low.

Figure 12. Impacted riparian corridor along the river left bank near river mile 1.2.

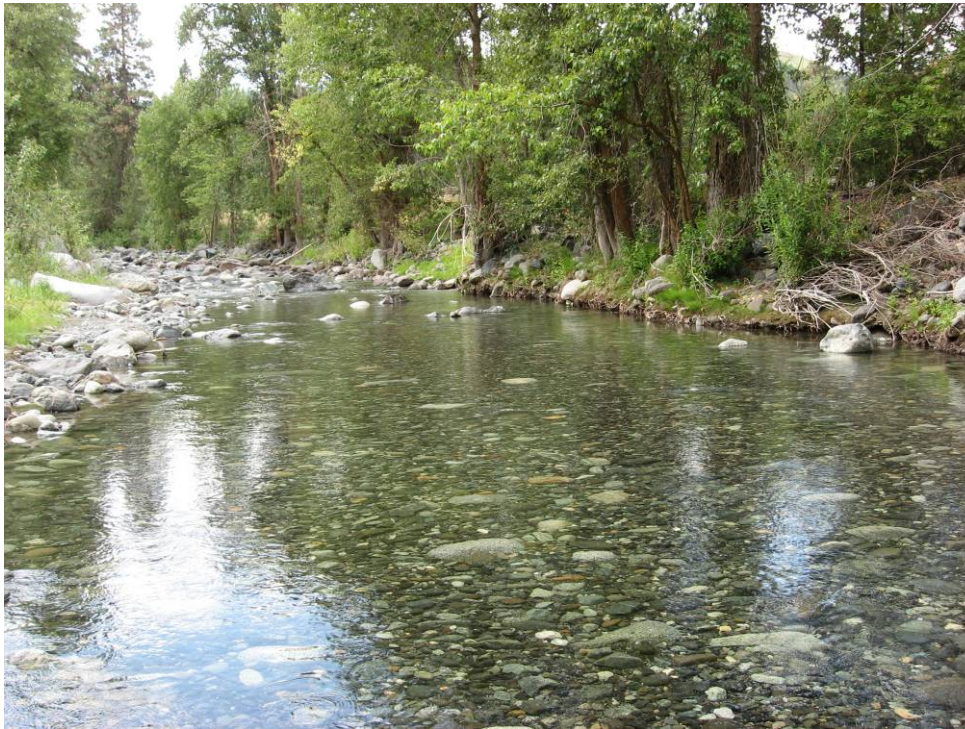
Figure 18. Typical pool in Reach 2 with minimal cover or habitat complexity. River mile 2.0.

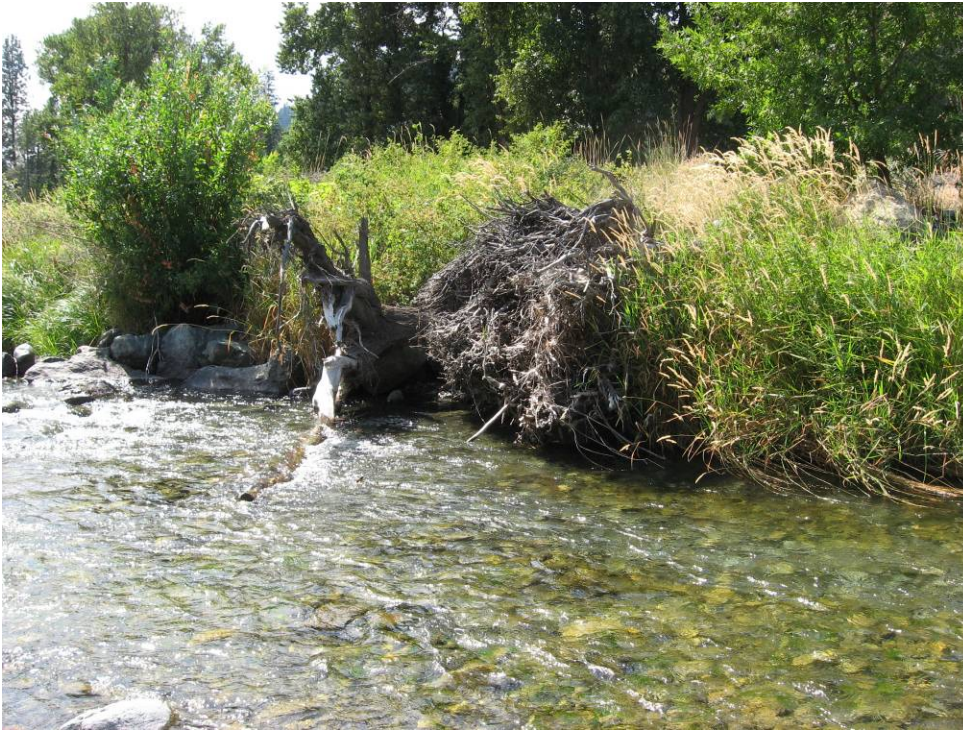
The coarse bed and high frequency of boulders provides areas of localized velocity refuge that may be utilized for rearing by juvenile steelhead and resident trout. Steelhead and Chinook spawning may occur in the handful of suitable pool tail-outs. A few logs with rootwads have been placed near river mile 4.2 on the left bank, presumably to provide habitat-friendly streambank protection (Figure 23).

Figure 23. Logs with rootwads placed for streambank protection and fish habitat near river mile 4.2.

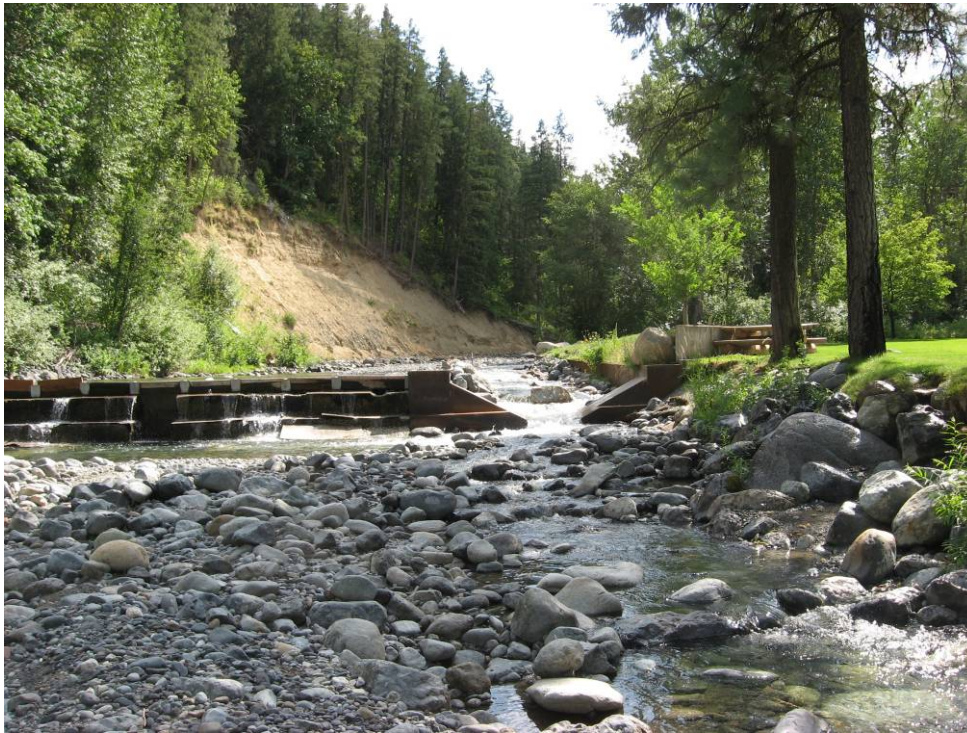
The irrigation diversion dam at RM 2.5 has recently (2005) undergone modification to provide fish passage. This structure now has a fish passage channel on the river left side of the dam (see Figure 24).

Figure 24. Irrigation diversion dam and fish passage channel at river mile 2.5.

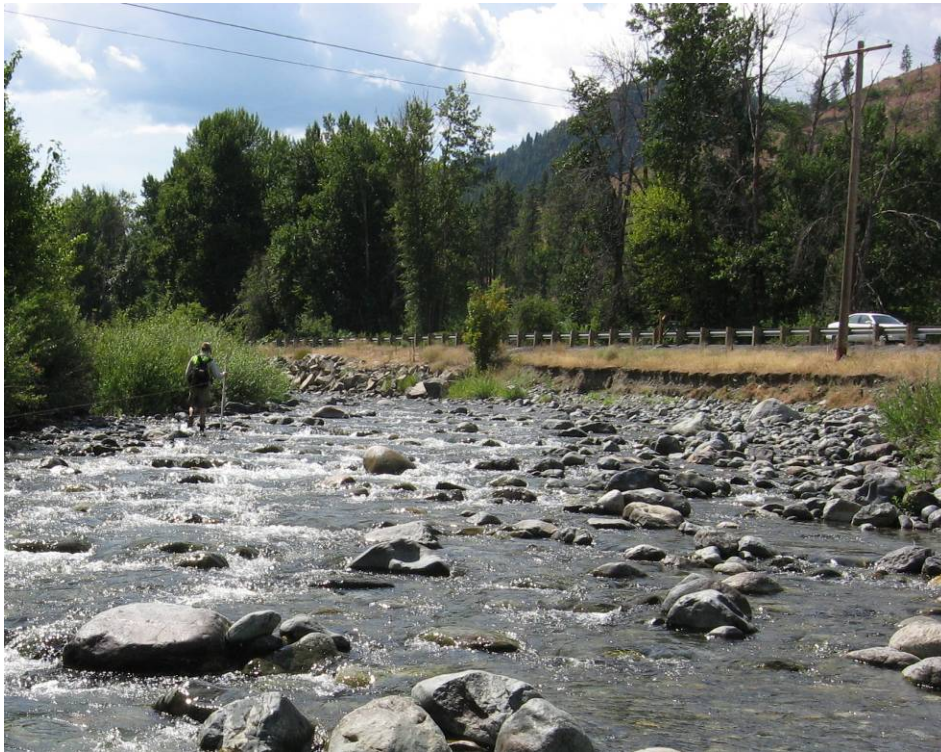
Vegetation in the riparian zone is heavily modified. The riparian corridor is confined to a narrow buffer through most of the reach. Roadways, residential development, and orchards lie adjacent to the reach and have impacted the width and species composition of the riparian corridor (Figure 25). There are no large trees in either the inner (near-channel) or outer zones (Figure 26 and Figure 27). Shrub/seedling size classes dominate the inner zone and grass/forbes dominate the outer zone. There is inadequate riparian vegetation that is necessary to provide stream shade, bank stabilization, and LWD recruitment.

Figure 25. Impacted riparian corridor and rip-rap bank along Highway 97 near river mile 4.1 (river left bank).

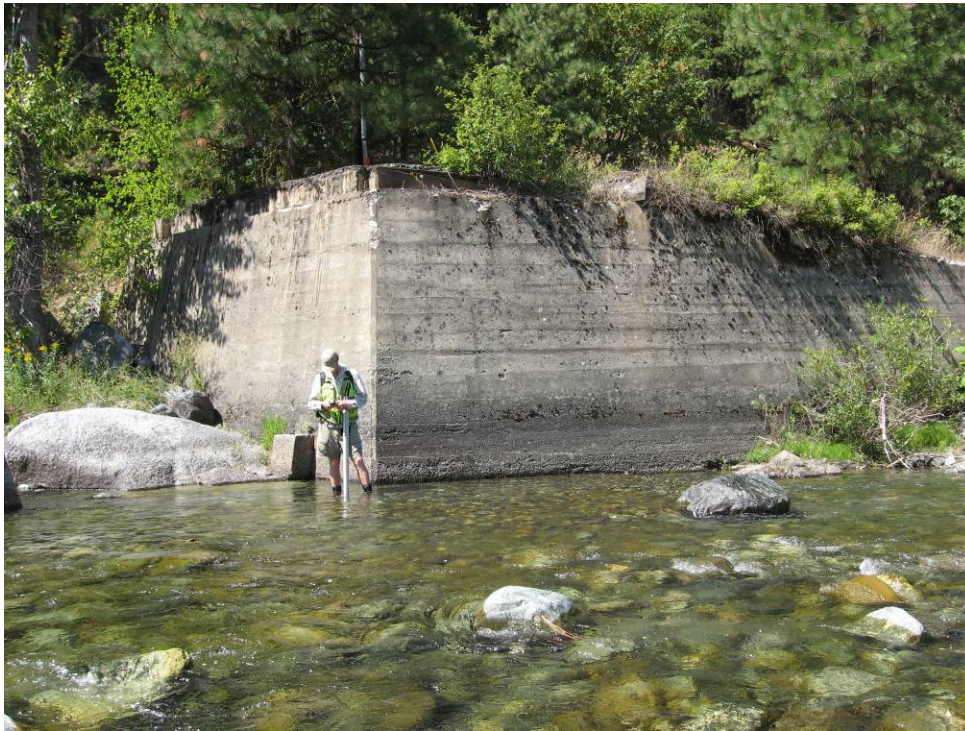
Aside from the presence of Highway 97, general clearing and thinning of vegetation along the riparian corridor is the predominant human disturbance in this reach. There is a concrete bridge abutment at RM 5.25 (Figure 35) that extends for approximately 30 feet on river left.

Figure 35. Concrete bridge abutment (no longer used) at river mile 5.3.

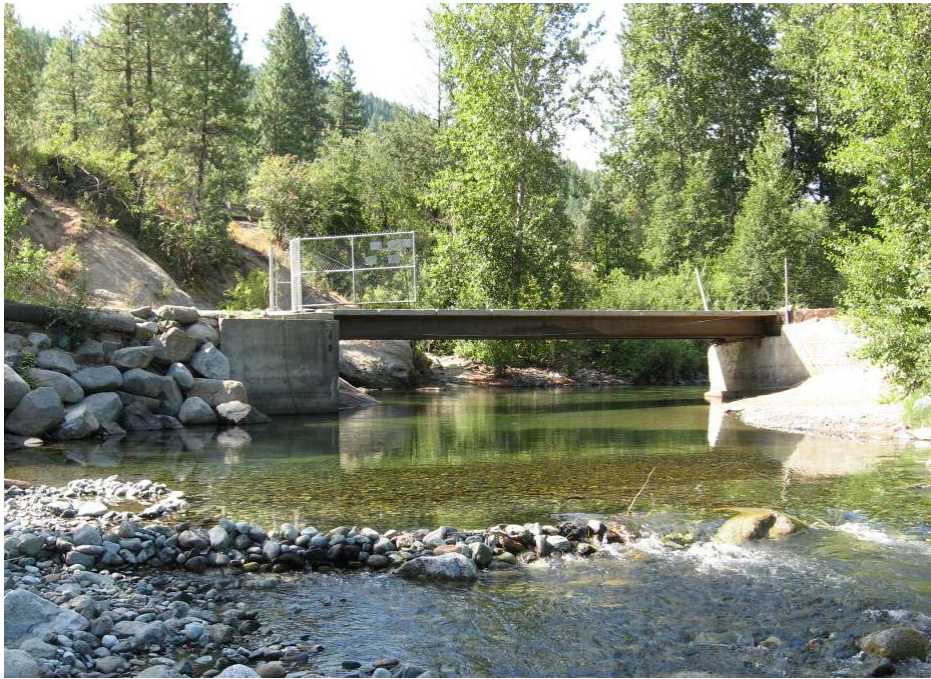
Figure 47. Private bridge crossing near river mile 6.5.

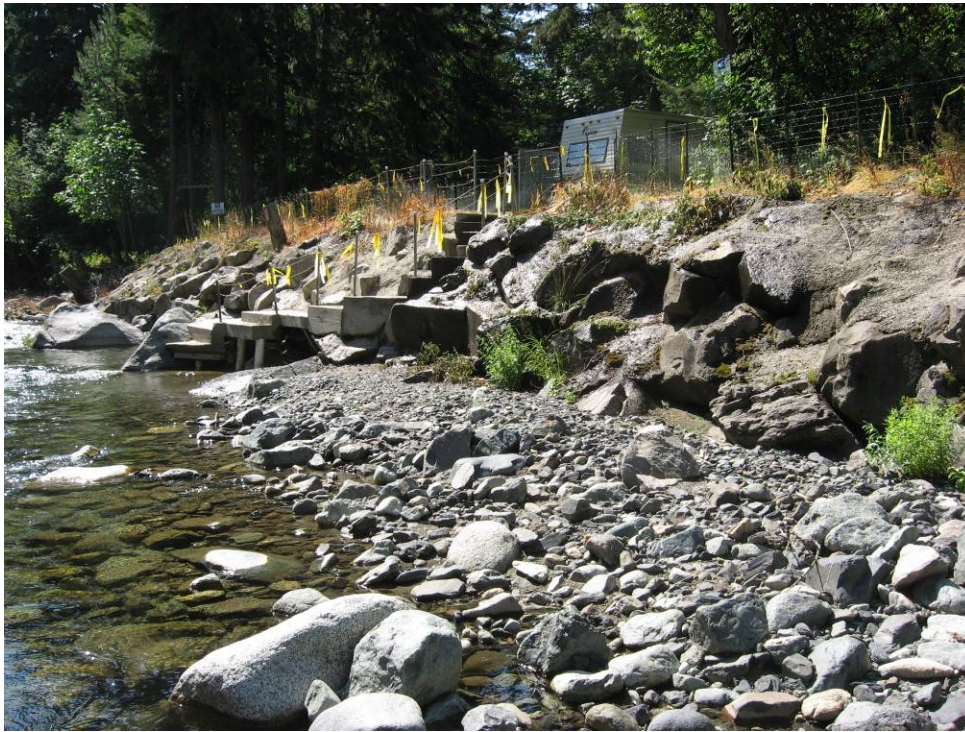
Figure 57. Bank armoring on river left bank near river mile 8.1.

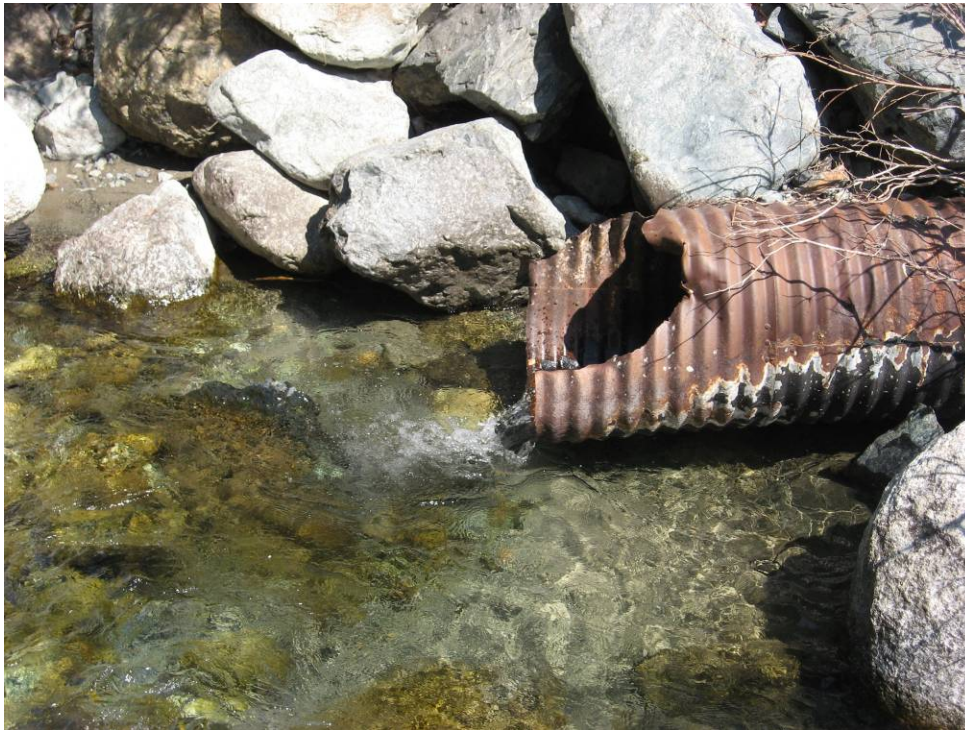
Figure 58. Culvert entering the mainstem on the river right bank near river mile 8.4.
