### Index of Existing Reach Assessment Data

### Reach Assessment Map Series

**Beaver Creek Reach Assessment**  
**Survey Area Topography and Existing Features**

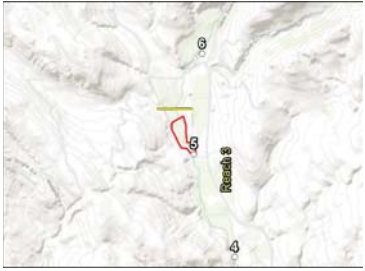
Project Area 9 – RM 5.0 to 5.3	<ul style="list-style-type: none"> <li>- Install LWD structures (whole trees, jams, etc.)</li> <li>- Secondary channel (non-perennial) creation/enhancement</li> <li>- Alcove creation/enhancement</li> <li>- Pool creation/enhancement</li> </ul>	<p>Project area includes Upper Schoolhouse restoration project, large complex jam at upper end of project area.</p> <p>Install large wood habitat structures in areas that have not received restoration actions to increase floodplain connectivity, create habitat complexity and hydraulic diversity.</p> <p>Construct perennial side channels and alcoves in areas that have not received restoration actions to create juvenile rearing habitat.</p>	17

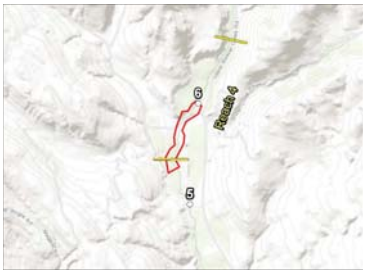
Project Area 10 – RM 5.3 to 6.0	<ul style="list-style-type: none"> <li>- Road grading and drainage improvements</li> <li>- Road decommissioning or abandonment</li> <li>- Remove non-native plants</li> <li>- Riparian planting</li> <li>- Remove bank armoring</li> <li>- Install LWD structures (whole trees, jams, etc.)</li> <li>- Remove and/or relocate floodplain infrastructure</li> <li>- Reconnect/enhance cold water springs</li> <li>- Perennial side channel creation/enhancement</li> <li>- Secondary channel (non-perennial) creation/enhancement</li> <li>- Wetland creation/enhancement</li> <li>- Alcove creation/enhancement</li> <li>- Groundwater fed off-channel habitat enhancement</li> <li>- Pool creation/enhancement</li> </ul>	<p>Project area has been confined by anthropogenic actions and straightened in many areas, with disconnected side channels.</p> <p>Install large wood habitat structures to increase floodplain connectivity, create habitat complexity and hydraulic diversity.</p> <p>Remove bank armoring where feasible throughout project area.</p> <p>Consider alternatives to relocate Bally Hill Road and private drive crossings and remove road fill and abutment construction to increase floodplain connectivity.</p> <p>Evaluate bridge crossings in project area for potential improvements to floodplain connectivity.</p> <p>Construct perennial alcoves in relic channel meanders in road fill removal locations and at confluence of Storer Creek to provide juvenile rearing.</p> <p>Improve road drainage systems at Storer Creek and other areas of the Upper Beaver Creek Road to reduce chronic sediment inputs.</p>	5

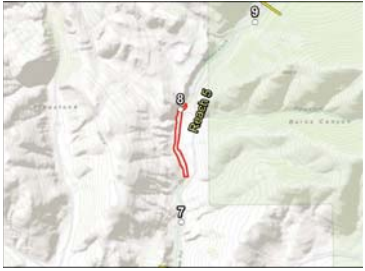
Project Area 13 – RM 7.4 to 8.1	<ul style="list-style-type: none"> <li>- Road grading and drainage improvements</li> <li>- Install LWD structures (whole trees, jams, etc.)</li> <li>- Reconnect/enhance cold water springs</li> <li>- Perennial side channel creation/enhancement</li> <li>- Secondary channel (non-perennial) creation/enhancement</li> <li>- Alcove creation/enhancement</li> <li>- Pool creation/enhancement</li> </ul>	<p>Channel confined in tight valley, limited floodplain and side channels, exposed bedrock throughout project area.</p> <p>Install large wood habitat structures to increase scour pool habitat for habitat complexity.</p> <p>Place large wood structures to aggrade channel for increased floodplain connectivity and to access relic side channels at more frequent flows.</p> <p>Construct perennial alcove at Piper Creek confluence for juvenile rearing and high-flow refugia.</p> <p>Improve road drainage systems at Burns Creek and other areas of the Upper Beaver Creek Road to reduce chronic sediment inputs.</p>	13

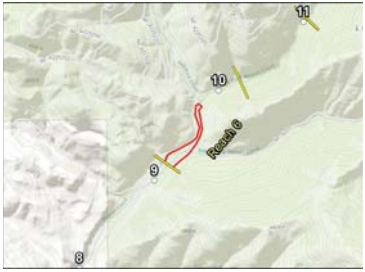
Project Area 15 – RM 9.2 to 9.8	<ul style="list-style-type: none"> <li>- Recreation Management</li> <li>- Road grading and drainage improvements</li> <li>- Install LWD structures (whole trees, jams, etc.)</li> <li>- Remove and/or relocate floodplain infrastructure</li> <li>- Groundwater fed off-channel habitat enhancement</li> <li>- Pool creation/enhancement</li> <li>- Evaluate fish passage at diversions</li> </ul>	<p>Single thread channel in confined valley, with little available floodplain, and undersized culvert at NF-4225 crossing.</p> <p>Install large wood habitat structures to create habitat complexity and hydraulic diversity</p> <p>Replace or repair culvert at NF-4225 crossing to improve the passage of flow, sediment, and woody debris to reduce the risk of catastrophic failure.</p> <p>Evaluate alternatives for recreation management to reduce impacts.</p>	18

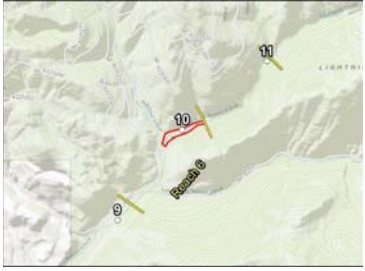
Project Area 16 – RM 9.8 to 10.2	<ul style="list-style-type: none"> <li>- Recreation Management</li> <li>- Road grading and drainage improvements</li> <li>- Install LWD structures (whole trees, jams, etc.)</li> <li>- Alcove creation/enhancement</li> </ul>	<p>Single thread channel in confined valley, with sparse floodplain availability and limited access. Install large wood habitat structures in lower portion of project area to create habitat complexity.</p> <p>Construct large perennial alcove at Volstead Creek confluence for juvenile rearing habitat.</p> <p>Hand-fell existing trees or helicopter place woody debris in upper portion of project area to increase habitat complexity.</p> <p>Evaluate alternatives for recreation management to reduce impacts.</p> <p>Improve NF-200 Road crossings on Volstead Creek to reduce chronic sediment inputs or relocate road.</p>	19
