Appendix B: Chewuch Project Opportunities

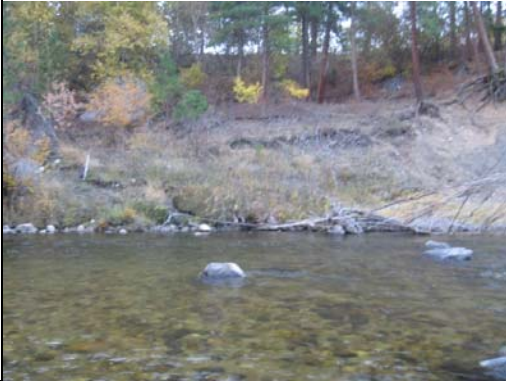
<p>View to the east at the river left bank near RM 2.44 at a potential LWD location. November 2009.</p>
2a	Project RM 2.68L	Outer Zone 5 (OZ-5)	Off-Channel Habitat Enhancement	Wetland habitat enhancement	At the downstream end of OZ-5, a long, narrow wetland occupies an area that was an active side-channel in 1954. There does not appear to be an upstream surface connection. The wetland appears to be groundwater fed with a downstream surface water connection with the main channel near RM 2.65. The outlet channel has a passable gradient and likely provides access to quality off-channel habitat in its current condition. There is an opportunity to increase habitat cover and complexity in the off-channel complex using LWD. Passage conditions at the outlet should also be further investigated to ensure year-round passage.

Reach	Project Number	Sub-Unit	Strategy Category	Project Name	Description	Photo
2a	Project RM 2.44L	Inner Zone 2 (IZ-2)	Instream Habitat Enhancement	LWD enhancement	This project is located at a pool tail-out just upstream of a riffle crest. The river left bank is low near 2.44, with low-velocity habitat along the bank. A LWD jam would create and maintain pool scour and enhance existing in-stream habitat.

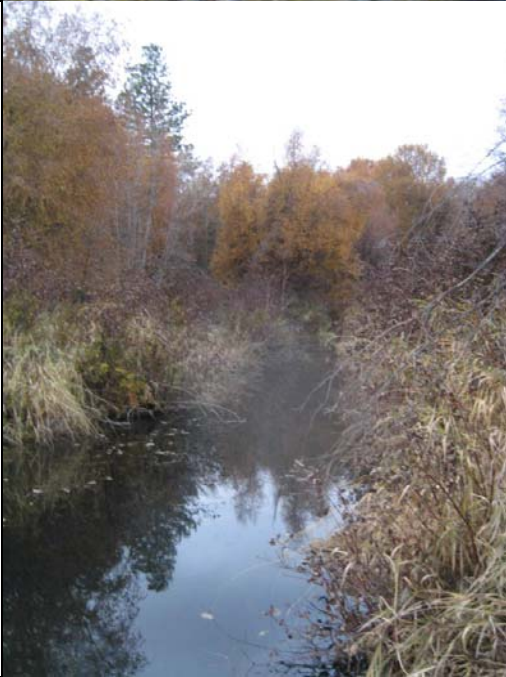
<p>View to the north in the upstream direction at a wetland located at the down-stream end of OZ-5 near RM 2.65. November 2009.</p>

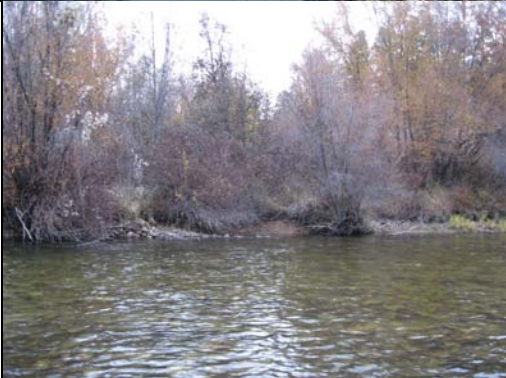
<p>View to the east at the river left bank near RM 2.65 where LWD could enhance in-stream habitat. November 2009.</p>

2a	Project RM 2.65L	Inner Zone 2 (IZ-2)	Instream Habitat Enhancement	LWD enhancement	At this location, LWD would be used to enhance existing streamside riparian willows and alders that are currently providing limited cover to an area of slow water along the river left bank near RM 2.65.

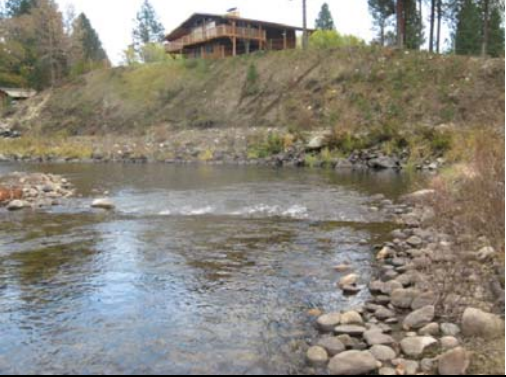
<p>View to the south in the downstream direction at riprap along the river right bank near RM 2.75. November 2009.</p>
2a	Project RM 2.87R	Inner Zone 2 (IZ-2)	Reconnect Stream Channel Processes	Side-channel habitat reconnection	There is one location in IZ-2 where the historical channel position has been relatively dynamic. A steady eastward meander migration has resulted in almost 500 ft of lateral change since 1945, and the formation of a large gravel point bar and side-channel between RM 2.76 and 2.94. This channel currently functions as a frequently inundated high flow cut-off channel. Limited LWD is present near the upstream inlet. There is a well-defined channel that has a gravel bed with a high percentage of fines. The channel spreads out near the outlet and has several potential points of outflow, large sand deposits, and stabilizing vegetation that has colonized sand and gravel bars. There are several large pines that are being recruited on the opposite bank from the outflow.

Reach	Project Number	Sub-Unit	Strategy Category	Project Name	Description	Photo
2a	Project RM 2.75R	Inner Zone 2 (IZ-2)	Reconnect Stream Channel Processes	Riprap removal or modification	Along river right near RM 2.75, there is approximately 450 ft of riprap protecting the toe of the glacial terrace and creating a barrier to channel floodplain connection at the upstream end of DOZ-2. This riprap is located on the outside of a meander bend. Look for opportunities to remove the rip-rap and replace with LWD meander jams or enhance the riprap in situ with LWD. Adjacent residential development will be a potential significant constraint.

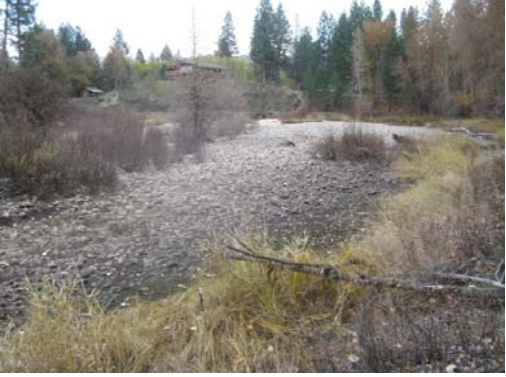
<p>View to the south in the downstream direction at the outflow of a high flow side-channel near RM 2.76. November 2009.</p>

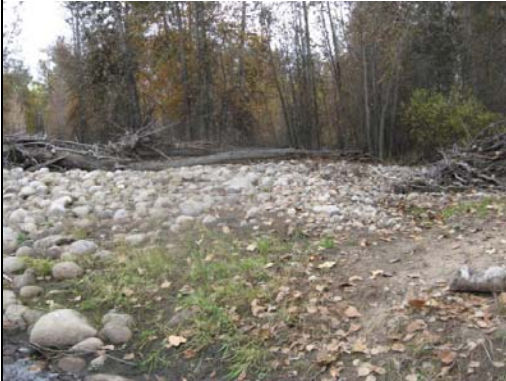
<p>View to the south in the downstream direction at the inlet to a high-flow channel near RM 3.9. November 2009.</p>
2a	Project RM 4.15L	Inner Zone 1 (IZ-1)	Reconnect Stream Channel Processes	Side-channel habitat reconnection.	An opportunity exists here to enhance an existing high-flow cut off channel by select excavation of material to reduce the elevation of the side-channel bed and placing bar apex LWD jams to direct flow into the side-channel. Creating perennial flow through the channel would increase the availability of off-channel habitat.

2a	Project RM 3.85R	Inner Zone 1 (IZ-1)	Reconnect Stream Channel Processes	Side-channel habitat reconnection	At this site, a high-flow split channel extends between RM 3.75 and 3.9. The channel is well-defined with a gravel and cobble bed. There is an existing apex LWD jam at the inlet to the channel. This jam could be enhanced to increase lateral channel dynamics and the frequency of inundation.

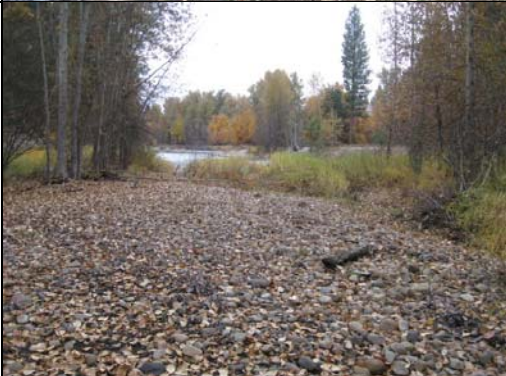
<p>View to the south in the downstream direction at the outflow of a side-channel near RM 4.1. November 2009.</p>

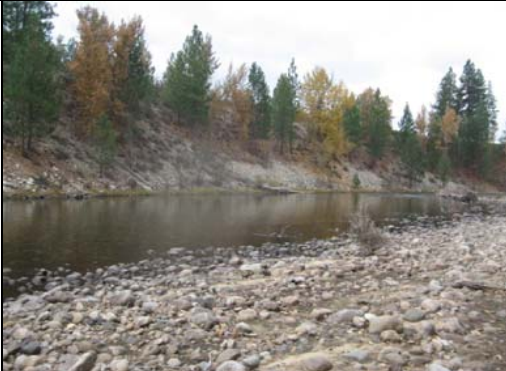
<p>View to the southeast in the downstream direction at a potential LWD jam location along river left near RM 4.45. November 2009.</p>
2a	Project RM 4.65L	Inner Zone 1 (IZ-1)	Reconnect Stream Channel Processes	Side-channel habitat reconnection	This project combines elements of Projects RM 5.3L and 5.25L. There is a high-flow cut-off channel on the inside of a meander bend extending between RM 4.5 and 7.73, similar to Project RM 5.25. However, this high-flow channel is well defined and experiences more frequent ground disturbing flow similar to Project RM 5.3. Sand deposition at this site is similar to RM 5.3L. A combination of excavation and LWD placement could increase low flow connection and habitat in this side-channel.

2a	Project RM 4.45L	Inner Zone 1 (IZ-1)	Instream Habitat Enhancement	LWD enhancement	A long pool runs along the outside of the bend along river left in this area. LWD structures along the river left bank would encourage scour to enhance pool formation, provide cover and increase habitat quality. The proposed location is at the toe of the glacial terrace, which is composed of unconsolidated alluvial material. There is a home built near the top of the bank. Excess erosion of the bank may be undesirable at this location.

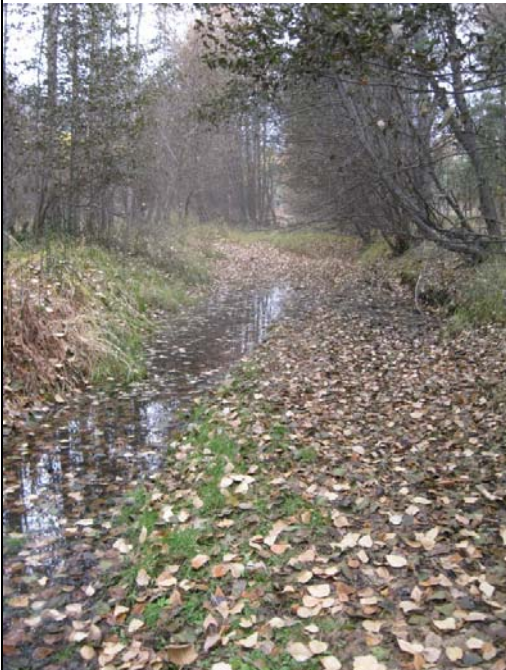
<p>View to the northwest in the upstream direction at groundwater collected in a high-flow channel near RM 4.5. November 2009.</p>

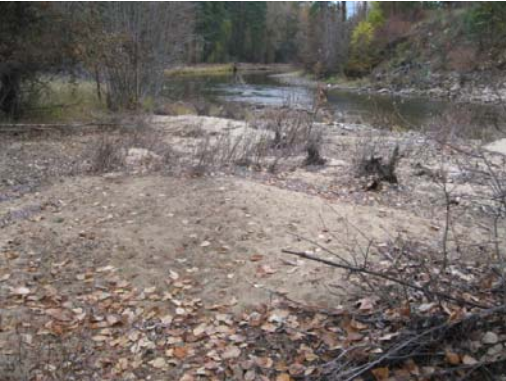
<p>View to the south in the downstream direction at the outflow of a network of high-flow channels near RM 5.21. November 2009.</p>

Reach	Project Number	Sub-Unit	Strategy Category	Project Name	Description	Photo
2a	Project RM 4.75C	Inner Zone 1 (IZ-1)	Instream Habitat Enhancement	LWD enhancement	There are a series of actively migrating meander bends between RM 4.55 and 4.95. There are opportunities to place several large meander bend jams on outside bends to mimic jams formed through natural recruitment. Jams would increase scour pool development and habitat cover and complexity.	
2a	Project RM 5.25L	Inner Zone 1 (IZ-1)	Reconnect Stream Channel Processes	Side-channel habitat reconnection	This site consists of a large point bar with a network of high-flow channels located at the inside of a tight meander bend between RM 5.2 and 5.3. The frequency of flow through these channels is variable, with decreasing scour farther from the channel. Bar apex LWD jams and select excavation could be used to enhance side-channel connectivity across the bar. The meander appears to be actively migrating to the west, away from the project location. The river's abandonment of the constructed channel could be a possibility in the future.

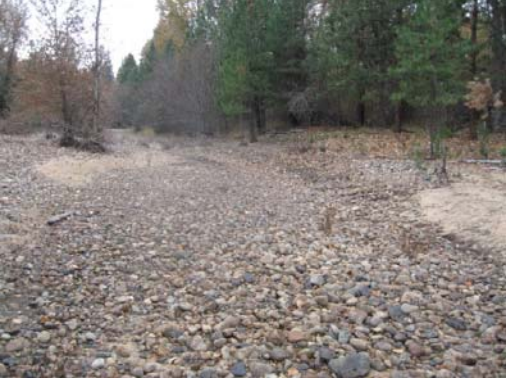
<p>View to the southeast in the downstream direction at the upstream end of a large high-flow channel near RM 5.47. November 2009.</p>

2a	Project RM 5.3L	Inner Zone 1 (IZ-1)	Off-Channel Habitat Enhancement	Side-channel habitat enhancement	This project involves enhancing existing side-channel habitat in a large high-flow side channel that extends between RM 5.1 to 5.5. At the upstream end, the side-channel is well-defined and frequently scoured by high energy flows. The low water surface is about 3 ft below the bed of the side channel. Bed material fines to sand near the downstream end of the side channel and there is a large deposit of sand at the outlet. Enhancing flow in the channel could increase velocities and maintain a sand-free bed that is suitable for salmonid habitat. The upstream end would require some excavation to create a split flow condition, or increase the frequency of flow through the side channel. LWD near the inlet to the side-channel could also enhance low-flow connection.

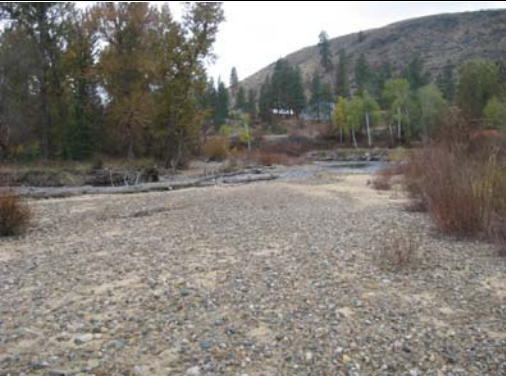
<p>View to the north in the upstream direction at a split flow location where some wood has naturally accumulated. November 2009.</p>

2a	Project RM 5.37C	Inner Zone 1 (IZ-1)	Reconnect Stream Channel Processes	Re-establish channel LWD dynamics	At this location, flow splits around a stable gravel bar. This is a natural wood deposition area. The project would involve creating new or enhancing existing bar apex LWD jams to re-establish inner zone dynamics and enhance cover habitat and complexity.

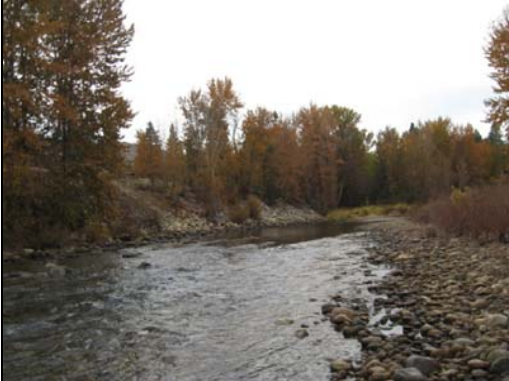
<p>View to the north in the upstream direction at a potential LWD placement along river right near RM 5.5. November 2009.</p>
2b	Project RM 5.6L	Inner Zone 2 (IZ-2)	Instream Habitat Enhancement	LWD enhancement	A transverse riffle orients flow into the river-left bank. A meander-bend log jam would provide cover, enhance scour for pool formation, and provide bank stability.	
2b	Project RM 5.69R	Inner Zone 2 (IZ-2)	Instream Habitat Enhancement	LWD enhancement	There is an exposed root mass and undercut bank providing limited cover to a shallow pool along the river-right bank near RM 5.69. A LWD meander bend jam would enhance existing habitat through creating and maintaining pool scour and increasing habitat cover and complexity.

Reach	Project Number	Sub-Unit	Strategy Category	Project Name	Description	Photo
2a	Project RM 5.5R	Inner Zone 1 (IZ-1)	Instream Habitat Enhancement	LWD enhancement	This project involves LWD placement along the river right bank. LWD could enhance scour and pool formation and provide cover to enhance habitat. This project is located immediately upstream of a riffle crest and a narrow low surface that expands along the right side of the channel. The low surface is backed by a terrace with residential development

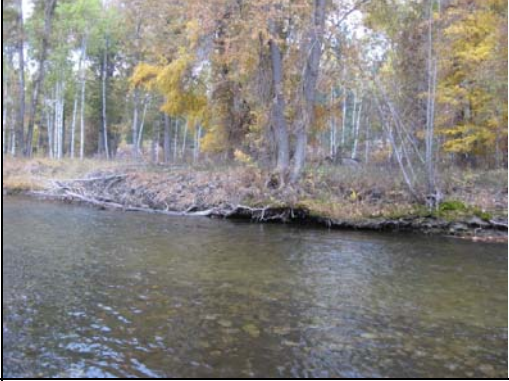
<p>View to the southwest in the downstream direction at the river-right bank near RM 5.76 where LWD could enhance existing habitat. November 2009.</p>

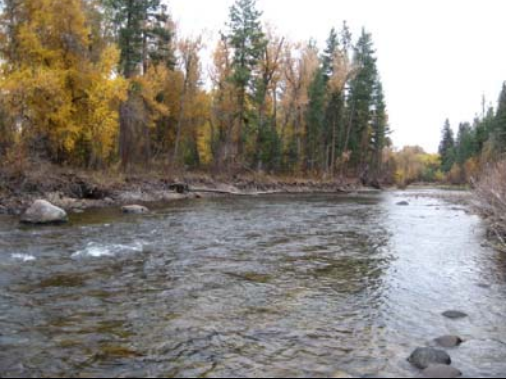
<p>View to the south in the downstream direction at bank erosion and LWD recruitment near RM 5.95. November 2009.</p>
2b	Project RM 6.1C	Inner Zone 1 (IZ-1)	Reconnect Stream Channel Processes	Re-establish channel LWD dynamics	This project involves several log jam placements between RM 6.17 and 6.07 to re-establish natural levels of LWD in the channel and the associate geomorphic processes. In addition, LWD will enhance existing instream habitat, add cover, and structure. At the upstream end of the project area near RM 6.17, LWD can be use to enhance an existing cut-bank that provides some cover and quality habitat. There are exposed root masses and overhanging riparian vegetation along the top of the cut-bank. Scour along the bank is caused by flow plunging over a transverse bar and flowing directly against the bank. Placing LWD at this location could increase scour depth and provide increased cover and habitat quality. Also near RM 6.16, a bar apex jam would be placed on a mid-channel gravel bar to encourage split flow and channel migration processes. At RM 6.07, a riffle tails out into the outside of a meander bend, creating a scour pool along the river right bank near RM 6.07. Unconsolidated alluvium in the bank is eroding, driving the recruitment of small woody debris. LWD could be placed along the bank to encourage dynamic inner zone processes and increase habitat quality.

Reach	Project Number	Sub-Unit	Strategy Category	Project Name	Description	Photo
2b	Project RM 5.95L	Inner Zone 1 (IZ-1)	In-Stream Habitat Enhancement	LWD enhancement	At this site, there is a long eroding bank section with active erosion of unconsolidated alluvium and limited LWD recruitment. Pool habitat could be enhanced with LWD meander jams to increase scour depth, lateral channel dynamics, and continued recruitment of LWD.

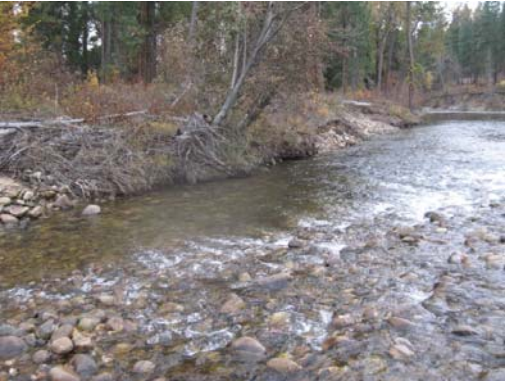
<p>View to the southeast in the downstream direction at a scoured cut-bank along river-left near RM 6.16. November 2009.</p>

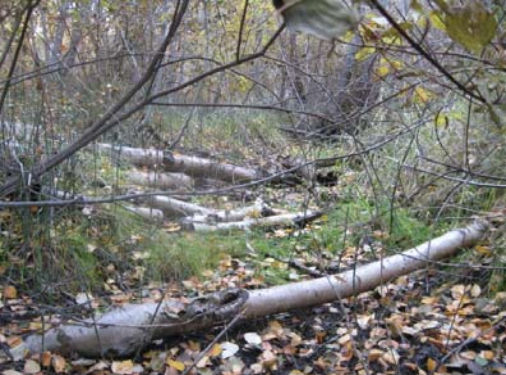
<p>Floodplain over flow channels in OZ-3 near RM 5.96. November 2009.</p>

2b	Project RM 6.1L	Outer Zone 3 (OZ-3)	Off-Channel Habitat Enhancement	High-flow habitat enhancement	Cadastral maps from 1915 place the active channel immediately upstream of this project. There are high flow channels associated with the older active channel and current flood overflow channels. Channel excavation and LWD placement could enhance the current connectivity of these high-flow channels to the active channel and create complex off-channel habitat.

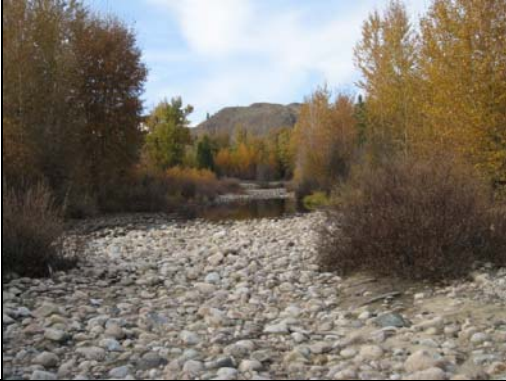
<p>View to the south in the downstream direction at a side-channel that is active during high flow near RM 6.8. November 2009.</p>
2b	Project RM 6.7R	Outer Zone 1 (OZ-1)	Off-Channel Habitat Enhancement	Wetland habitat enhancement	A meander scar provides wetland habitat made up of several small beaver ponds in this area. The upstream inlet is at RM 6.82, and the downstream outlet is at RM 6.62. At the inlet, the bank is high and there is no evidence of frequent conveyance of flood water. Where the channel scar hits the toe of the hillslope, groundwater fills low areas and the surface is wet and consists of a series of beaver ponds. This wet area becomes a more well-defined channel network in the downstream direction. A combination of LWD, channel excavation, and habitat enhancement would be used to enhance process dynamics and habitat connectivity as well as habitat quality through this area.

Reach	Project Number	Sub-Unit	Strategy Category	Project Name	Description	Photo
2b	Project RM 6.65C	Inner Zone 1 (IZ-1)	Reconnect Stream Channel Processes	Re-establish channel LWD dynamics.	Between RM 6.5 and 6.8 lateral channel migration has formed large gravel point bars, high-flow channels, and scour-pools. Several log jams at bar apexes and on the outsides of bends would increase side-channel connectivity and enhance inner zone processes such as scour, lateral channel dynamics, and future LWD recruitment.

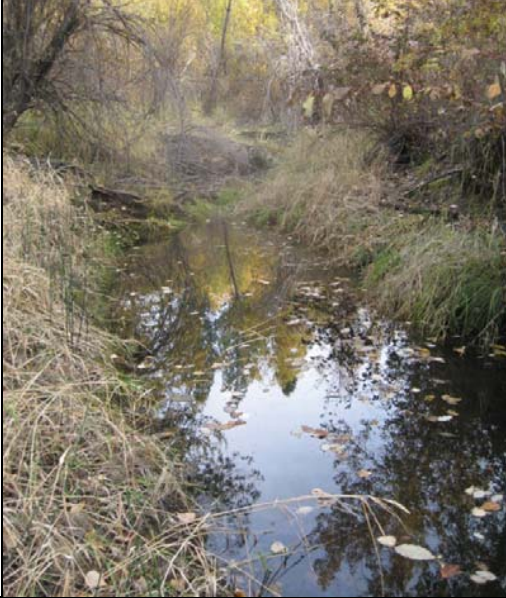
<p>View of off-channel wetland occupying a meander scar at the extreme west side of the floodplain near RM 6.82. November 2009.</p>

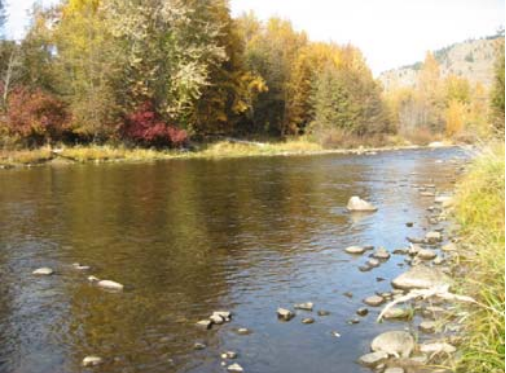
<p>View to the northwest in the upstream direction at a potential LWD location on the river-right bank near RM 6.95. November 2009.</p>
2b	Project RM 7.15L	Inner Zone 1 (IZ-1)	Reconnect Stream Channel Processes	Riprap removal or modification	There are 1,250 ft of riprap along river-left between RM 7.01 and 7.28 which creates a hardened 10-ft bank above the low flow water surface. Channel processes and floodplain connection are impaired by this modification. The riprap could be removed and replaced with LWD to provide bank protection and enhance in-stream habitat. Alternatively, the existing riprap could be enhanced with LWD to increase habitat cover and complexity.

Reach	Project Number	Sub-Unit	Strategy Category	Project Name	Description	Photo
2b	Project RM 6.95R	Inner Zone 1 (IZ-1)	In-Stream Habitat Enhancement	LWD enhancement	At this location, mature riparian trees overhang a long shallow pool. This location could be enhanced with LWD to increase scour depths, provide cover, and enhance in-stream processes.

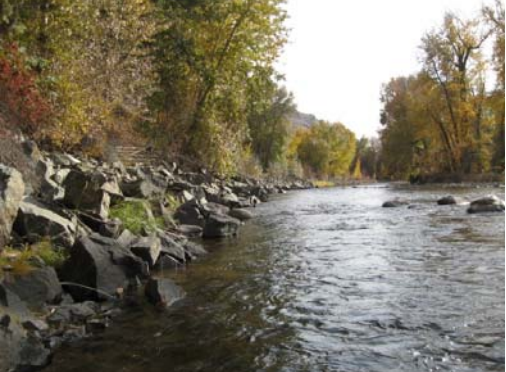
<p>View to the south in the downstream direction along the river-left bank near RM 7.28 where riprap has impaired in-stream processes and habitat. November 2009.</p>

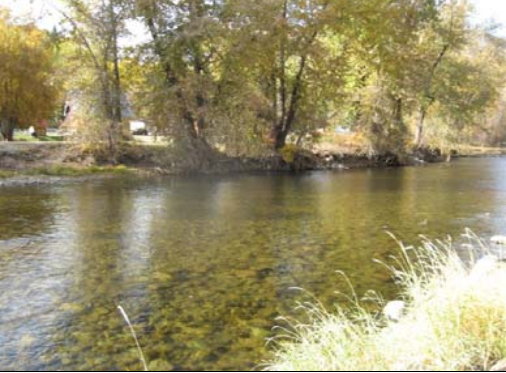
<p>View to the northwest in the upstream direction at the river-right bank near RM 7.2 where LWD could enhance in-stream habitat. November 2009.</p>
2b	Project CR_Prj-7.2 (USBR 2008b)	Outer Zone 1 (OZ-1)	Off-Channel Habitat Enhancement		The USBR has identified the entirety of OZ-1 as a restoration area with the primary goal of reconnecting primary side and overflow channels. The means to achieve this goal is stated as excavation of channel entrances and improving connectivity.

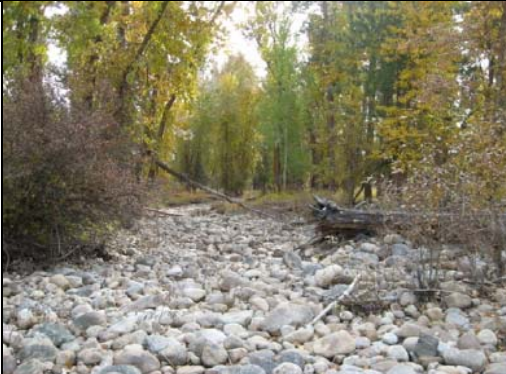
<p>View to the south in the downstream direction at the inflow to a side-channel along river-left near RM 7.48 (November 2009).</p>

3a	Project RM 7.42L	Inner Zone 2 (IZ-2)	Reconnect Stream Channel Processes	Side-channel habitat reconnection	An apex log jam and selected excavation would enhance flows into a high-flow cut-off channel across the floodplain margin of a large cobble point bar between RM 7.37 and 7.48. A log jam at the upstream end would create scour and encourage a split flow condition. LWD would also provide habitat cover and complexity.

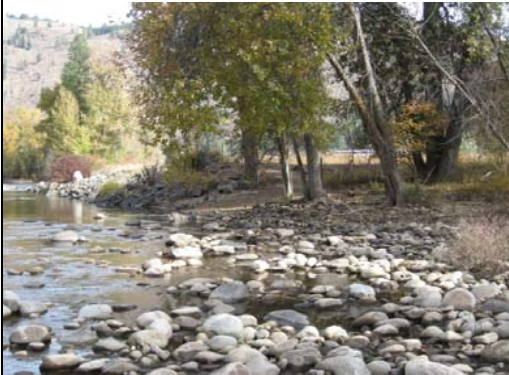
<p>View to the north in the upstream direction where livestock have accessed water along the river-left bank near RM 7.5 (November 2009).</p>
3a	Project RM 7.6L	Inner Zone 2 (IZ-2)	Reconnect Stream Channel Processes	Riprap removal or modification	There is a 400 ft long riprap bank along the river left near RM 7.6 that protects the toe of an eroding terrace. The terrace surface has been converted to agriculture. The riprap could be removed and replaced with log jams to enhance in-stream habitat and continue to provide bank protection. Alternatively, the existing riprap could be enhanced with additions of LWD to increase habitat cover and complexity. This project could be combined with restoration of a forested riparian buffer on the terrace in order to enhance long-term riparian functions including shading and LWD recruitment.

Reach	Project Number	Sub-Unit	Strategy Category	Project Name	Description	Photo
3a	Project RM 7.5L	Outer Zone 2 (OZ-2)	Riparian Restoration	Riparian habitat enhancement, fencing	The terrace to the east of the channel has been developed for agriculture. Cattle grazing and river access have degraded riparian vegetation. Riparian fencing and re-vegetation would enhance riparian habitat in this area.

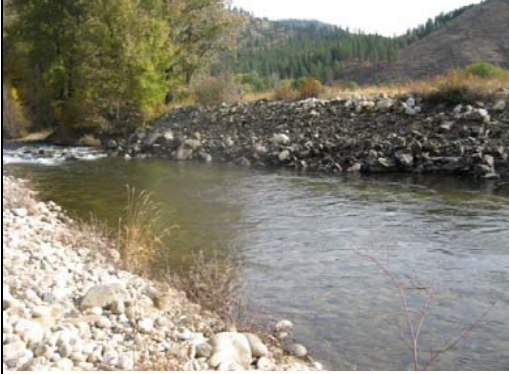
<p>View to the northeast in the upstream direction at riprap along the river-left bank near RM 7.6 (November 2009).</p>

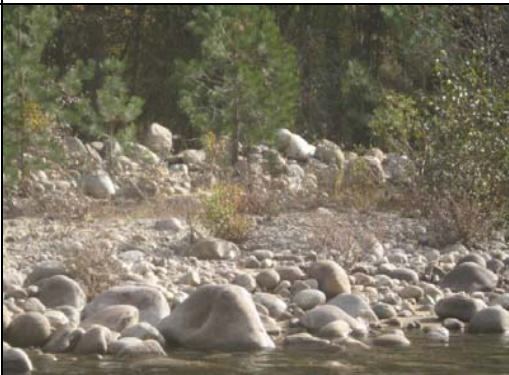
<p>View to the southeast in the downstream direction at a boulder push-up levee blocking a side-channel along river left near RM 7.95 (November 2009).</p>

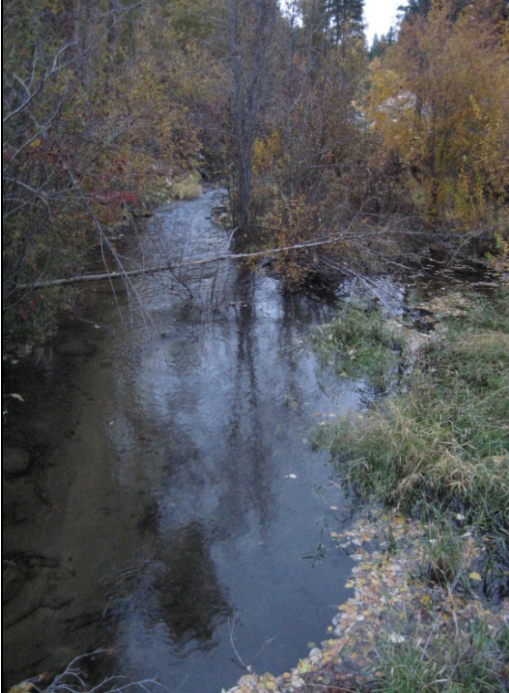
View to the south in the downstream direction at an irrigation return flow channel near RM 8.54 (November 2009).

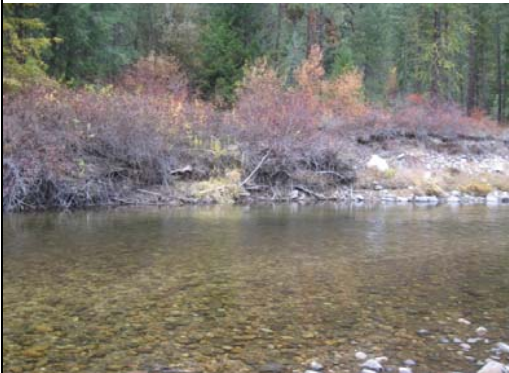
View to the west at the river-left bank near RM 9.5 (November 2009).

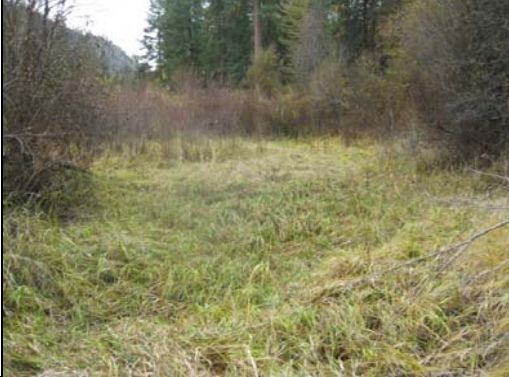
View to the south in the downstream direction at a side-channel near RM 9.6 (November 2009).
4a	Project RM 9.7R	Inner Zone 1 (IZ-1)	Reconnect Stream Channel Processes	Riprap removal or modification	There are approximately 590 ft of riprap along the toe of a road embankment along river-right centered near RM 9.7. This project would enhance the riprap with several log jams to increase habitat cover and complexity.

Reach	Project Number	Sub-Unit	Strategy Category	Project Name	Description	Photo
4a	Project RM 9.6R	Outer Zone 2 (OZ-2)	Off-Channel Habitat Enhancement	Side-channel habitat enhancement, alcove habitat enhancement	This side-channel feature does not receive regular scouring flows in its current condition. Although the lower portions of the feature hold surface water during wet periods, there is no evidence of scour from high-flows anytime in the recent past. Enhancing side-channel habitat may require the complete excavation of a new channel and habitat features. Another option at this site would be to create an open alcove or groundwater-fed channel at the downstream end.

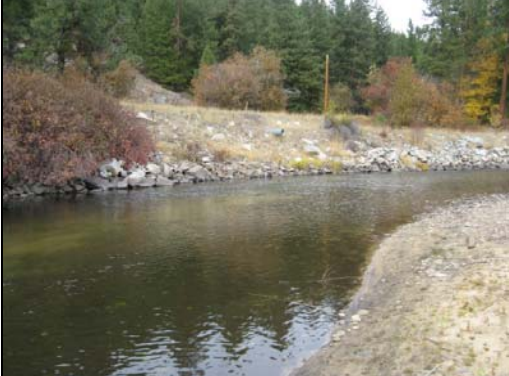
View to the northwest in the upstream direction at riprap along the toe of the road embankment along river-right near RM 9.7 (November 2009).

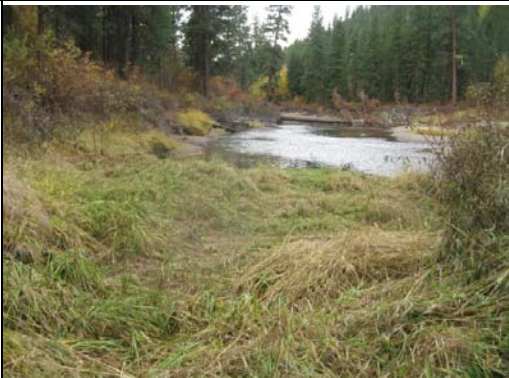
View to the south in the downstream direction at the outlet of a high-flow channel near RM 9.64 (November 2009).

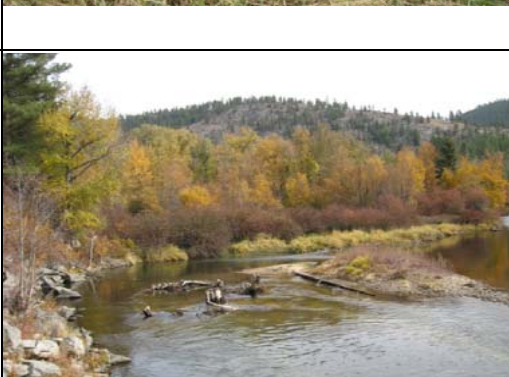
View to the northeast in the upstream direction at a pool on river right near RM 9.85 (November 2009).

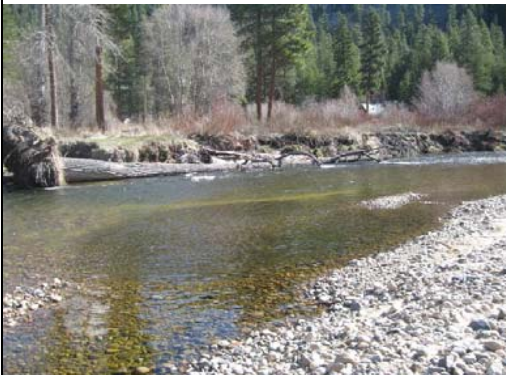
<p>Downstream view at the river-left bank where it is eroding near RM 10.37 (March 2010).</p>

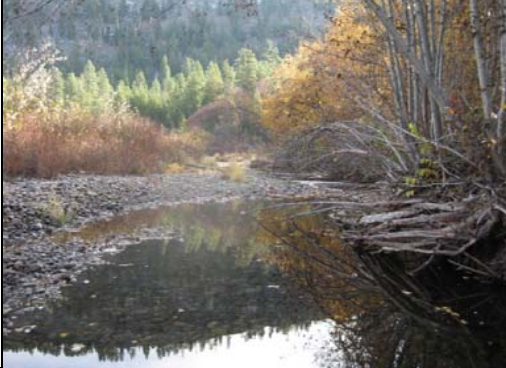
<p>View to the east in the downstream direction at a side-channel near RM 10.35 (November 2009).</p>
4b	Project CR_Prj-10.4R (USBR 2008b)	Disconnected Outer Zone 1 (DOZ-1)	Off-Channel Habitat Enhancement		This area has been identified by the USBR as a location for low surface reconnection through restoration of cleared areas.

4b	Project RM 10.37R	Inner Zone 1 (IZ-1)	Off-Channel Habitat Enhancement	Side-channel habitat enhancement	This project would enhance the habitat conditions of an existing side-channel that extends around the river-right side of a gravel bar between RM 10.33 and RM 10.42. The side-channel is active, carrying flow at a wide range of discharges. There is a pool formed at the upstream end by scour against bedrock and the hydraulic control of the gravel bar. Large log jams at the up and downstream end would be used to increase pool scour, add cover, and re-establish natural geomorphic features of the system.

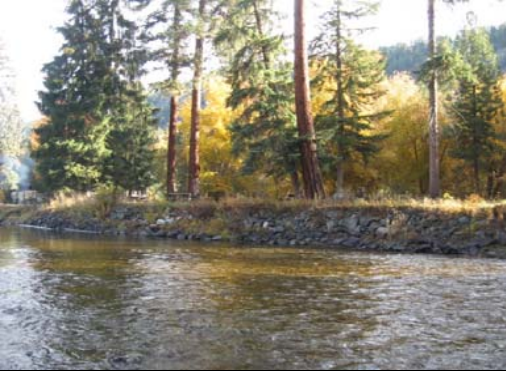
<p>View to the east at riprap and floodplain clearing along the river-left bank near RM 10.46 (November 2009).</p>
4c	Project RM 10.6R	Inner Zone 1 (IZ-1)	In-Stream Habitat Enhancement	LWD enhancement	This project involves LWD placement to increase local habitat quality and cover. This channel section is straight and currently lacks habitat complexity.

Reach	Project Number	Sub-Unit	Strategy Category	Project Name	Description	Photo
4b	Project RM 10.46L	Inner Zone 1 (IZ-1)	Reconnect Stream Channel Processes	Riprap removal or modification	Riprap has been placed to protect the bank on the inside of a bend. Residential development of the adjacent floodplain has resulted in riparian clearing along this bank. Riprap could be replaced with LWD to provide bank protection, increase habitat quality and cover, and increase hydraulic roughness. Alternatively, existing riprap could be enhanced with LWD enhancements to increase habitat cover and complexity. This project should also include re-establishment of a forested riparian buffer along this section.

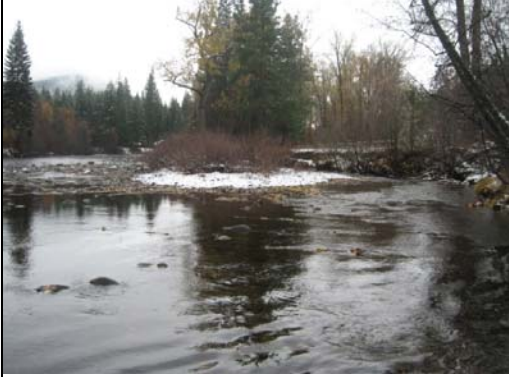
<p>View to the south in the downstream direction at an area of split flow near RM 10.93 (November 2009).</p>

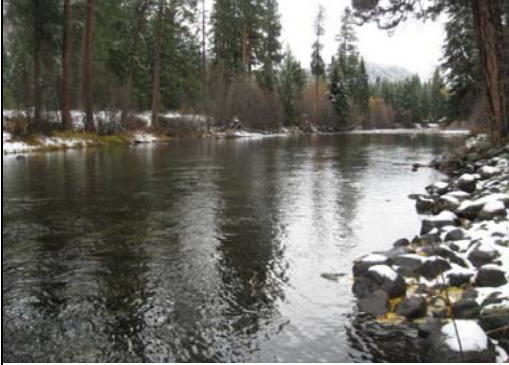
<p>View to the south in the downstream direction at a river section near RM 11 that has low habitat complexity (November 2009).</p>

4c	Project RM 11C	Inner Zone 1 (IZ-1)	In-Stream Habitat Enhancement	LWD enhancement	This project involves placing log jams at several locations on both sides of the channel between RM 11 and RM 10.98. Near RM 11, there is a location on river-right where LWD would increase local cover and habitat complexity. The reach is currently a long glide. Near RM 10.98 natural wood elements of the system have been lost along the river left bank. LWD placements would replace these elements to provide bank stabilization, and increase cover. There is residential development east of the channel that has resulted in almost complete clearing of riparian vegetation. The bank has destabilized in a few areas and there is riprap along the bank. There are no large trees near the channel for recruitment.

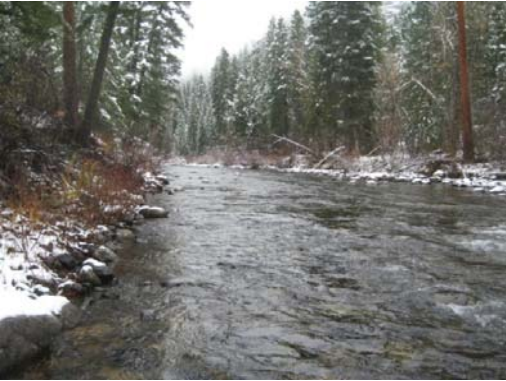
<p>View to the north in the upstream direction at a long riffle near RM 11.6 (November 2009).</p>

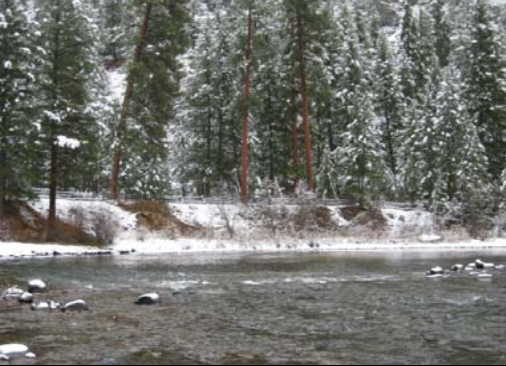
<p>View to the southeast in the downstream direction at river-left near RM 11.82 where the river bends south (November 2009).</p>
5a	Project RM 11.83L	Outer Zone 4 (OZ-4)	Off-Channel Habitat Enhancement	Off-channel habitat enhancement	There is an existing channel alcove along the toe of the hillslope at this site. This is a future potential meander bend cutoff channel. It currently serves as a backwater channel that will likely expand through time. Any backwater habitat enhancement may be better suited to expand to the northeast to neither encourage nor discourage a future natural avulsion. Survey and hydraulic analysis would help determine detailed habitat options at this site.

5a	Project RM 11.75L	Inner Zone 2 (IZ-2)	Reconnect Stream Channel Processes	Riprap removal or modification	The channel flows directly against the hillslope at this location. There is riprap along the bank to protect a roadway located on the slope. LWD could be used to either replace the riprap or add cover and habitat complexity if the riprap were left in place.	
5a	Project RM 11.82L	Inner Zone 2 (IZ-2)	In-Stream Habitat Enhancement	LWD enhancement	This site is located on the outside of the south bend that the river takes just downstream of RM 11.84. This meander is migrating north and eroding the glacial terrace. Several large jams could be placed along the left bank to increase rearing habitat cover and complexity.

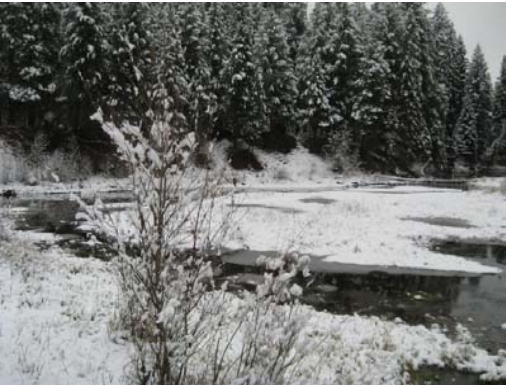
<p>View to the southeast in the downstream direction at a backwater located on river-left near RM 12.22 (November 2009).</p>

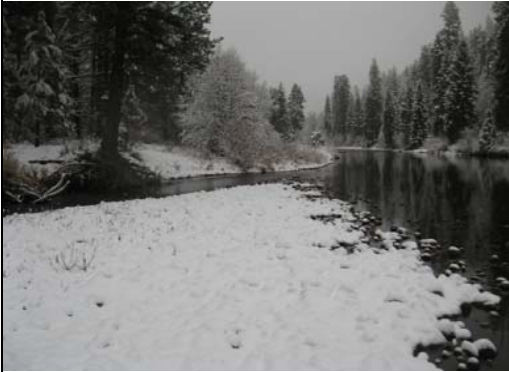
<p>View to the north in the upstream direction at the apex of a gravel bar and split flow location along river-right near RM 12.4 (November 2009).</p>

Reach	Project Number	Sub-Unit	Strategy Category	Project Name	Description	Photo
5a	Project RM 12.3C	Inner Zone 2 (IZ-2)	Reconnect Stream Channel Processes	LWD placement to enhance lateral connectivity	Between RM 12.25 and 12.4 there are multiple locations for log jam placements that would re-establish channel geomorphic processes such as lateral migration. In this area, the channel is more complex and wood placements can be used to increase the quality of existing habitat features. A series of bar apex jams near RM 12.4 could be used to enhance split flow conditions, increase scour for pool formation, and enhance habitat cover and complexity. The bank near RM 12.3 is fairly high and slightly undercut with overhanging vegetation. An LWD project here would increase the existing cover, and create scour thereby enhancing pool formation. Near RM 12.25 there are multiple split flows locations and side-channels. This is potentially rich habitat. LWD would be beneficial throughout IZ-2 to maintain channel dynamics and increase habitat complexity. This project is a bar apex jam that would maintain split flow, and increase scour to drive pool formation.

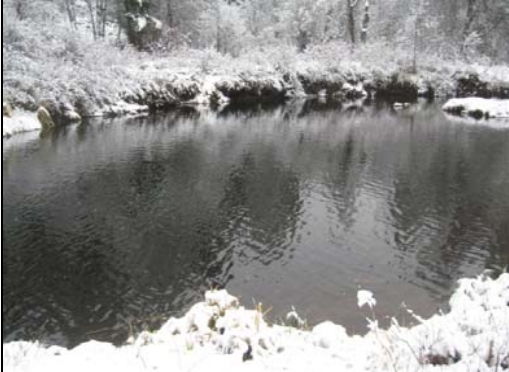
<p>View to the southeast in the downstream direction at a large backwater located on river left near RM 12.3 (November 2009).</p>
5a	Project RM 12.45R	Outer Zone 2 (OZ-2)	Reconnect Floodplain Processes	Enhance floodplain connectivity	OZ-2 provides the largest open water wetland in the study area. This feature is an oxbow pond formed by past channel avulsion and maintained through beaver activity. There are multiple high-flow channels originating at the upstream end of the sub-unit that provide high-flow connection to the wetlands. Campsite access roads create barriers in some of these high-flow channels. The USBR (2008b) has identified this as a restoration project area with a focus on removing or installing culverts in these roads to increase connectivity. Other restoration options include enhancing the upstream surface connection to the floodplain by excavating appropriate channel inlets and constructing log jams to increase juvenile rearing fish cover in downstream wetlands.

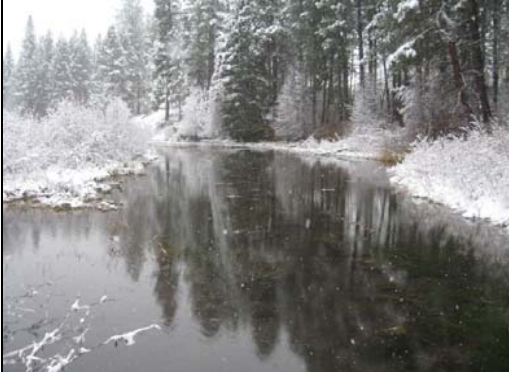
<p>View to the southeast at a large oxbow pond on the west side of the valley near RM 12.3 (November 2009).</p>

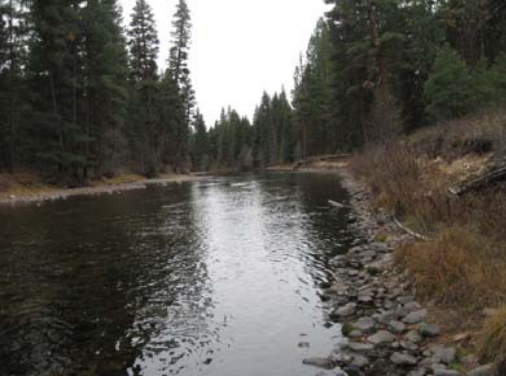
<p>View to the southeast in the downstream direction at a hydraulically simple section of river near RM 12.95 (November 2009).</p>

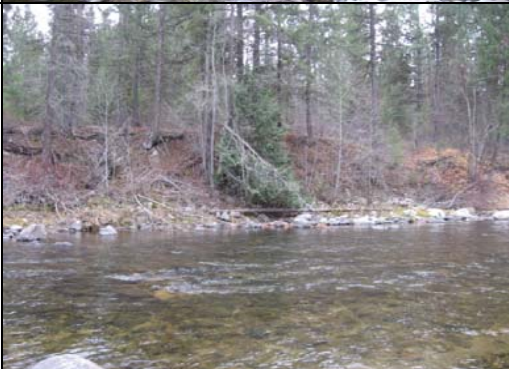
View to the southeast in the downstream direction at an eroding terrace on the outside of a bend near RM 13.27 (November 2009).

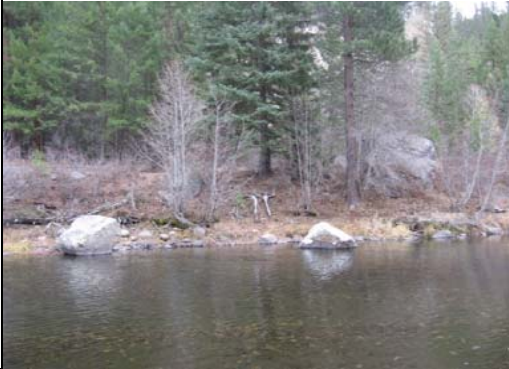
View to the east at the river-left bank near RM 12.34 (November 2009).
5b	Project RM 13.4R	Outer Zone 2 (OZ-2)	Reconnect Floodplain Processes	Enhance floodplain connectivity	This project involves enhancing a network of overflow channels that extends from RM 13.13 to 13.56. This floodplain surface is relatively high and does not appear to be frequently inundated. However, topographic evidence shows several areas with high-flow channels. These channels could be re-connected using log jams along the channel margin near the inlets. Inlet areas would need to be excavated to allow spring floods to access this area. At the downstream end of the unit, there may be opportunities for excavating to create a backwater channel with direct main channel connectivity.

5b	Project CR_Prj-13.3 (USBR 2008b)	Outer Zone 3 (OZ-3)	Reconnect Floodplain Processes		The USBR (2008b) has identified this area as a potential location to re-connect the low surface by removing riprap between RM 13.1 and 12.9. Riprap was not found during ground truthing.	
5b	Project RM 13.36L	Inner Zone 1 (IZ-1)	In-Stream Habitat Enhancement	LWD enhancement	At this location, the channel flows against a road embankment along river-left. Riparian vegetation has been cleared and there is no cover along the bank. LWD placed here could provide cover and increase the quality of the habitat.

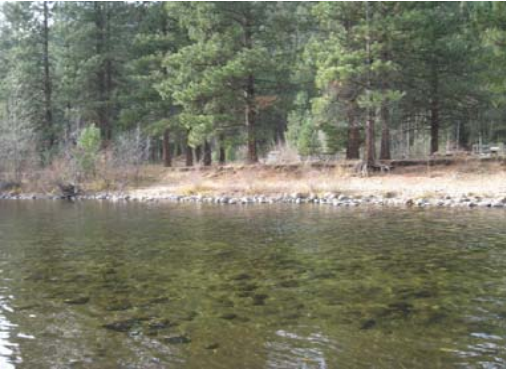
<p>View to the northeast in the upstream direction at the river left bank near RM 13.73 (November 2009).</p>

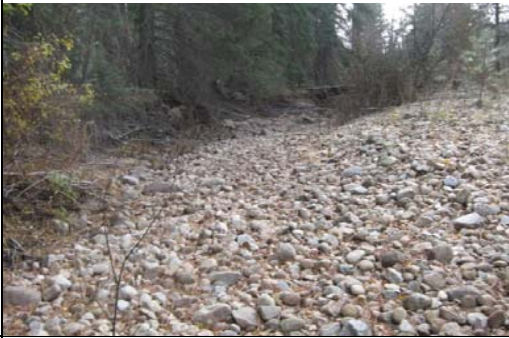
<p>View to the south in the downstream direction at a river-left side-channel near RM 13.85 (November 2009).</p>
7	Project RM 14.39L	Inner Zone 2 (IZ-2)	In-Stream Habitat Enhancement	LWD enhancement	A large log jam would be used here to increase local cover habitat. Currently, there are few features that provide quality habitat in this part of the river. A log jam would be placed on the outside of the bend, taking advantage of existing planform and hydraulics to create a scour pool

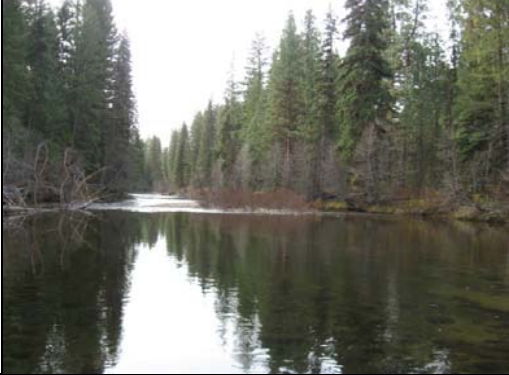
<p>View to the south in the downstream direction at a mid-channel bar near RM 14.53 (November 2009).</p>

7	Project RM 14.49C	Inner Zone 2 (IZ-2)	Reconnect Stream Channel Processes	Abandoned bridge abutment removal/modification.	There are old wooden bridge abutments on both sides of the channel here. They do not pose a significant hydraulic obstruction but may hinder riparian growth and LWD recruitment. These abutments could be removed and replaced with log jams or incorporated into a larger log jam depending on future hydraulic analysis and findings.	
7	Project RM 14.53C	Inner Zone 2 (IZ-2)	Reconnect Stream Channel Processes	LWD placement to enhance lateral connectivity.	This is a location where log jams could be placed on both sides of the channel to increase the general availability of habitat and cover and to increase lateral migration, scour-and-fill, and pool formation. There is a small mid-channel bar at this site providing a location for a bar apex jam.

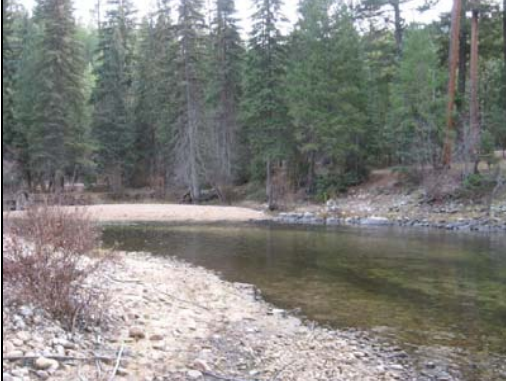
<p>View to the northeast in the upstream direction at a bend in the river near RM 14.76 (November 2009).</p>
7	Project RM 15.15C	Inner Zone 2 (IZ-2)	In-Stream Habitat Enhancement	LWD enhancement	Between RM 15.34 and 14.93 there are opportunities to enhance instream habitat with bank log jams on both sides of the channel. Near RM 15.34 there is a long, straight section with little habitat availability. Several log jams could be placed along both banks in order to provide habitat cover and complexity. Near RM 15.21 is a right bank log jam opportunity meant to increase cover and habitat complexity. The bank is high and eroding, exposing several large root masses. There are pines that could be recruited as LWD. A log jam near RM 15.14 would alternate with the jam at RM 15.21, increasing overall density of cover and creating a location of potential pool scour on the opposite side of the channel. Bank conditions are similar with ongoing erosion of a terrace and potential for LWD recruitment. Near RM 14.93 there are several log jam opportunities in stream banks on both sides of the river. As with the inner zone upstream of this site, there is very little habitat complexity and there is an opportunity at this location to improve it.

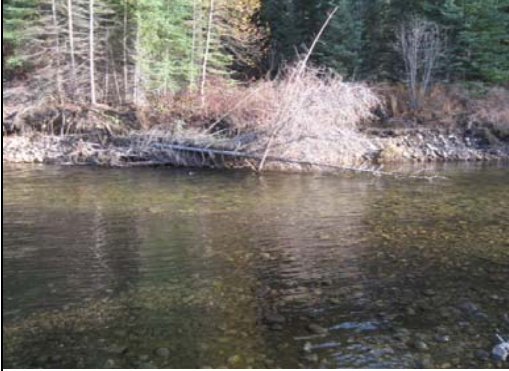
View to the east at an eroding bank and LWD recruitment along river-left near RM 15.62 (November 2009).

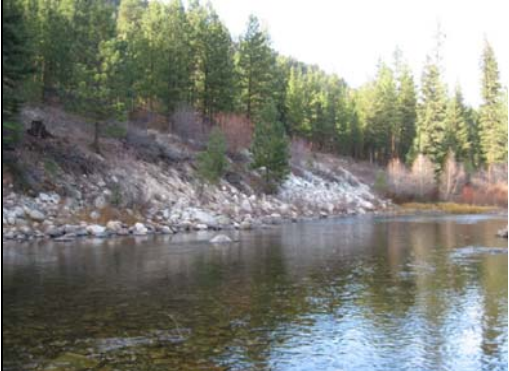
View to the north in the upstream direction at riprap along river right near RM 15.8 (November 2009).
8	Project RM 15.9C	Inner Zone 2 (IZ-2)	Reconnect Stream Channel Processes	LWD placement to enhance lateral connectivity	This area of the inner zone exhibits high complexity with multiple bars, high flow channel networks on both sides of the channel, and off-channel backwater areas. This project entails several large log jams placed on both sides of the channel with the intention of working with the current geomorphic dynamics to increase lateral migration, enhance connections between the main channel and side-channel habitats, and create conditions conducive to long-term habitat formation. Several jams would be created along the river-left bank between RM 16 and RM 15.9. These would provide local cover as well as encourage high-flow onto the adjacent floodplain. A bar apex jam would be placed near RM 15.9 to enhance inner-zone processes and maintain split flow. Downstream of the gravel bar near RM 15.85, log jams would be constructed across the majority of the width of the active channel in order to move water east into floodplain habitat (See Project RM 16L).

8	Project RM 15.8R	Inner Zone 2 (IZ-2)	Reconnect Stream Channel Processes	Riprap removal or modification	The river flows directly against the road embankment at this location. Riprap has been placed at the toe of the slope providing very little habitat or cover. This project would replace or enhance the riprap with LWD to increase the quality of instream habitat.

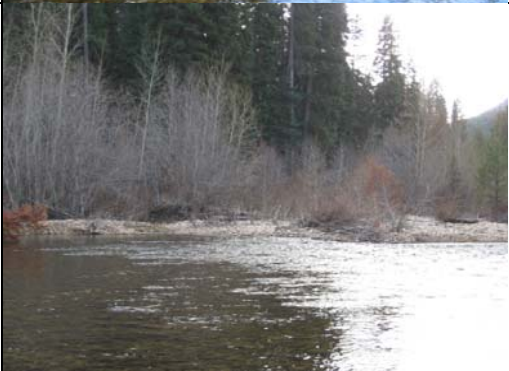
View to the southeast in the downstream direction towards a low area along river-left near RM 16 that provides access to high-flow channel that access inner zone side-channels and floodplain channels to the east (November 2009).

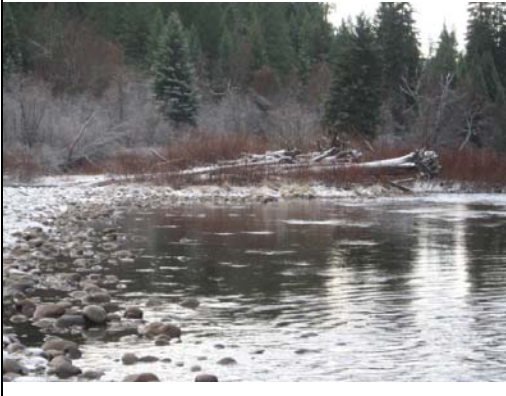
<p>View to the south in the downstream direction at a bar apex log jam near RM 16.8 (November 2009).</p>

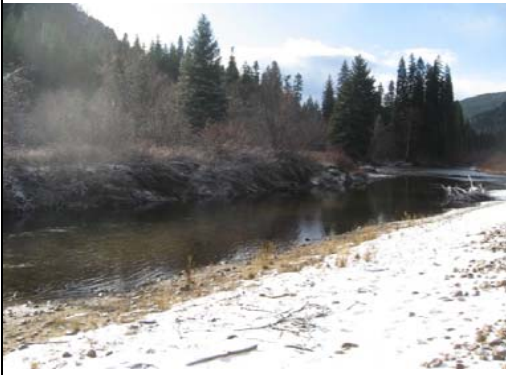
<p>View to the southeast in the downstream direction at a river-left side-channel near RM 16.78 (November 2009).</p>
8	Project RM 16.7R	Inner Zone 2 (IZ-2)	Off-Channel Habitat Enhancement	Side-channel habitat enhancement	There is a long narrow side-channel that runs along the river-right between RM 16.6 to 16.8. This channel is separated from the main channel by a narrow gravel bar. Near RM 16.7 the side-channel turns west and flows away from the main channel providing a greater connection to floodplain habitats. There is outflow at this point that reduces flow in the rest of the side-channel downstream during low flow periods. This project would include several log jams throughout the side-channel including at this outflow location with the intention of enhancing side-channel habitat and floodplain connectivity during high flow events. A wetland at the downstream end near RM 16.6 could be enhanced with wood for cover, and potentially excavated at its outlet to increase its connectivity with the main channel.

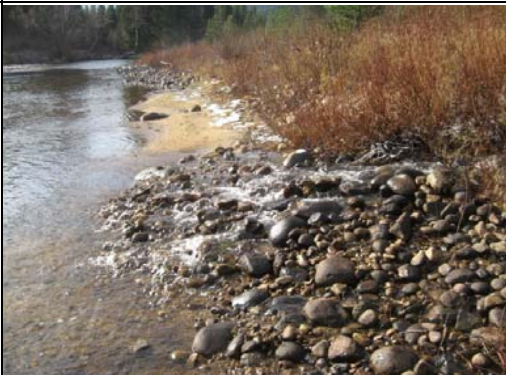
<p>View to the southwest in the downstream direction at a side-channel outflow on river-right near RM 16.7 that dewateres the side-channel for the remainder of its length (November 2009).</p>

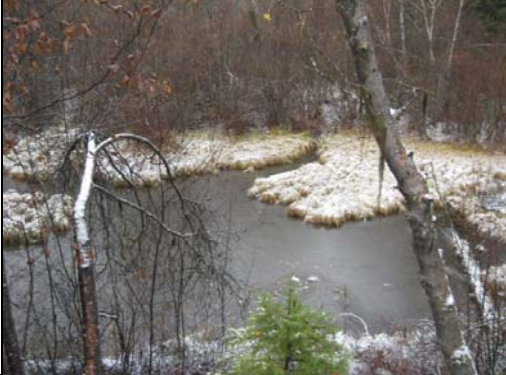
View to the west at a floodplain wetland near RM 16.8 (November 2009).
8	Project RM 17C	Inner Zone 2 (IZ-2)	In-Stream Habitat Enhancement	LWD enhancement	This project area encompasses a straight stretch of river with very little cover or in-channel habitat complexity. Several log jam placements on both sides of the channel would increase overall habitat availability and channel complexity. At each proposed location, there is natural bank scour that has led to moderate recruitment of LWD. This process, as well as habitat quality, could be enhanced through log jam placement.

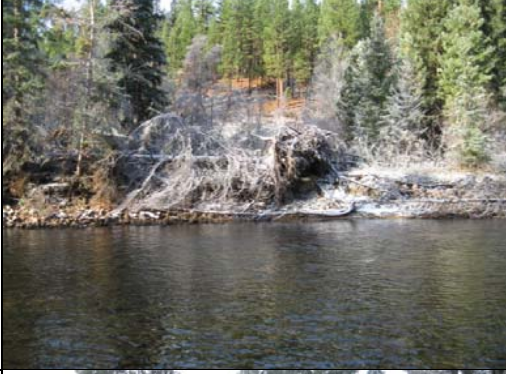
View to the west at an example of bank erosion and LWD recruitment along the river-right bank near RM 17 (November 2009).

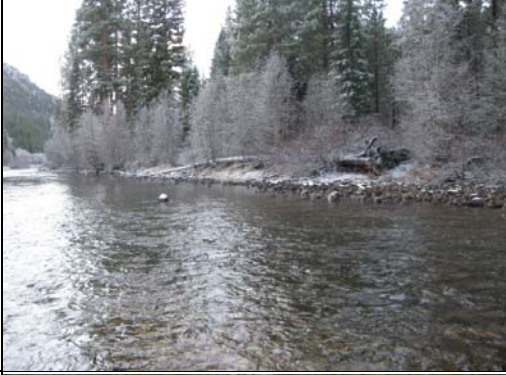
View to the northeast in the upstream direction at the river-left bank near RM 17.16 (November 2009).
8	Project RM 17.31R	Inner Zone 2 (IZ-2)	Reconnect Stream Channel Processes	Riprap removal or modification	There is large riprap along the river-right bank between RM 17.3 and 17.37. This material protects a roadway that runs along the hillslope above the channel. The river flows west directly against the riprap, then turns south and runs along the riprap for several hundred feet. The availability of complex bank habitat is limited by the presence of the riprap. This project would add LWD jams to this area to increase habitat cover and complexity. Two log jams are proposed in this area. One jam would increase habitat quality and cover at the point where the river turns against the riprap and a pool has formed. The second is at the downstream end where overhanging vegetation could be enhanced to increase cover.

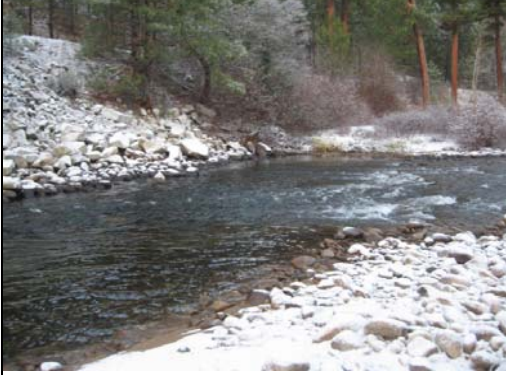
View to the northwest in the upstream direction at riprap lining the margin of a pool along river-right near RM 17.35 (November 2009).
