Appendix B: Chewuch Project Opportunities

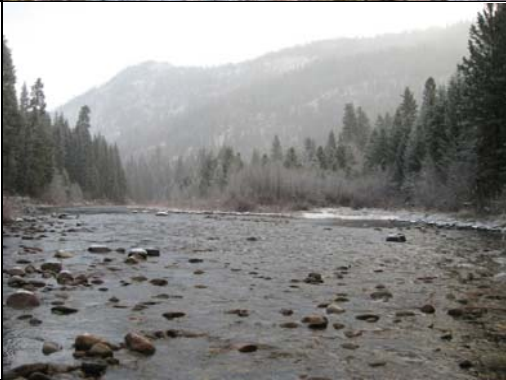
<p>View to the southwest in the downstream direction at a gravel bar and side-channel inlet on river-right near RM 17.45 (November 2009).</p>

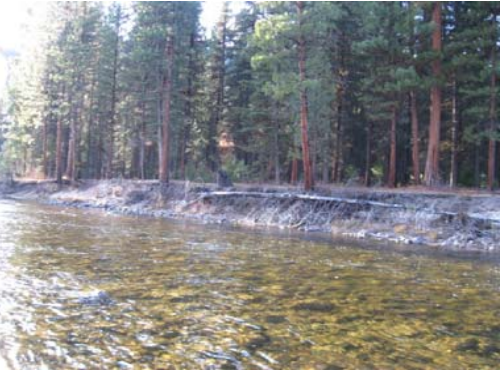
View to the southwest in the downstream direction at potential LWD recruitment along the river right bank near RM 17.55 (November 2009).

Reach	Project Number	Sub-Unit	Strategy Category	Project Name	Description	Photo	
8	Project RM 17.56L	Inner Zone 2 (IZ-2)	Reconnect Stream Channel Processes	LWD placement to enhance side-channel connectivity	This project area involves using several log jams on both side of the river between RM 17.6 and 17.55 to enhance the flow conditions in a side-channel that extends along river-left between RM 17.5 and 17.6. Between RM 17.55 and 17.6 there are two river-right locations where streambank log jams would increase the amount of cover and available habitat in the vicinity while pushing flow to left with increasing discharge. At the upstream site, the log jam placement would enhance bank erosion that has the potential to recruit large pine trees. The inlet to the side channel is at about RM 17.6 on river left. Vegetation and geomorphic evidence suggest that the channel does not carry flows with sufficient energy to scour the bed. The bank at the upstream end is high, and there is not a well-defined inlet. However, farther downstream there are depressions that hold groundwater and a backwater pool with an open surface connection at the downstream end. A log jam at the upstream end would encourage scour and increase flow into the side channel. The backwater channel at the downstream end could be enhanced with wood for cover.

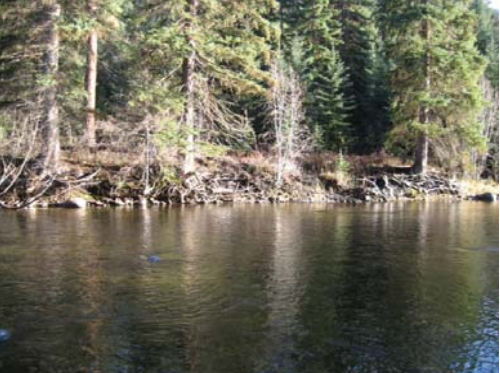
View to the east at exposed root masses along the river-left bank near RM 17.5 (November 2009).
8	Project RM 17.95C	Inner Zone 1 (IZ-1)	Reconnect Stream Channel Processes	LWD placement to enhance habitat and connectivity	This project area includes the potential for several large log jams on both sides of the channel between RM 17.98 to RM 17. This area, as with most locations in the study area, is low in wood density in comparison to undisturbed conditions. An overarching goal of all of these placements is to re-establish natural LWD loading and provide the habitat complexity and cover that is generated by LWD. At the upstream end of this project site, there are two locations with high eroding banks where streambank log jams would enhance habitat cover and complexity. At the downstream end of the project area, there is a mid-channel bar and riffle-pool sequence that provides a location for a bar apex jam and large wood complexes in the downstream pool to enhance lateral connectivity (i.e. encourage split flow) and habitat.

8	Project RM 17.77C	Inner Zone 1 (IZ-1)	Reconnect Stream Channel Processes	LWD placement to enhance lateral connectivity	This project area includes potential log jam locations at RM 17.75 and at RM 17.8. At each of these locations, bank erosion is resulting in exposed root masses and moderate LWD recruitment. Log jams placed in these locations would serve to increase the local cover and habitat availability as well as encourage increased natural LWD recruitment and lateral migration that is taking place at moderate rates under current conditions.

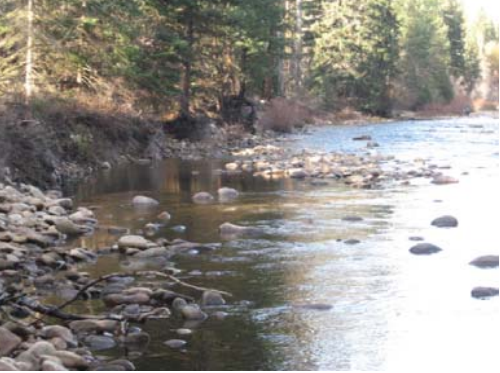
View to the northwest in the upstream direction at an example of a potential streambank LWD jam project location near RM 17.97. A similar location is found on the opposite bank near RM 17.98 (November 2009).

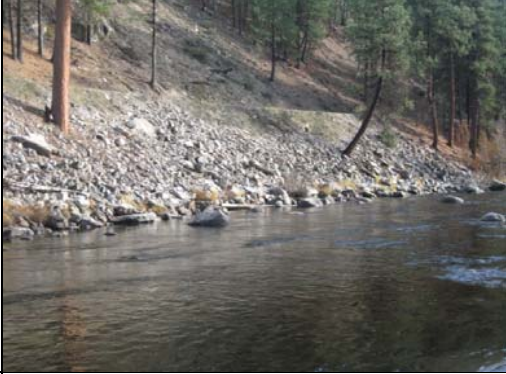
<p>View to the southeast in the downstream direction at riprap along the toe of the river-left bank near RM 18.05 (November 2009).</p>
9	Project RM 18.34L	Inner Zone 2 (IZ-2)	In-Stream Habitat Enhancement	LWD enhancement	This project site has the potential for installation of several channel-spanning log jams along the river-left bank between RM 18.33 and 18.35. Riparian vegetation is in good condition but the channel lacks cover and habitat complexity. LWD would serve to provide these features to this portion of the channel.

Reach	Project Number	Sub-Unit	Strategy Category	Project Name	Description	Photo
9	Project RM 18.05L	Inner Zone 2 (IZ-2)	Reconnect Stream Channel Processes	Riprap removal or modification	The river turns due south near RM 18.15 and flows directly against the hillslope. There is a road on the slope and riprap at the toe. Riprap could be replaced or enhanced with several log jams and root wads placed along the left bank between RM 18.15 and 18.05.

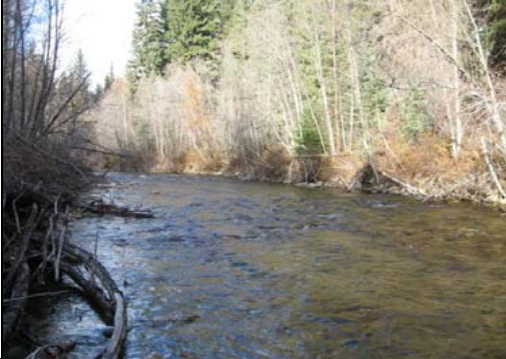
<p>View to the north in the upstream direction at the river left bank near RM 18.34 (November 2009).</p>

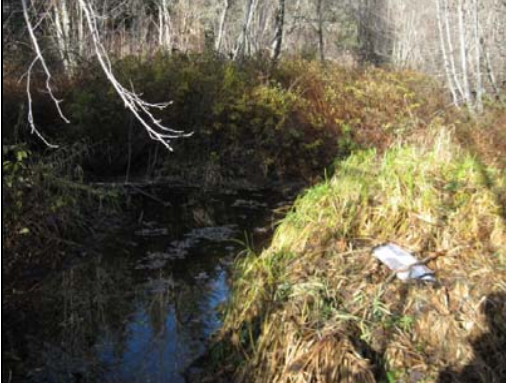
<p>View to the east at a wetland located near RM 18.4 (November 2009).</p>

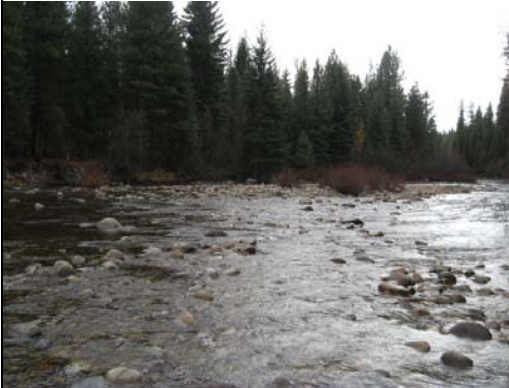
View to the south in the downstream direction at a mid-channel bar near RM 18.81 (November 2009).
9	Project RM 18.9L	Inner Zone 2 (IZ-2)	In-Stream Habitat Enhancement	LWD enhancement	The left bank is the toe of a large alluvial fan that has delivered boulders to the Chewuch valley during high energy debris torrent events. Boulder substrate is not easily moved by the Chewuch once it enters the river, resulting in coarse uniform bed morphology with relatively little habitat complexity. To enhance habitat complexity, several large log jams could be placed in the left bank glide.

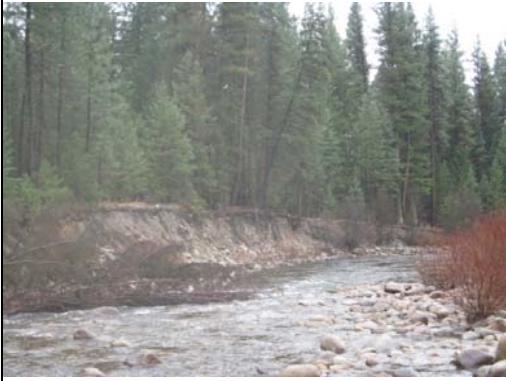
<p>View to the southeast in the downstream direction at erosion of the river-left bank near RM 19.25 (November 2009).</p>
