Chewuch River Reach Assessment

Provided for:

Yakama Nation Fisheries Program

JUNE 2010

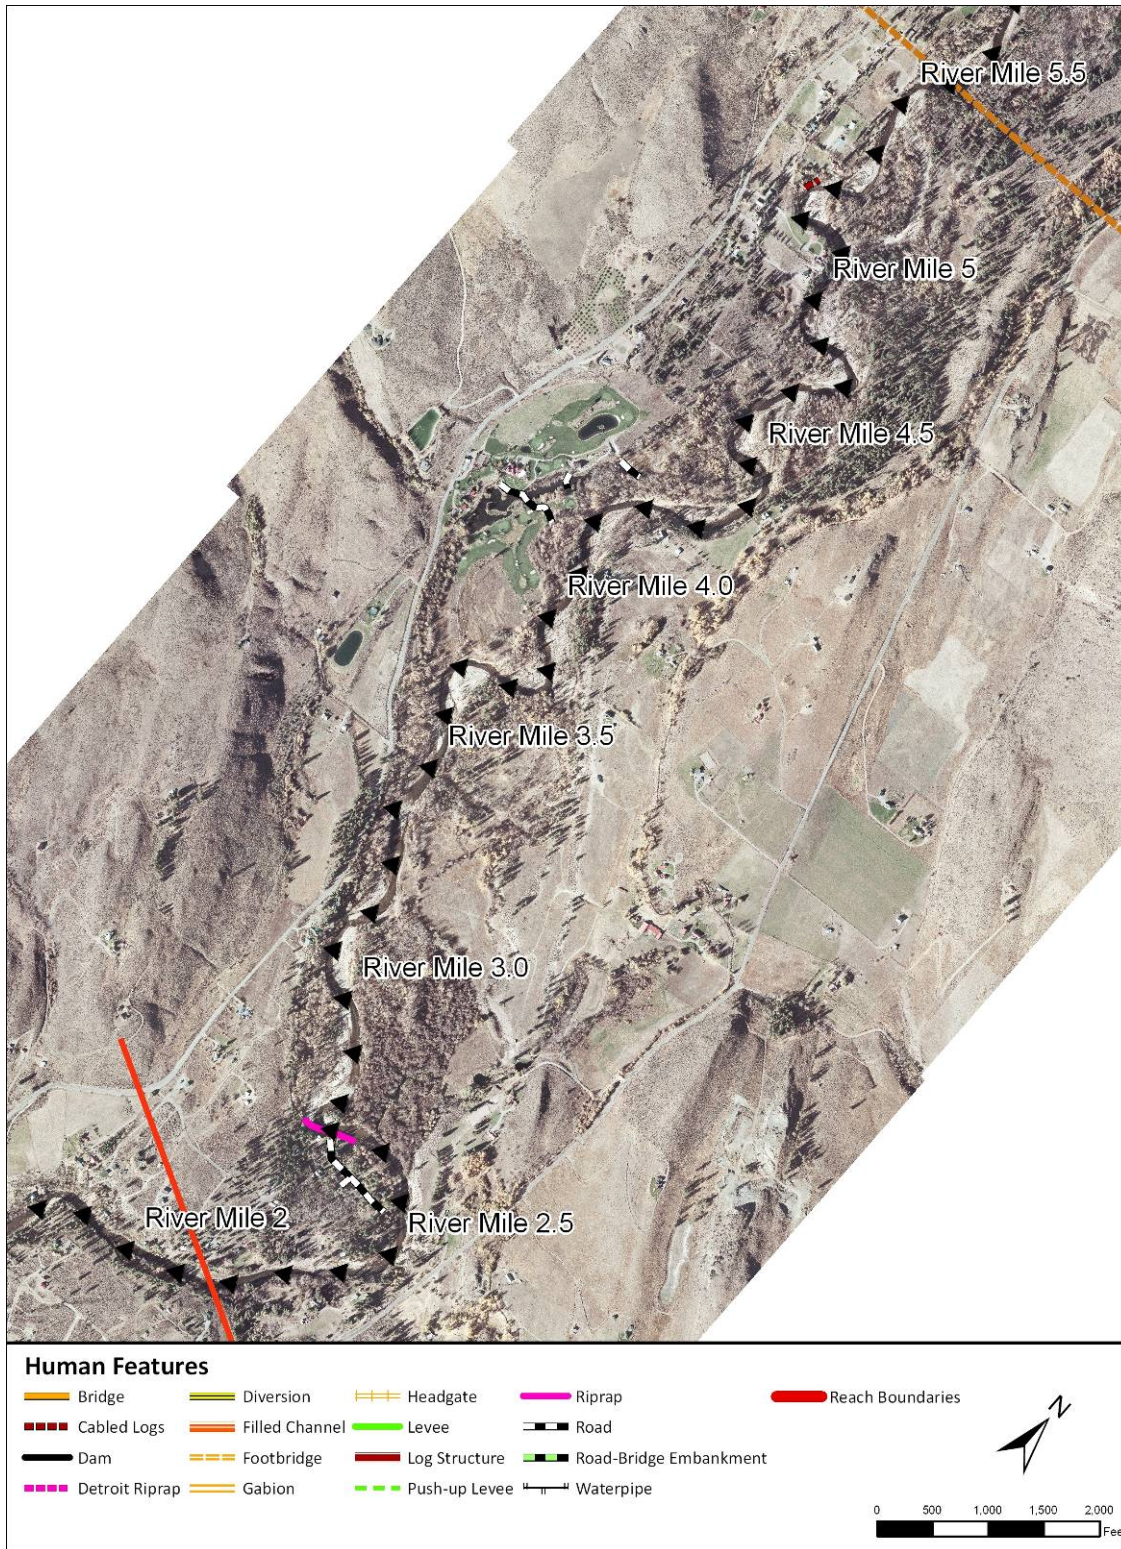
Anthropogenic influence on the river corridor is minor in Reach C2a (Figure 3). Major roadways are set back along the toe of bounding hillslopes, outside of the low surface area. Development has been concentrated between RM 2.2 and 2.7 and between RM 3.6 and 4.3 along the west side of the valley. In the downstream area, there is moderate residential development with associated roadways and fill. A 460 ft section of riprap protects houses at the upstream end of this area near RM 2.7. Only small patches of riparian forest clearing have taken place as part of this rural development. At the upstream golf course development, the riparian area has been completely cleared and artificial wetlands have been constructed. The former floodplain surface has been filled and graded, leaving no evidence of high flow channels or off-channel habitat.

Figure 3. Aerial photo showing human features in Reach C2a. Flow is from north to south.

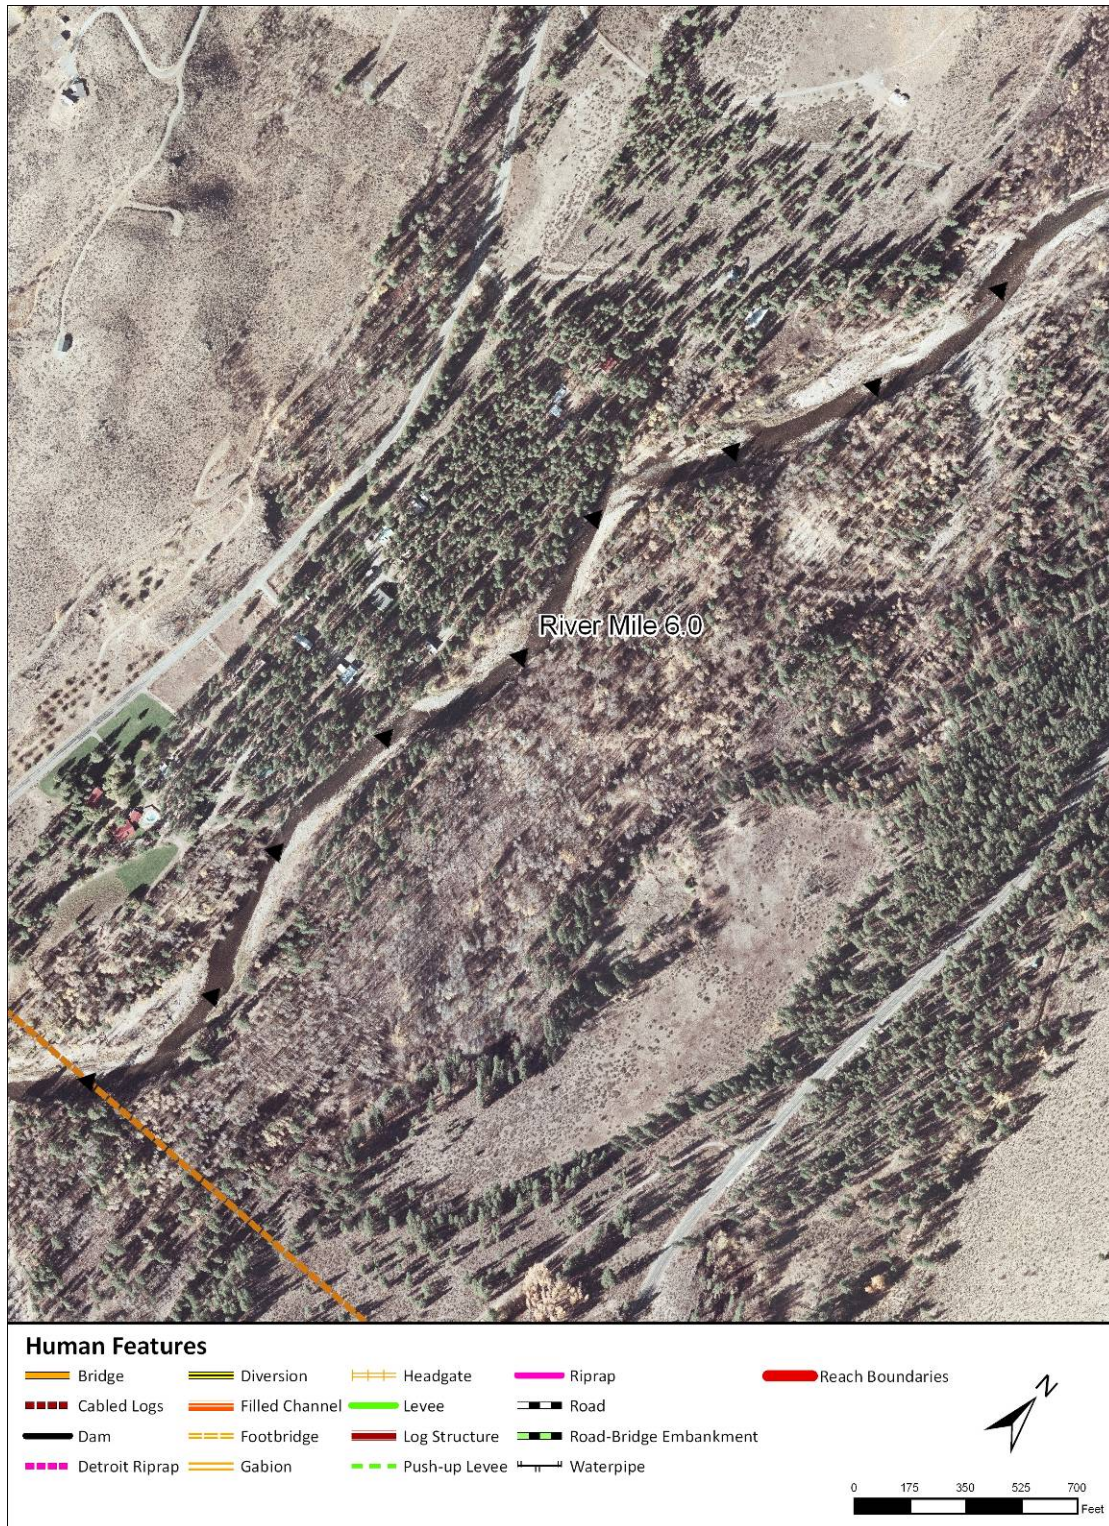
Few alterations have been made to the channel and floodplain in Reach C2b (Figure 8, Figure 9). At the upstream end of the reach there are 1,240 ft of riprap along the east side of the channel between RM 7.01 to 7.27. This riprap blocks a historical channel that now contains a large wetland on a private ranch. On the other side of the valley, there is recreational development near the channel adjacent to residential development on the alluvial terrace. Downstream of this, floodplain surfaces are free of development and channel form and channel banks have not been modified.

Figure 8. Aerial photo showing human features in the downstream portion of Reach C2b. Flow is from north to south.

Figure 9. Aerial photo showing human features in the upstream portion of Reach C2b. Flow is from north to south.

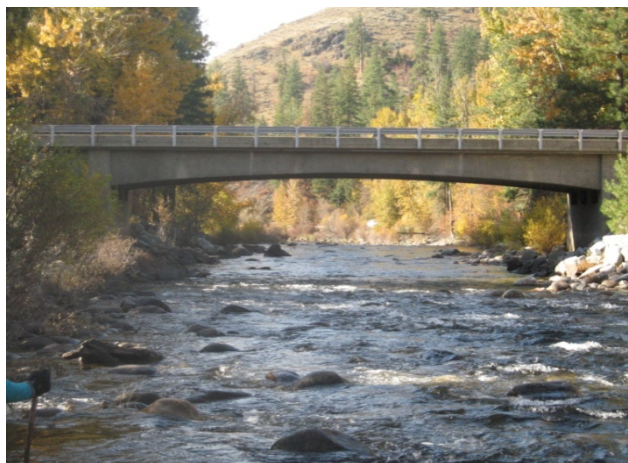
Anthropogenic activities play a larger role in this reach than in adjacent downstream or upstream reaches. A bridge crosses the channel at RM 8.3 creating a hydraulic constriction at higher flows (Figure 14). Both banks are protected with riprap up and downstream of the bridge for about 600 ft. East and west side roads laterally bisect the floodplain at this location, with the west side road also running longitudinally through the floodplain. The bank and floodplain alterations result in hydrologic and geomorphic disconnection between the channel and the only substantially wide floodplain in the reach. The floodplain has also been cleared, leveled, and developed on the east side of the valley downstream of the bridge. Downstream of the bridge on the west side of the valley, a road parallels the channel. The road embankment increases lateral constriction between RM 8.0 and 8.2.

Figure 14. View to the south in the downstream direction at the bridge near RM 8.3 (November 2009).

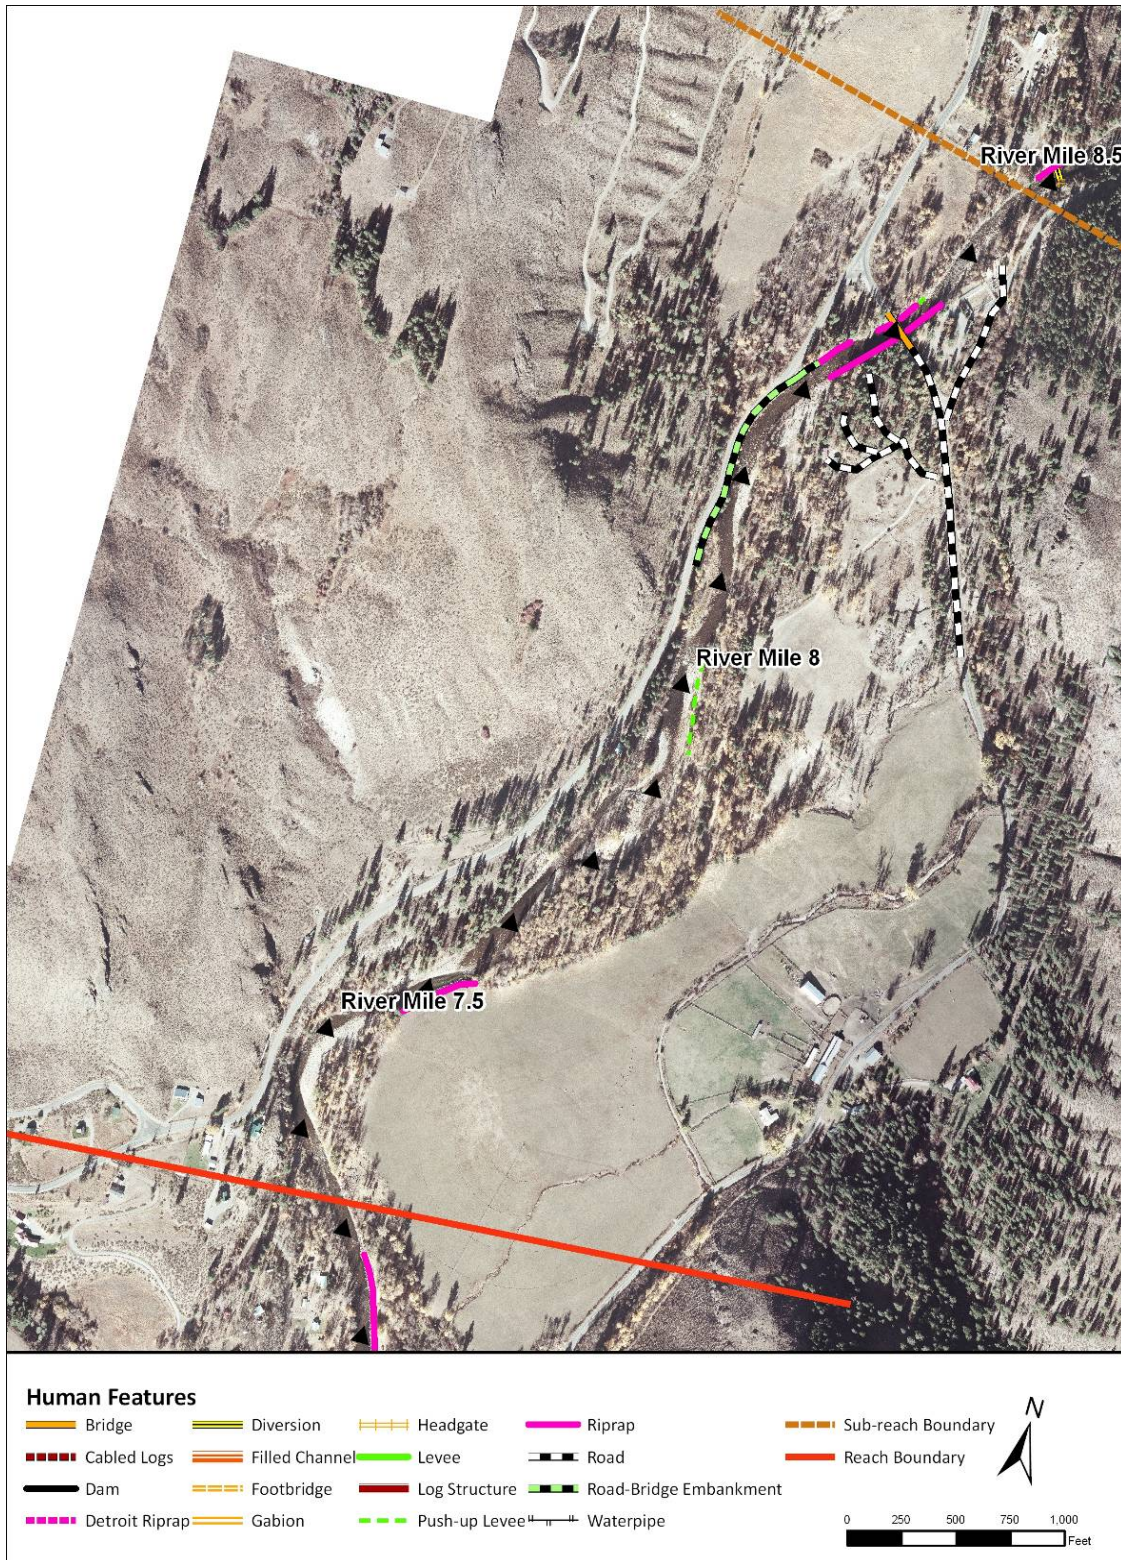
Human modification decreases downstream of RM 8.2. The west side road climbs away from the river corridor and floodplain development on the east side decreases. There are, however, large cleared areas to the east of the channel associated with agricultural development. There is a 430 ft long push-up levee centered on RM 7.95 that creates a barrier to active channel processes. There is no clear object of protection by this levee. Near RM 7.6, the toe of the terrace is protected by riprap along the edge of a large open pasture. Figure 15 shows all human features in Reach C3a.

Figure 15. Aerial photo showing human features in Reach C3a. Flow is from north to south.

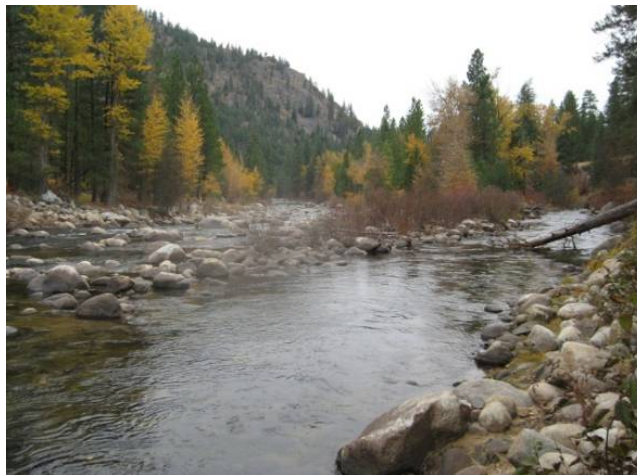
Figure 18. View to the southeast in the downstream direction at the Chewuch River diversion near RM 9.3. November 2009.

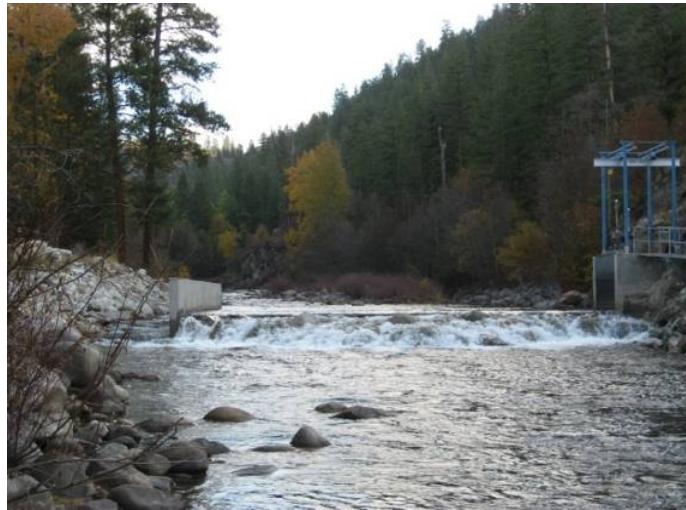
Figure 19. View to the north in the upstream direction at a diversion near RM 8.5 (November 2009).

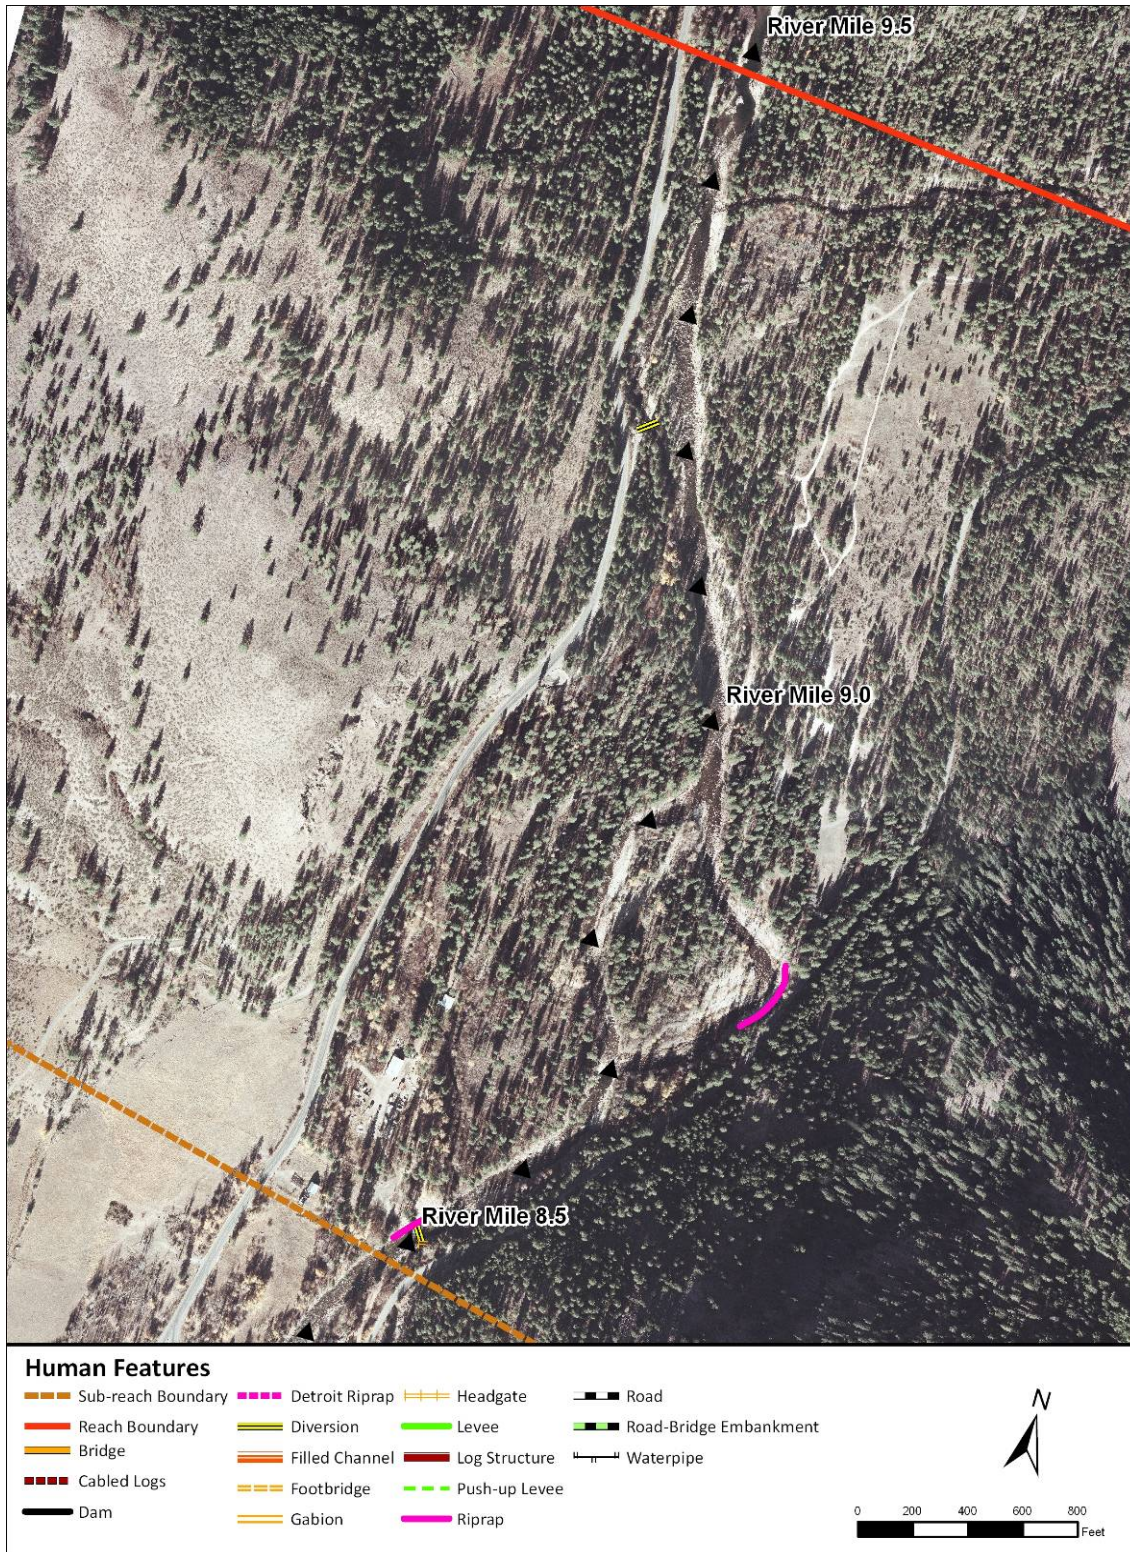
There is minimal floodplain development in this reach. Dispersed camping is found along the northwest side of the valley, mainly on a terrace surface adjacent to an active side-channel. There is residential development on the extreme west side of the valley near RM 8.6. This floodplain is also affected by return flow from the Skyline canal which creates an active floodplain channel that is accessible to fish at the downstream end. Figure 20 shows all human features found in the reach.

Figure 20. Aerial photo showing human features in Reach C3b. Flow is from north to south.

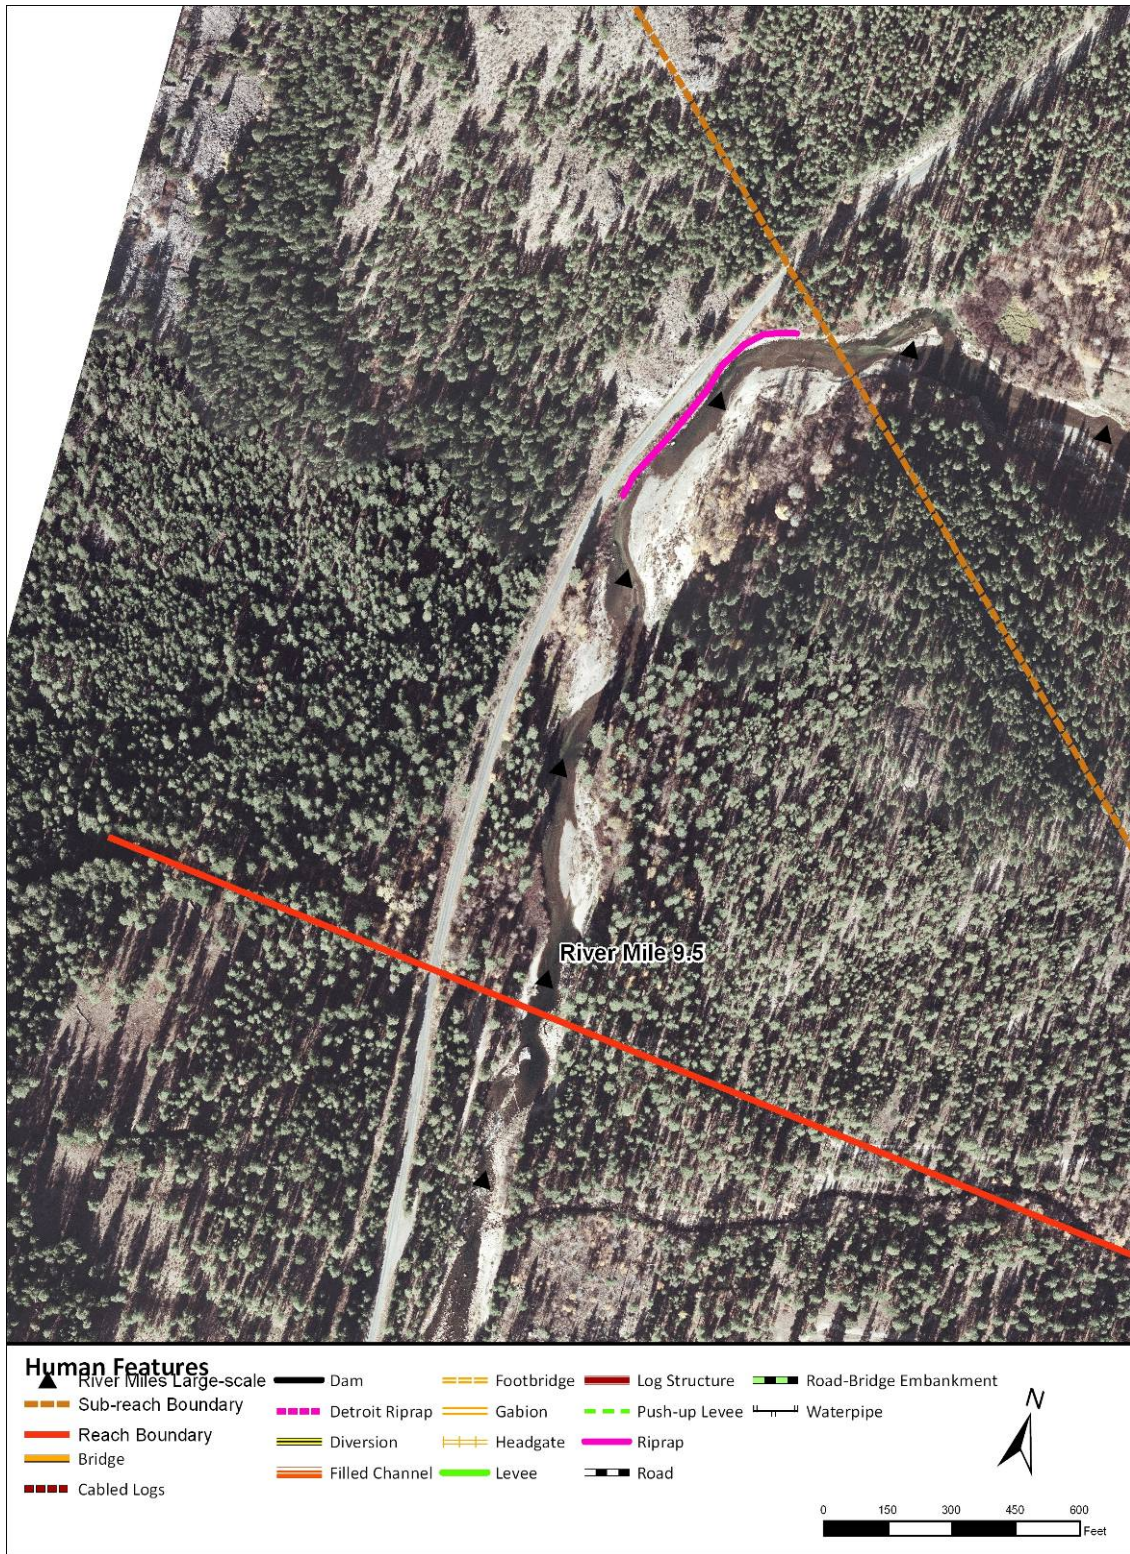
The only significant human alteration to the river corridor is the road that runs parallel to the river-right side of the channel for the majority of the reach (Figure 23). The road runs along the hillslope toe and so only provides limited constraints to lateral connectivity. However, the embankment is composed of 588 ft of riprap at the upstream end that alters boundary hydraulics and reduces habitat cover and complexity along the bank.

Figure 23. Aerial photo showing human features in Reach C4a. Flow is from north to south.

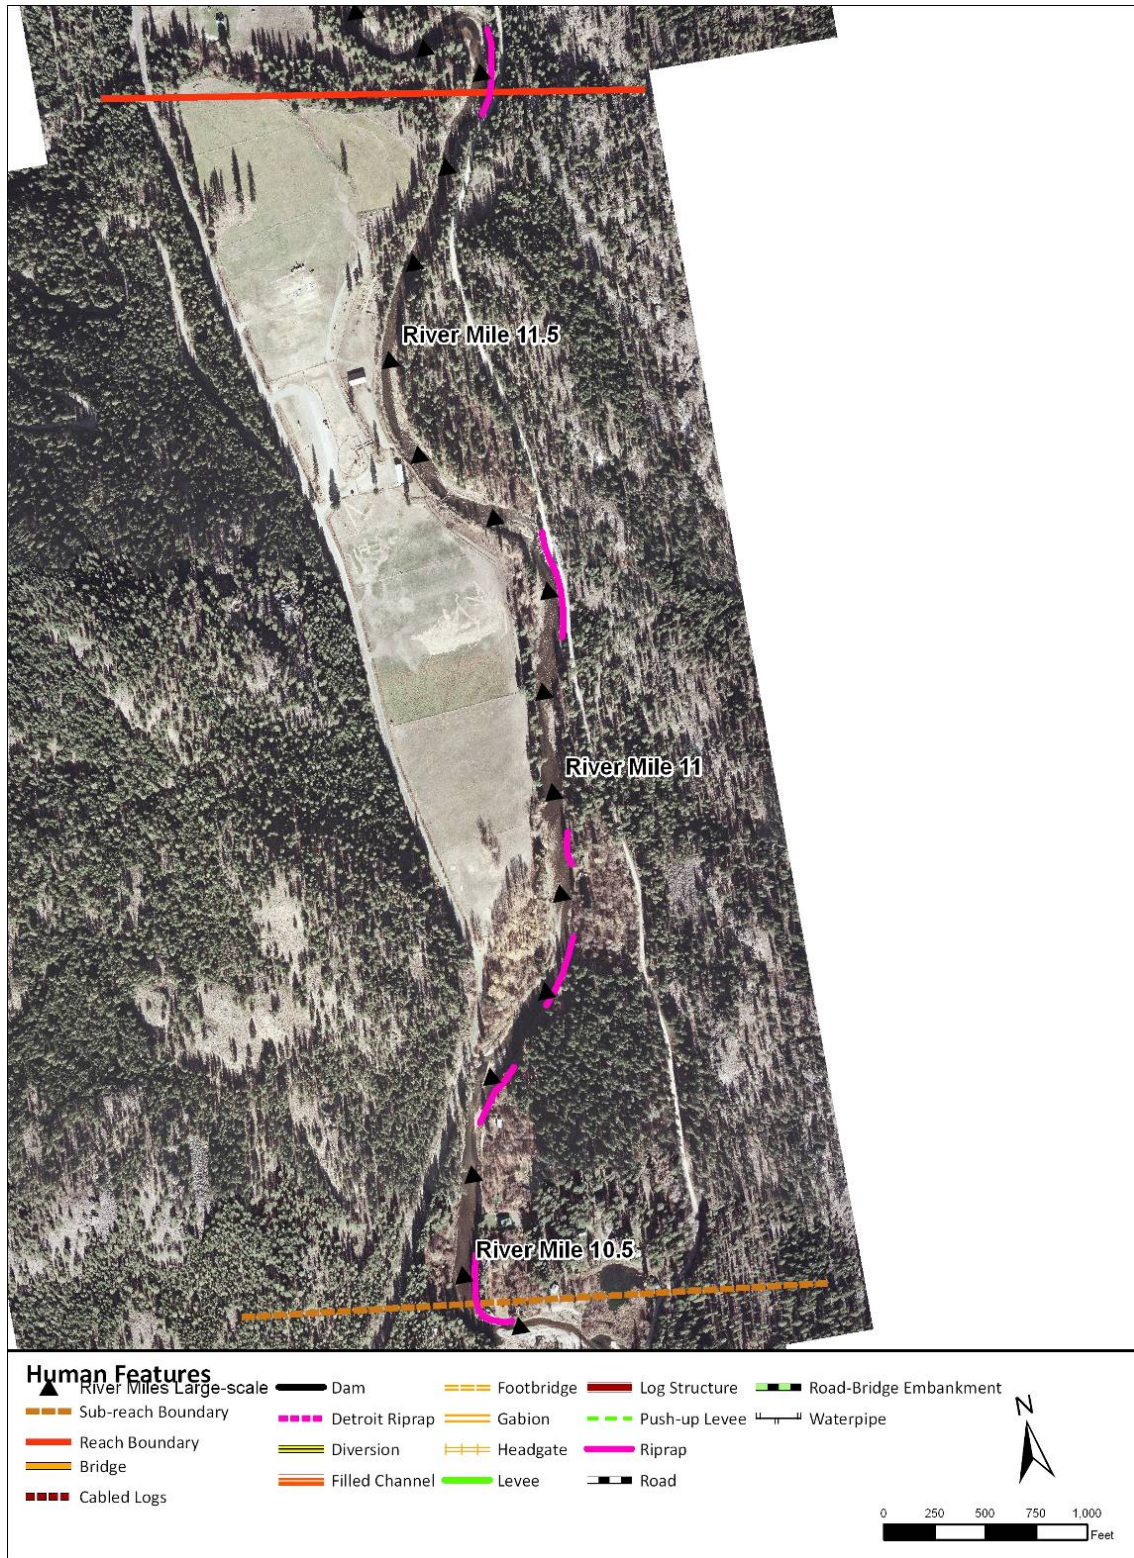
of riprap along river-left at several locations and clearing on the high terrace along the west side of the valley in the upstream half of the reach. Perhaps the most deleterious human action in Reach C4c was LWD clearing following large floods in 1948 and 1972 (USBR 2008b). There is little potential for future recruitment due to riparian clearing and natural constraints on lateral channel adjustments. There is residential development on the most expansive floodplain surface in the reach, which is on the east side of the valley between RM 10.46 and 10.93. Riparian vegetation has been cleared along portions of the channel margin and the banks are hardened with riprap.

Figure 29. Aerial photo showing human features in Reach C4c. Flow is from north to south.

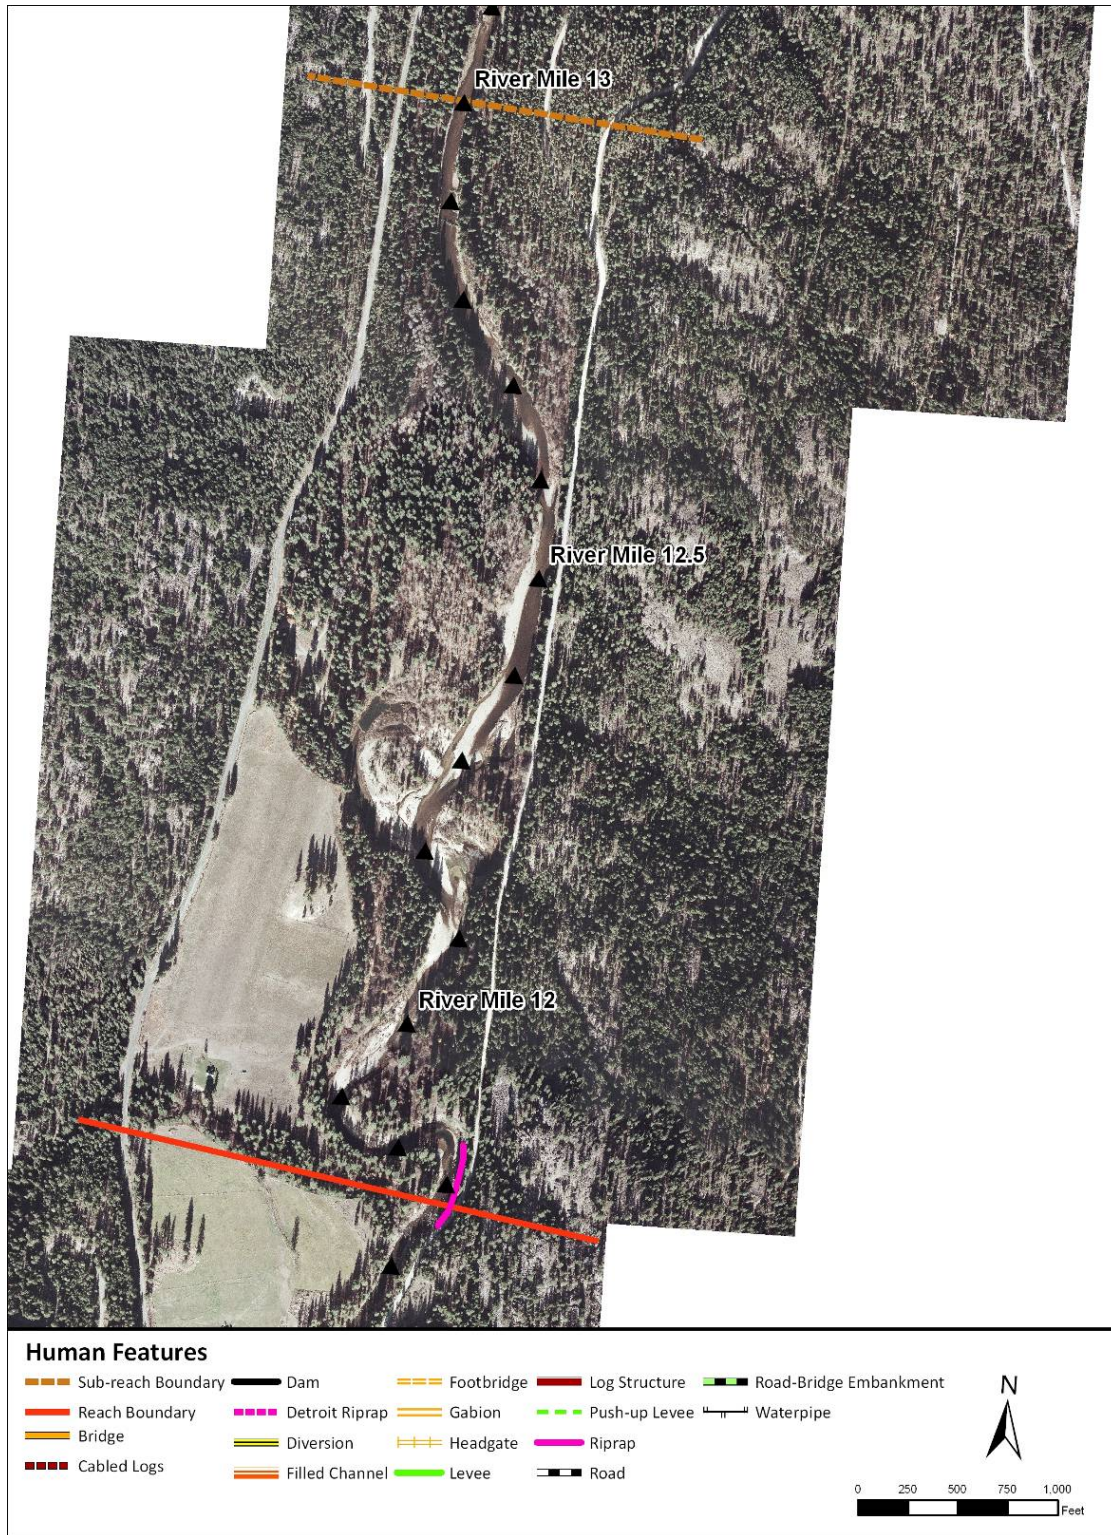
a bedrock hillslope that provides a natural lateral constraint. There is some semi-maintained camping on the west side of the valley in the widest portion of the floodplain near RM 12.5. Some of the campsites and access roads block floodplain channels and seasonal wetlands (USBR 2006). There are approximately 430 ft of riprap along river-left at the downstream end of the reach.

Figure 32. Aerial photo showing human features in Reach C5a. Flow is from north to south.

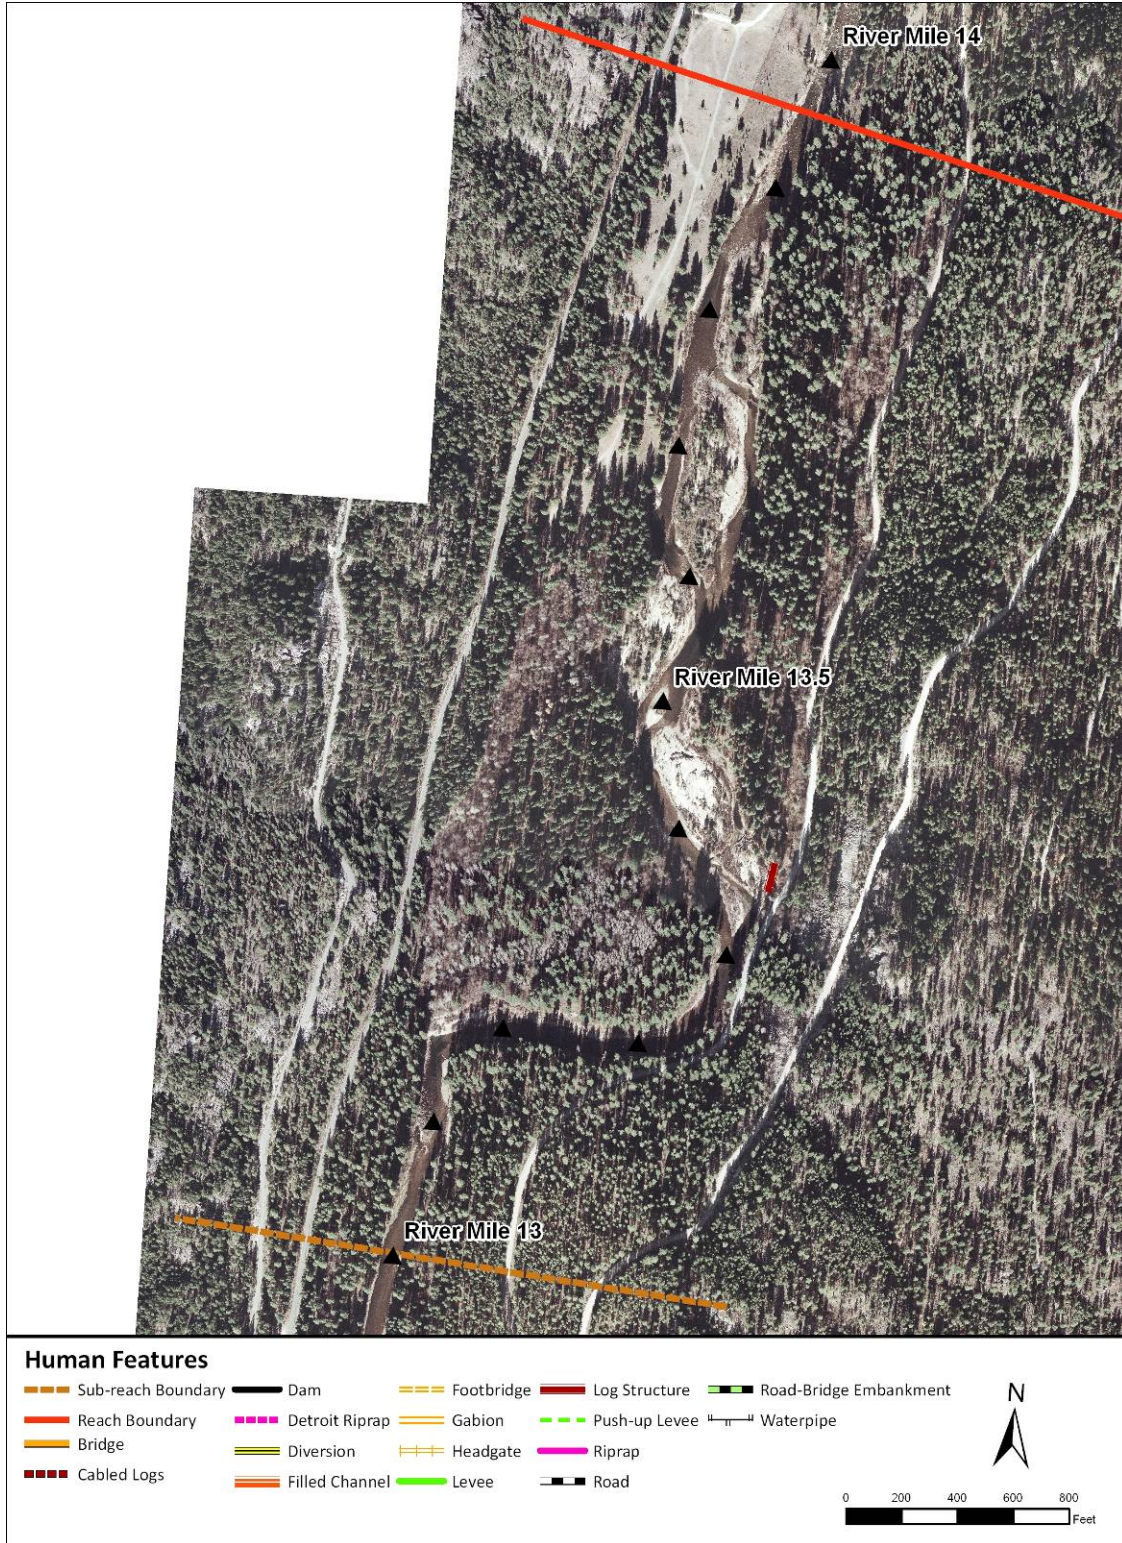
Human alteration of the river corridor in Reach C5b is minimal (Figure 35). There is no manipulation of the channel. There is some clearing of the low surface along the west side of the valley near the upstream end of the reach. The floodplain is otherwise intact. Roads are set on hillslopes above the low surface and have no direct impact on physical or ecological processes.

Figure 35. Aerial photo showing human features in Reach C5b. Flow is from north to south.

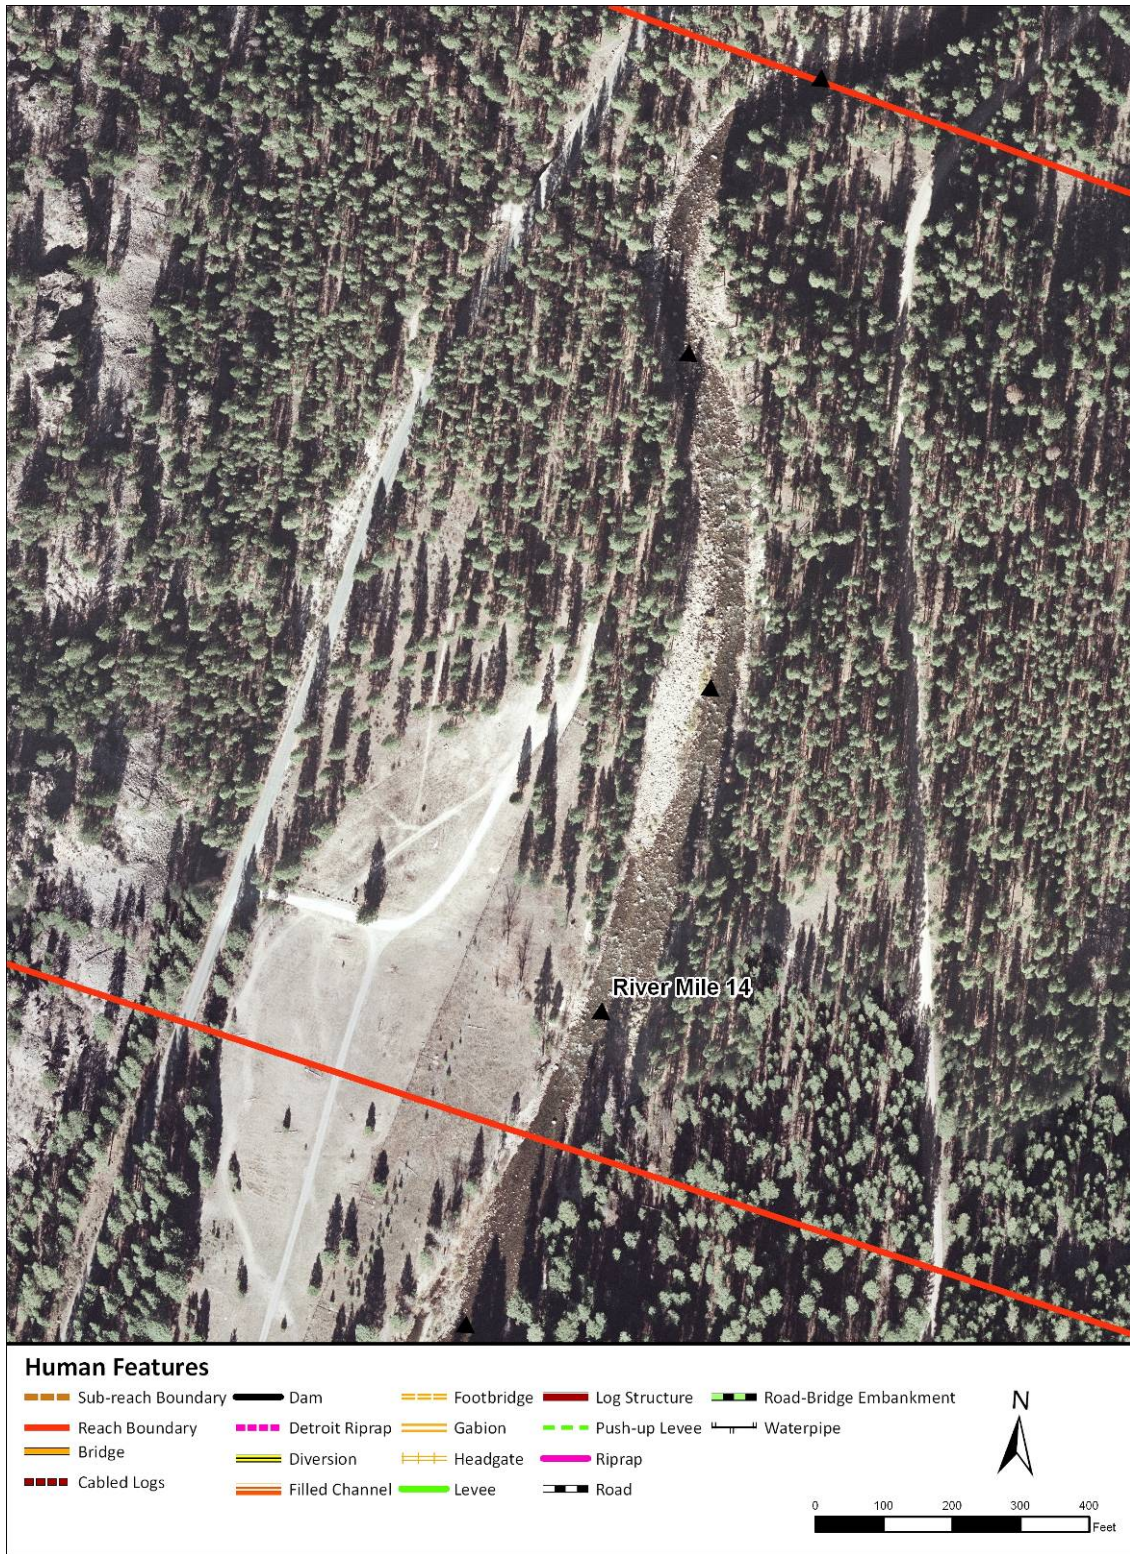
What little floodplain area there is in this reach has been cleared and developed for recreation and agriculture (Figure 38). There are unimproved camping and grazing areas, as well as roads across the surface. There are no direct alterations to the channel.

Figure 38. Aerial photo showing human features in Reach 6. Flow is from north to south.

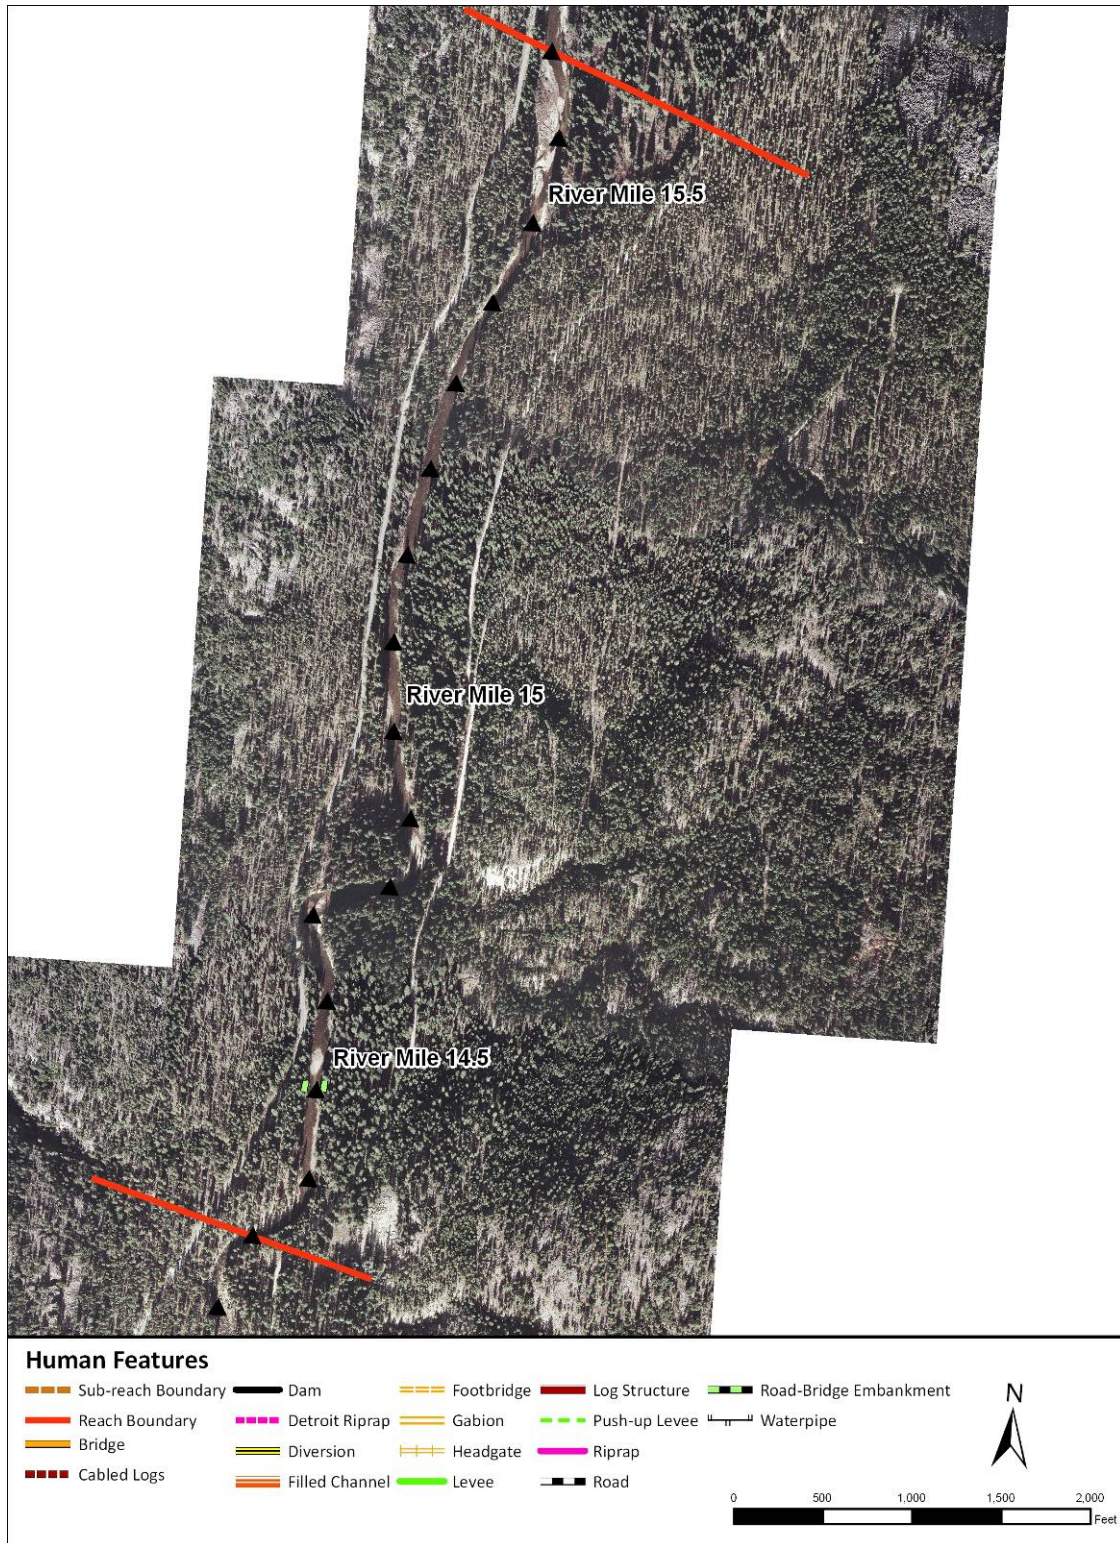
Roads are the only human features that create a disturbance in Reach C7 (Figure 41). For the most part, the roads are located on upland slopes out of the river corridor. However, the westside road embankment creates the channel margin between RM 15.06 and 15.15 and at locations near RM 14.68 and 14.53. The eastside road creates the floodplain margin between RM 14.78 and 15.03.

Figure 41. Aerial photo showing human features in Reach C7. Flow is from north to south.

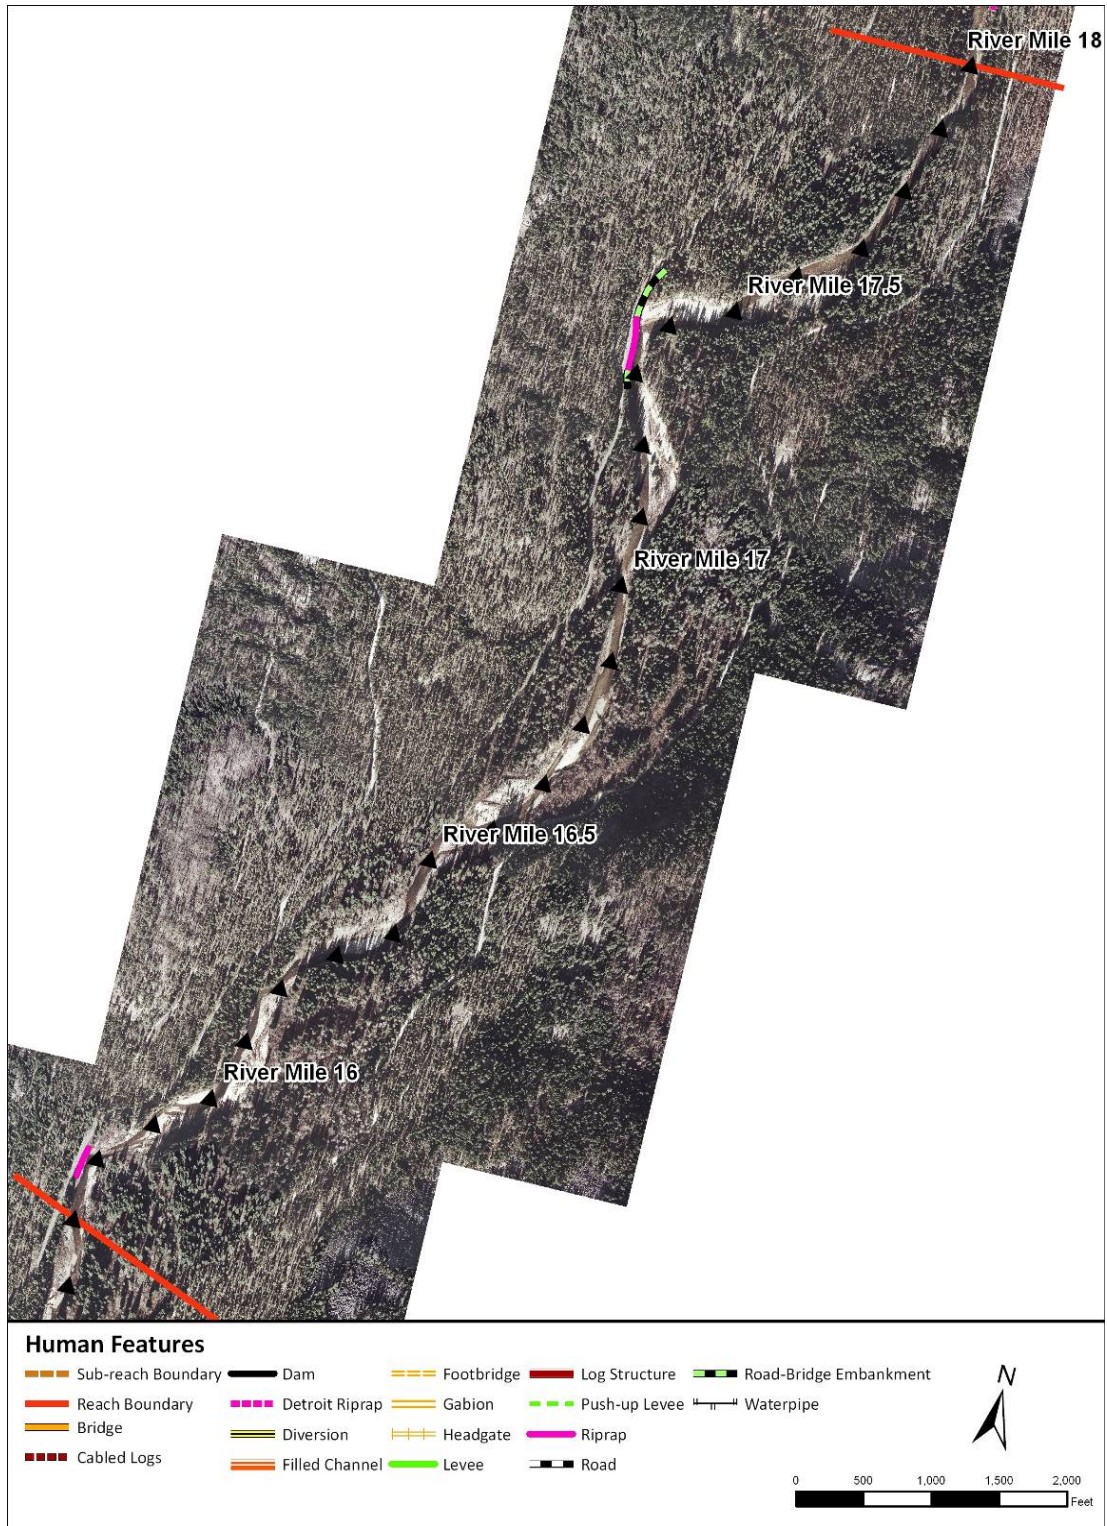
points decrease bank stability in some locations. Some of the camping areas show signs of recent improvements such as fencing and boulder placements to limit vehicle disturbance.

Figure 44. Aerial photo showing human features in Reach C8. Flow north to south.
