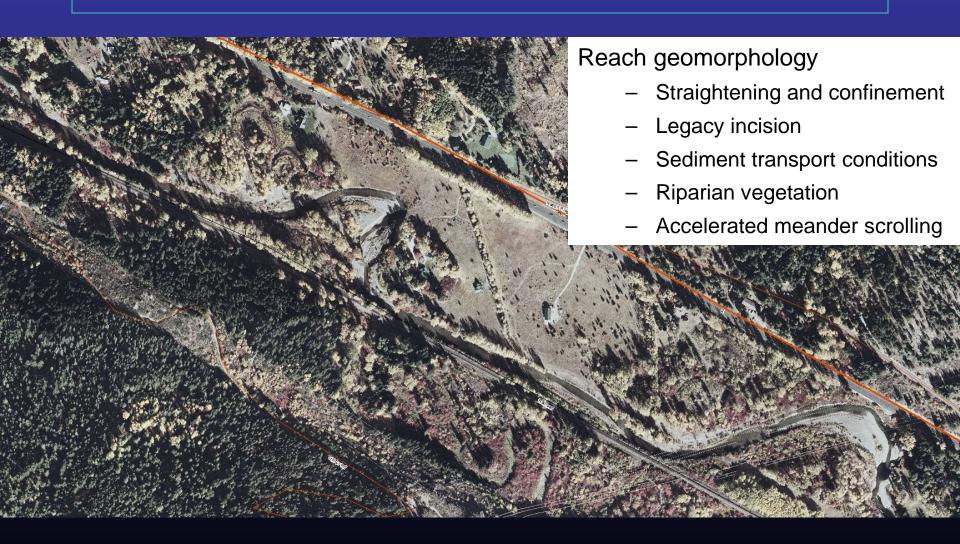
- Accelerated bank erosion
- No woody streambank or riparian vegetation
- Low floodplain roughness (in oxbow and on field)
- Log jam at downstream end of bend
- Poor margin habitat along bank

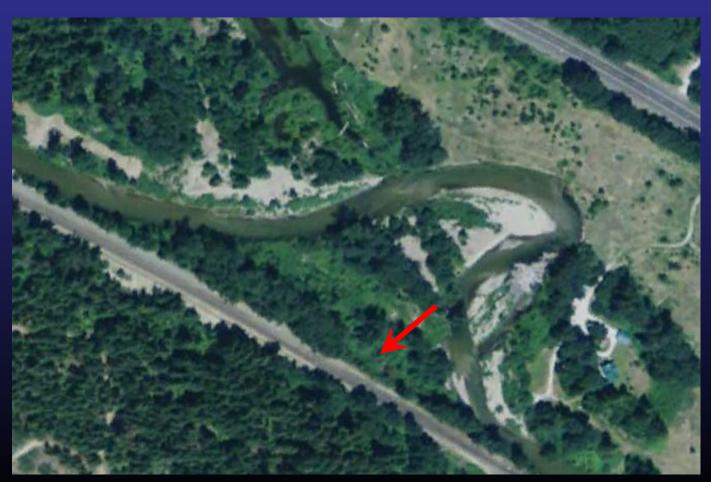
Headcut along railway embankment

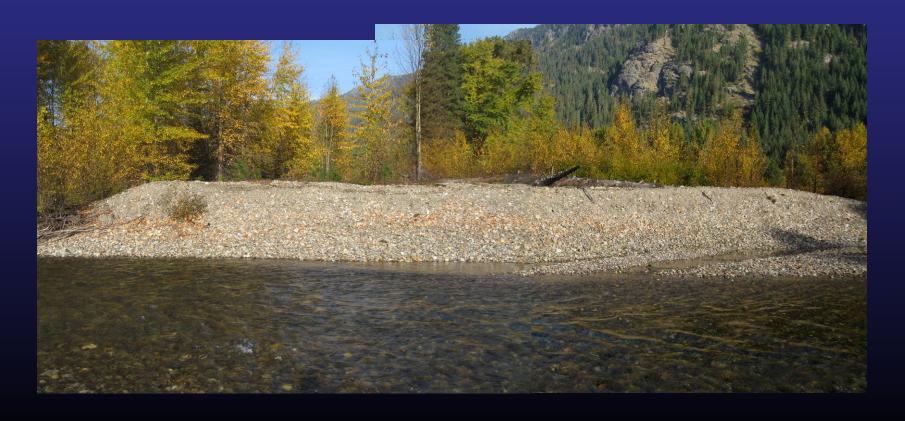
Large bar deposits

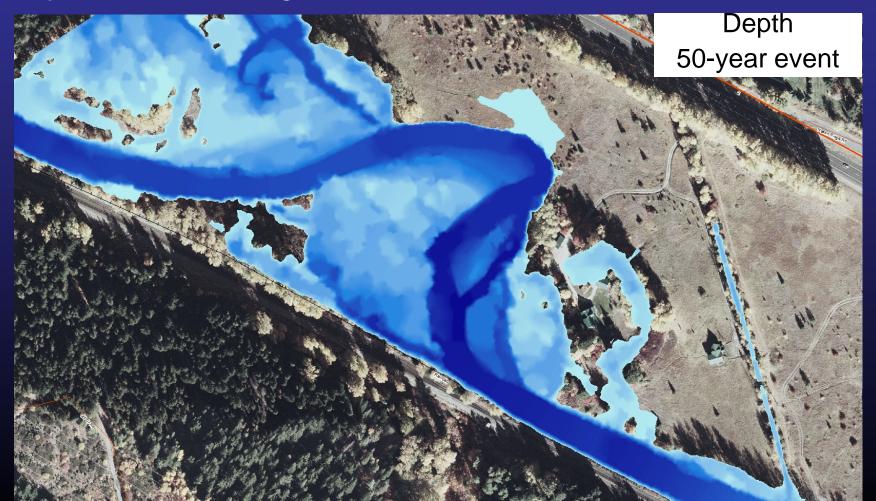
- Created by human disturbance
  - Denuded streambank vegetation (root strength)
  - Denuded floodplain roughness (across oxbow)
  - Legacy incision
  - Sediment imbalance
- Consequences of avulsion
  - Additional straightening of reach
  - Loss of pool-riffle habitat
  - Probable stranding of existing log jam
