# Lower Twisp River Reach Assessment

Provided for:

**Yakama Nation Fisheries Program**

JUNE 2010

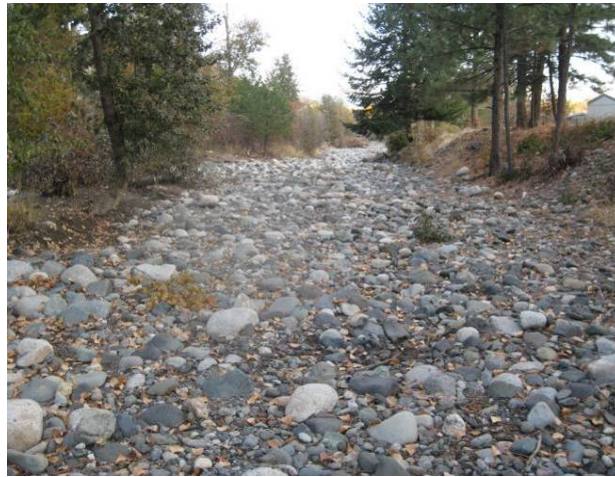
**Figure 5. High-flow channel that was mapped as active side-channel in 1985 (November 2009).**

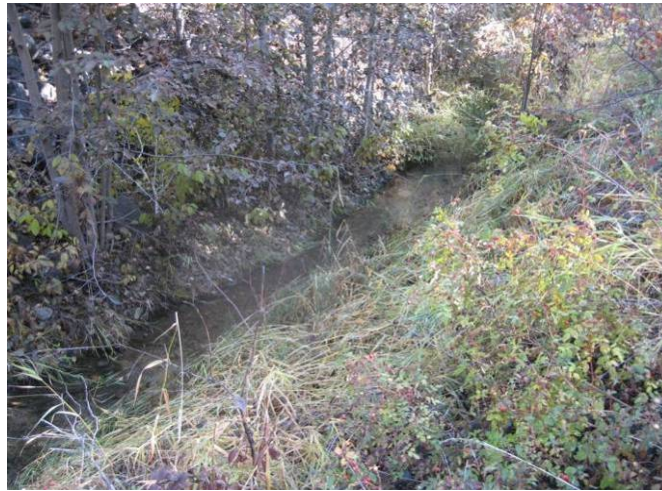
**Figure 11. Diversion canal near RM 1.58 that occupies a historical split flow channel that was active prior to 1964 (October 2009).**

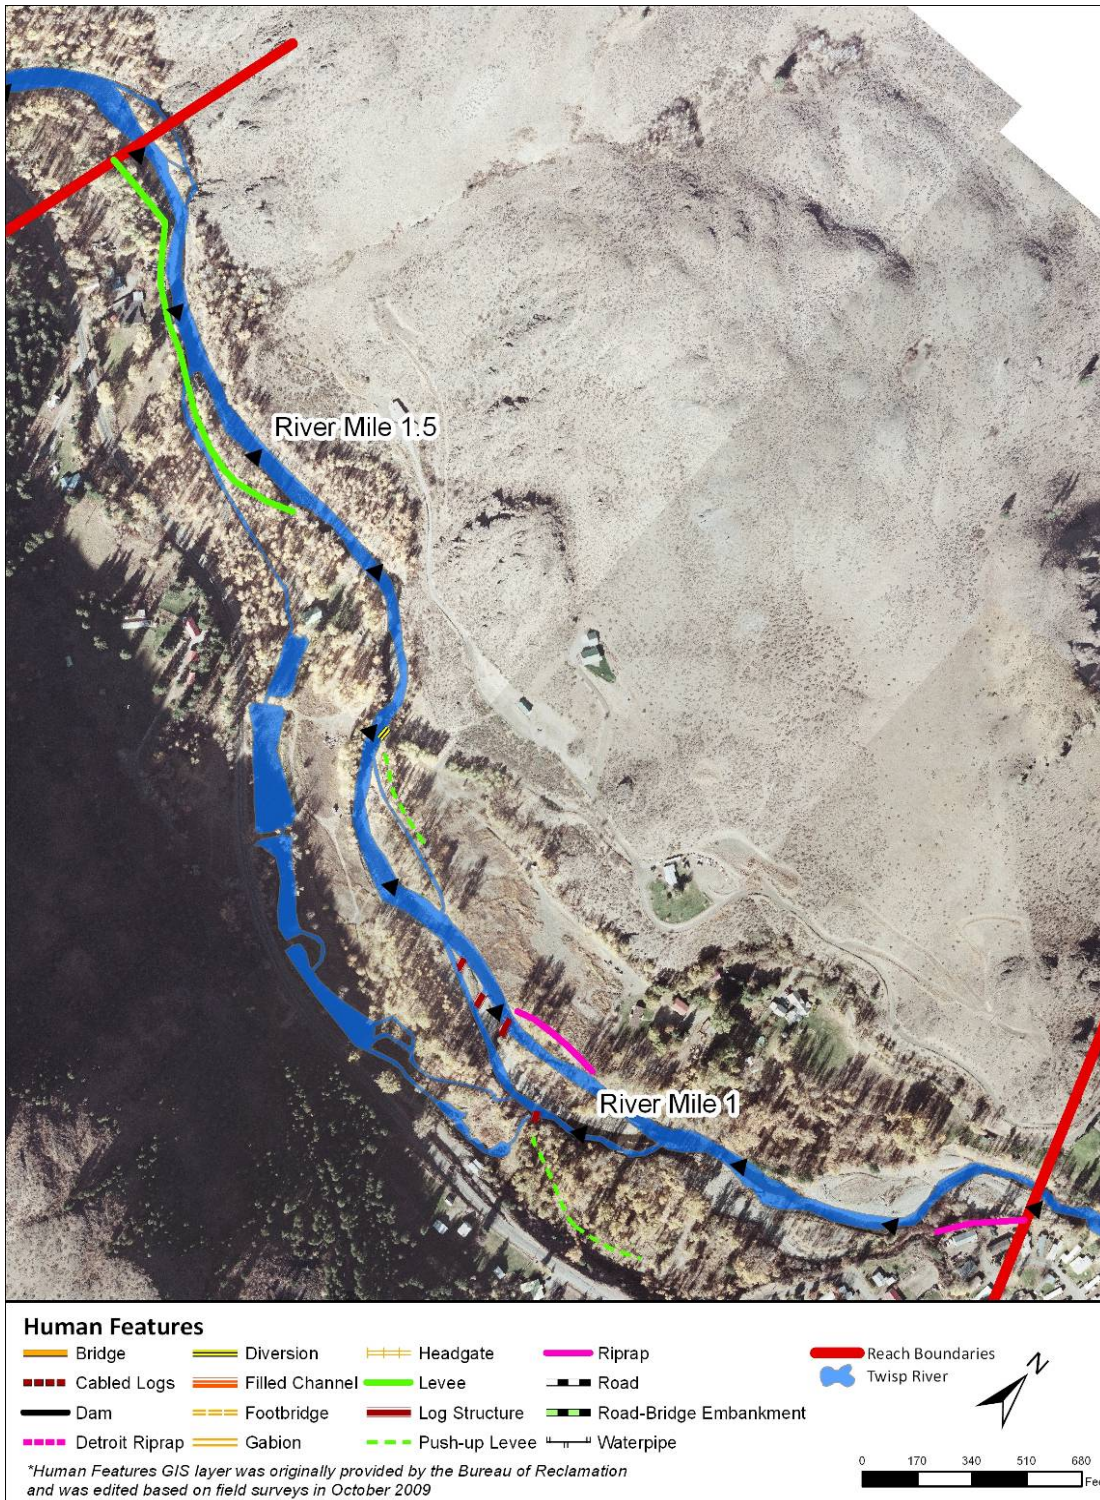
area is disconnected in this reach. Scattered residences and managed fisheries facilities are the primary human features occupying the floodplain. Bank armoring protects private lands and residential development on both sides of the channel, including about 1,869 ft of the upstream right bank (Figure 16). A diversion through the levee near RM 1.55 provides water to off-channel ponds (Figure 17). This area also includes trails, an observation area, pump houses, a pit tag station, and a screw trap in the channel. The ponds and diversion canal occupy a historical side-channel that was abandoned sometime after 1964. The restoration of the floodplain ponds in this area helps to alleviate some of the floodplain disconnection in this reach and restore off-channel habitat. An additional 630 ft of levee and riprap modifies the banks and disconnects the floodplain along the river left of the channel near the downstream end of the reach. An irrigation diversion near RM 1.3 appears to have been abandoned (Figure 18). A push-up levee on the river-left bank just downstream of the structure disconnects the floodplain from the channel.

Figure 15. Aerial photo showing human features in Reach T2a. Flow is from west to east. Processes are hindered by bank hardening and development within the floodplain.

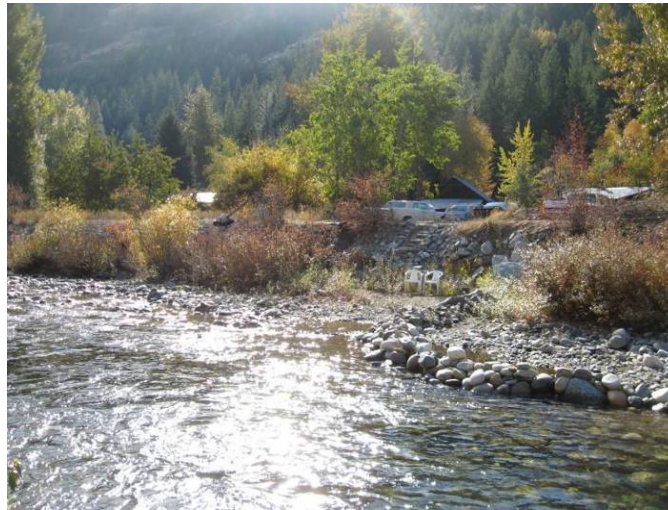
**Figure 16. View looking downstream toward the west at the levee and development in the floodplain along river-right near RM 1.65 (October 2009).**

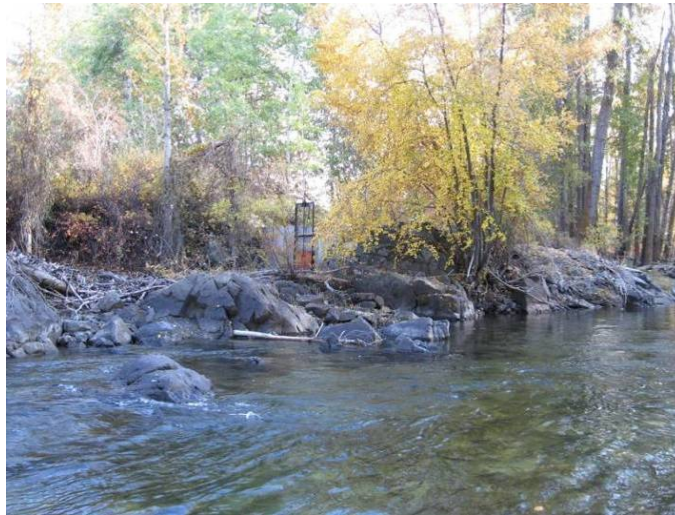
Figure 18. View looking downstream toward the west at the abandoned irrigation diversion on river-left near RM 1.3 (October 2009).

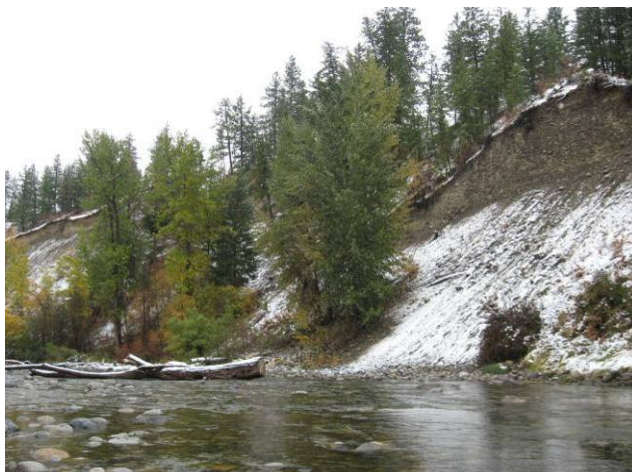
**Figure 21. View to the southeast in the downstream direction at a high glacial terrace that is being actively eroded (October 2009).**

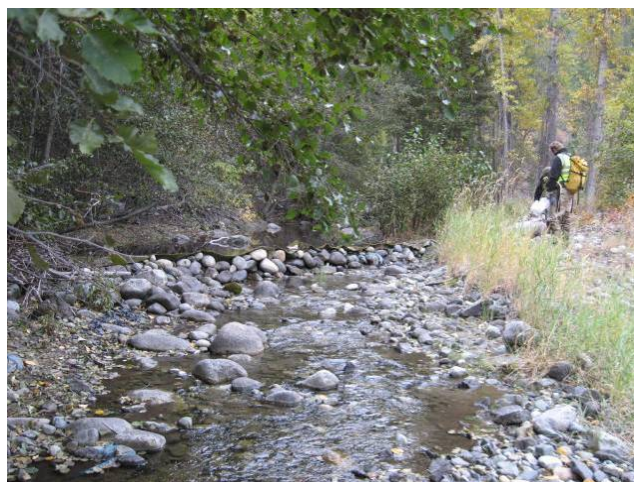
**Figure 35. View to the southwest in the upstream direction at an irrigation diversion in a side-channel near RM 6.5 (October 2009).**

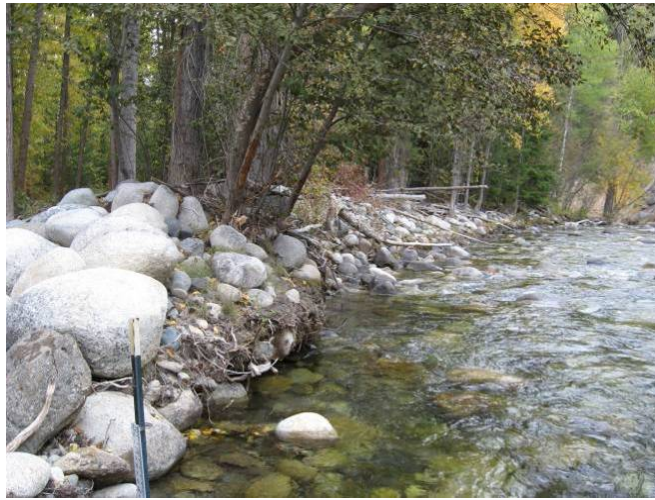
There is more extensive channel and bank modification between RM 6.3 and 5.9. Near RM 6.3, a 240 ft long levee blocks an inner zone side channel and reduces channel/floodplain connection to the south of the channel. The floodplain in this area has been cleared for agriculture. There is a small amount of rural residential development on the floodplain near RM 6.08. Access to the house is provided by a bridge crossing that includes about 100 ft of riprap upstream and downstream of the crossing. The Twisp River Road embankment forms the river-left channel margin between RM 6.0 and 6.28. The bank is protected with riprap along most of this length. Figure 37 shows all human features in reach T3b.

**Figure 36. View to the southeast in the downstream direction at a push-up levee near RM 6.65 (October 2009).**
