APPENDIX A

Lower Libby Creek Stream Habitat Assessment River Mile 0 to 1.4

Survey: September 2011

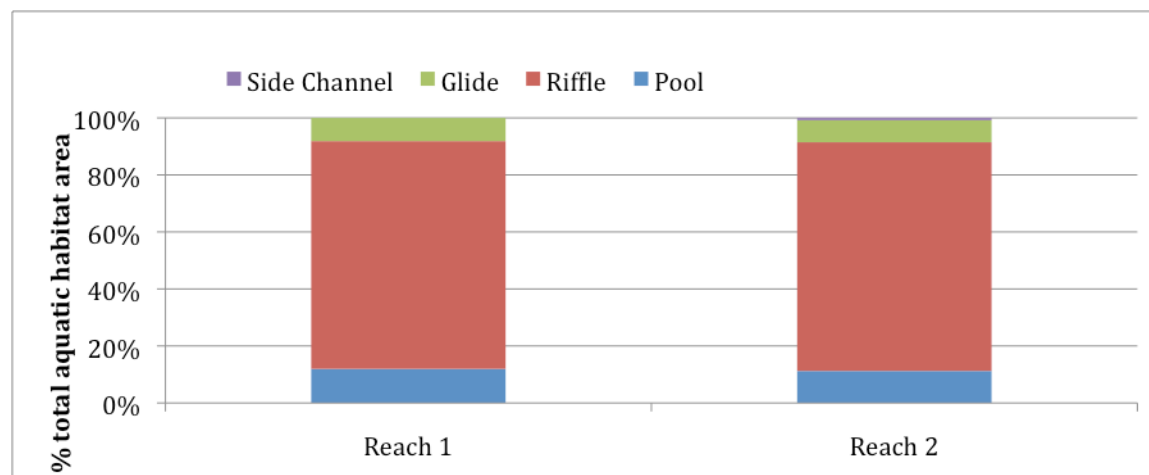
Riffles were the dominant habitat unit type, making up 80% of the total habitat area. Pools and glides comprised approximately 12% and 8% of the total habitat area, respectively. Side-channel habitat was less than 0.5% of the survey area (Figure 2).

Figure 2. Proportion of habitat types in Reaches 1 and 2 in lower Libby Creek.

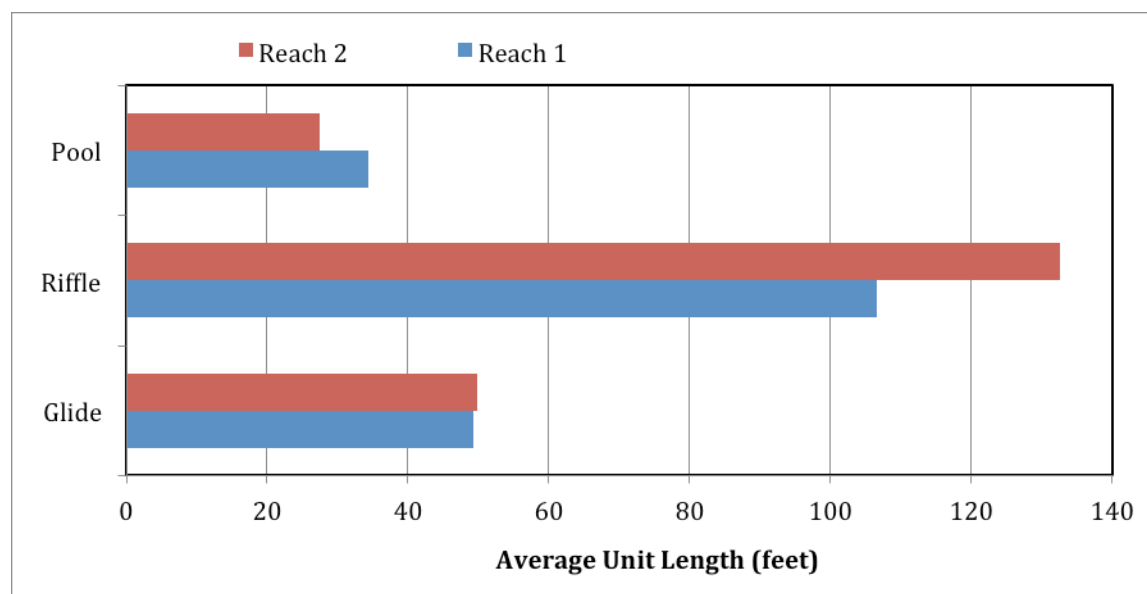
Average unit lengths for the three habitat types (pools, riffles, and glides) are presented in Figure 3. Reach 1 had slightly longer pools, as they are predominately scour pools versus the plunge pools that dominate Reach 2. Reach 2 had longer riffles and slightly longer glides.

Figure 3. Comparison of average habitat unit lengths for Reaches 1 and 2 in lower Libby Creek.

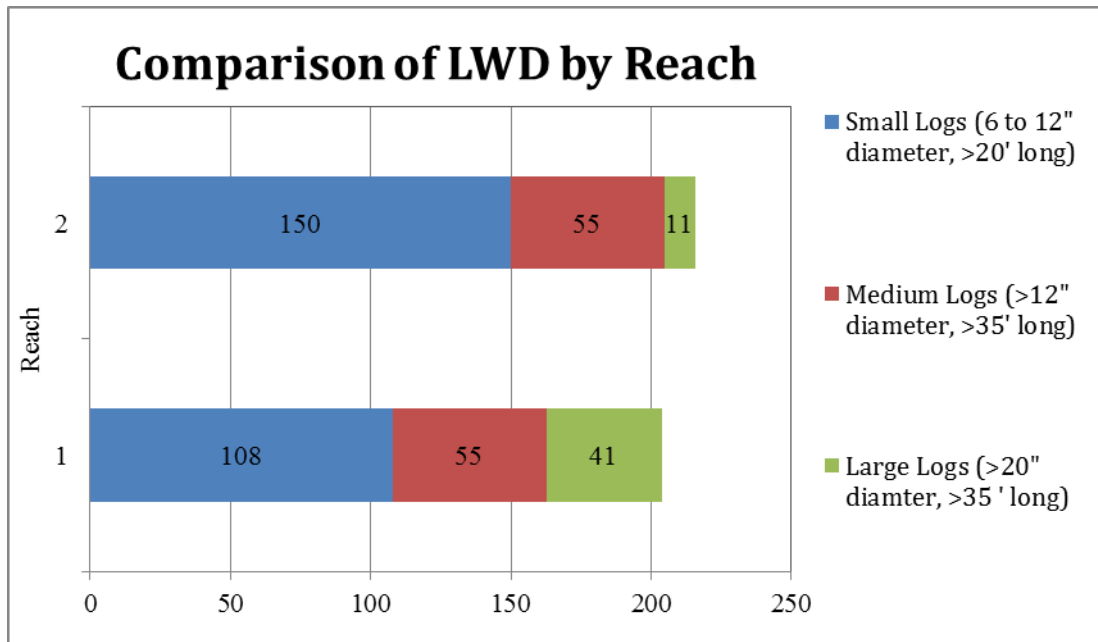
wood frequency in lower Libby Creek (both reaches combined) was 211 pieces/mile. As a reference, median wood loading on “undisturbed” streams of comparable size in the Douglas-Fir/ponderosa pine forest zones in Washington State is 274 pieces/mile (Fox and Bolton 2007). When making these comparisons, it should be noted that the size criteria for large wood used by Fox and Bolton (2007) is based on the WA State Timber Fish & Wildlife criteria, which is smaller (4 inches diameter and 6.6 feet long) than the size criteria used for the USFS Level II surveys (6 inches diameter and 20 feet long).

Figure 4. Small and medium/large wood pieces/mile for each reach.

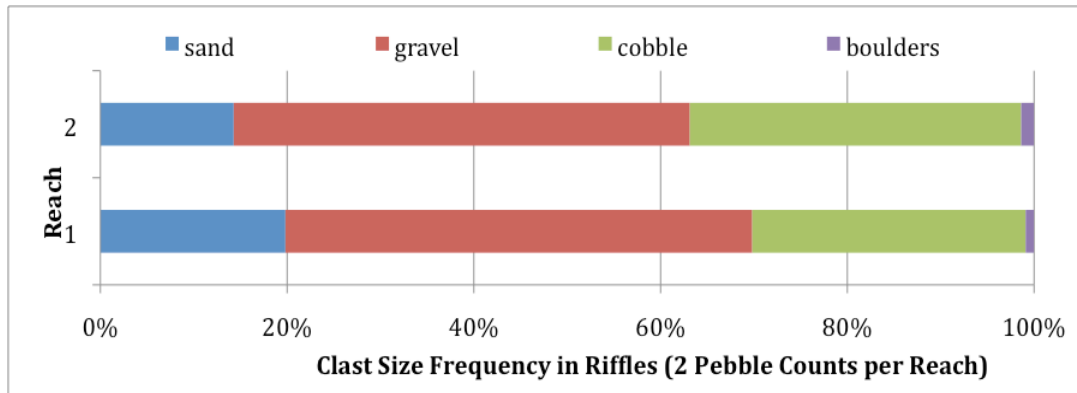
Bed substrate was based on ocular estimates at each fast water unit and pebble counts at two representative riffle locations within each of the two reaches. Pebble counts suggested that ocular estimates in Reach 1 slightly underestimated sand and gravel, and slightly underestimated gravel in Reach 2 (Figure 5).

Figure 5. Pebble count classification of substrate by reach for lower Libby Creek (frequency values are derived by pooling the 2 pebble counts per reach).

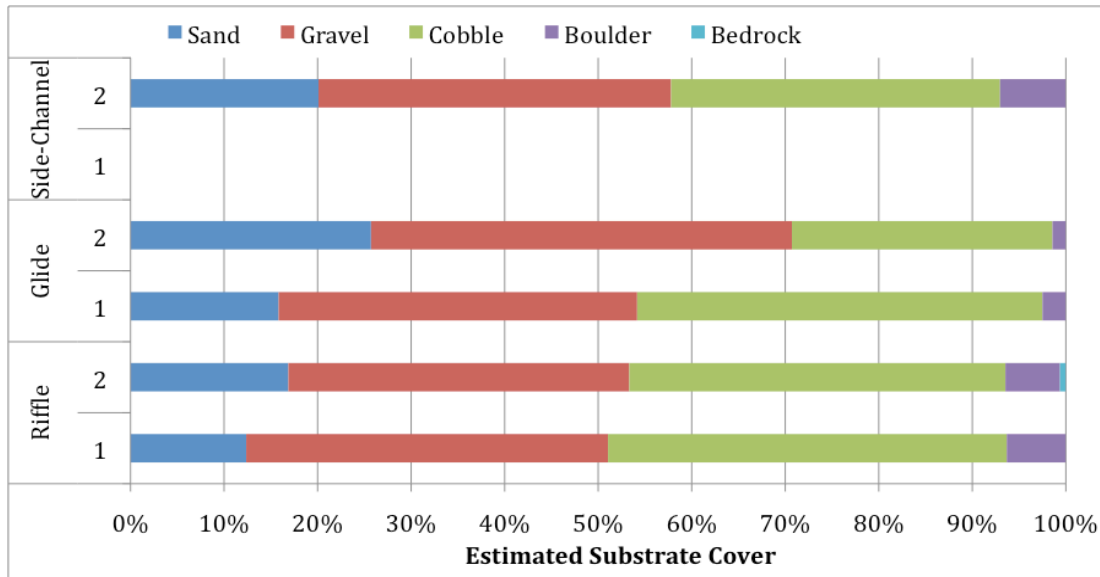
Gravels and cobbles were dominant in lower Libby Creek, with sand a subdominant substrate type (Figure 5 and Figure 6). Boulders were observed infrequently and were more common in riffle habitat towards the upstream end of the survey area. Bedrock was rare and was only observed in two riffles in Reach 2. Generally, Reach 1 had smaller bed substrate than Reach 2.

Figure 6. Ocular estimates of substrate by habitat unit type and reach for lower Libby Creek.

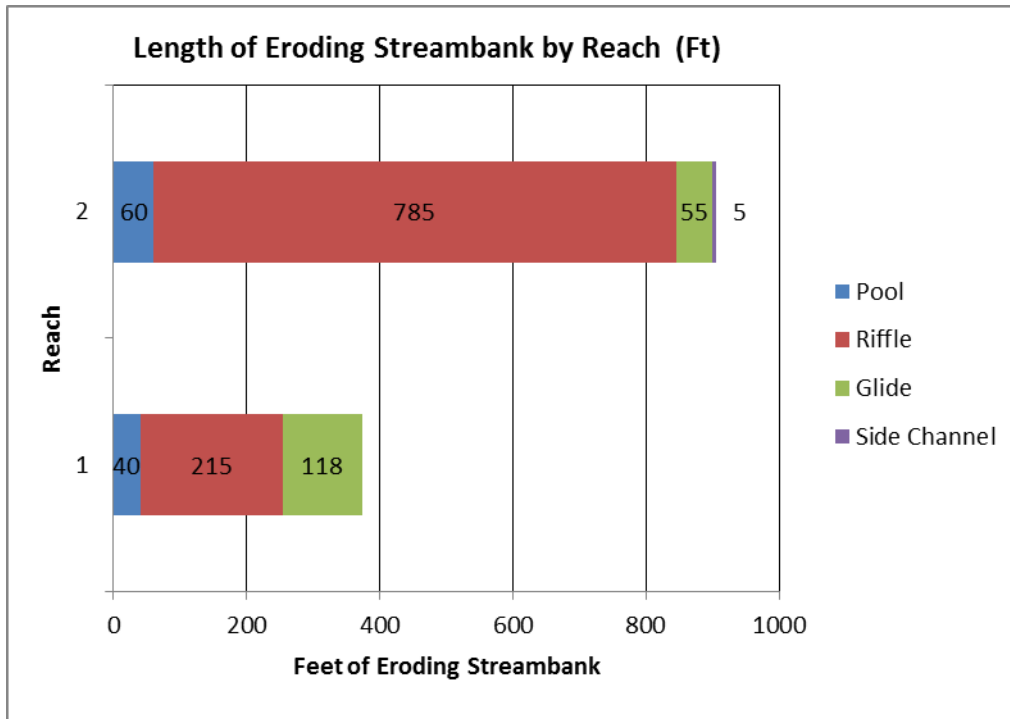
Reach 2 bank erosion was higher with a total of 11% of the mainstem streambanks (905 feet) showing signs of active erosion (Figure 7). Erosion in this reach can be attributed to natural conditions as well as land uses including livestock grazing. Eroded areas were characterized by loam soils with fewer instances of cobble banks than was observed in Reach 1.

Figure 7. Length of bank erosion by habitat type and reach along lower Libby Creek.

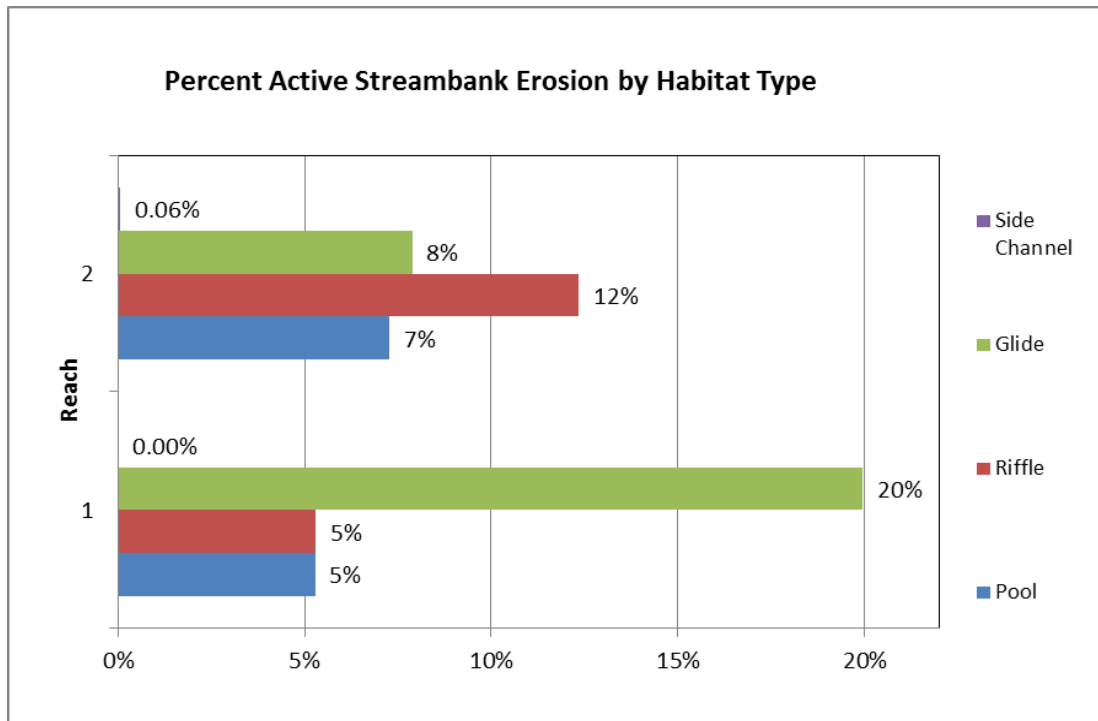
Bank erosion occurred in all habitat types; however, it was most frequently observed in riffle and glide habitats (Figure 8). In portions of Reach 1, streambank erosion is limited by the presence of riprap armoring near residential development. Plywood riprap lines a small (10 feet) section in Reach 2 near an abandoned irrigation diversion along river-right.

Figure 8. Percent active erosion of each habitat type along lower Libby Creek.

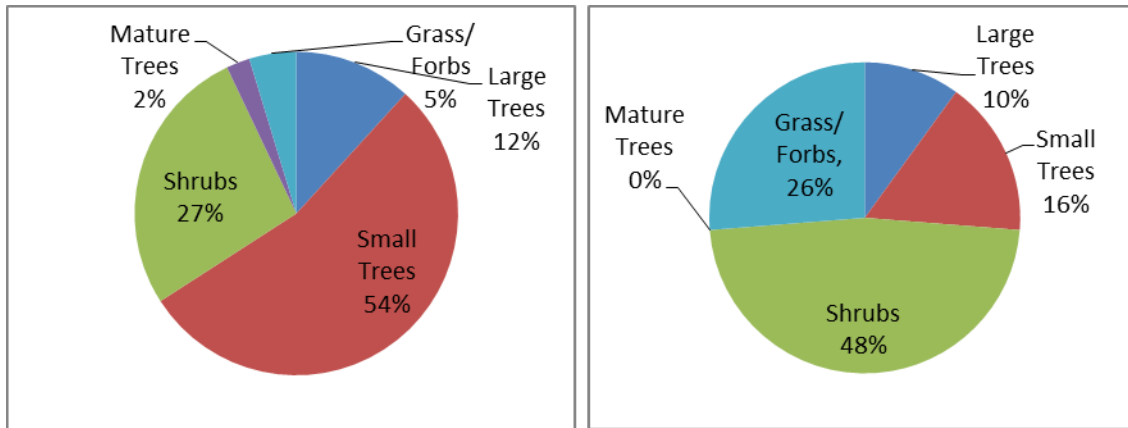
Riparian inner zones were typically dominated by small trees (54% of units) or shrubs (27% of units); large trees were dominant in only 12% of units (Figure 9). Outer zones were typically dominated by shrubs (48%) or grass/forbs (26%). Small trees dominated 16% and large trees dominated only 10% of units. Many of the outer zones were within areas that had been cleared for agricultural or residential uses.

Figure 9. Libby Creek Inner Zone Distribution (left) and Outer Zone Distribution (right) of the dominant diameter class category for the riparian zones in lower Libby Creek (RM 0.0 to RM 1.3).

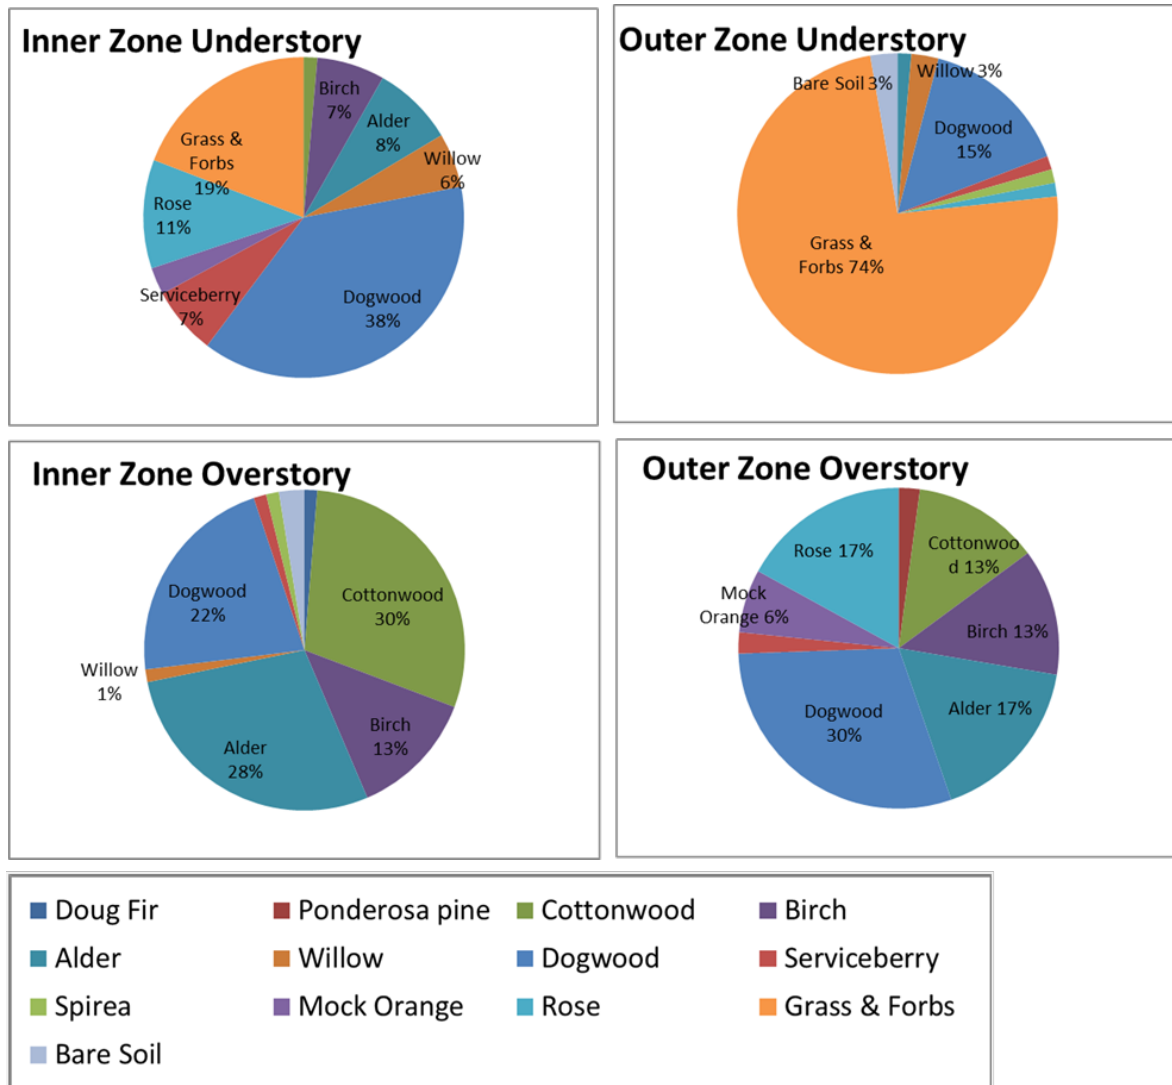
The species composition of riparian areas was dominated by deciduous species (Figure 10). The inner zone understory was typically dogwood or grass/forbs. The inner zone overstory was typically either cottonwood, dogwood, alder, or birch. The outer zone understory was typically grass/forbs but the overstory varied considerably.

Figure 10. Proportions of vegetation cover in lower Libby Creek. The dominant species of grasses and forbs were not determined, however curly dock, Canada thistle, burdock, slough sedge, nettles and reed canary grass were observed.

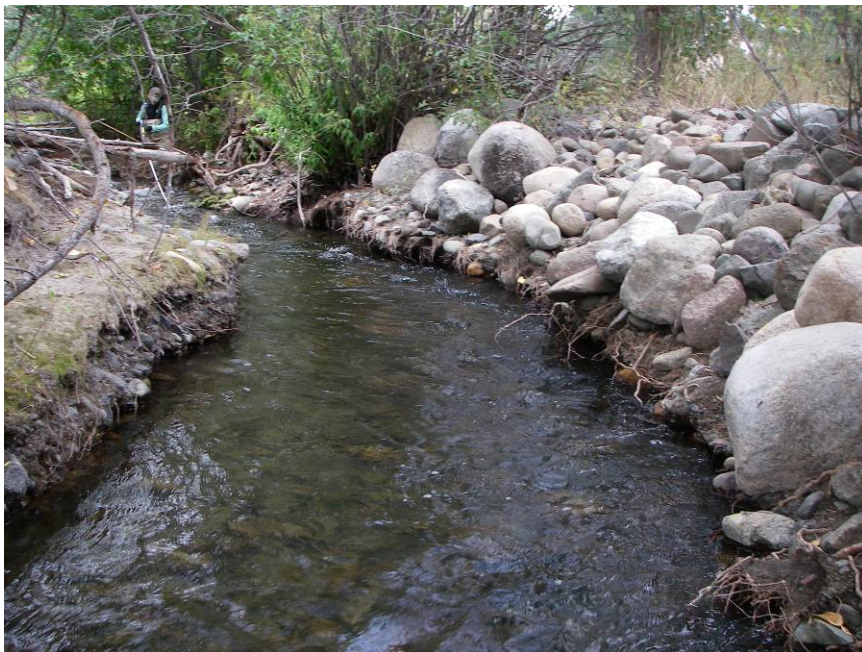
Figure 11. Bank armoring and scour along lower Libby Creek (September 2011).

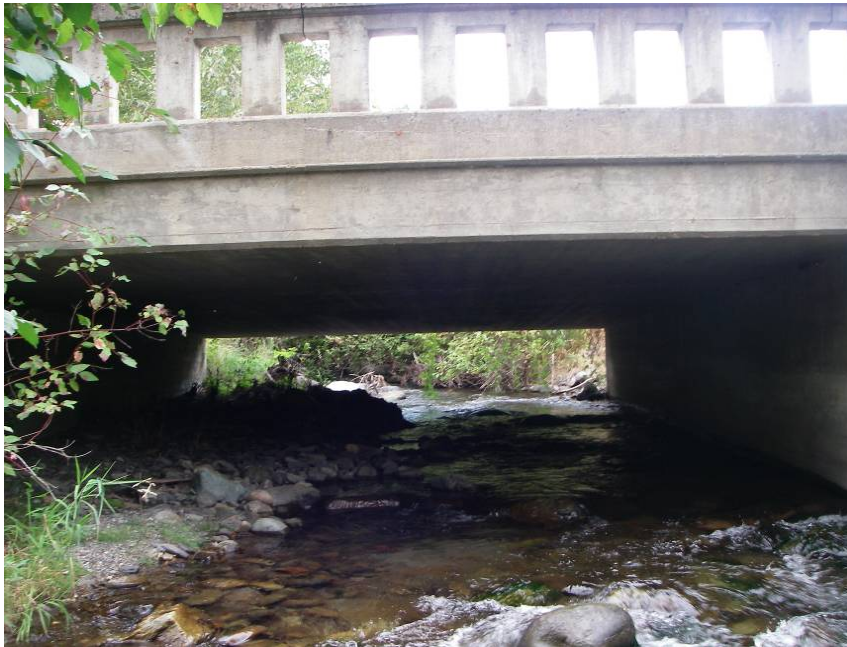
Figure 12. Habitat alteration and channel confinement at the Hwy 153 Bridge (RM 0.3).

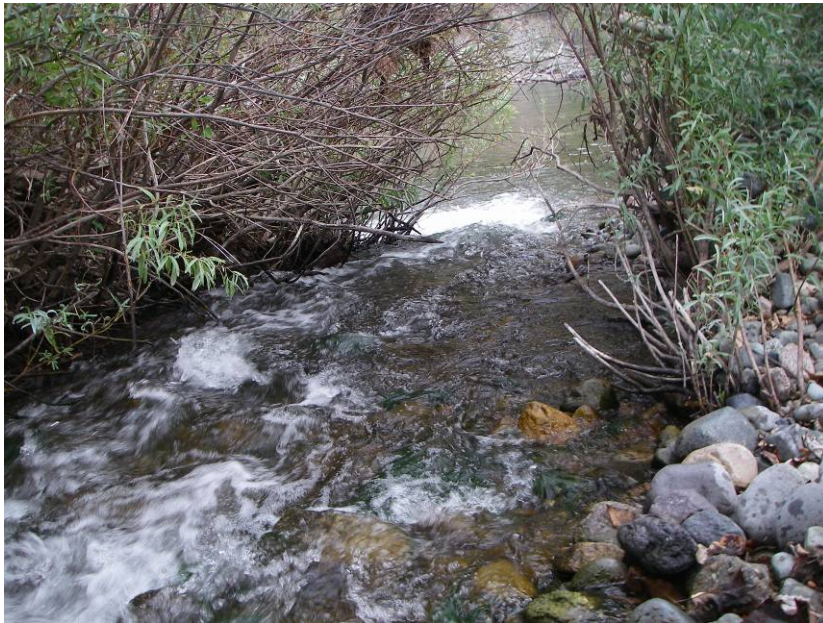
Figure 13. Confluence of Libby Creek looking downstream towards the Methow River. Young willows are growing along the alluvial deposits (September 2011).

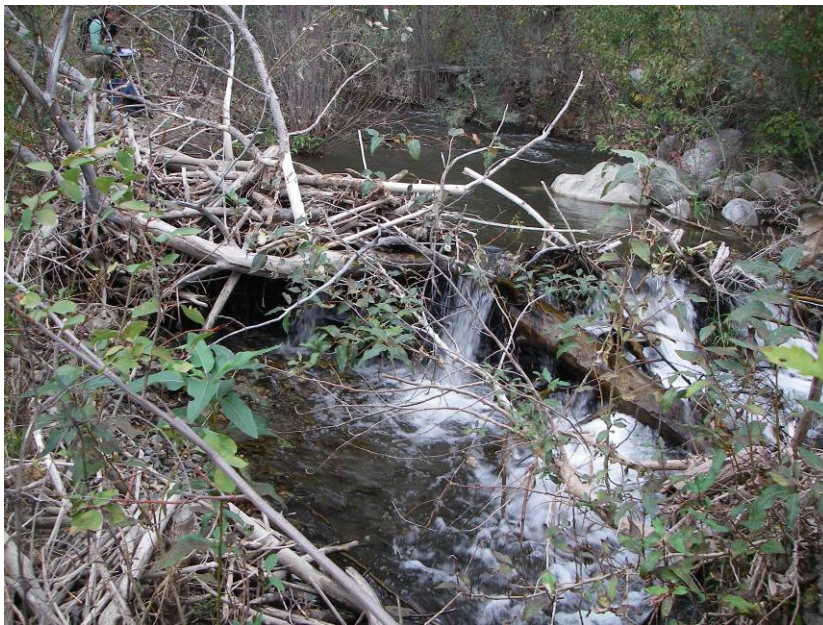
Figure 14. Looking upstream from the mouth of Libby Creek at a beaver-dammed pool (September 2011).

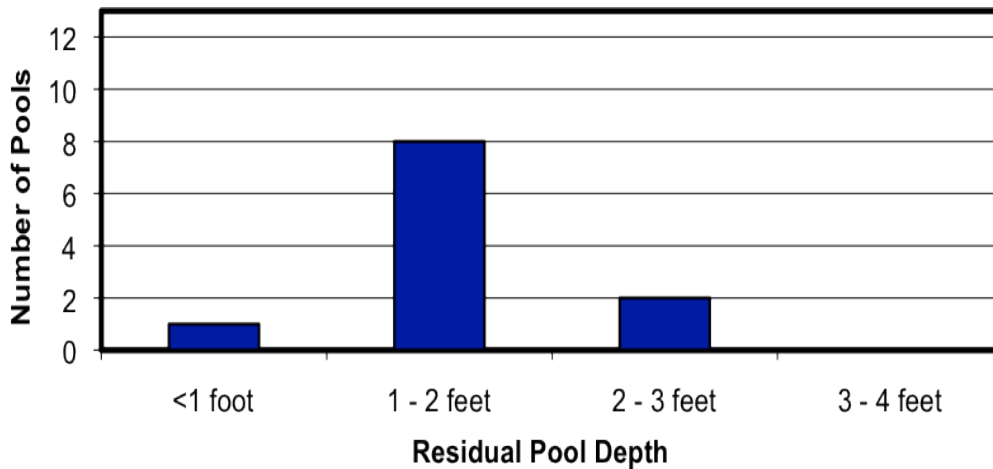
Figure 16. Reach 1 residual pool depths.

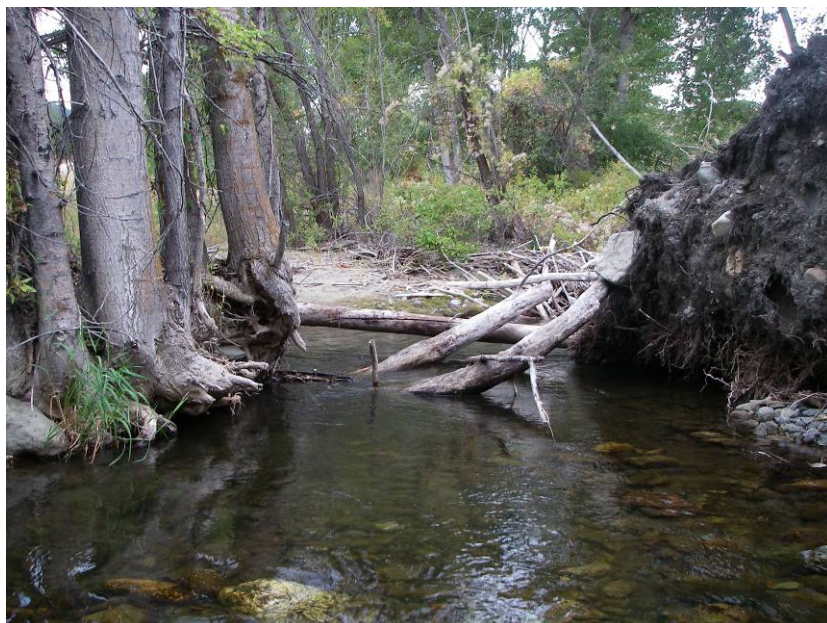
considered “functioning at risk” with respect to pool spacing based on USFWS (1998). Average residual pool depth was 1.4 feet. Average maximum pool depth was 2.4 feet. Scour pools were the dominant pool type (e.g. Figure 17).

Figure 17. Scour pool near the mouth of Libby Creek. This is a representative slow water unit (pool) observed in Reach 1 (September 2011).

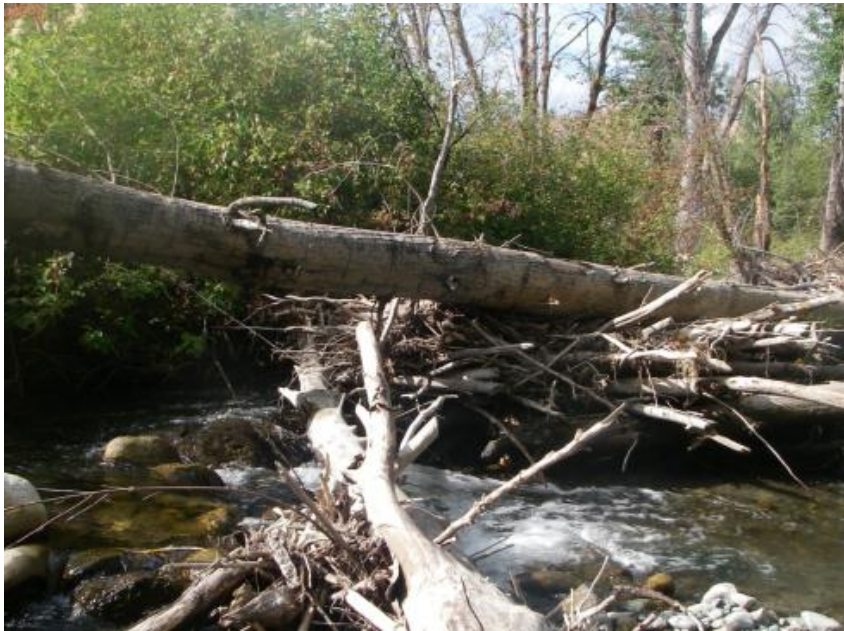
Wood plays a moderate role in Reach 1, including sediment sorting, habitat cover, and channel complexity (Table 1 and Figure 18). The number of LWD pieces in Reach 1 was higher than in Reach 2. LWD frequency was 104 pieces/mile, with “large” pieces comprising 20% of all LWD in the reach. “Medium” wood pieces accounted for 27% of all LWD in the reach, and “small” pieces accounted for 53%. Black cottonwood is the most abundant species of LWD. Wood quantities averaged 204 pieces per mile in Reach 1, less than the recommended quantities of 274 pieces/mile for median wood loading in unmanaged stream systems of comparable size and type (Fox and Bolton 2007). When making these comparisons, it should be noted that the size criteria for large wood used by Fox and Bolton (2007) is based on the WA State Timber Fish & Wildlife criteria, which is smaller (4 inches diameter and 6.6 feet long) than the size criteria used for the USFS Level II surveys (6 inches diameter and 20 feet long).

Figure 18. Large woody debris jam in Reach 1 (September 2011).

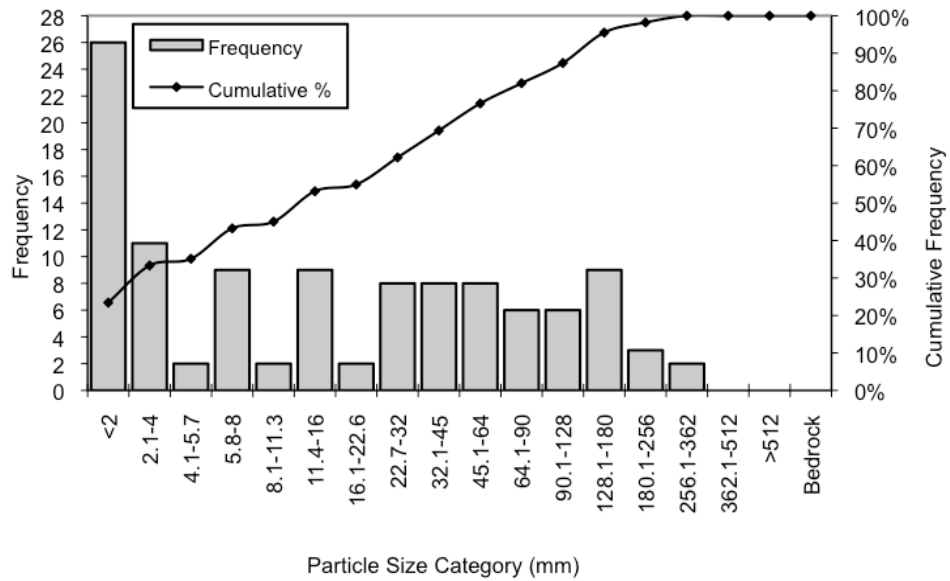
Material	Percent Composition
Sand	23%
Gravel	53%
Cobble	22%
Boulder	2%
Bedrock	0%

Size Class	Size percent finer than (mm)
D5	<2
D16	<2
D50	14
D84	104
D95	177

Figure 20. Grain size distribution and particle size classes from pebble count taken at RM 0.46.

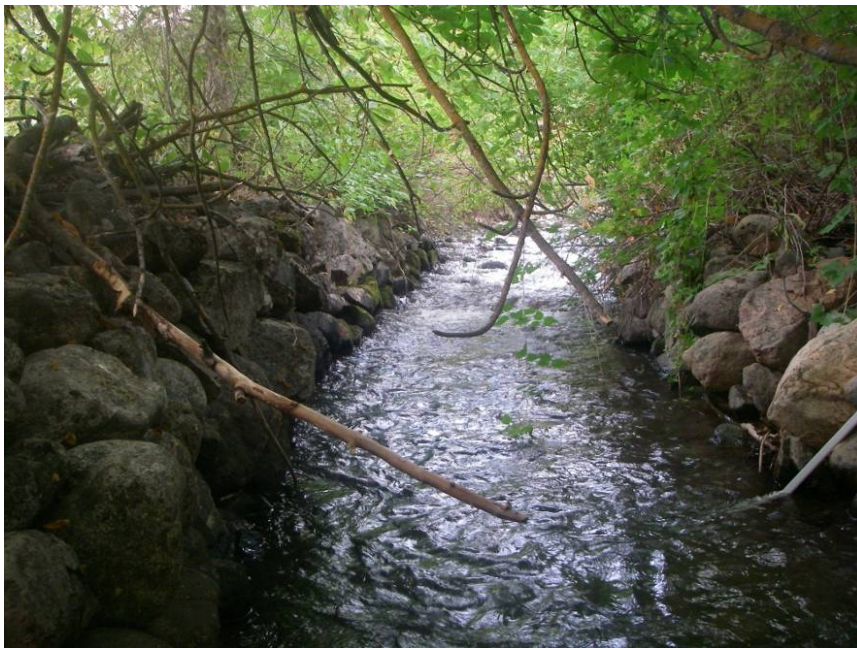
Figure 23. Riprap armoring limits floodplain connectivity and lateral channel dynamics near RM 0.3, Reach 1 (September 2011).

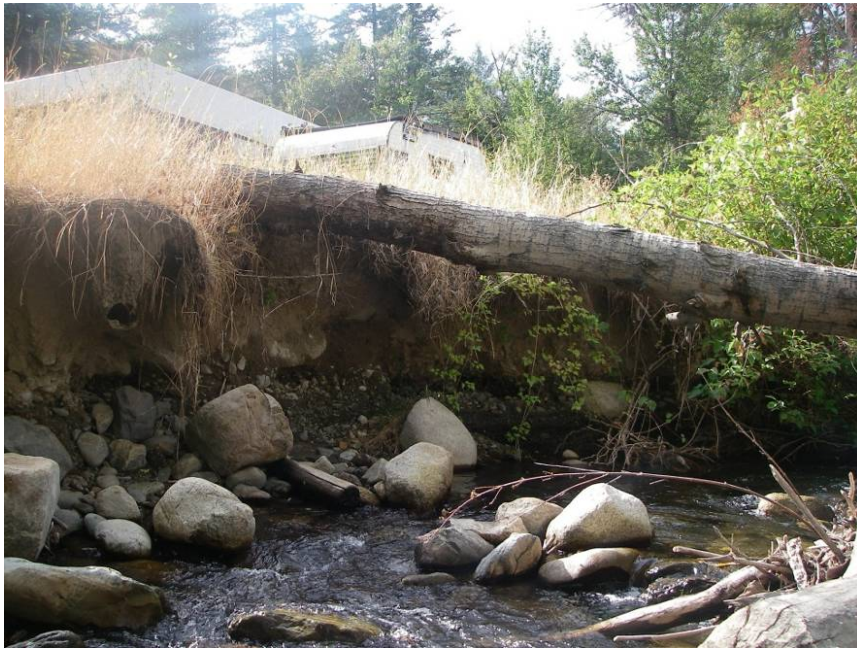
In some areas, bank erosion was associated with a lack of riparian vegetation due to livestock grazing (RM 0.3) and residential development (RM 0.5) (Figure 24). Riparian plantings would help provide natural stability to streambanks and floodplain areas.

Figure 24. Vegetation clearing and development in the riparian zone near RM 0.5, Reach 1 (September 2011).

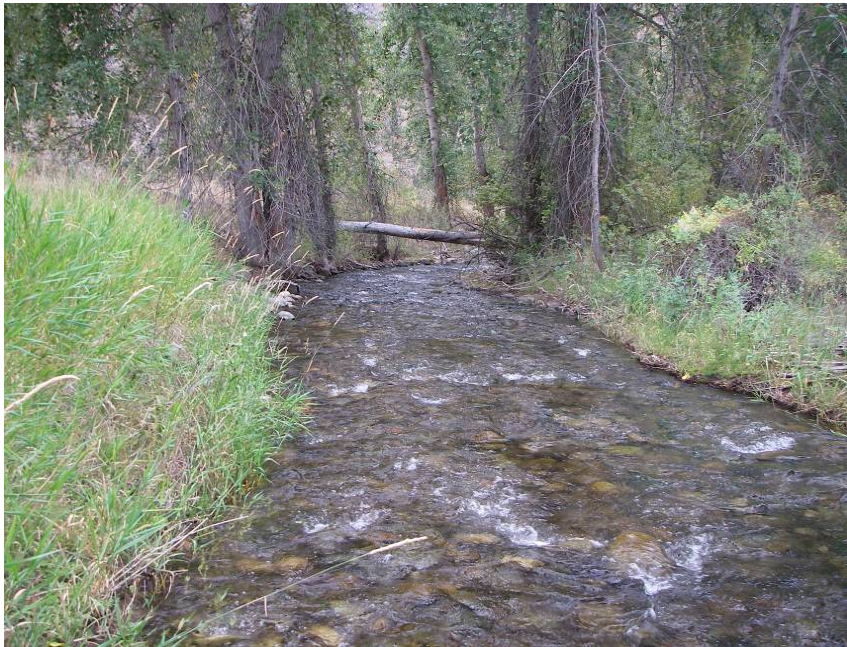
Figure 25. Riffle habitat in Reach 1 with sparse canopy cover and embedded substrate (September 2011).

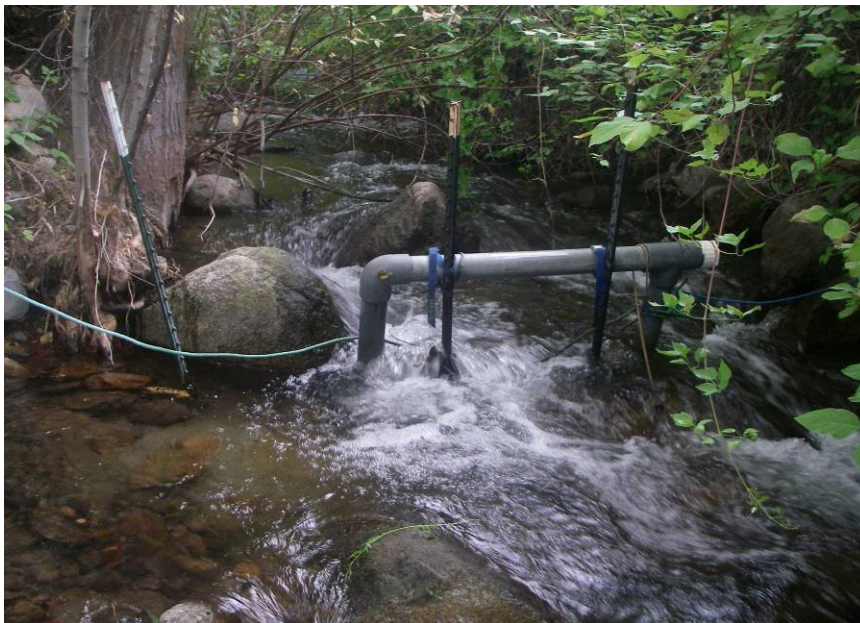
Steelhead and trout primarily use this reach as a migration corridor to access upstream habitat closer to the Okanogan National Forest boundary. WDFW collects PIT (Passive Integrated Transponder) tag data from steelhead and other salmonids migrating through Reach 1 (Bob Jateff, WDFW, personal communication, Oct. 19, 2011). An instream PIT tag detection antenna is located at RM 0.3, just upstream from the Hwy 153 Bridge (Figure 26).

Figure 26. Instream PIT tag detection antenna in Lower Libby Creek at RM 0.3 (September 2011).

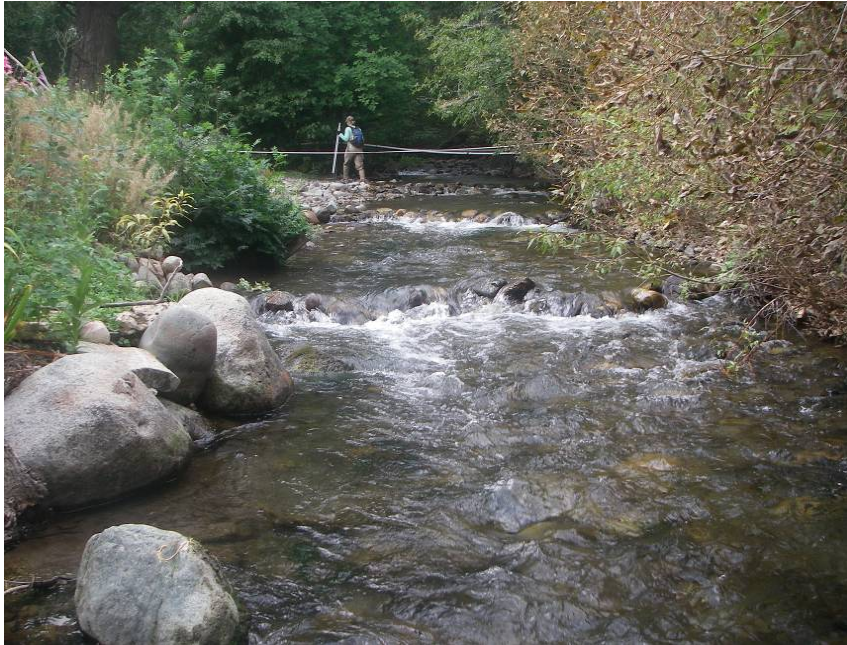
migration barrier during times of low flow. The beaver dam had a 2-ft difference in water surface elevation that could hinder upstream migration during the summer and fall. At approximately RM 0.35, several channel spanning rock weirs that protect a river-right home and horse ford may prevent the upstream colonization of juvenile fish at times of very low flow (Figure 17).

Figure 27. Rock weirs (located at RM 0.35) may prevent upstream colonization by juvenile fish during low water years (September 2011).

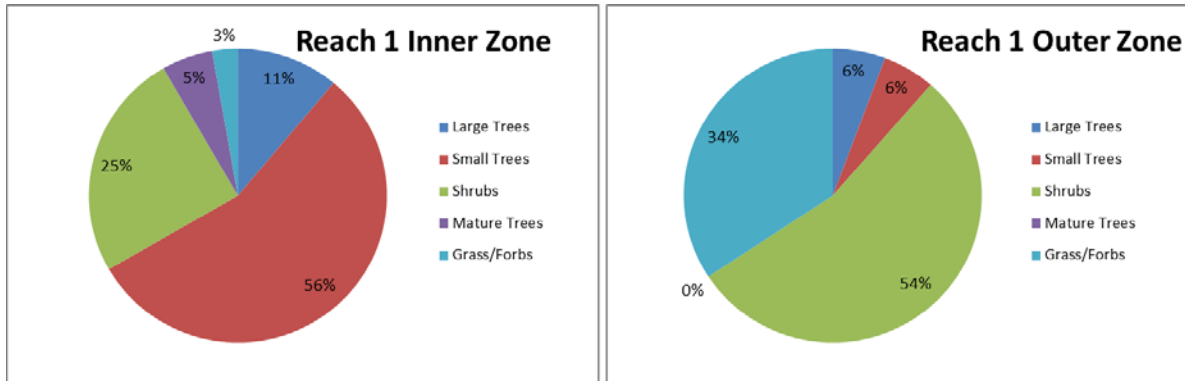
Figure 28. Distribution of vegetation size class categories for the riparian inner and outer zones in Reach 1.

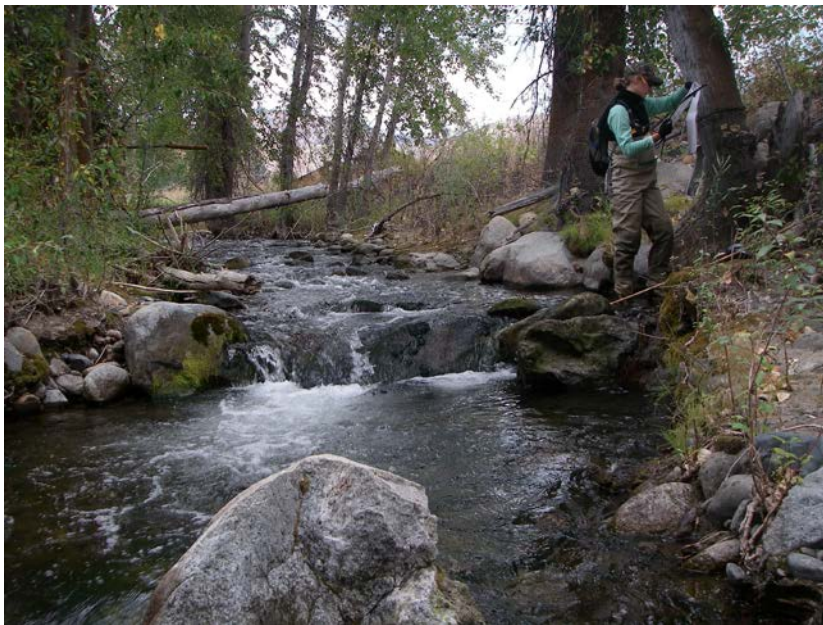
Figure 29. Dominant vegetation observed in Reach 1 near RM 0.2 (September 2011).

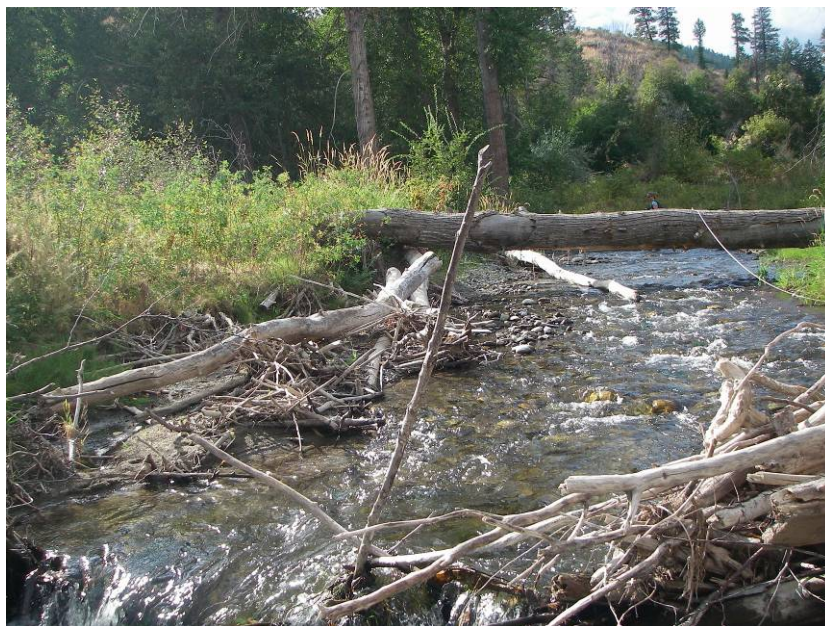
Figure 30. Reach 2 flows through a narrow floodplain and has a greater wood supply than Reach 1. The channel is moderately confined between the right bank hillside (observed in the photo) and a left bank road (September 2011).

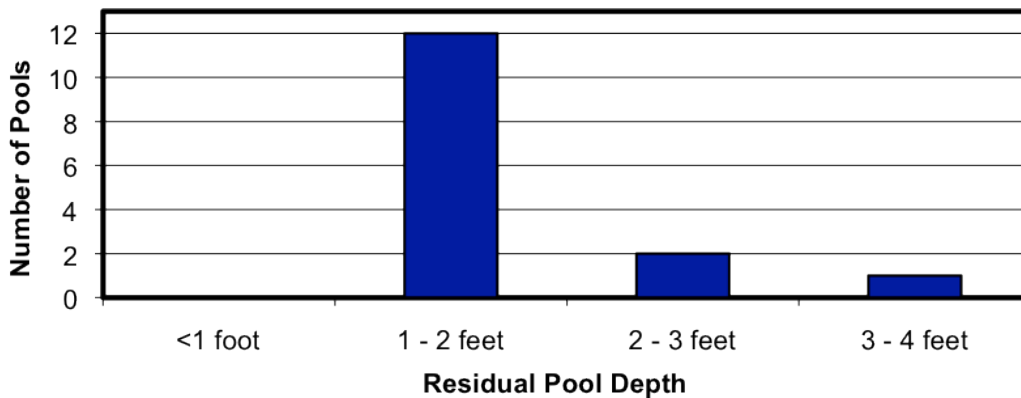
Figure 32. Reach 2 residual pool depths.

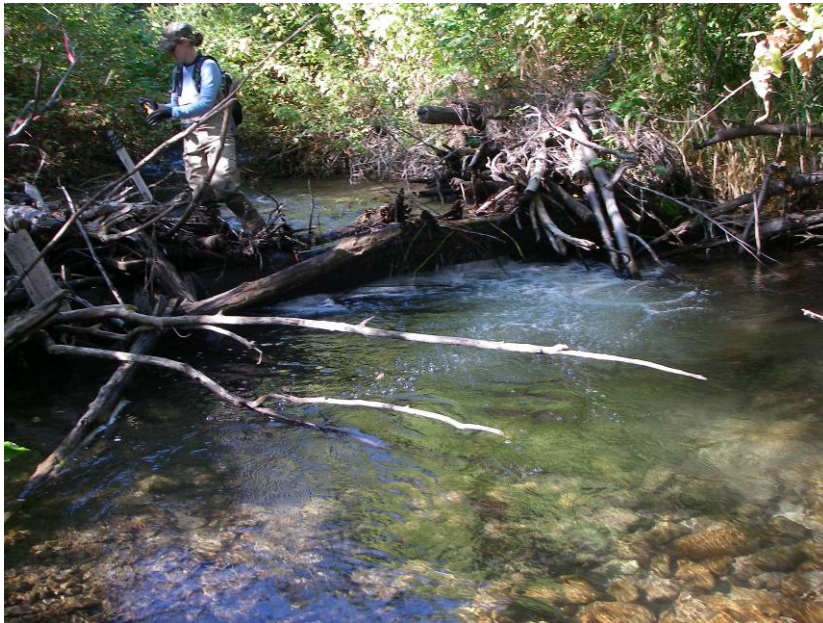
Figure 33. Representative plunge pool in Reach 2 (September 2011).

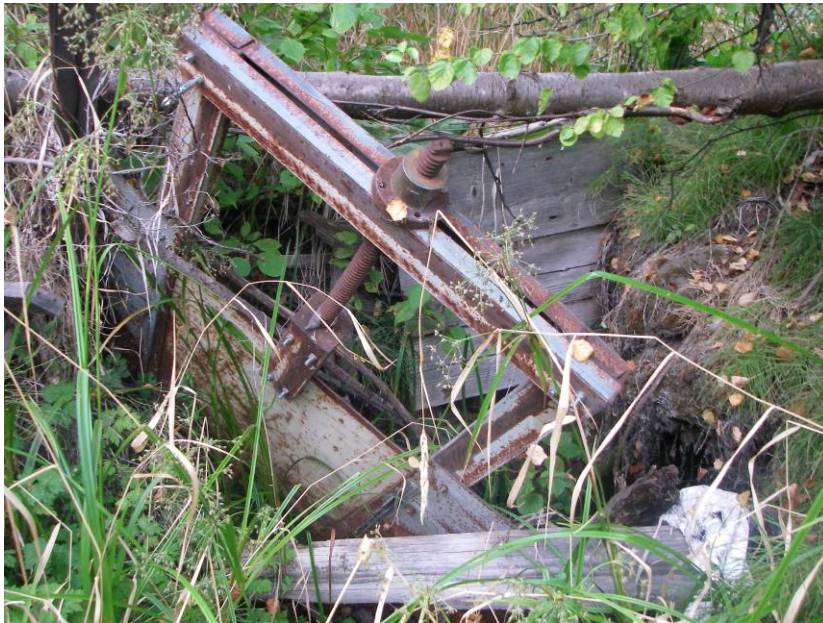
Figure 34. Headgate in an abandoned irrigation diversion at RM 0.7 (September 2011).

A failed irrigation diversion was located at RM 0.7. The channel was likely altered in this area to divert water into the irrigation canal. The system was no longer functional; however, flows continue to be affected by the diversion structure and are causing erosion along the river-right bank.

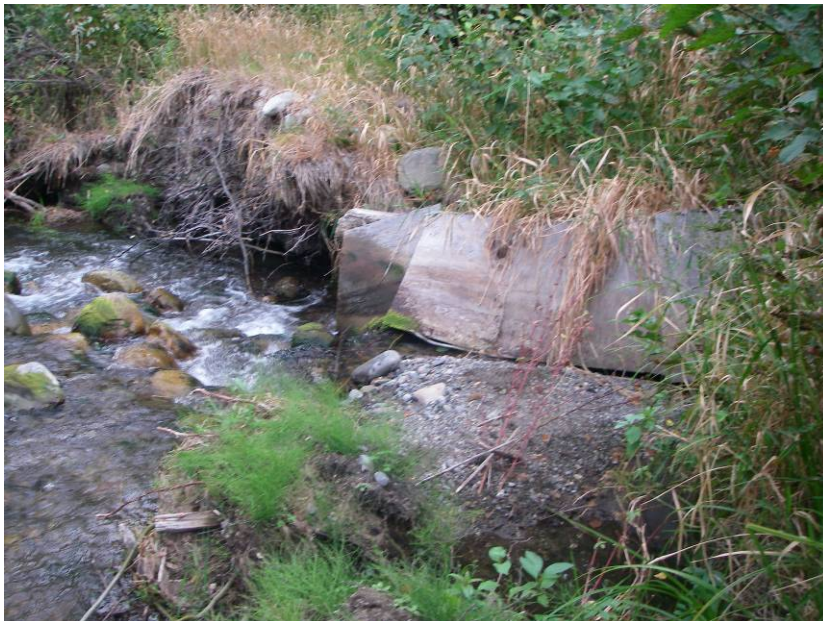
Figure 35. Plywood armoring along river-right near the downstream end of Reach 2 (September 2011).

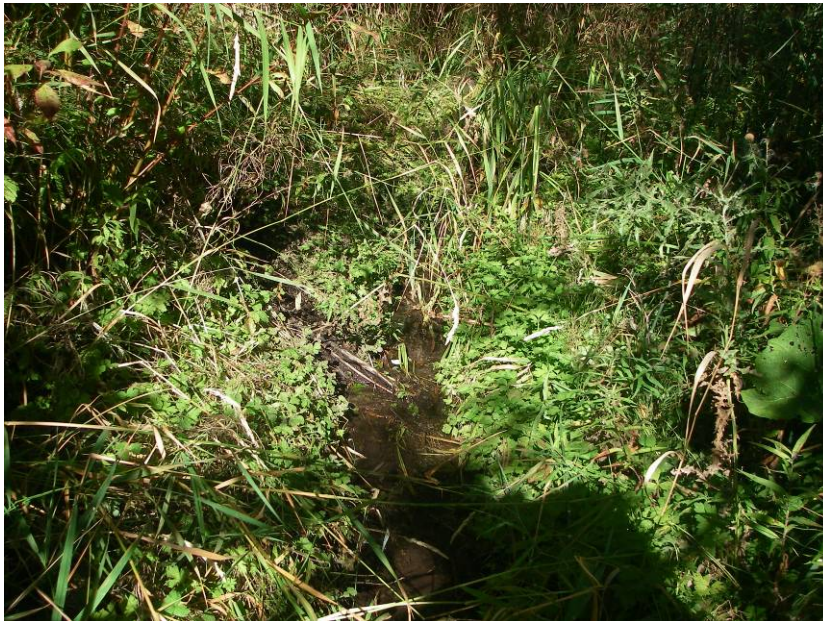
Figure 36. Spring-origin tributary entering the channel from river-right (September 2011).

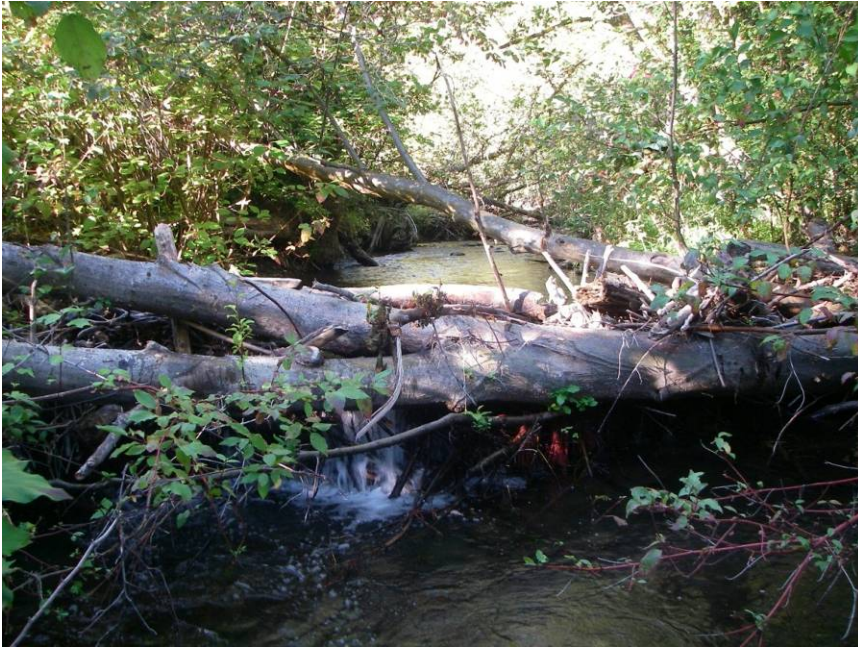
Instream wood plays a moderate role in Reach 2, including sediment sorting, habitat cover, flood refuge habitat, and channel complexity (Table 2). Wood was an important component of plunge pool formation observed in Reach 2 (Figure 37). Most wood jams were comprised principally of small material that had accumulated behind larger stable pieces. The jams had captured fallen leaves, needles, and other stream detritus, improving habitat cover and providing food for macroinvertebrates and fish.

Figure 37. Characteristic plunge pool formed by channel-spanning LWD, Reach 2 (September 2011).

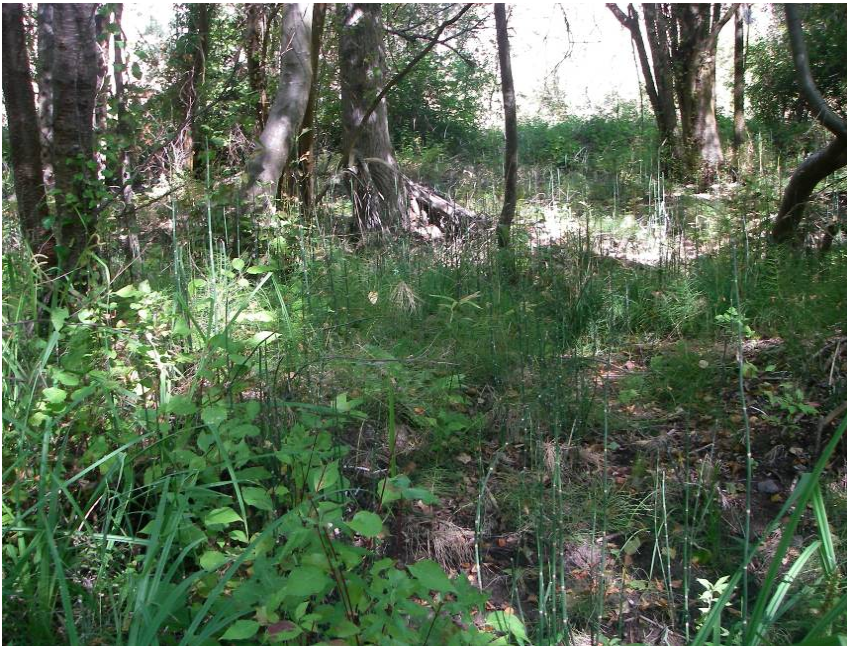
Figure 38. Narrow floodplain with large cottonwoods and high flow channel along river-left (September 2011).

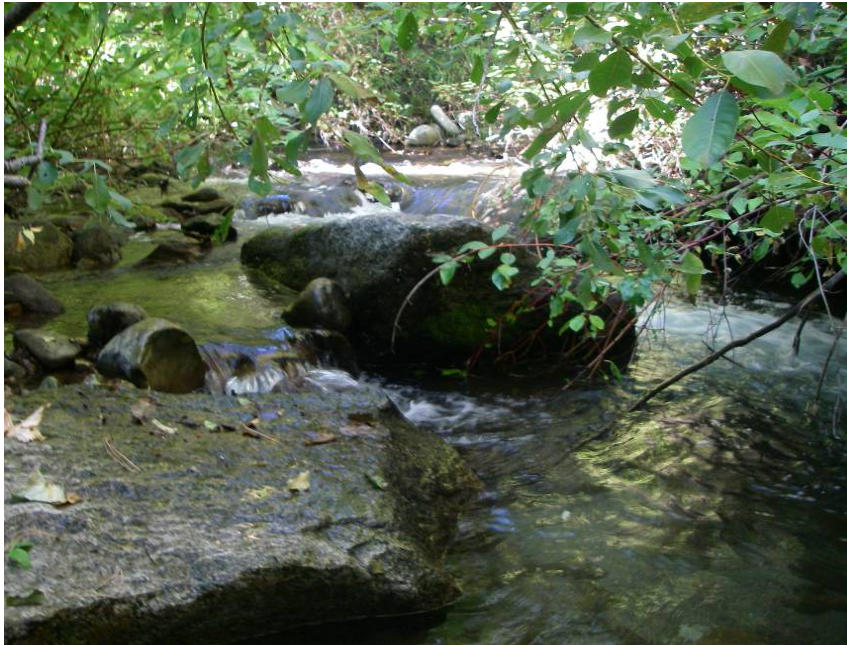
Bed substrate was dominated by gravels and cobbles. Bedrock and boulders were rare, although large boulders become more prevalent above RM 1.2 (Figure 39). The percentage of fine sediment (<2mm) was relatively high, making up approximately 13-19% of the substrate distribution. Reach 2 would be considered “functioning at risk” with respect to fines in gravel (near areas of spawning and incubation) based on USFWS (1998). The pebble count data and ocular estimates are presented in Figure 40, Figure 41, and Figure 42.

Figure 39. Boulders were observed towards the upstream end of Reach 2 (September 2011).

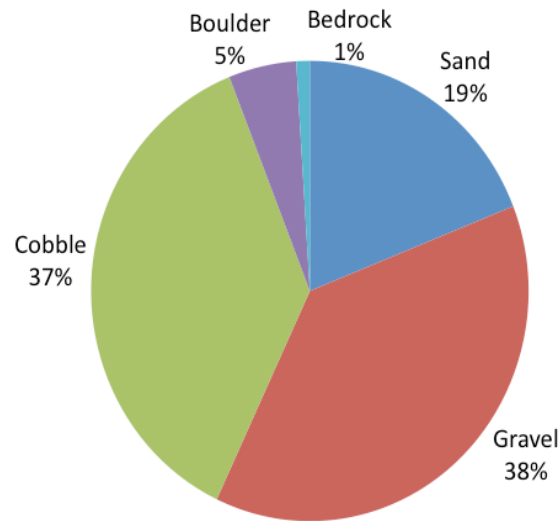
Figure 42. Percent composition of bed substrate based on ocular estimates, Reach 2.

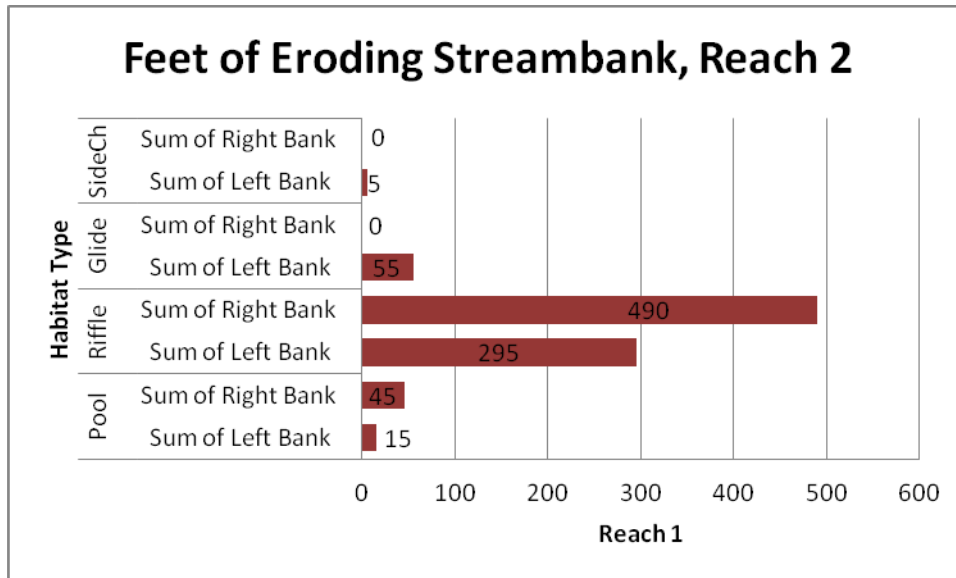
Figure 43. Length of eroding streambank in feet.
