APPENDIX A

Lower Libby Creek Stream Habitat Assessment River Mile 0 to 1.4

Survey: September 2011

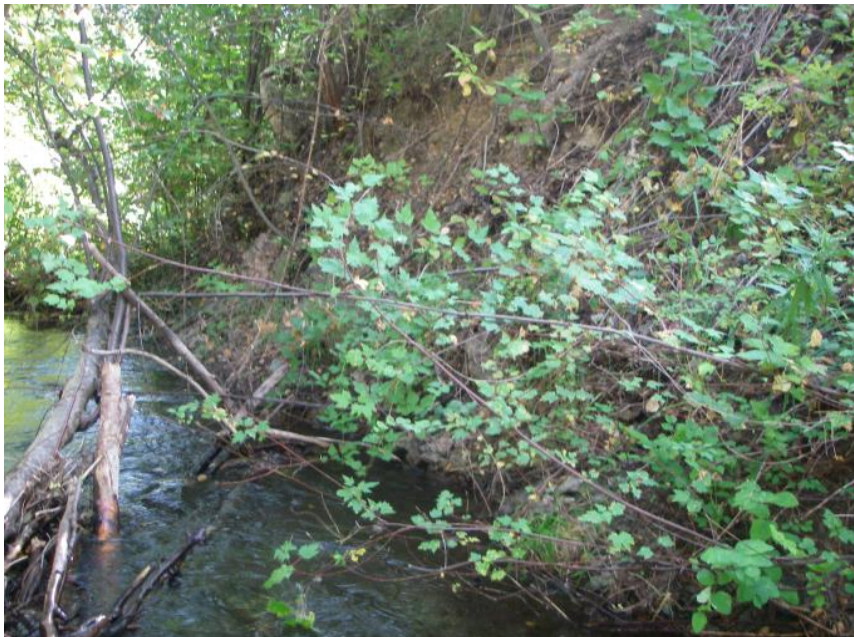
The channel was naturally confined along river-right. Loam soils were exposed in a few incised channel sections (Figure 44). Past land use practices (including logging and road building) may have contributed to these conditions.

Figure 44. Channel incision observed in the upper portion of Reach 2 (September 2011).

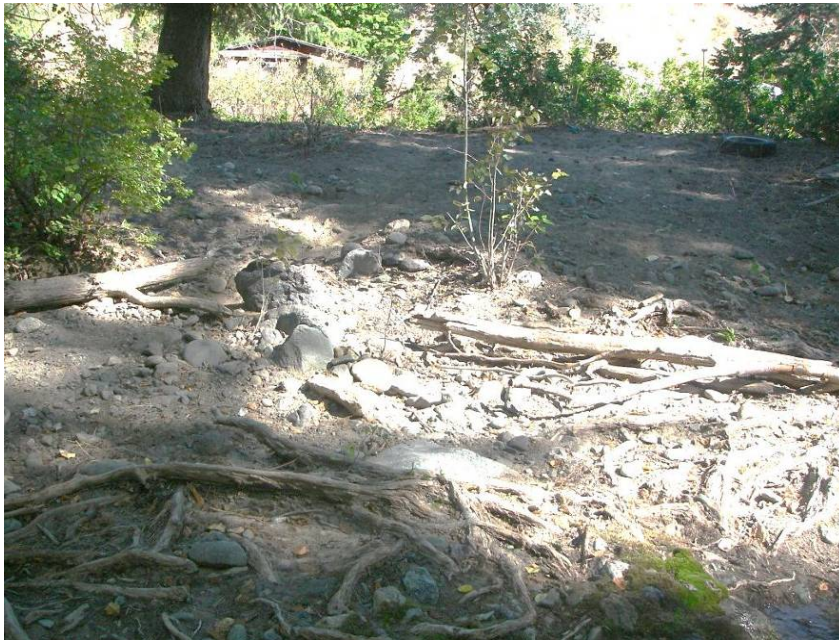
Figure 45. Riparian grazing, Reach 2 (September 2011).

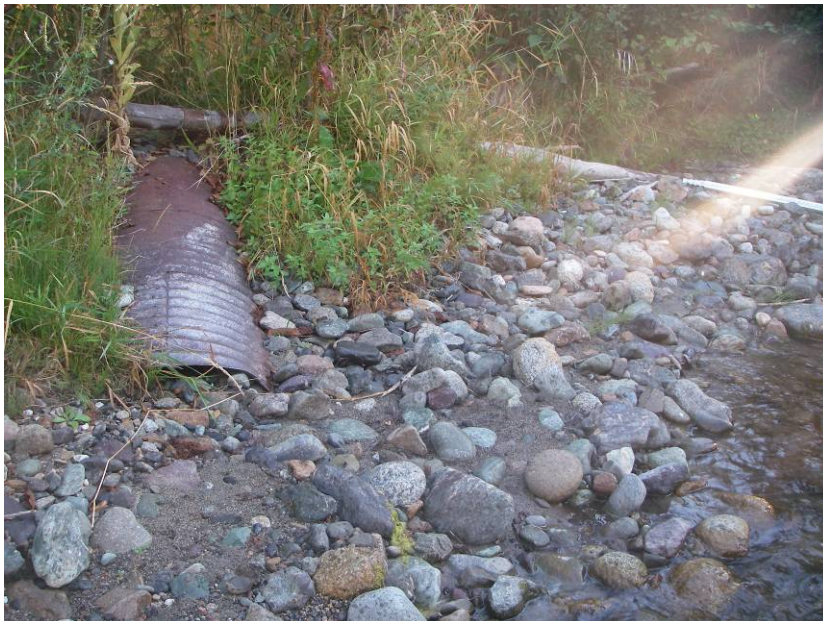
A non-functional culvert was located instream near RM 0.7 (Figure 46). This culvert may have been used to drain the slope wetland located within the river-left floodplain bench.

Figure 46. Remnant culvert in Reach 2 (September 2011). This culvert may have been used to drain the river-left wetland at RM 0.7.

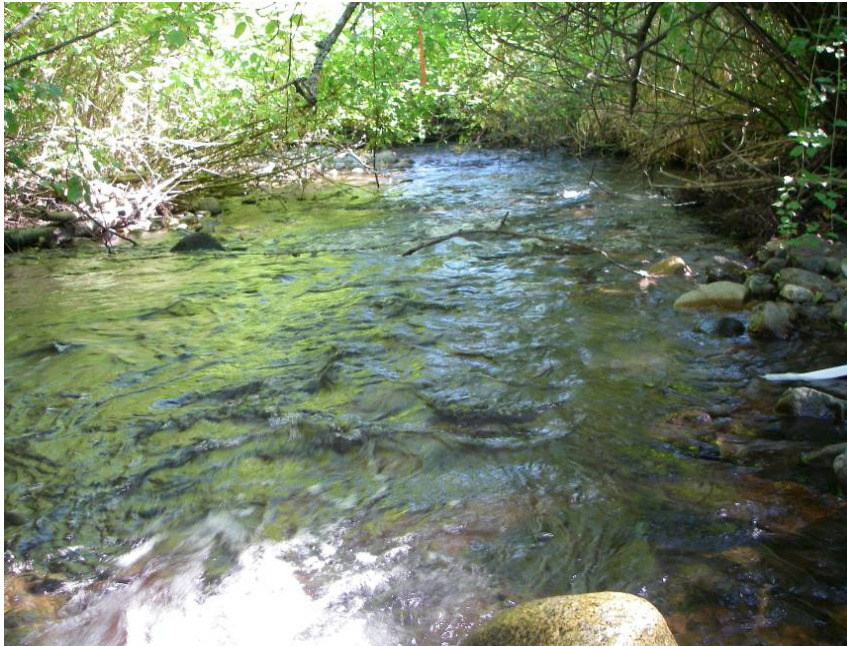
Figure 47. Riffle where steelhead spawning has been observed during past spawning surveys (September 2011).

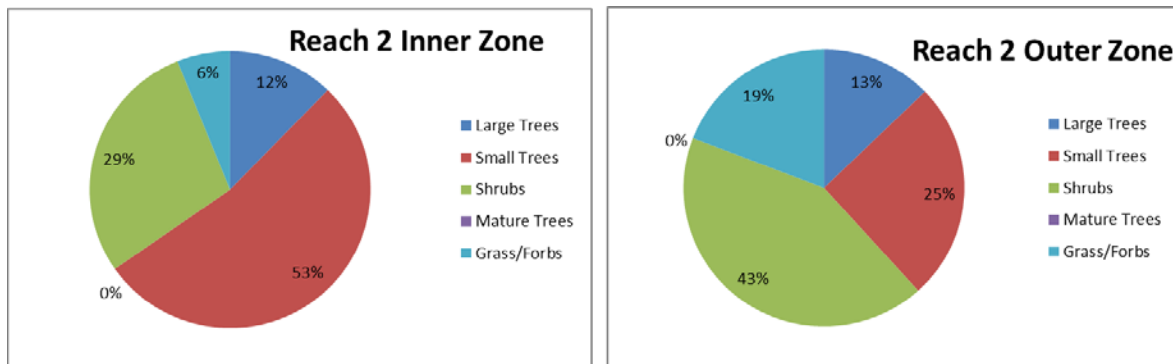
In the riparian inner zone (near-channel), small trees were the dominant size class (53%) (Figure 48) and shrubs were sub-dominant (29%). In the riparian outer zone, 43% of the units were dominated by shrubs, including red osier dogwood, hawthorne, spirea, and sagebrush. The stream is naturally confined by the valley wall along river-right, which shades the stream in the afternoon.

Figure 48. Distribution of vegetation size class categories for the riparian inner and outer zones in Reach 2.
