APPENDIX C

Stream Habitat and Geomorphic Map Series River Mile 0.0 to 26.4

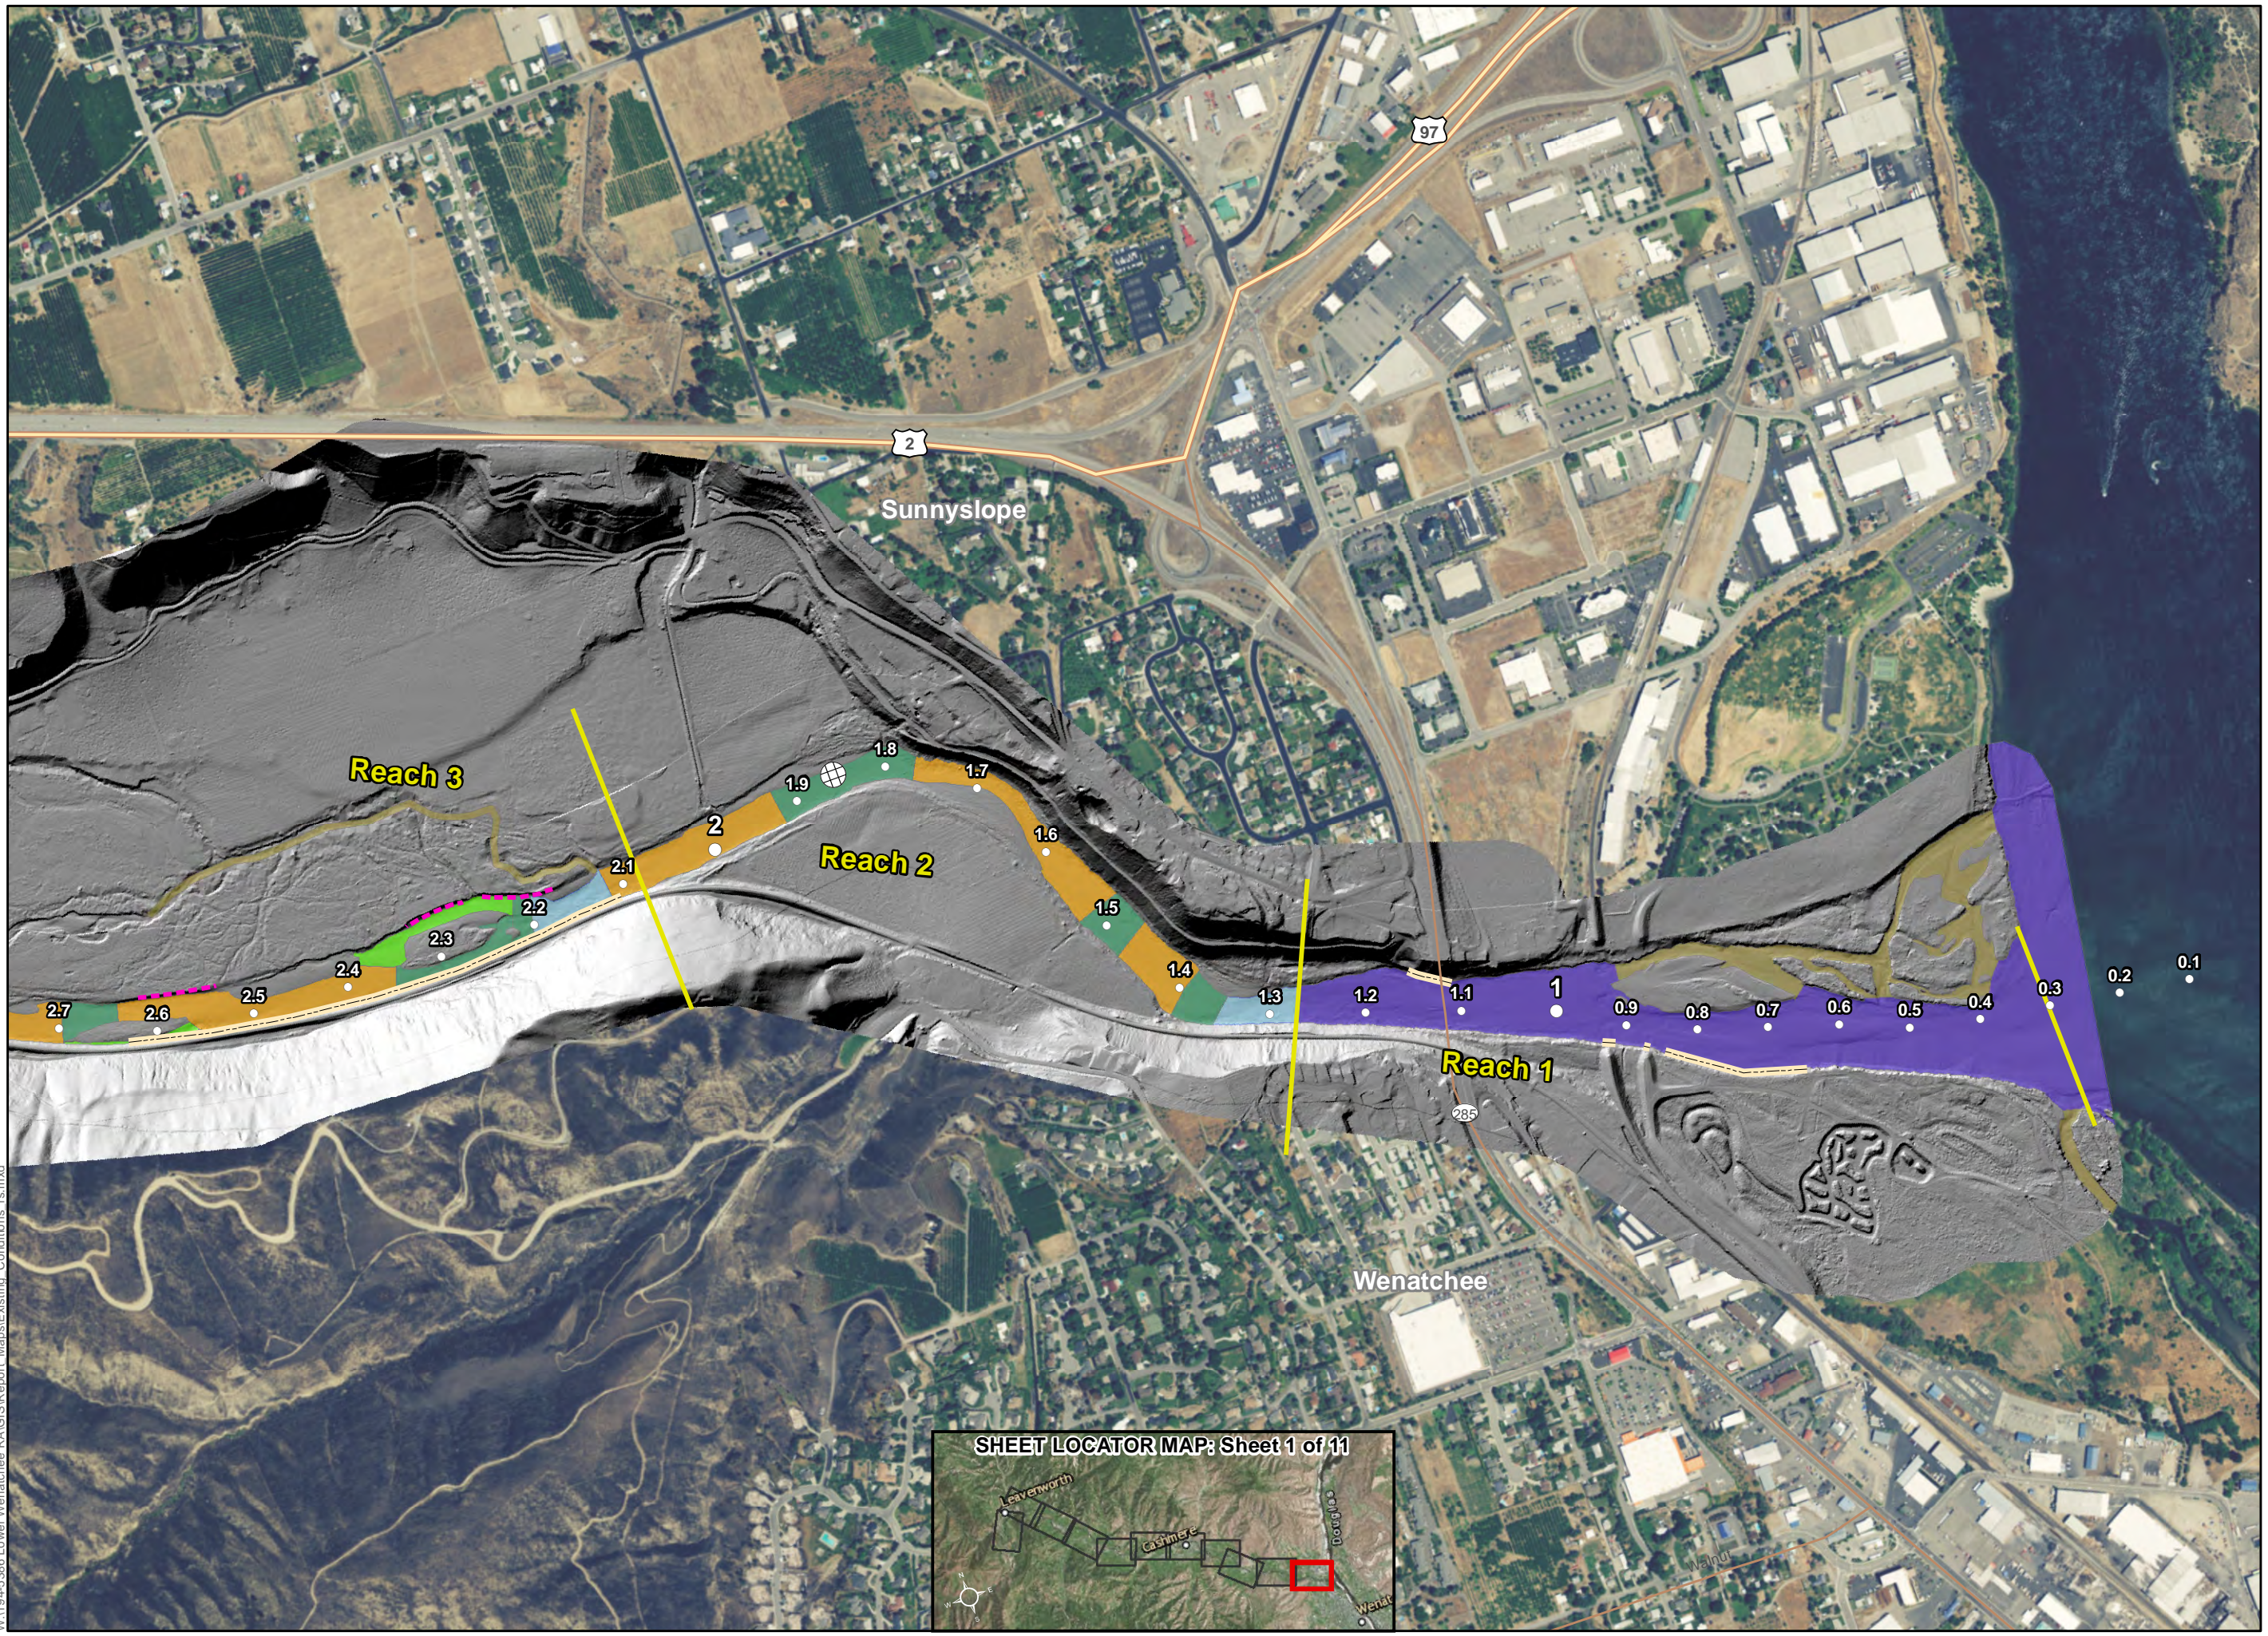
**Figure C-1a
Existing Conditions**

-   USGS Stream Gage
 -   Pebble Count Location
 -   Bank Protection
 -   Eroding Bank
 -   Geomorphic Reach Breaks
- Channel Unit
-   Dam Pool
 -   Glide
 -   Riffle
 -   Side Channel (slow)
 -   Side Channel (fast)
 -   Pool

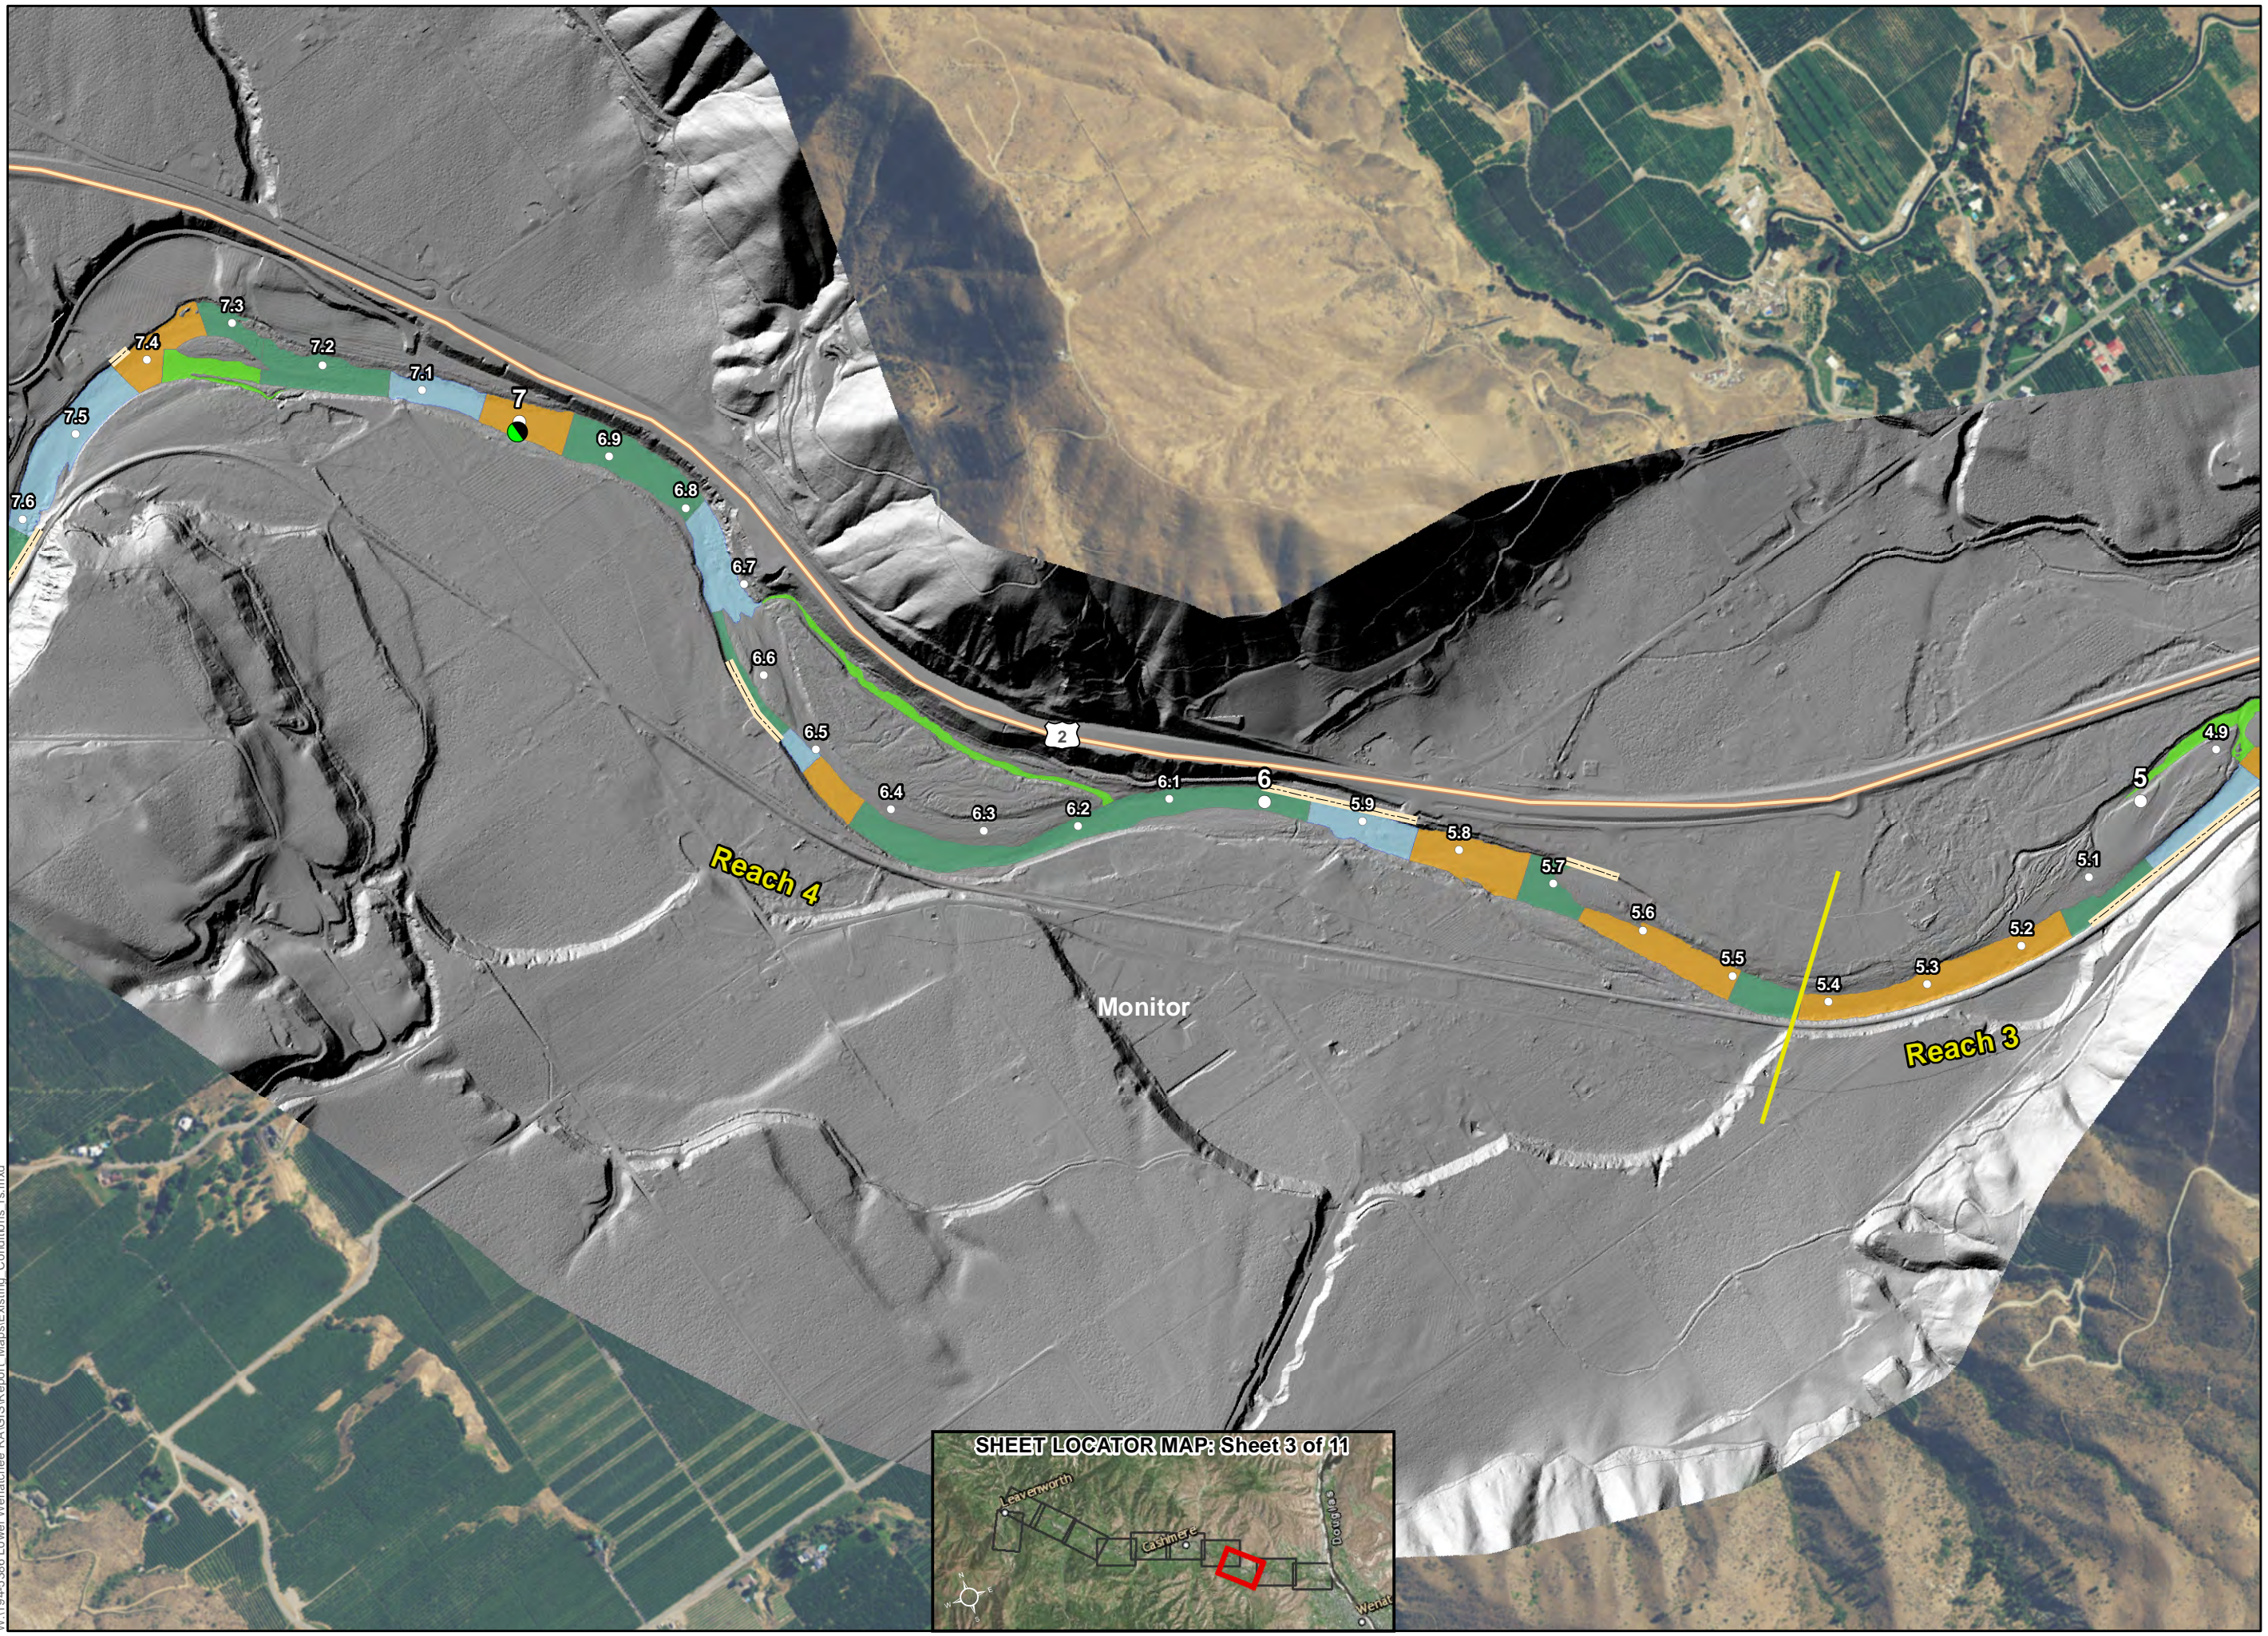
Figure C-1c
Existing Conditions

- USGS Stream Gage
 - Pebble Count Location
 - Bank Protection
 - Eroding Bank
 - Geomorphic Reach Breaks
- Channel Unit
- Glide
 - Riffle
 - Side Channel (fast)
 - Pool

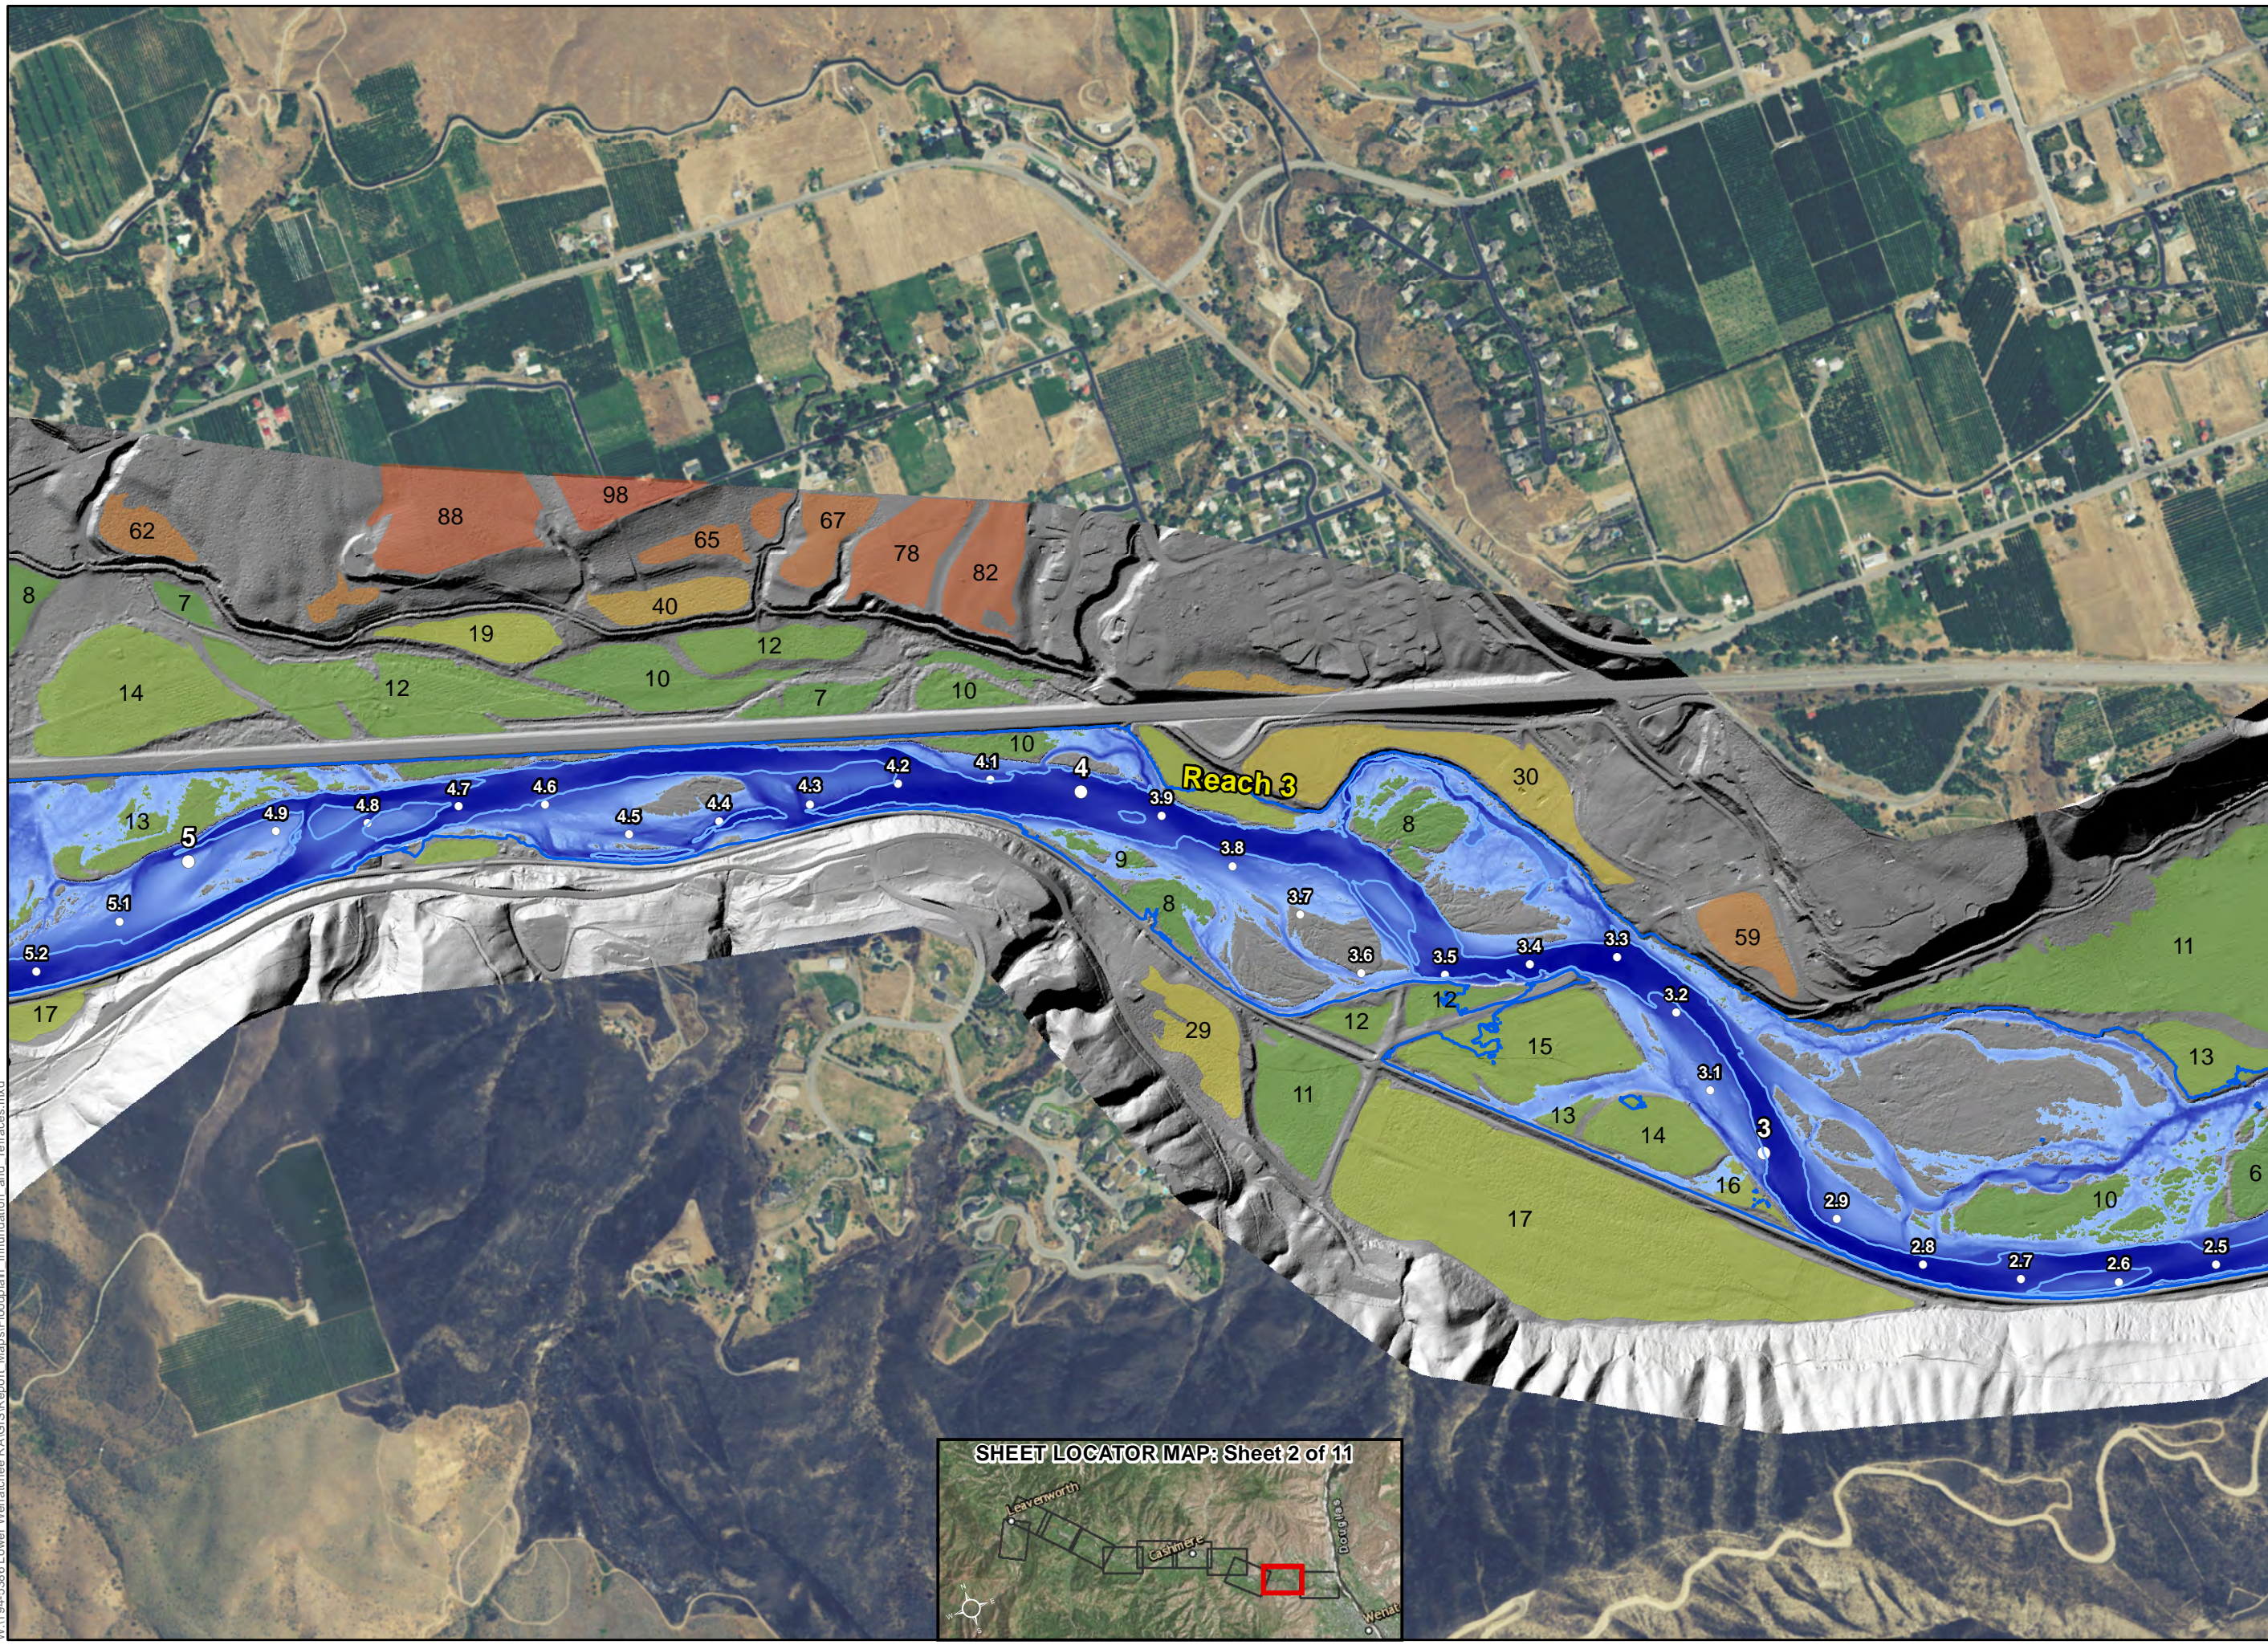
**Figure C-2b
Inundation and
Terrace Mapping**

Average terrace relief is measured relative to the average elevation of the adjacent channel bed. See values labeled on map.

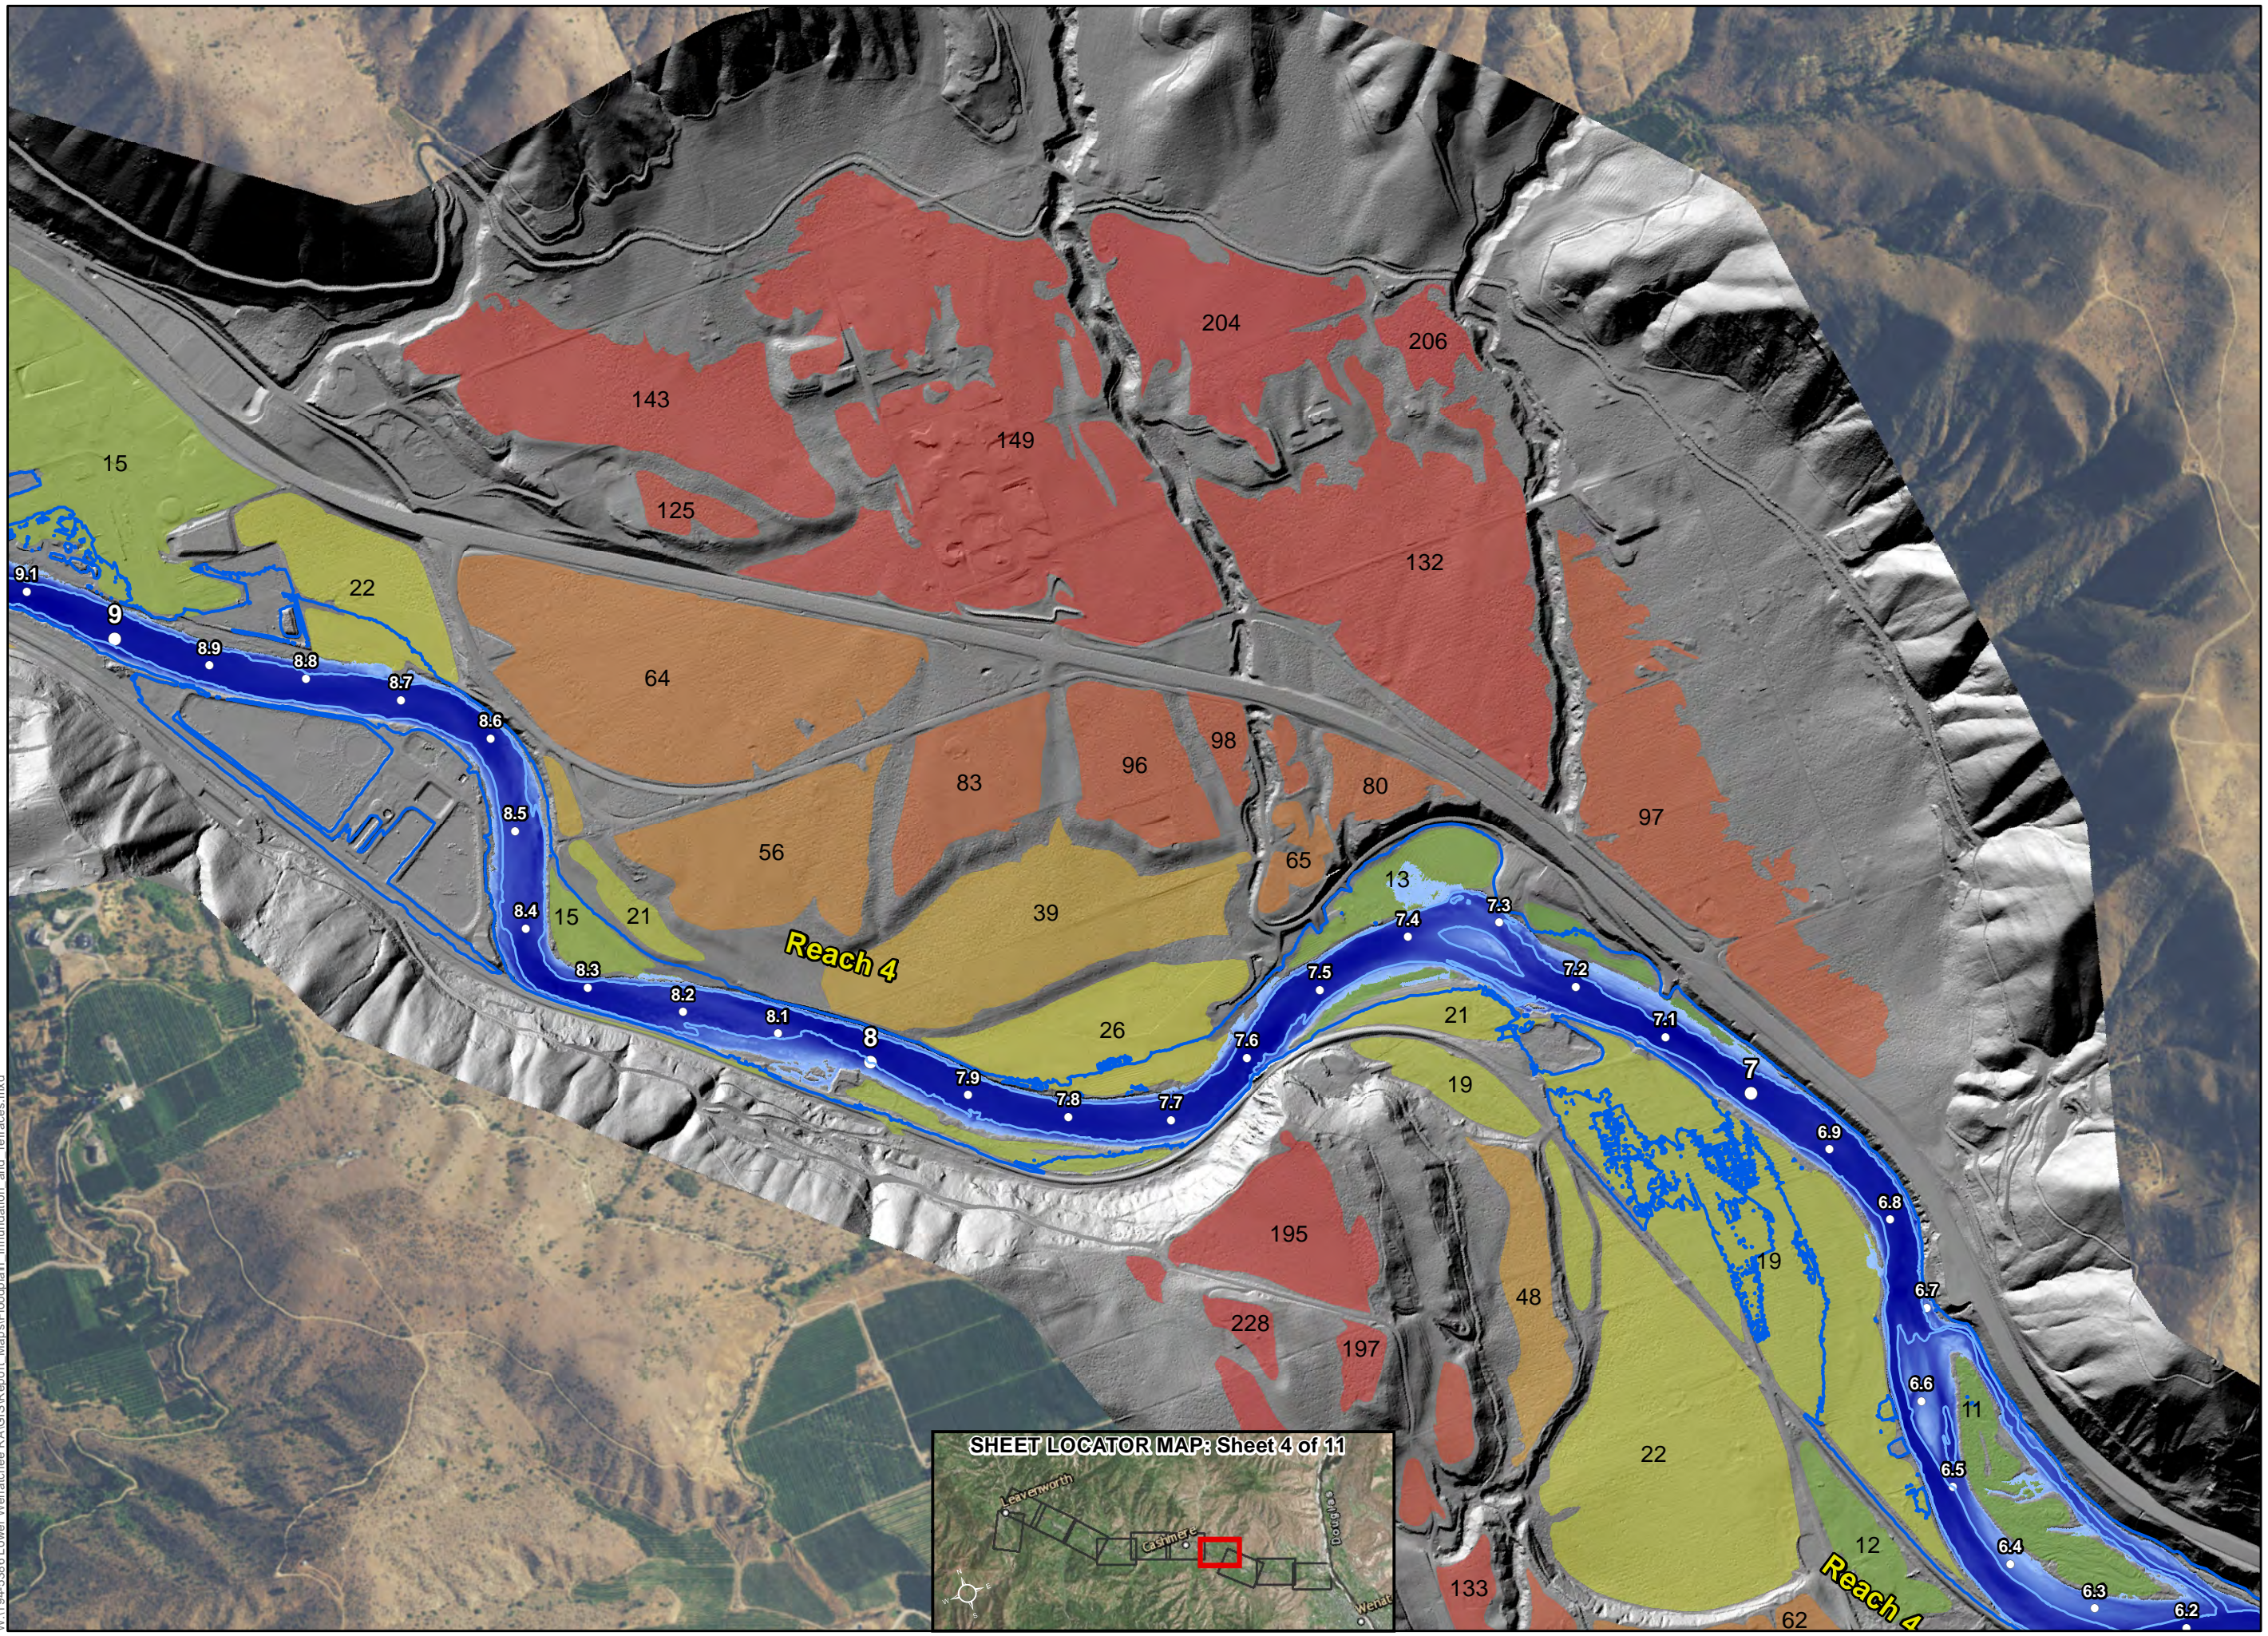
**Figure C-2d
Inundation and
Terrace Mapping**

Average terrace relief is measured relative to the average elevation of the adjacent channel bed. See values labeled on map.

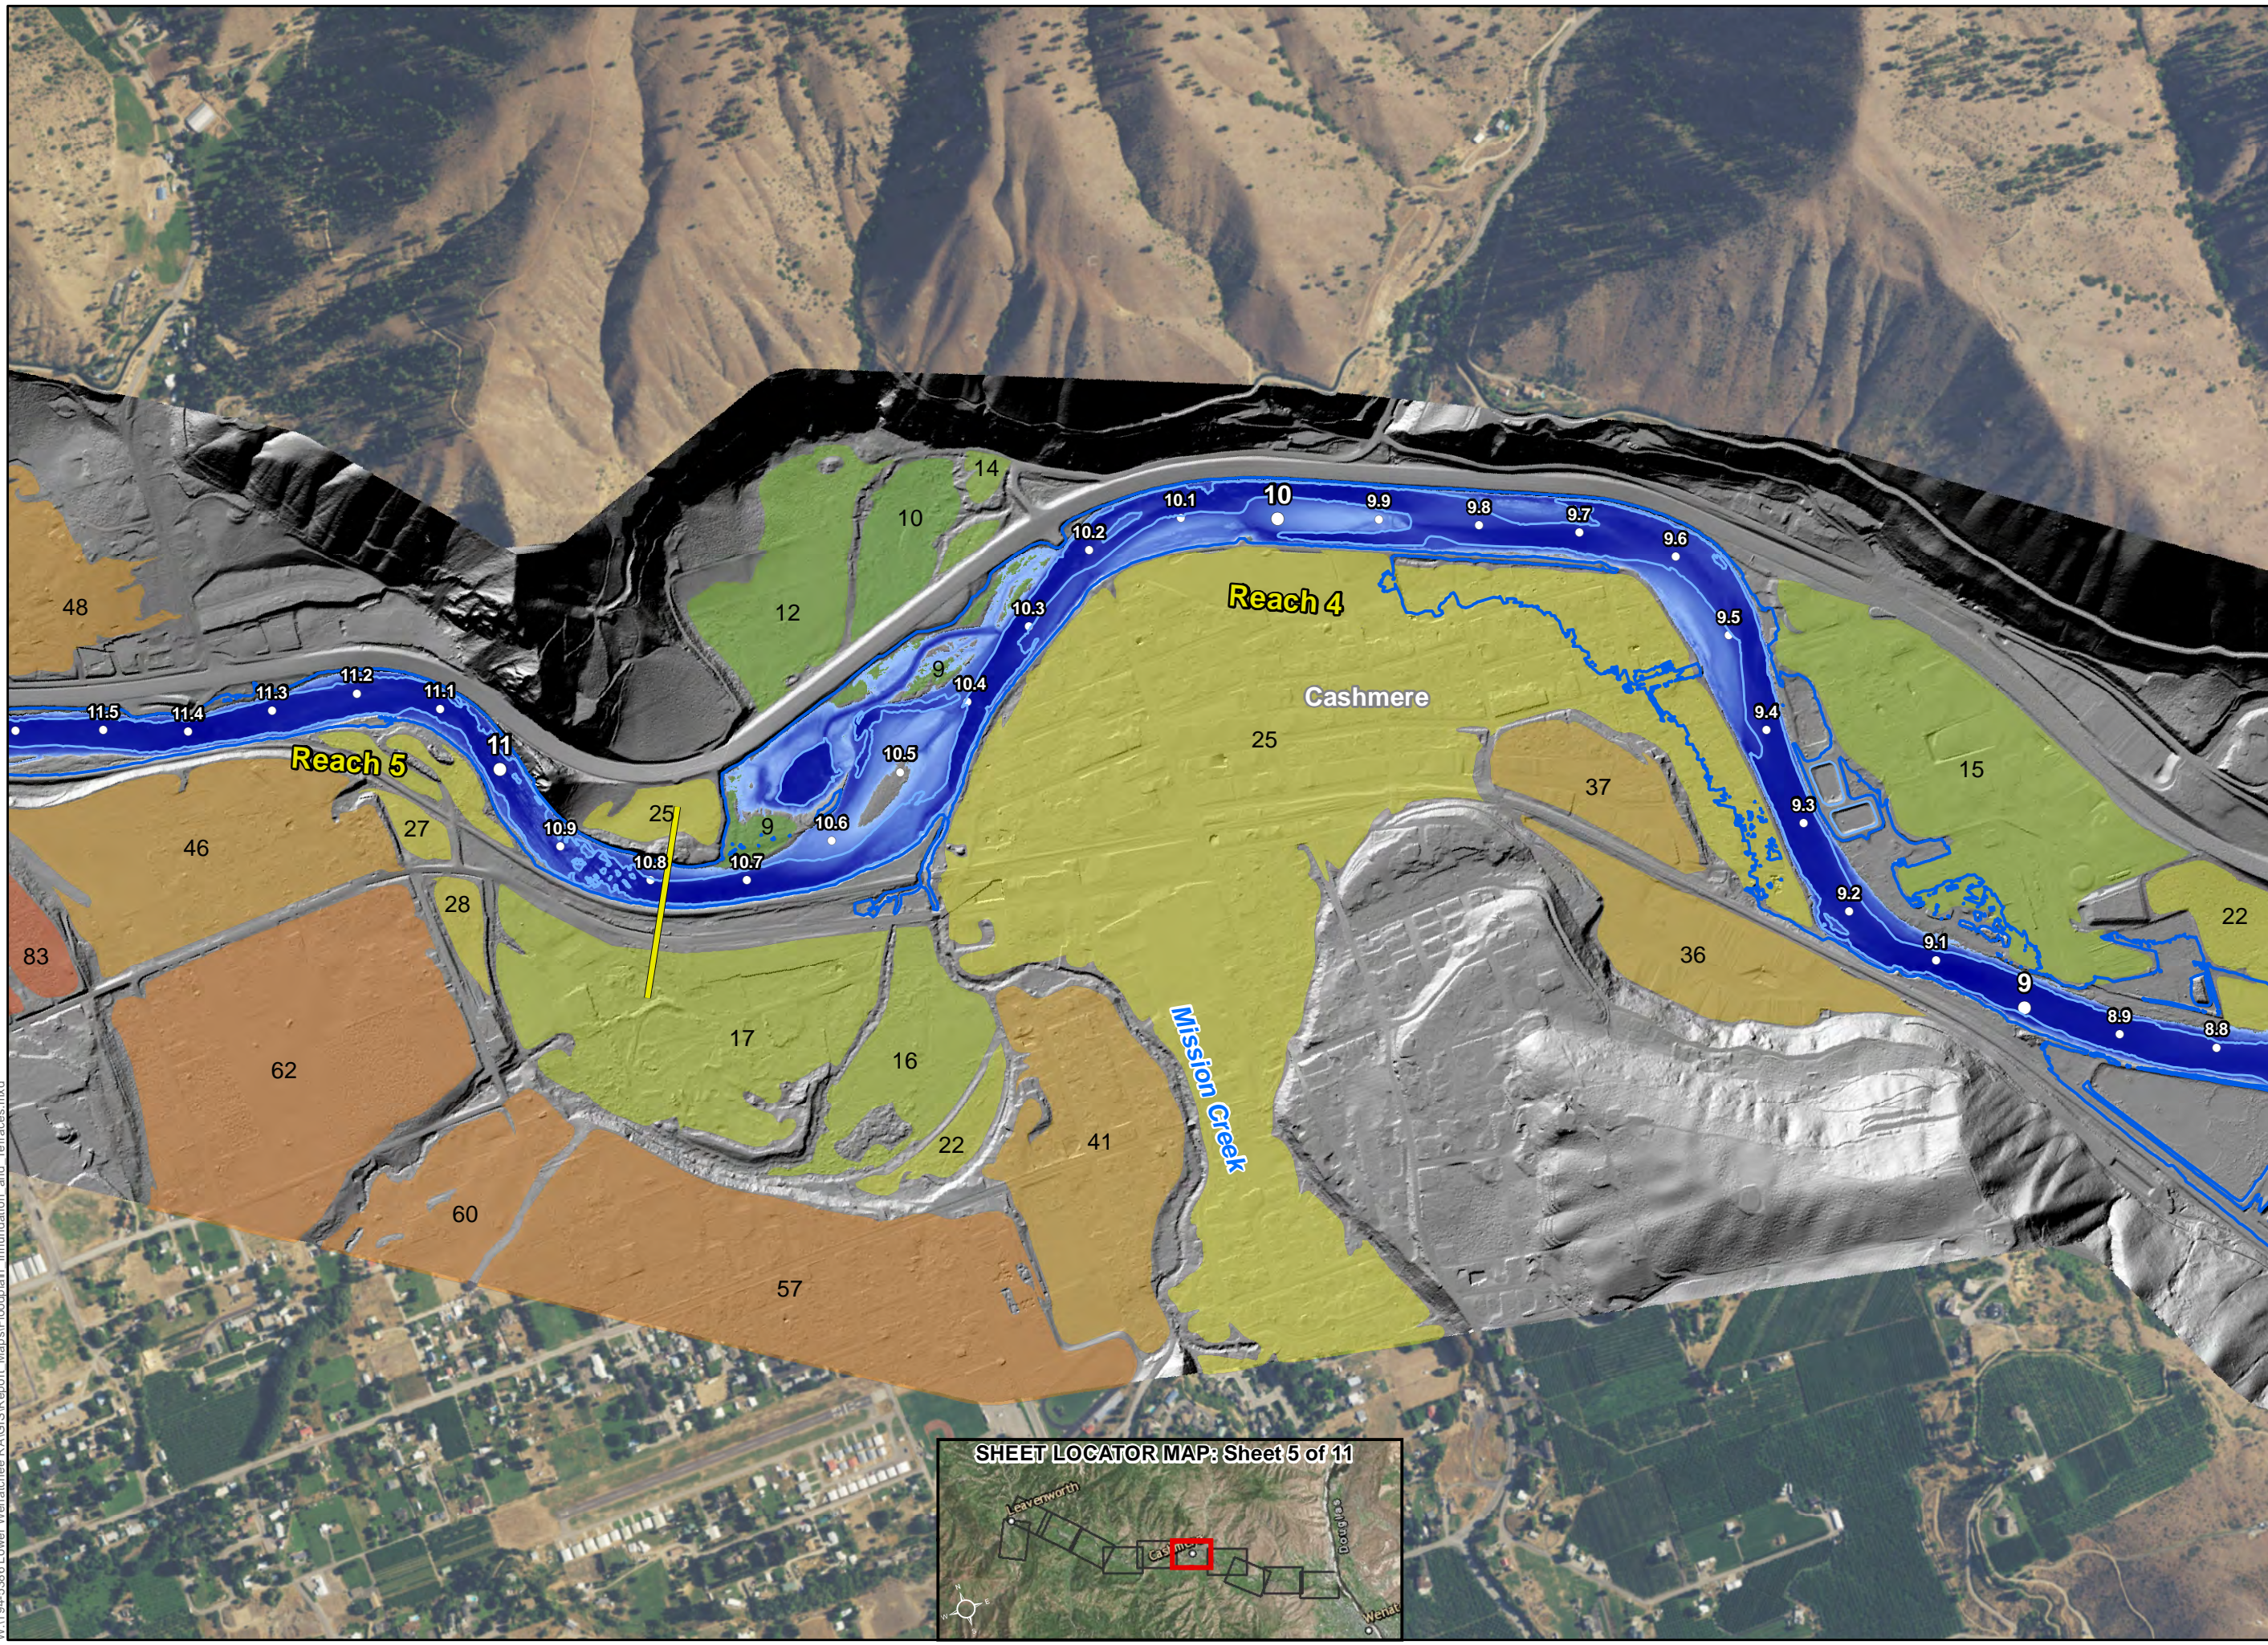
**Figure C-2e
Inundation and
Terrace Mapping**

Average terrace relief is measured relative to the average elevation of the adjacent channel bed. See values labeled on map.

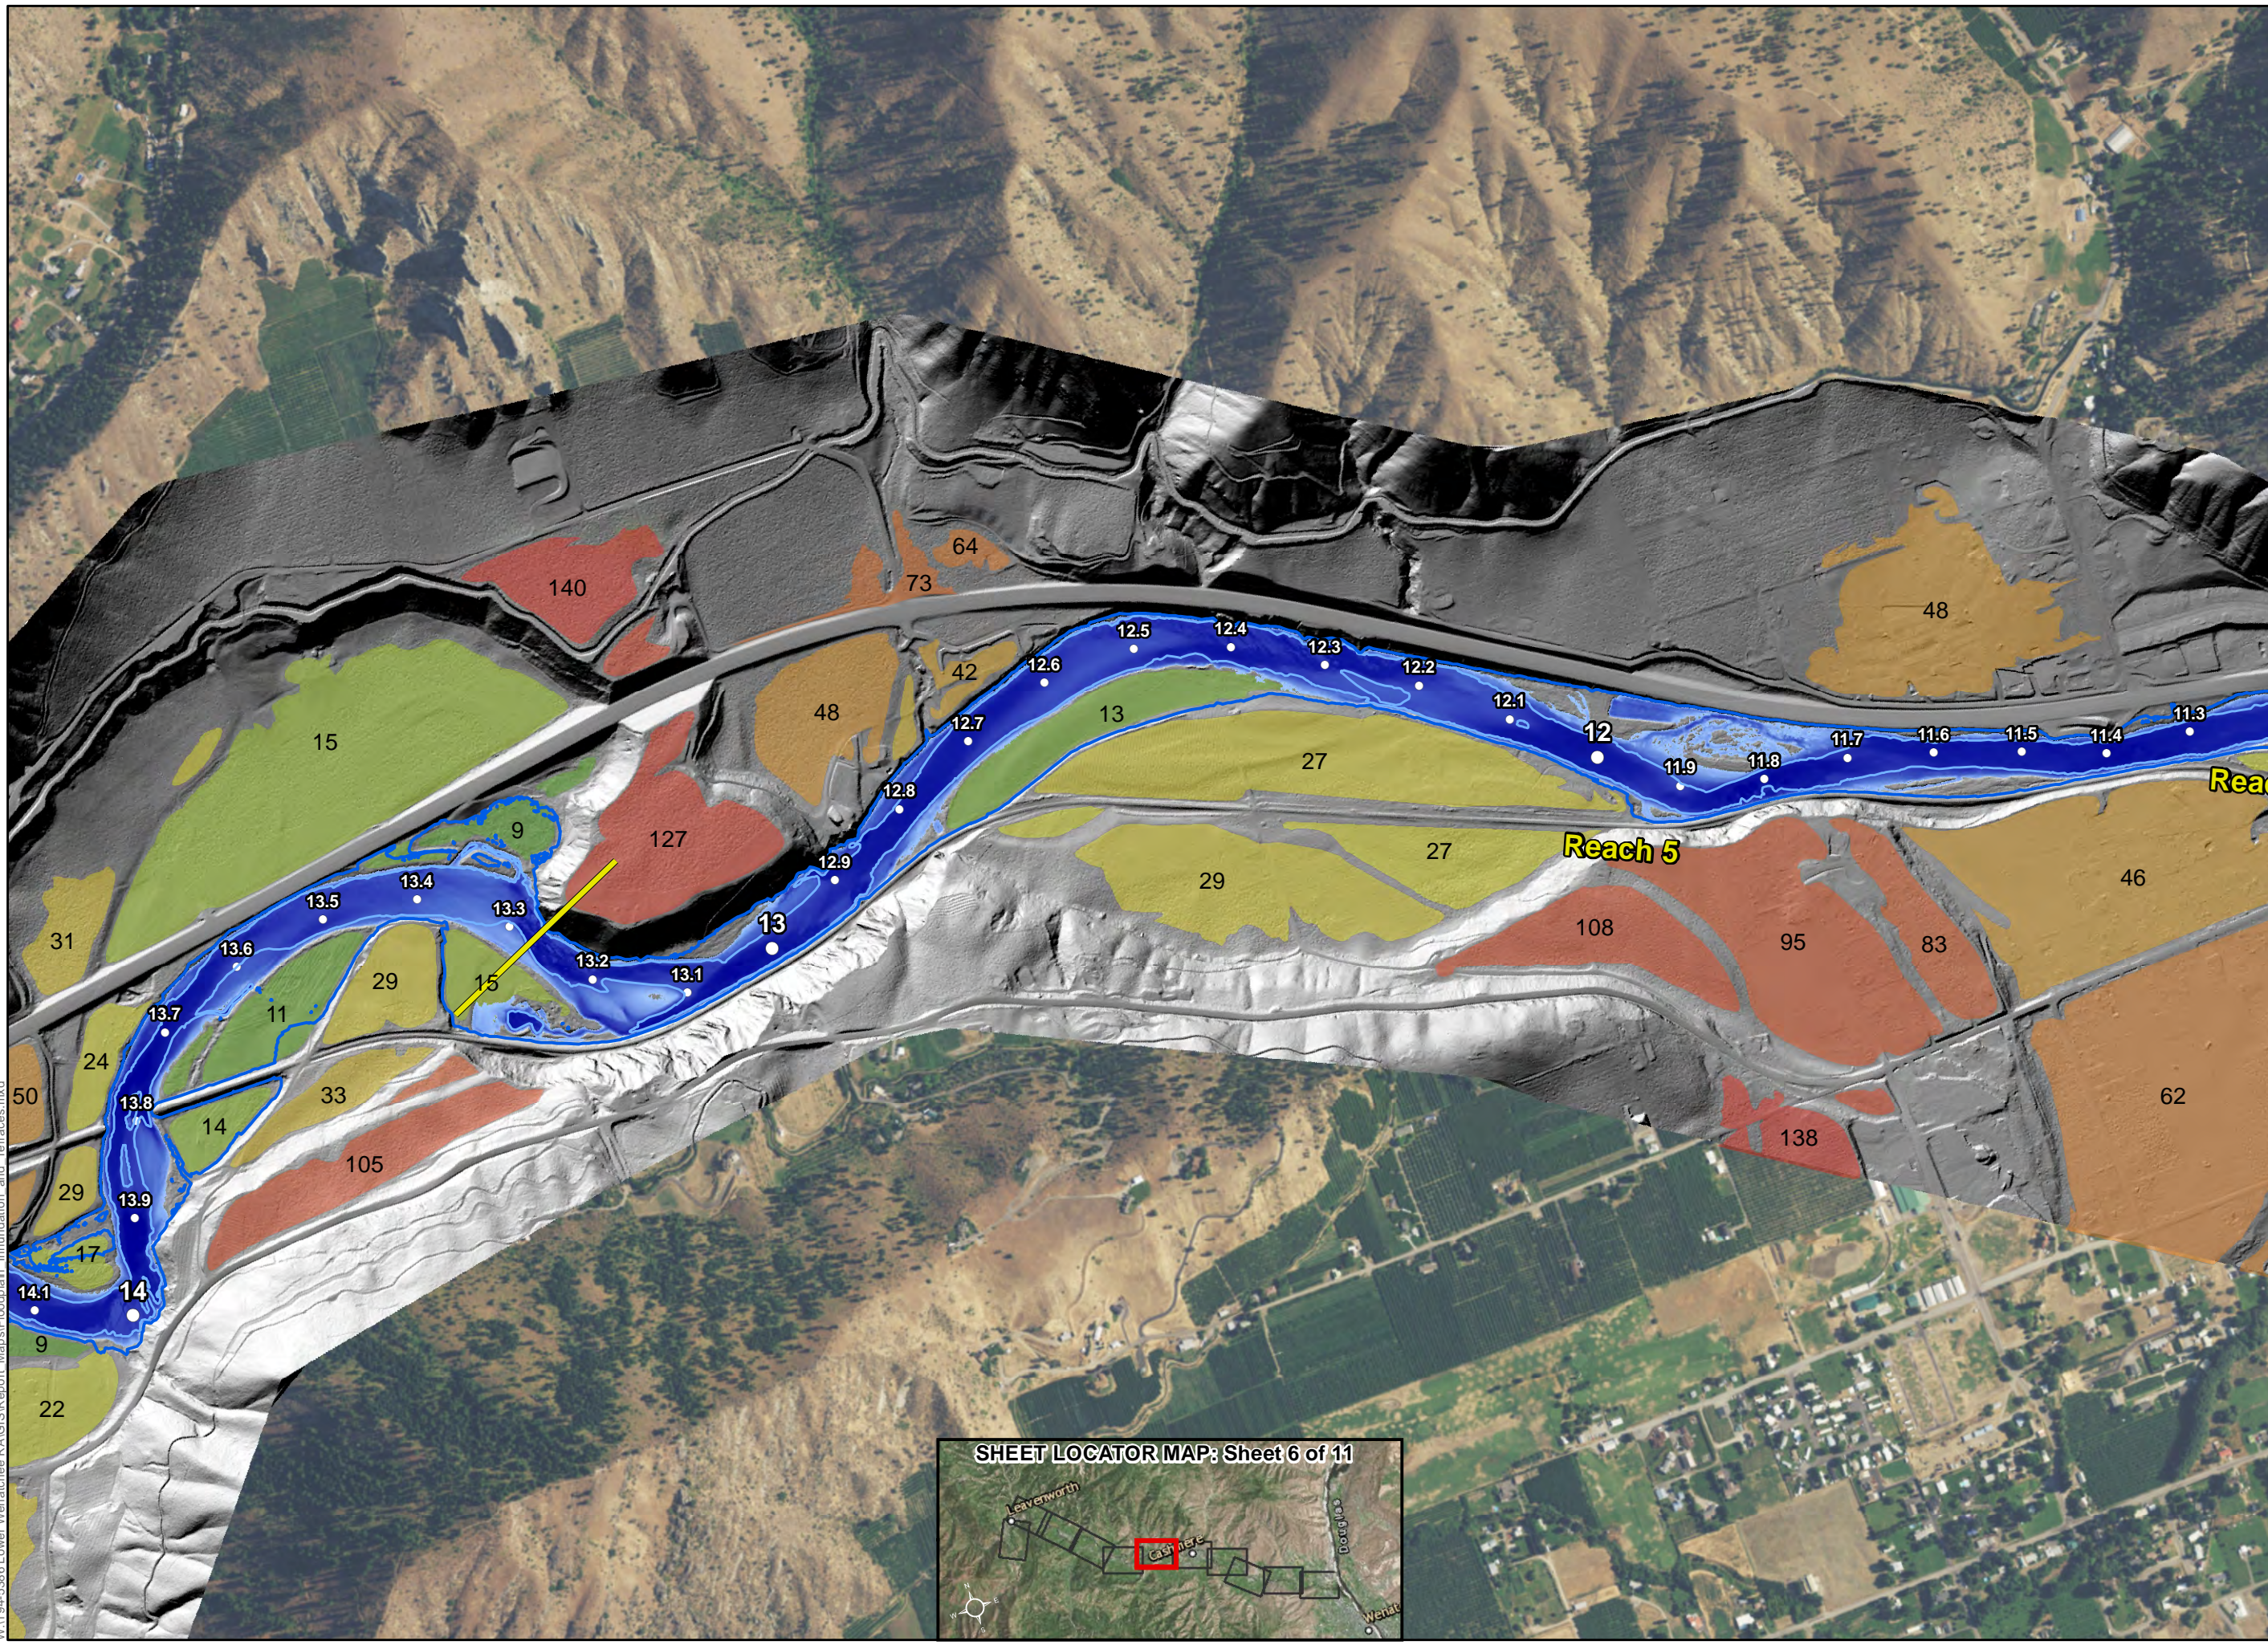
**Figure C-2f
Inundation and
Terrace Mapping**

Average terrace relief is measured relative to the average elevation of the adjacent channel bed. See values labeled on map.
