APPENDIX C

Stream Habitat and Geomorphic Map Series River Mile 0.0 to 26.4

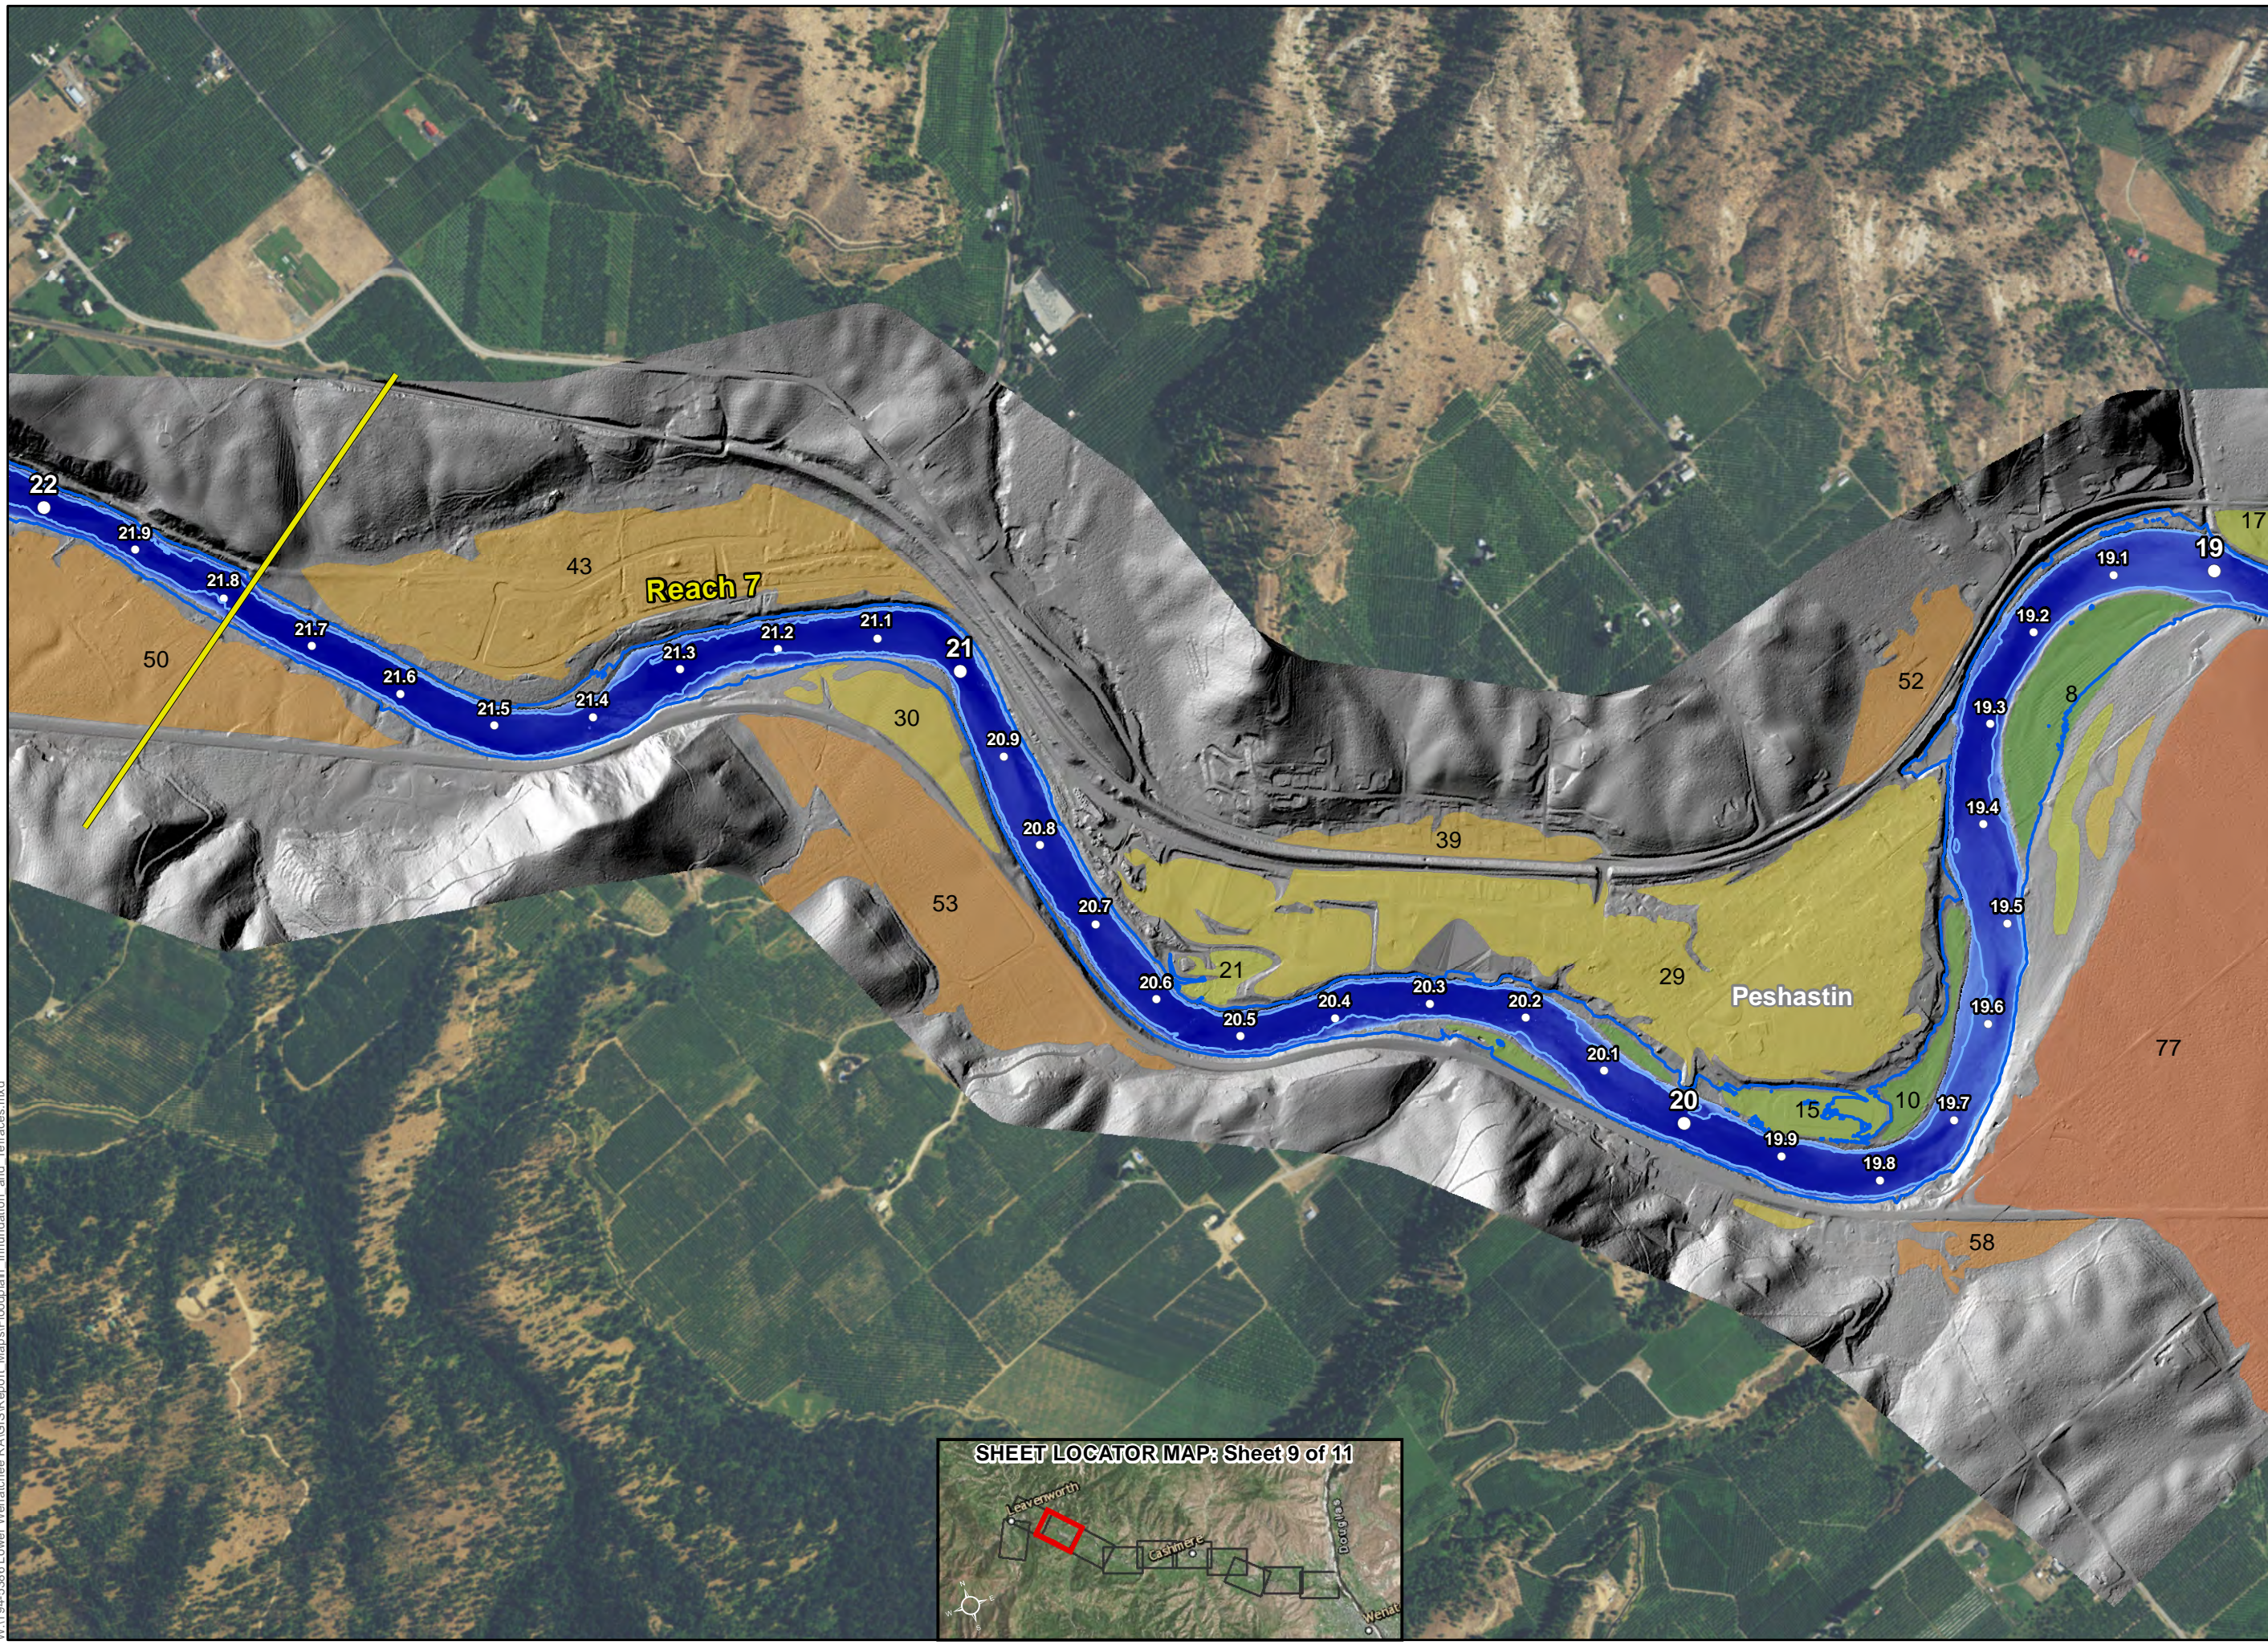
**Figure C-2i
Inundation and
Terrace Mapping**

Average terrace relief is measured relative to the average elevation of the adjacent channel bed. See values labeled on map.

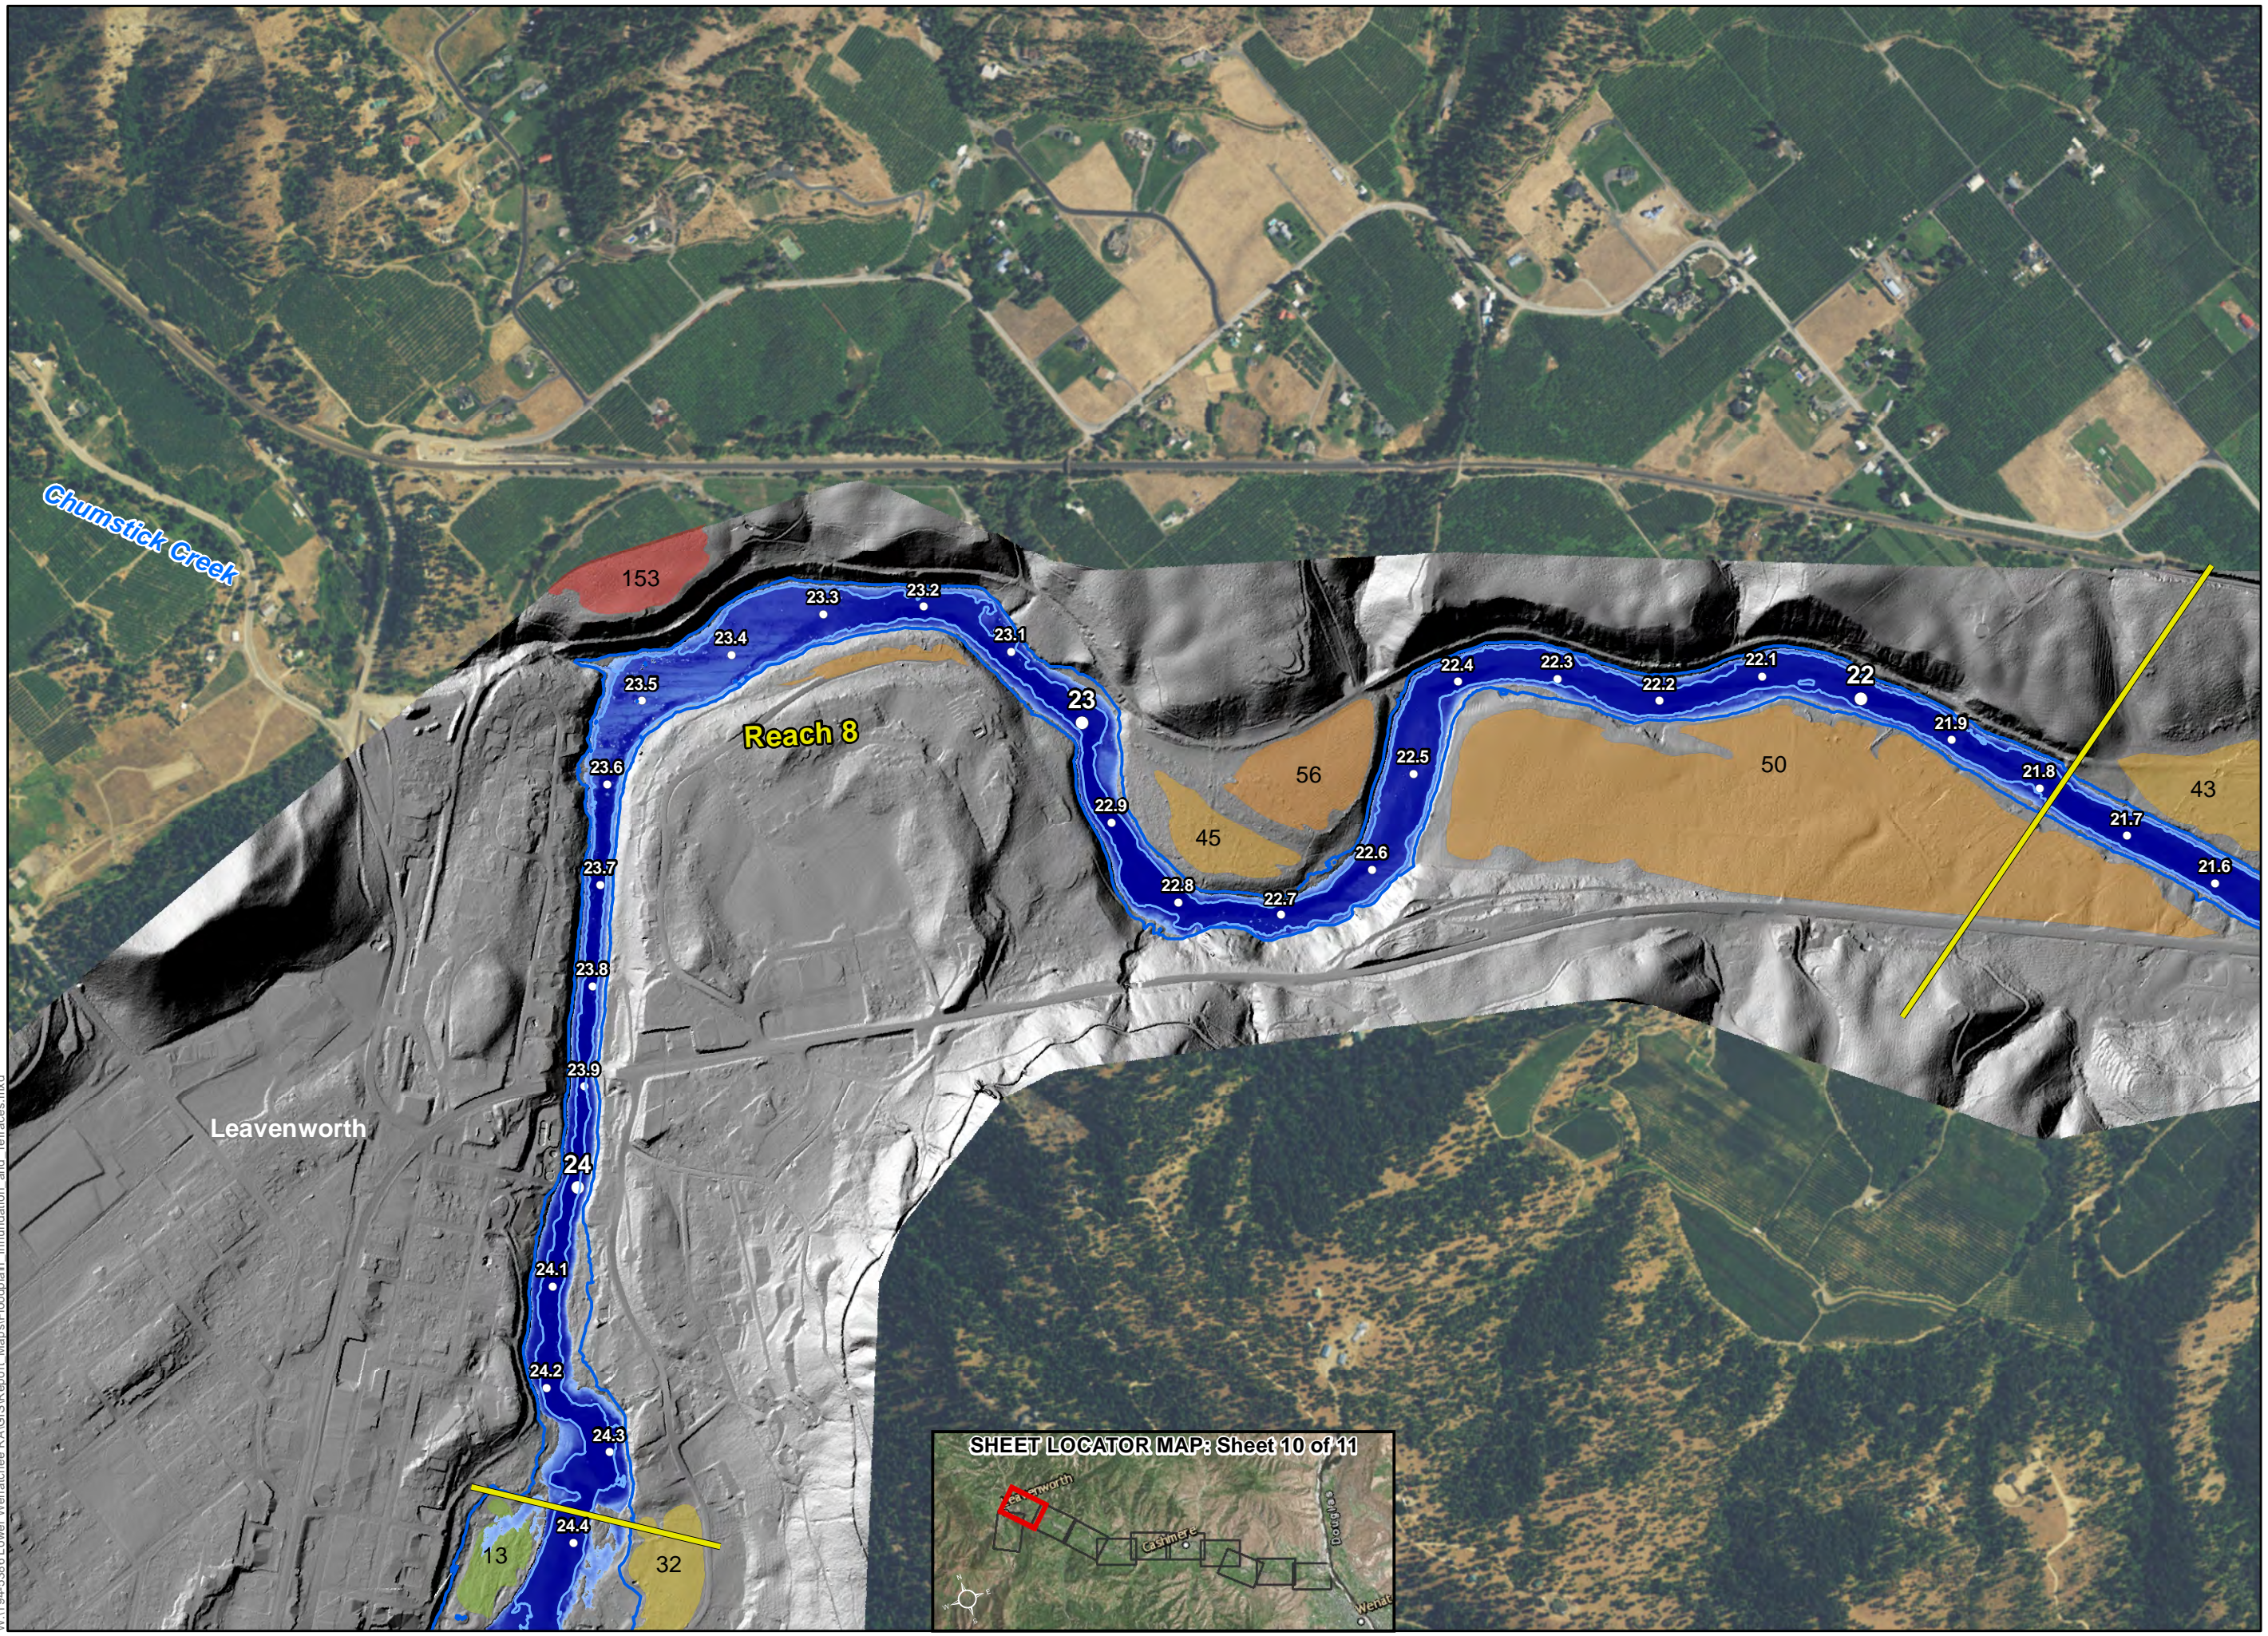
Figure C-2j
Inundation and
Terrace Mapping

Average terrace relief is measured relative to the average elevation of the adjacent channel bed. See values labeled on map.
