ENTIAT RIVER RESTORATION DESIGN:

Upper Stillwaters Reach

CONCEPT LEVEL DESIGN

May 2018

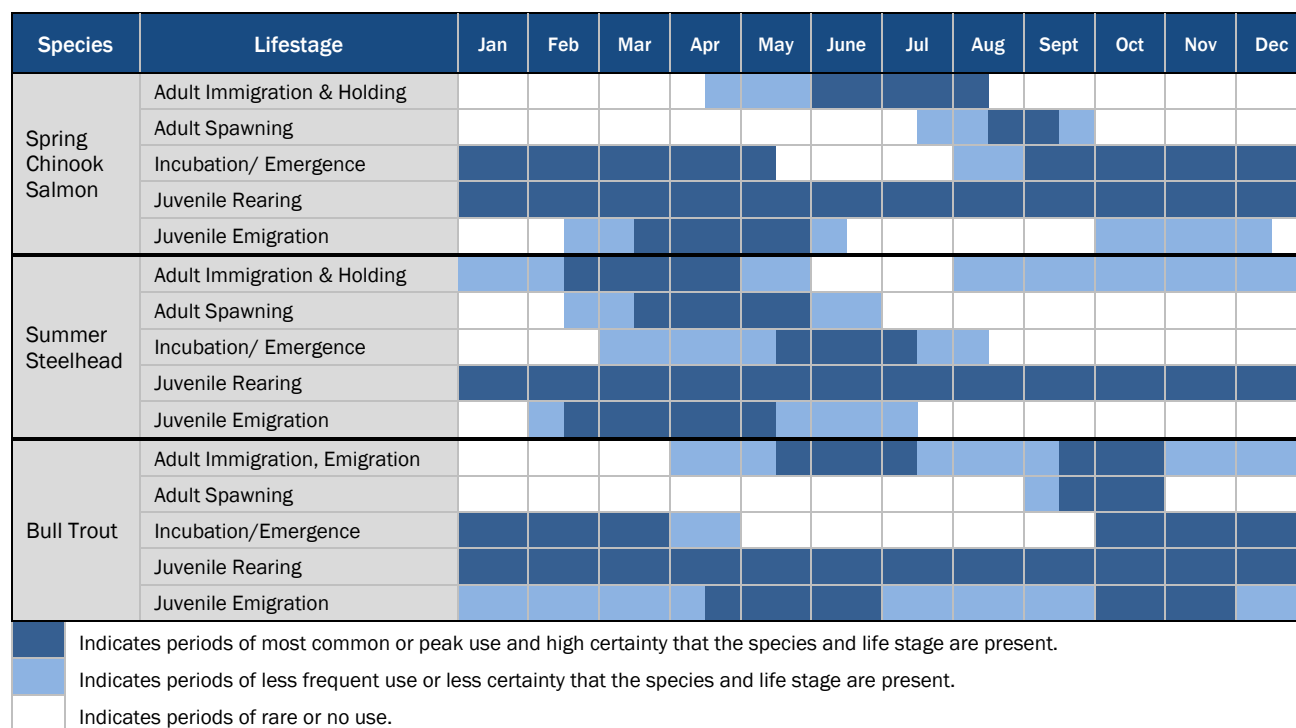
Figure 1-2 Fish Periodicity Chart for the Focal Fish Species

As mentioned above, there are three fish populations within the Entiat River that are protected under the ESA: spring Chinook salmon, summer steelhead, and bull trout. The Upper Columbia River (UCR) spring Chinook salmon evolutionary significant unit (ESU) was listed as endangered in 1999. This status determination was reaffirmed in 2005 (NOAA Fisheries 2017). The UCR steelhead distinct population segment (DPS) was originally listed as endangered in 1997, but was relisted as threatened in 2007. The revised status was confirmed in 2009. The National Oceanic and Atmospheric Administration National Marine Fisheries Service (NOAA Fisheries) designated the Entiat River and certain tributaries as critical habitat for spring Chinook salmon and steelhead in 2005 (NOAA Fisheries 2005). Bull trout were listed as threatened in 1999. The U.S. Fish and Wildlife Service (USFWS) designated the Entiat River as critical habitat for bull trout in 2010. The Entiat River in this reach is an important migration corridor for spring Chinook salmon, steelhead, and bull trout, and contains spawning and rearing habitat for all three species (Figure 1-2).

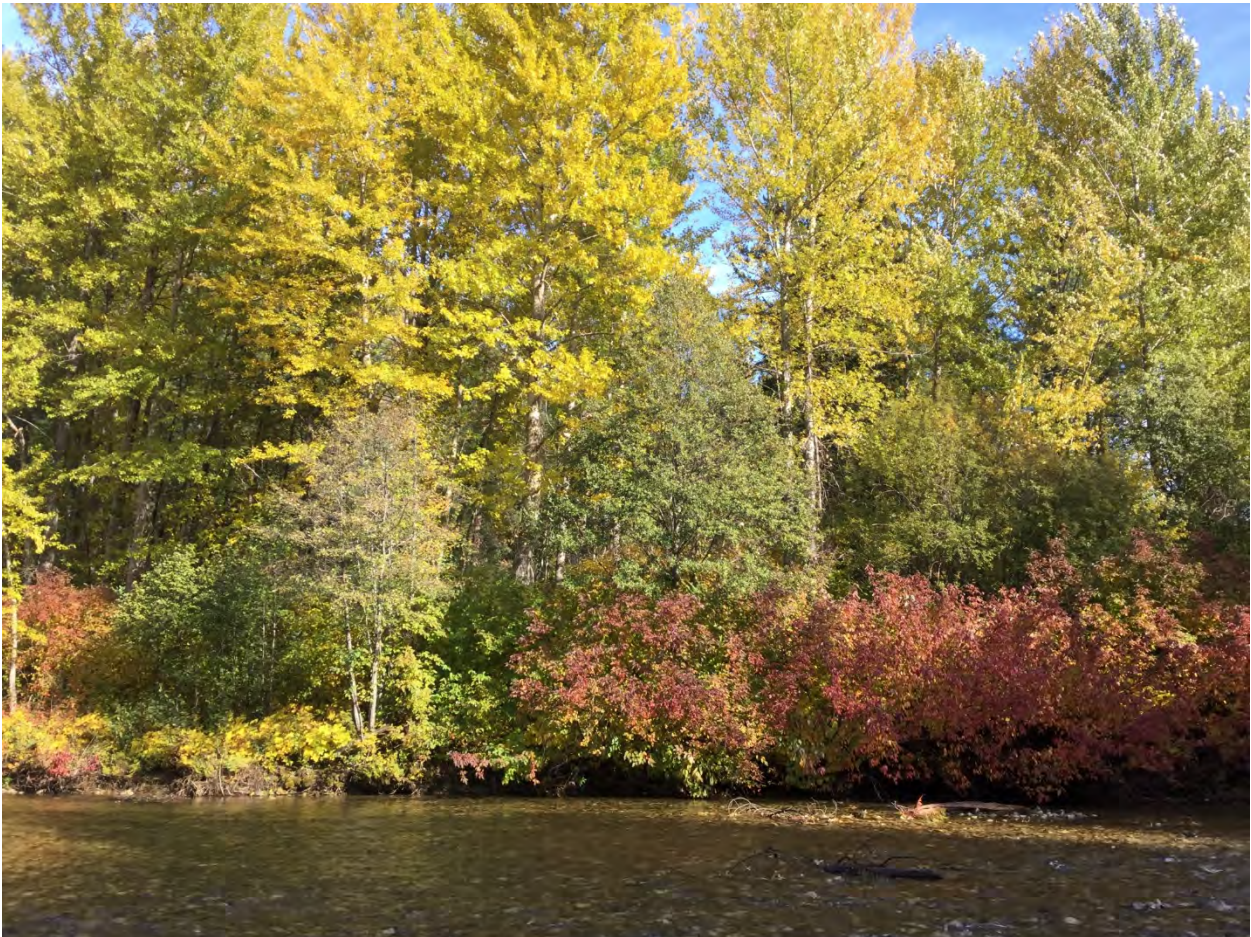
Figure 2-1. Riparian Corridor in the Burns Reach

Field surveys conducted in October 2017 confirmed that riparian corridors are mostly dense and intact. Plant species identified during the surveys indicated species composition consisting of more hardwoods (cottonwood, alder, willow, red osier dogwood) in the lower elevation Burns Reach, or in other areas with low terraces, while the transitional reaches with more confined channels and corridors with mostly higher terraces were dominated by conifers of mixed age stands (red cedar, Douglas fir, grand fir, Engelmann spruce, and sparse lodgepole pine [*Pinus contorta*]). Representative riparian conditions of depositional reaches are shown in Figure 2-1, while conditions typical of transition reaches are illustrated in Figure 1-4.

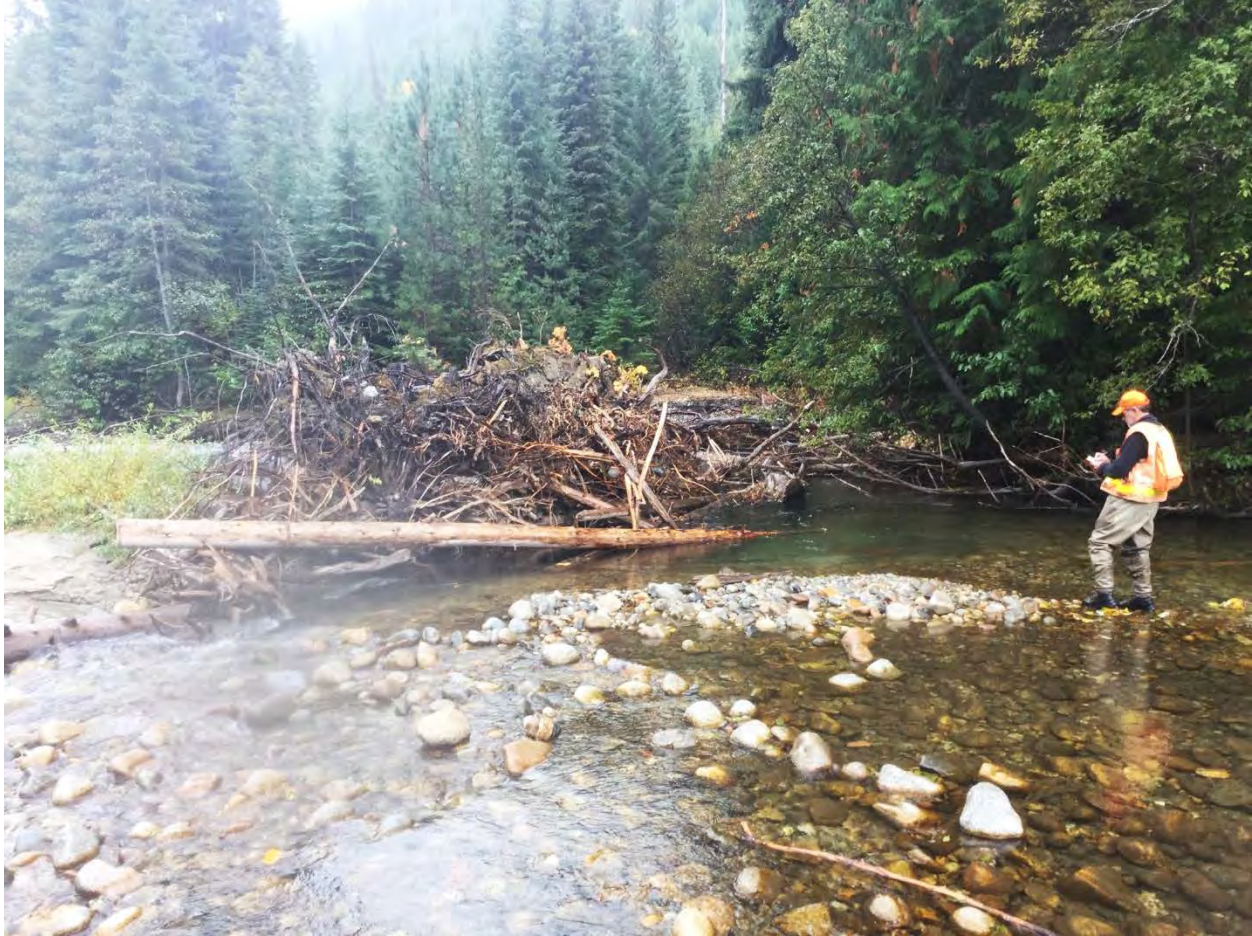
Figure 2-2. Riparian Corridor in the Silver Falls Reach

Reach 9 (Silver Falls Reach) – The riparian canopy consists of mixed older forest on the higher terraces, while understory varies depending on groundwater. Floodplain areas show various age classes from before and after major floods. Shrubs such as willows are present in the active channel banks where smaller substrate is present.

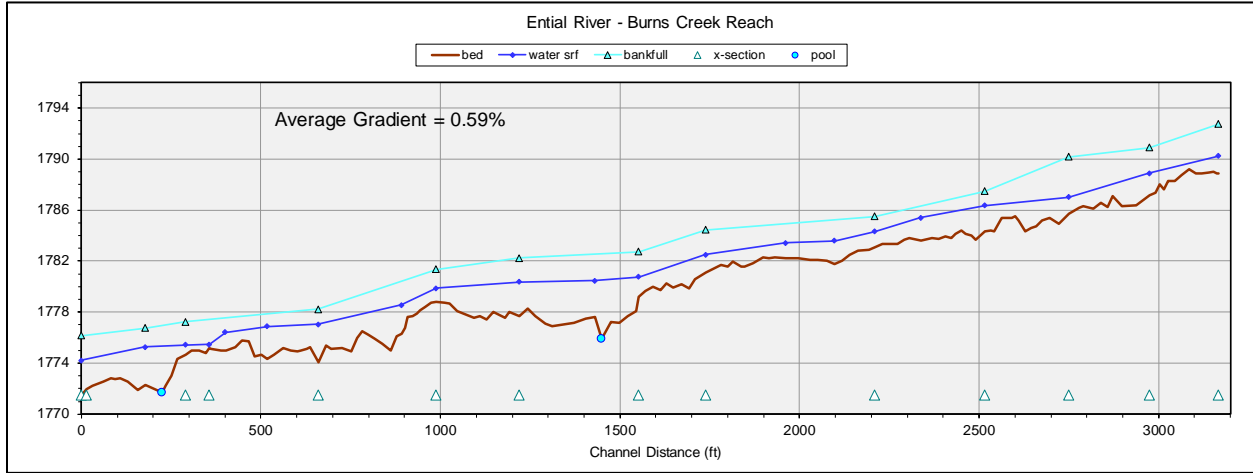
Figure 3-1. Longitudinal Profile of the Entiat River, Burns Reach

The topographic surveys included longitudinal profiles of the thalweg, with data collected at approximately 20-foot intervals, and capturing all major breaks in slope necessary for hydraulic analyses. The profiles for the Burns, Lower Signal, and Fox Creek reaches are illustrated in Figures 3-1, 3-2, and 3-3, respectively, and show how the gradient decreases significantly in the downstream reaches.

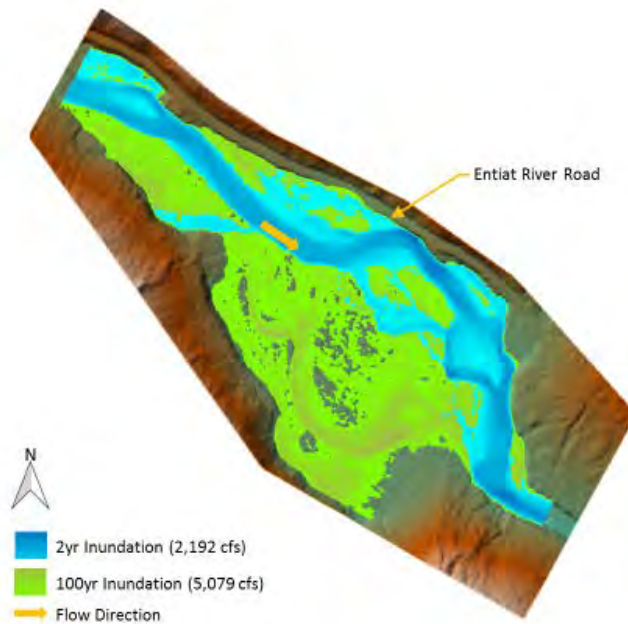
Figure 3-4. Burns Reach Inundation Extents: Existing Conditions 2- and 100-Year Gage Transfer Peak Flows

During topographical survey activities in April 2018 at the Burns Reach, the flow in the Entiat River was estimated at 177 cfs utilizing the provisional daily average flow recorded at the gage and the same gage transfer methodology discussed in Section 3.3. Edge of water survey points were reviewed against survey flow inundation model extents. Model calibration was an iterative process using modeled results for survey flow and adjusting the Manning's roughness of the channel until inundation results matched up with the edge of water survey points at time of survey. A channel Manning's roughness value of 0.06 was selected for Burns Reach. Upon completion of model calibration, unsteady flow analysis computations were computed for the remainder of the scenarios. Modeled results for the 2- and 100-year existing conditions hydraulic scenarios for the Burns Reach are provided in Appendix B. Figure 3-4 below illustrates the inundation extents for the existing conditions 2- and 100-year gage transfer peak flows for the Burns Reach.

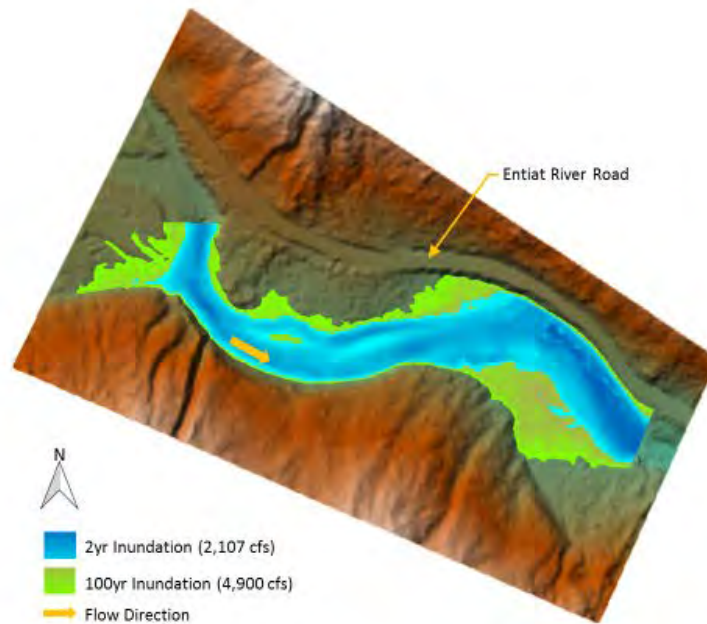
Figure 3-5. Lower Signal Reach Inundation Extents: Existing Conditions 2- and 100-Year Gage Transfer Peak Flows

During topographical survey activities at the Lower Signal Reach in October 2017, the flow in the Entiat River was estimated as 70.5 cfs, utilizing the same methodology discussed earlier. Edge of water survey points were reviewed against survey flow inundation extents. Model calibration was an iterative process using survey flow and adjusting the Manning’s roughness of the channel until inundation results matched up with the edge of water survey points at time of survey. A channel Manning’s roughness value of 0.07 was selected for the Lower Signal Reach. Upon the completion of model calibration, unsteady flow analysis computations were completed for the remainder of the scenarios. Modeled results for the 2- and 100-year existing conditions hydraulic scenarios for Lower Signal Reach are provided in Appendix B. Figure 3-5 below illustrates the inundation extents for the existing conditions 2- and 100-year gage transfer peak flows for the Lower Signal Reach.

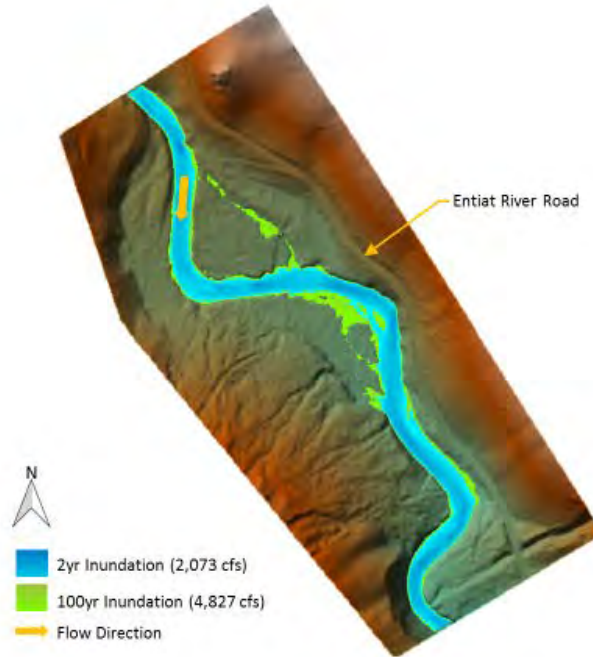
Figure 3-6. Fox Creek Reach Inundation Extents: Existing Conditions 2- and 100-Year Gage Transfer Peak Flows

During topographical survey activities at the Fox Creek Reach, the flow in Entiat River was estimated as 70.5 cfs. Edge of water survey points were reviewed against survey flow inundation extents. Model calibration was an iterative process using survey flow and adjusting the Manning’s roughness of the channel until inundation results matched up with the edge of water survey points at time of survey. A channel Manning’s roughness value of 0.06 was selected for Fox Creek Reach. Upon the completion of model calibration, unsteady flow analysis computations were computed for the remainder of the scenarios. Modeled results for the 2- and 100-year existing conditions hydraulic scenarios for Fox Creek Reach are provided in Appendix B. Figure 3-6 below illustrates the inundation extents for the existing conditions 2- and 100-year gage transfer peak flows for Fox Creek Reach.

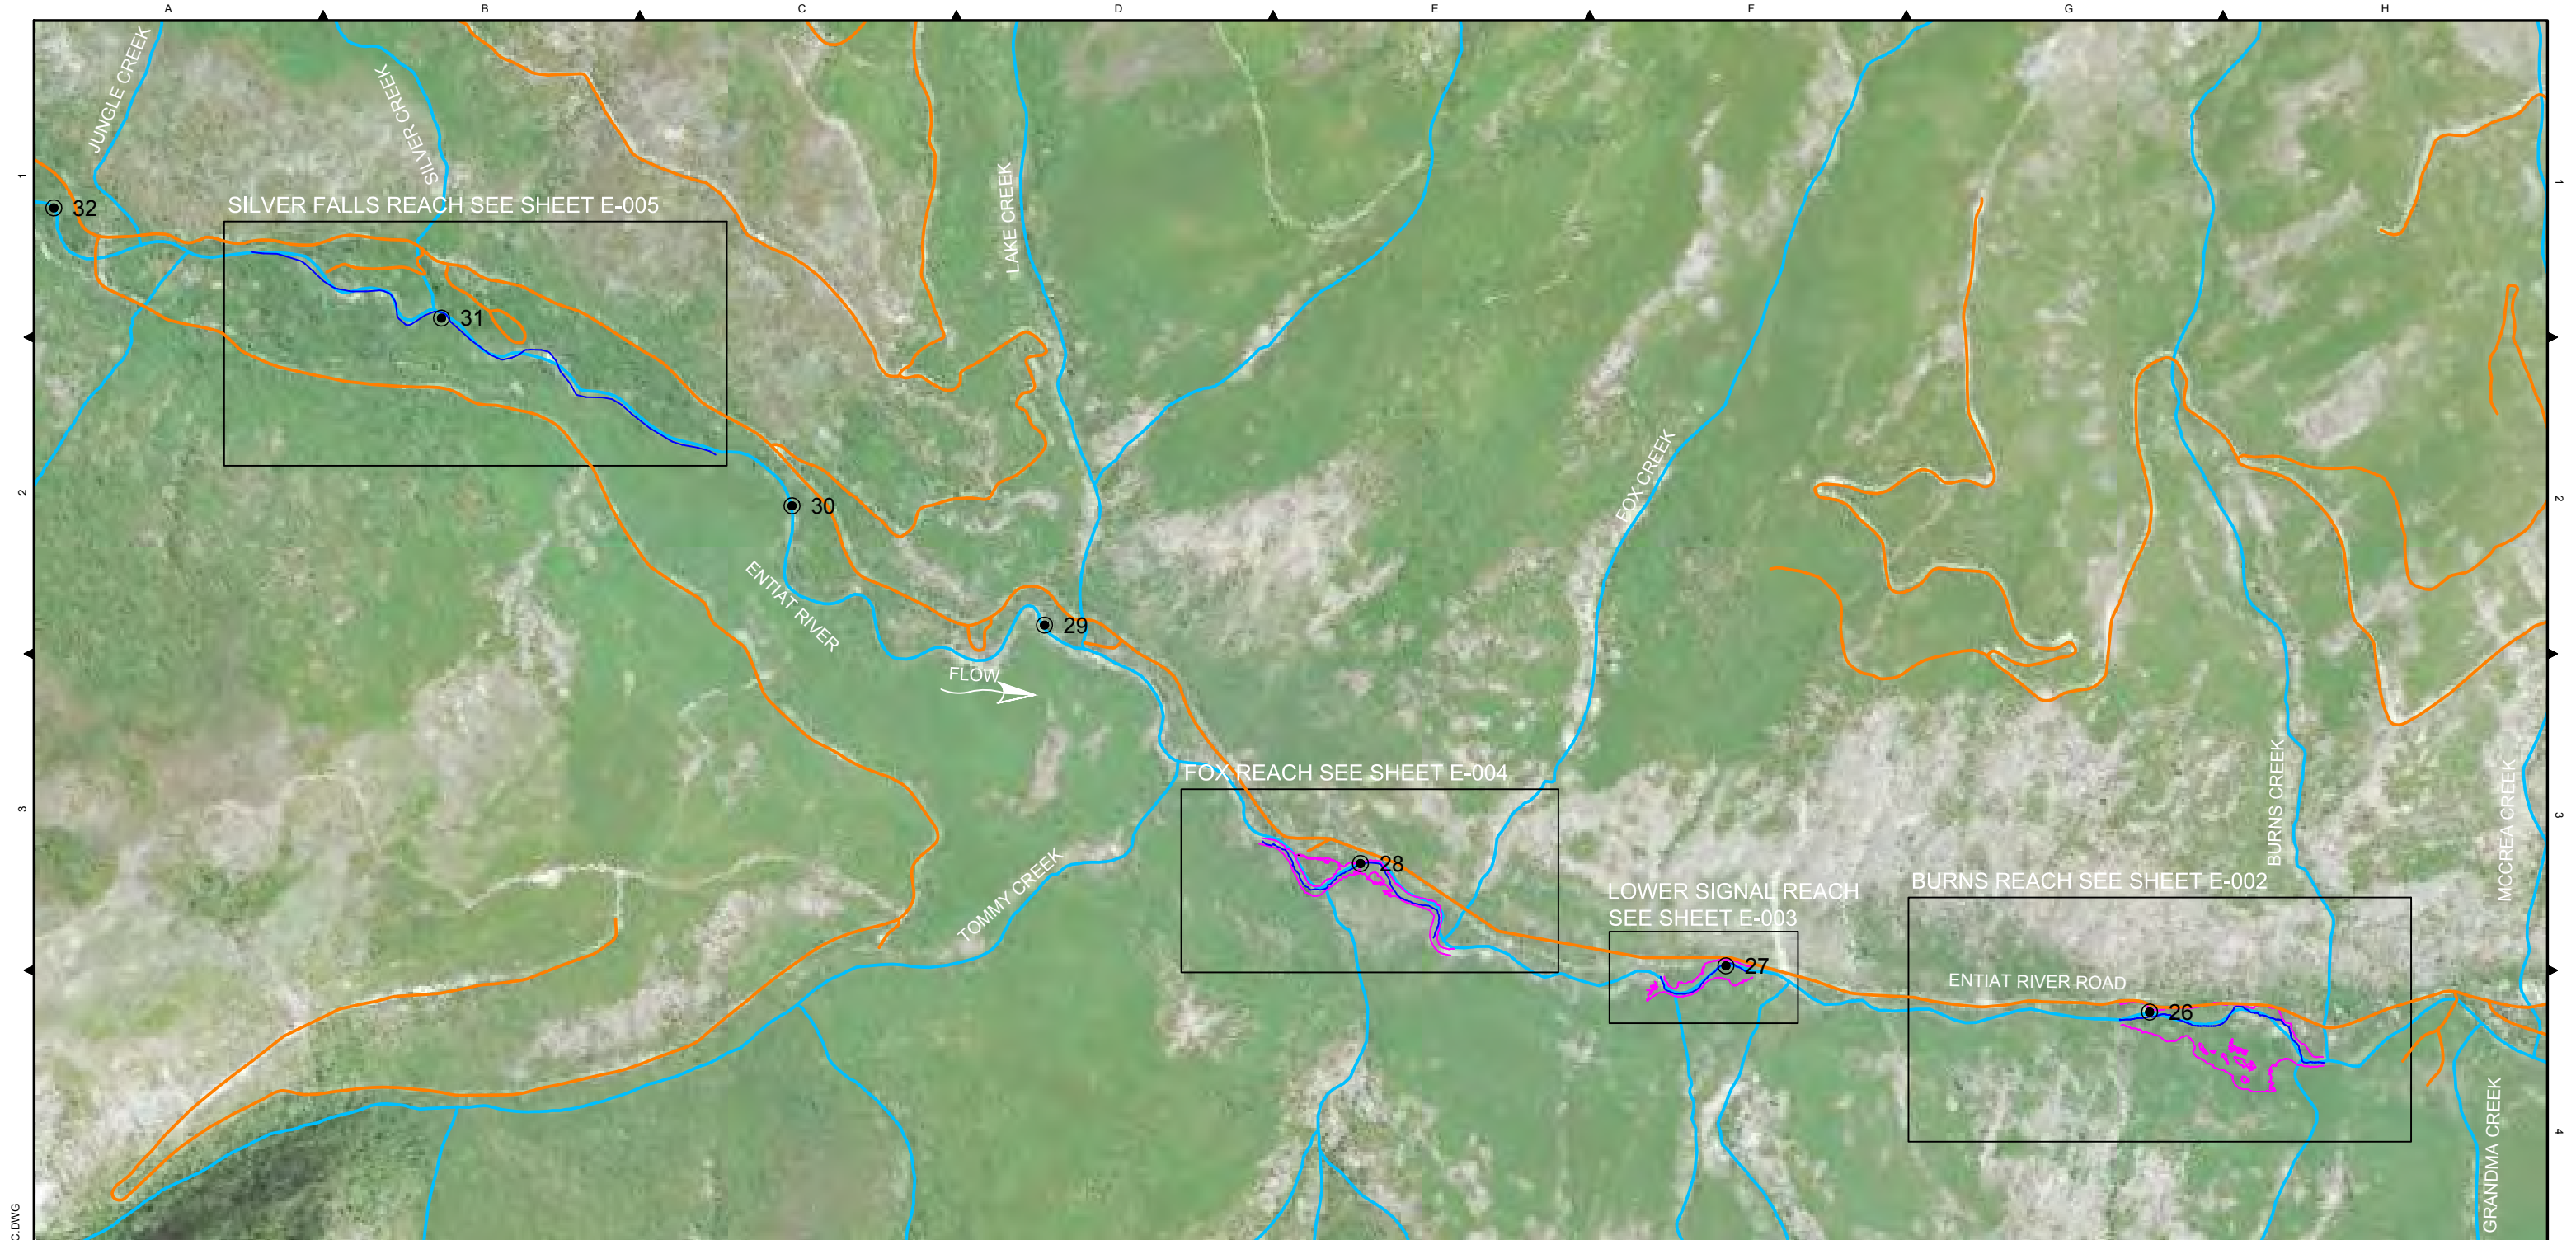
EXISTING CONDITIONS OVERVIEW

- LEGEND:**
- ENTIAT RIVER THALWEG REACH ALIGNMENTS
 - USGS RIVER MILE
 - EXISTING 100-YEAR INUNDATION
 - EXISTING TRIBUTARIES
 - EXISTING ROADS

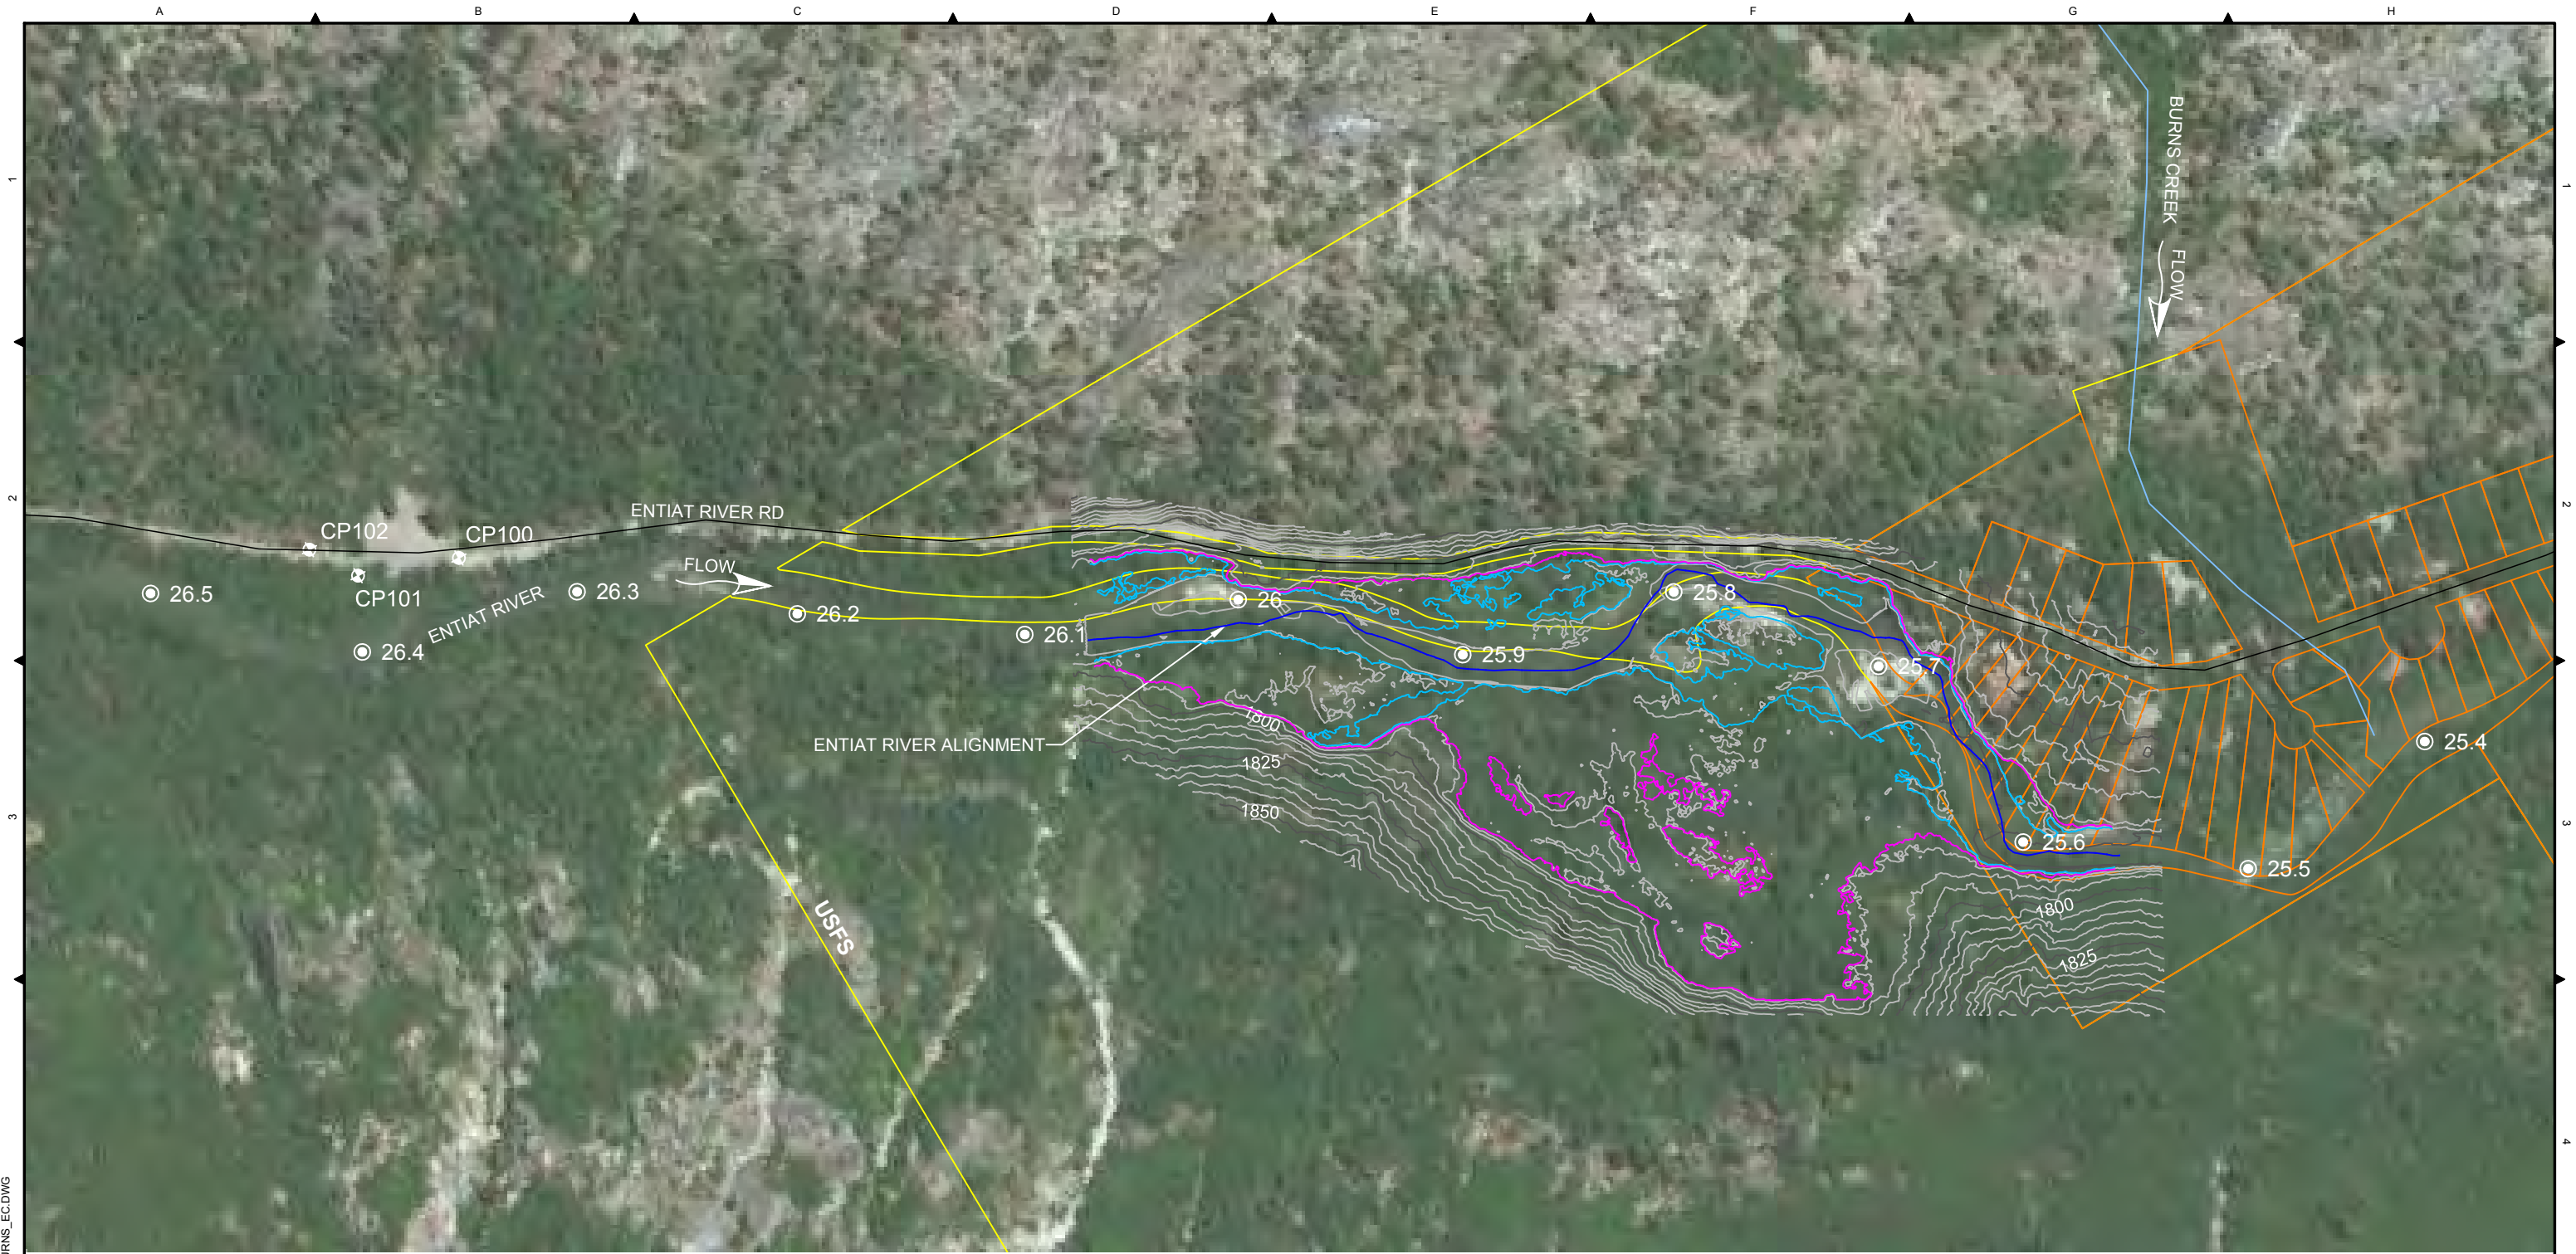
BURNS REACH CONTROL POINT TABLE				
POINT #	NORTHING	EASTING	ELEVATION	DESCRIPTION
100	331901.65	1725721.09	1814.32	CP100
101	331989.78	1725479.54	1819.45	CP101
102	332107.27	1725406.65	1826.86	CP102

- LEGEND:**
- ENTIAT RIVER THALWEG ALIGNMENT
 - USFS PROPERTY BOUNDARY
 - PRIVATE PROPERTY BOUNDARY
 - USGS RIVER MILE
 - ⊕ SURVEY CONTROL POINT
 - EXISTING 2-YEAR INUNDATION (BANKFULL)
 - EXISTING 100-YEAR INUNDATION
 - EXISTING TRIBUTARY (BURNS CREEK)
 - 25-FT MAJOR CONTOUR
 - 5-FT MINOR CONTOUR

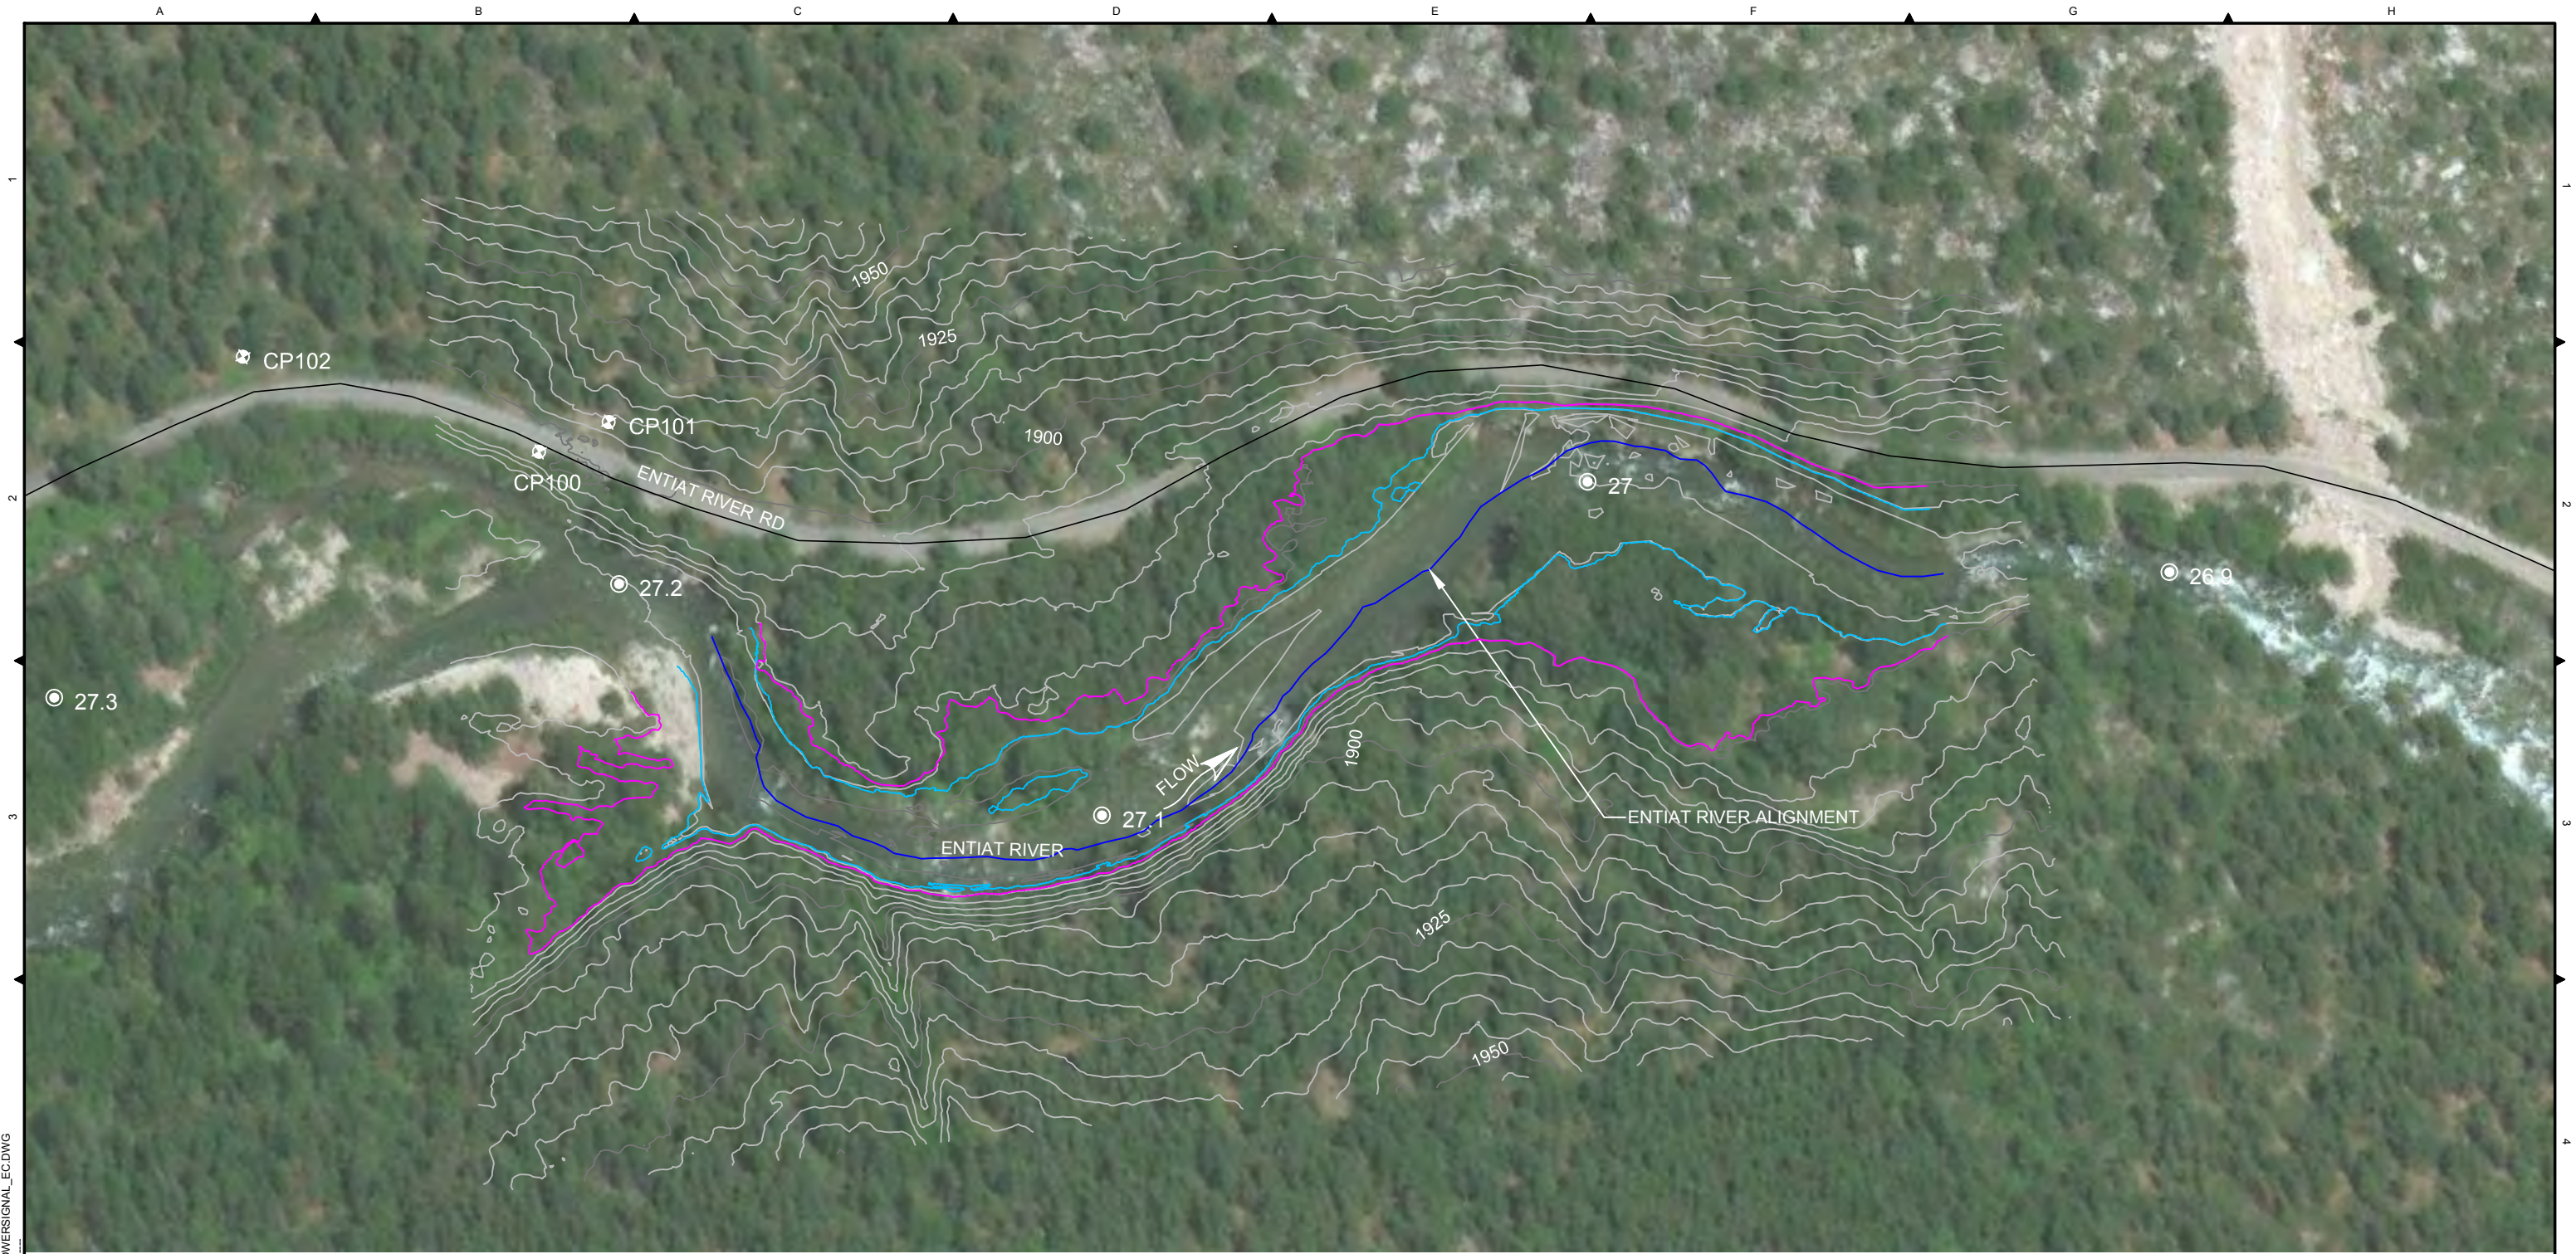
LOWER SIGNAL & FOX REACHES CONTROL POINT TABLE				
POINT #	NORTHING	EASTING	ELEVATION	DESCRIPTION
100	334532.64	1722178.57	1898.99	CP100
101	334524.00	1722249.36	1907.05	CP101
102	334749.33	1721982.08	1902.49	CP102

- LEGEND:**
- ENTIAT RIVER THALWEG ALIGNMENT
 - USGS RIVER MILE
 - ⊕ SURVEY CONTROL POINT
 - EXISTING 2-YEAR INUNDATION (BANKFULL)
 - EXISTING 100-YEAR INUNDATION
 - EXISTING TRIBUTARY
 - 25-FT MAJOR CONTOUR
 - 5-FT MINOR CONTOUR

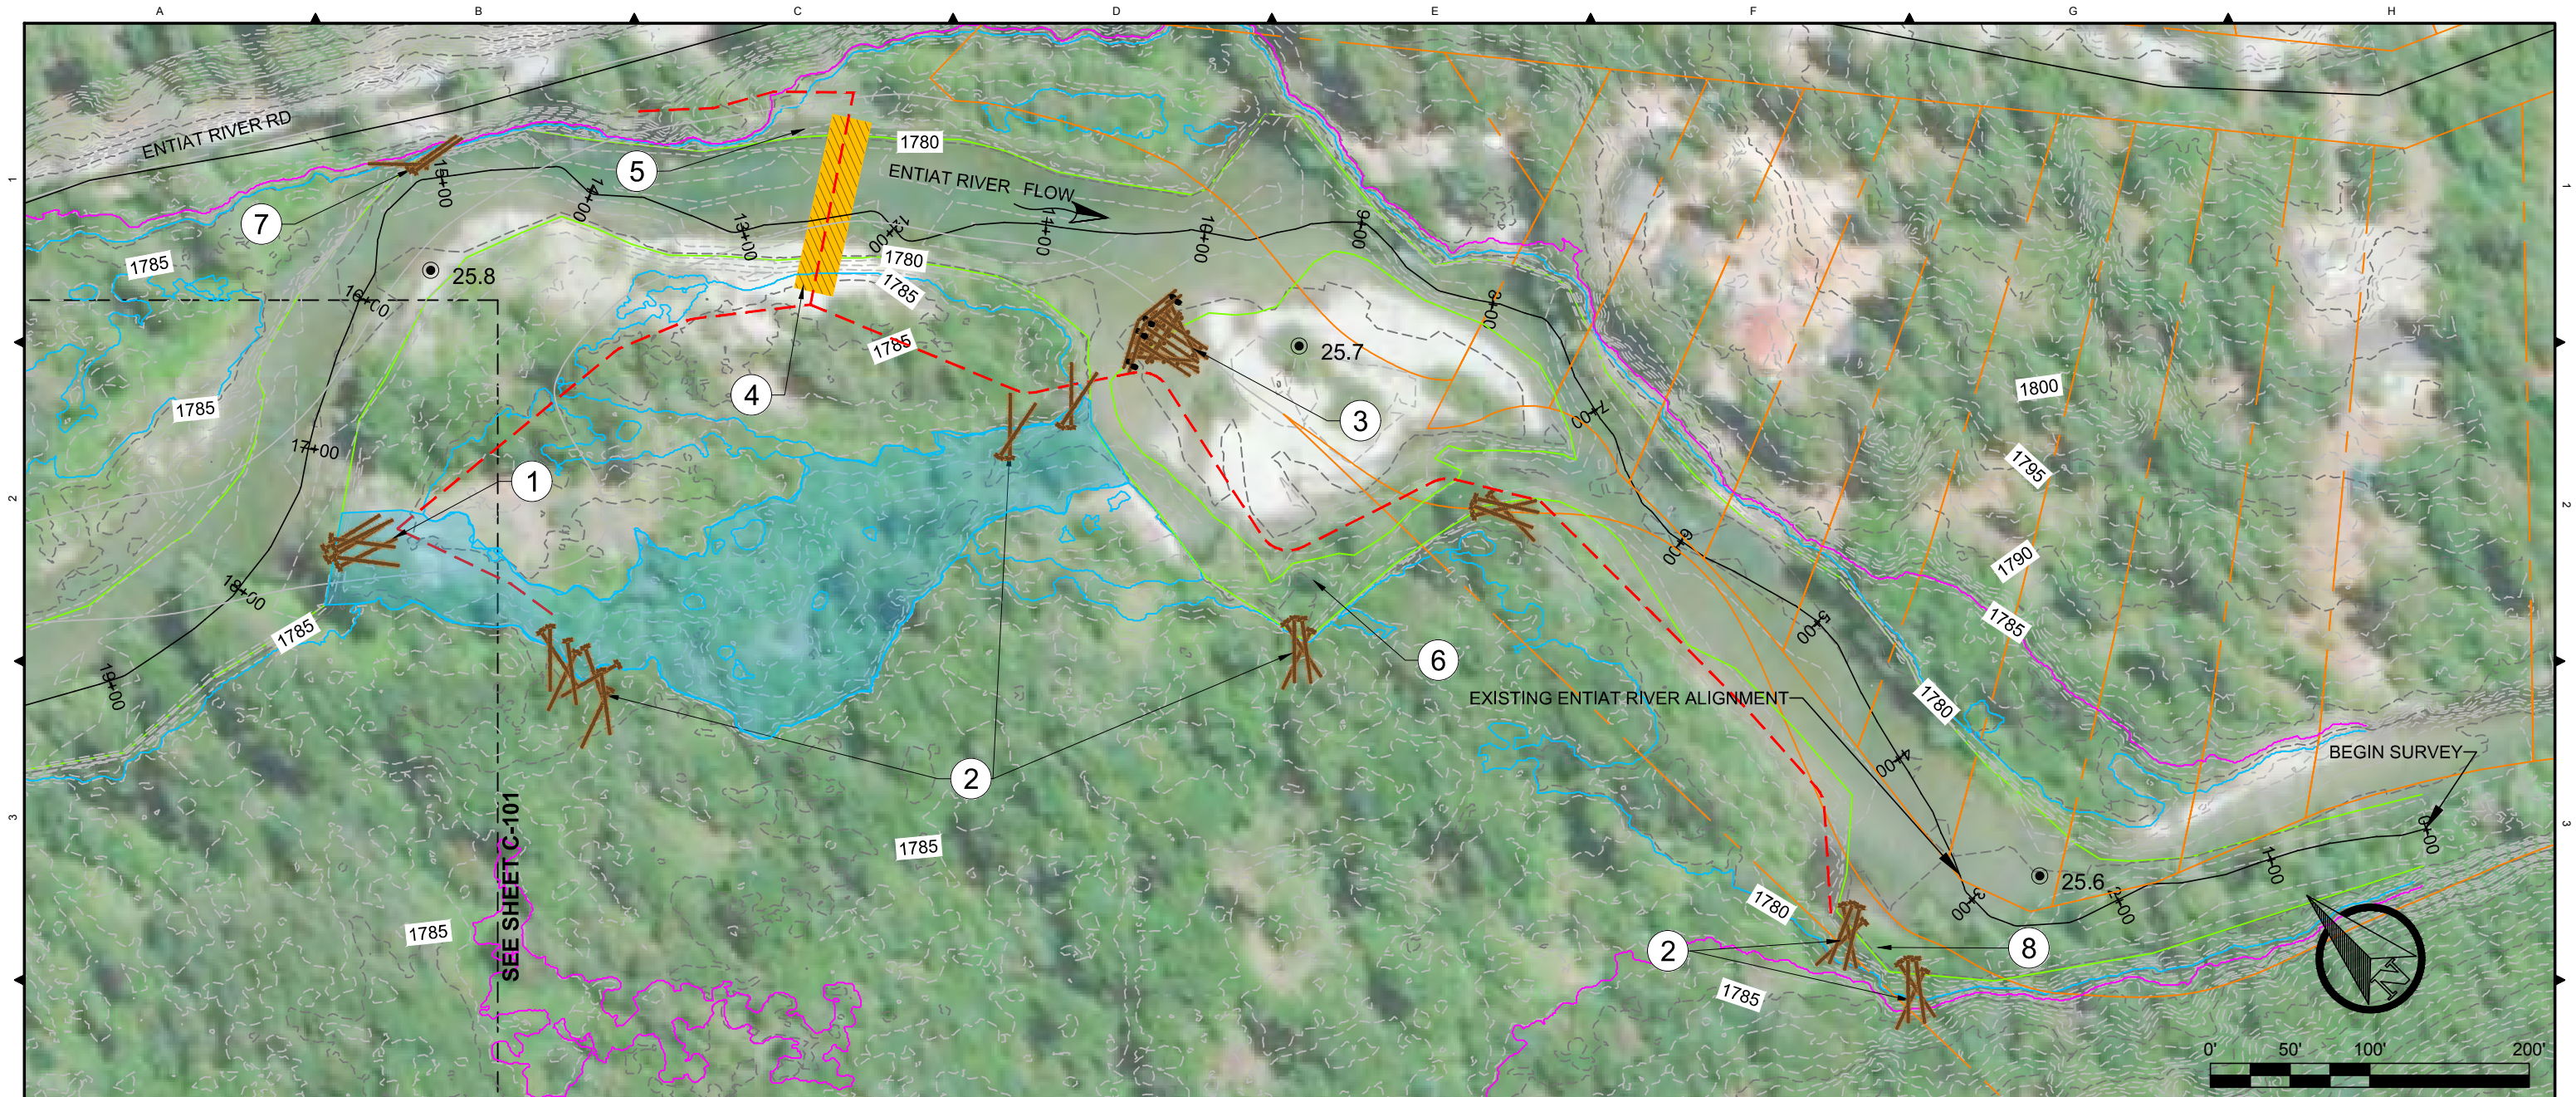
DWG. NO.: **C-100**
CREATED: 4/26/2018
SHEET: 8 of 22

1. SUPPLEMENT EXISTING LWD JAM AT THE HEAD OF THE HIGH FLOW SIDE CHANNEL. FINAL LWD JAM TO ACTIVATE THE SIDE CHANNEL AT LOWER FLOWS. PLACE ROOTWADS INTO LOW FLOW. FINAL LWD CONFIGURATION COORDINATION IN THE FIELD. SEE SHEET C-502 FOR TYPICAL DETAILS. STRUCTURES TO INCLUDE BALLAST AND BUMPER LOGS.

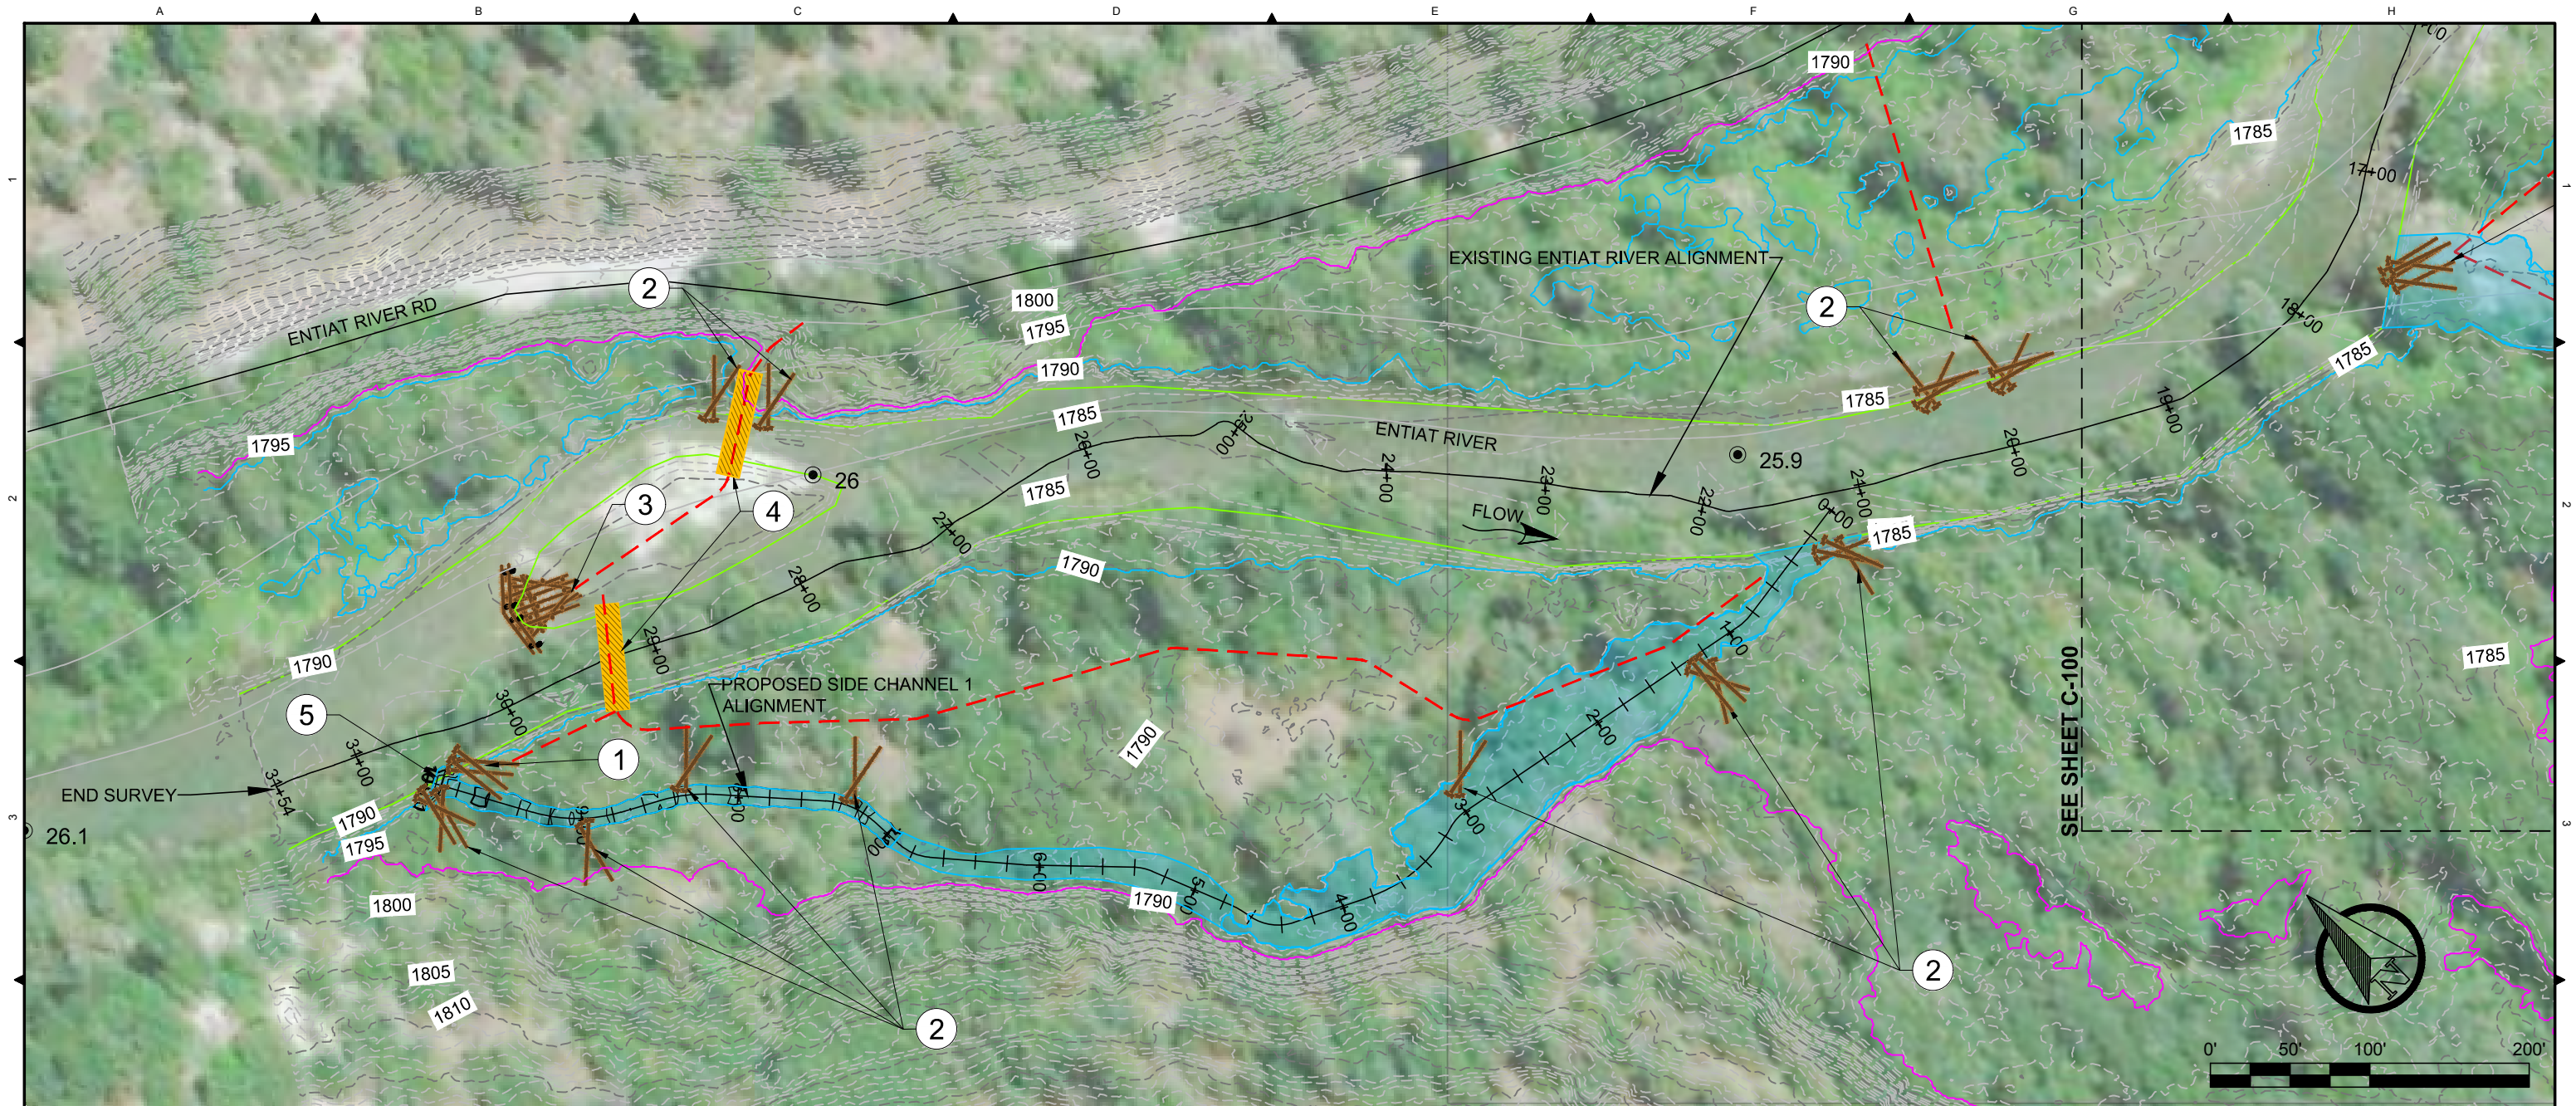
DWG. NO.: **C-101**
CREATED: 4/26/2018
SHEET: 9 of 22

1. PLACE LWD JAM AT THE HEAD OF THE PROPOSED SIDE CHANNEL. FINAL LWD JAM TO ACTIVATE THE SIDE CHANNEL AT LOW FLOWS. PLACE ROOTWADS INTO LOW FLOW. FINAL LWD CONFIGURATION COORDINATION IN THE FIELD. SEE SHEET C-502 FOR TYPICAL DETAILS. STRUCTURES TO INCLUDE BALLAST AND BUMPER LOGS.
