ENTIAT RIVER RESTORATION DESIGN:

Upper Stillwaters Reach

CONCEPT LEVEL DESIGN

May 2018

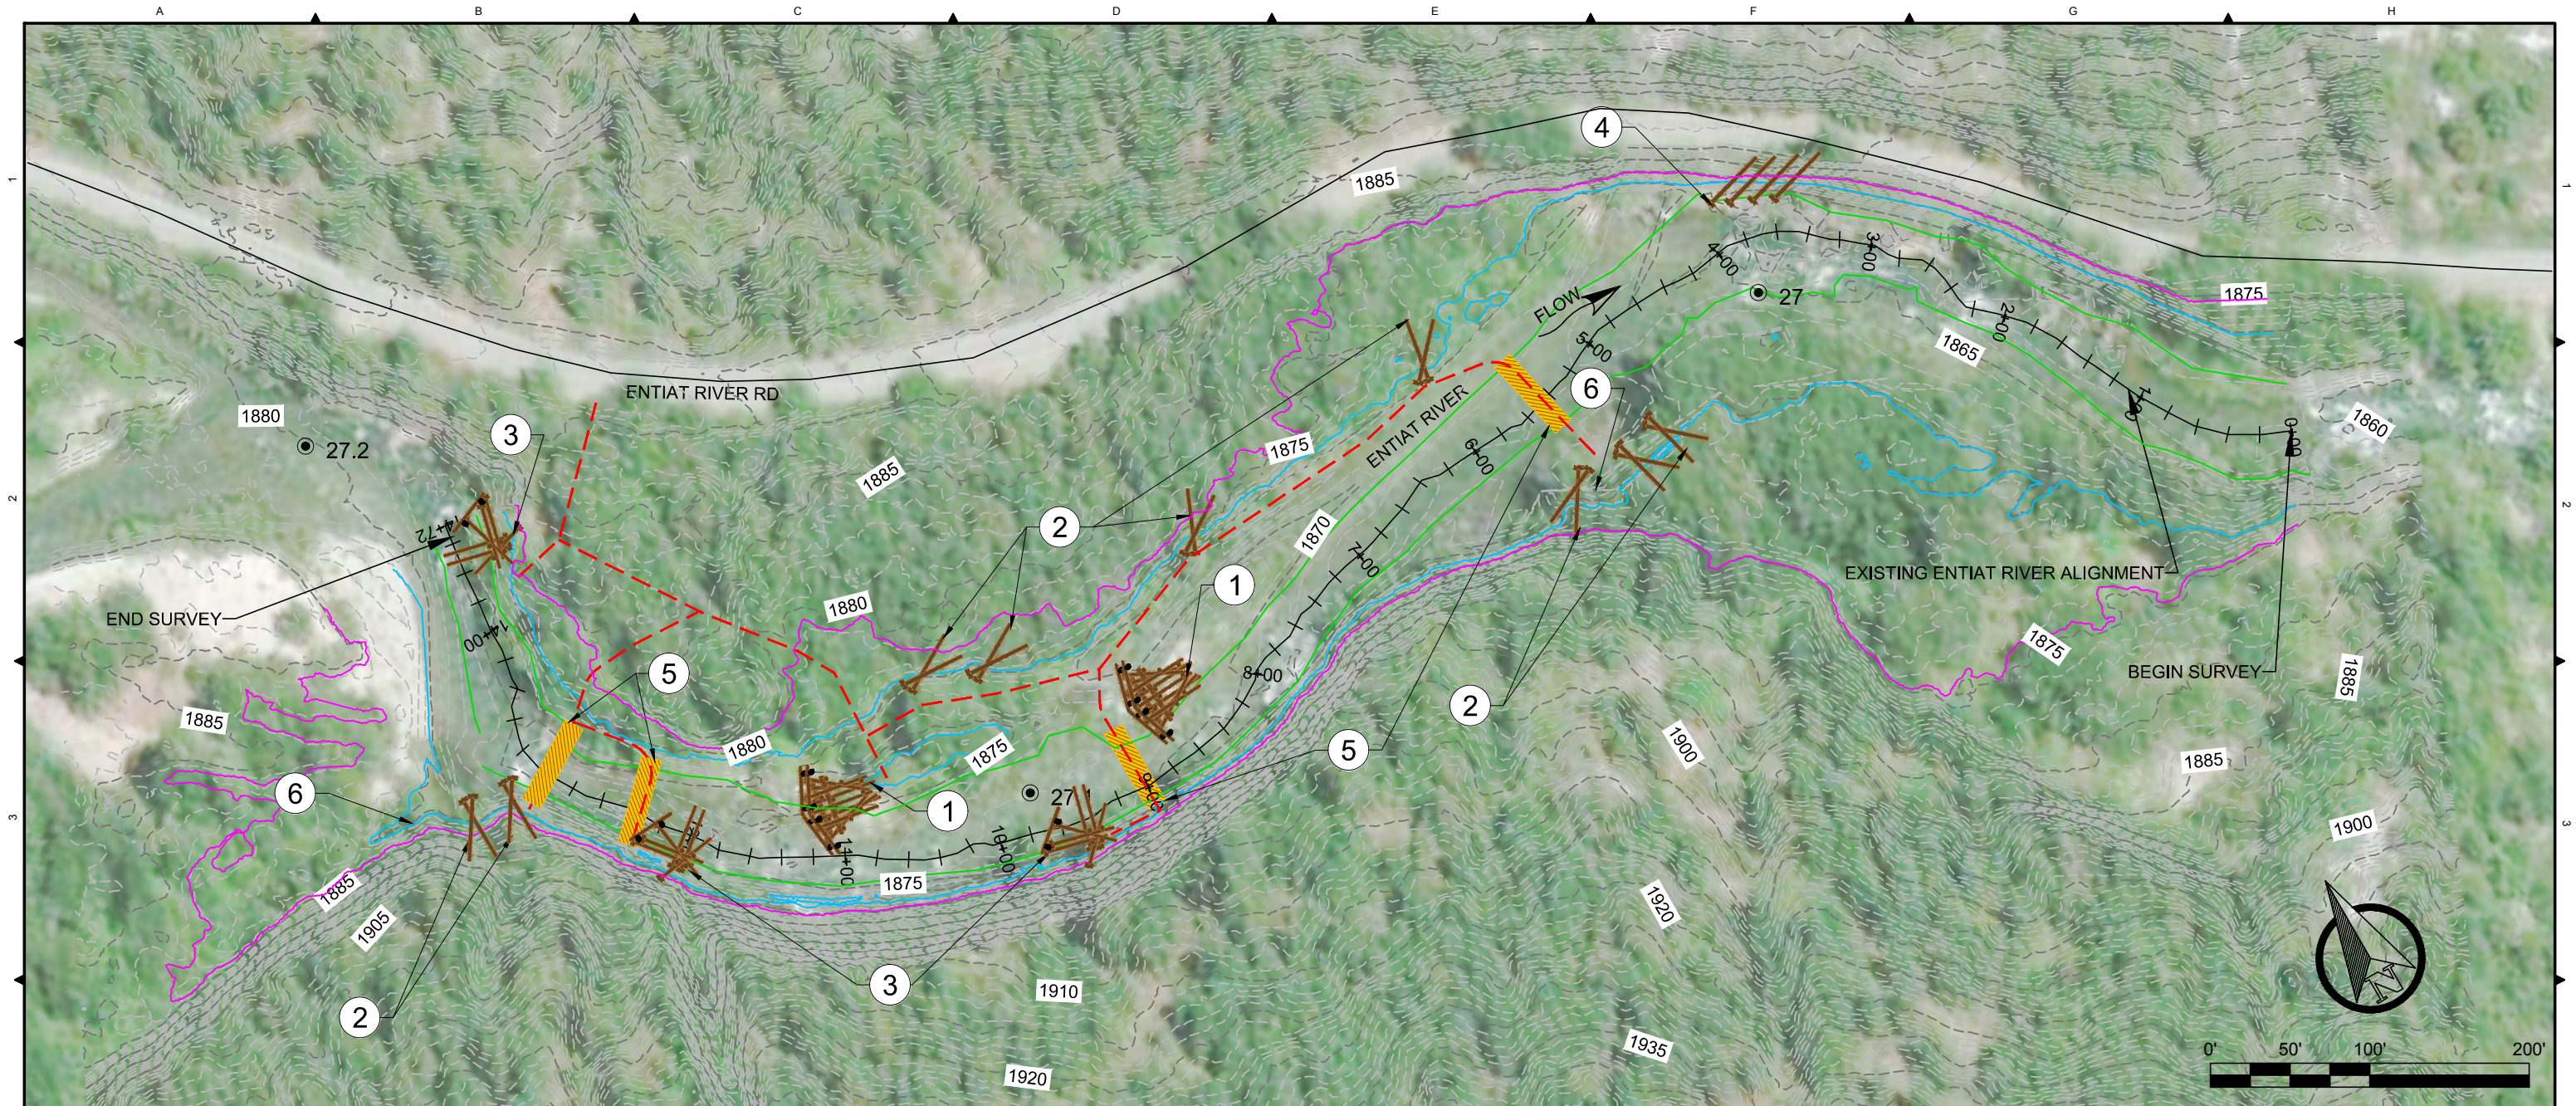
DWG. NO.: **C-200**
CREATED: 4/26/2018
SHEET: 10 of 22

1. INSTALL LOG JAM TO PROMOTE ADDITIONAL SPLIT FLOW AND INCREASE CHANNEL COMPLEXITY. SEE SHEET C-501 FOR TYPICAL DETAILS.
2. PLACE LWD FOR COVER AND INCREASED HABITAT COMPLEXITY ON SIDE CHANNELS AND ALCOVE. FINAL LWD CONFIGURATION COORDINATION IN THE FIELD. SEE SHEET C-502 FOR TYPICAL DETAILS. STRUCTURES EXPOSED TO MAIN CHANNEL FLOW SHALL HAVE BOULDER BALLAST AND BUMPER LOGS INSTALLED.

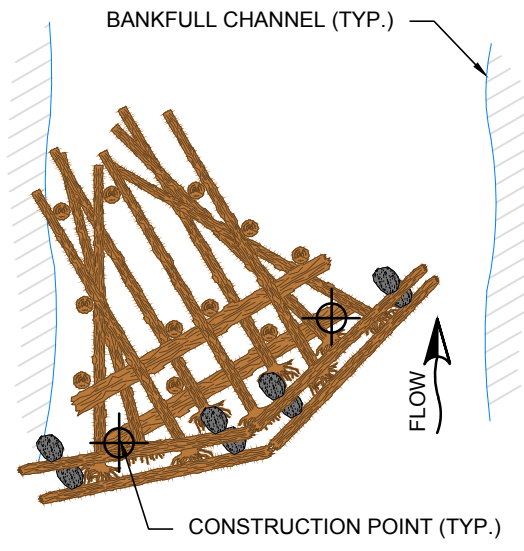
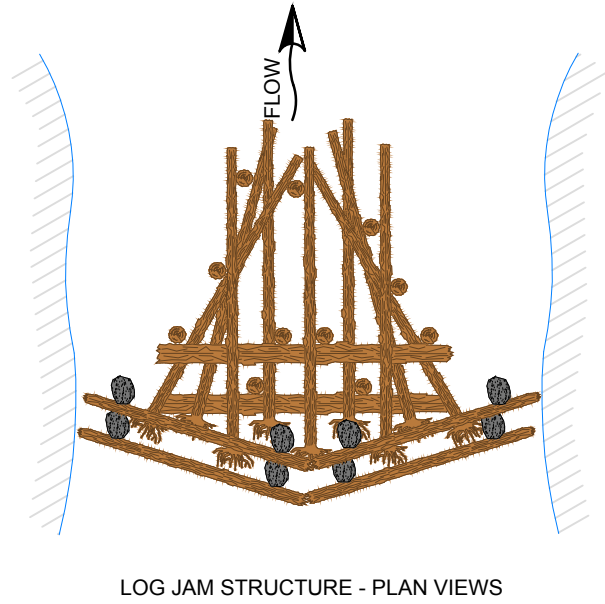
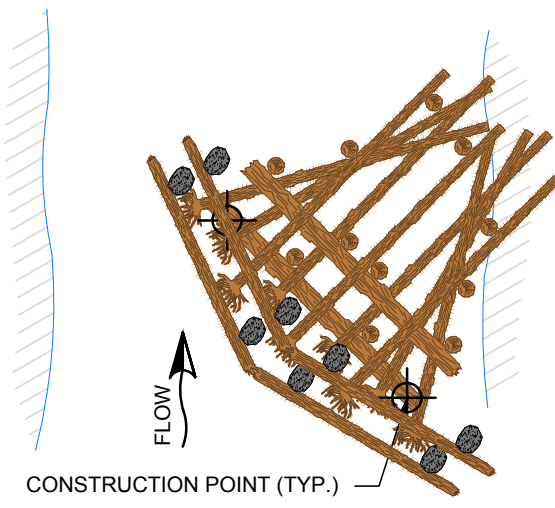
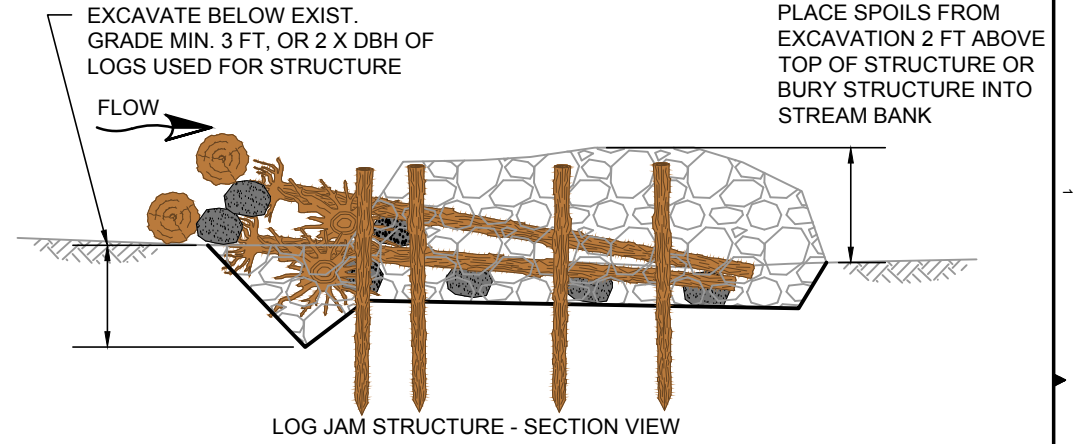
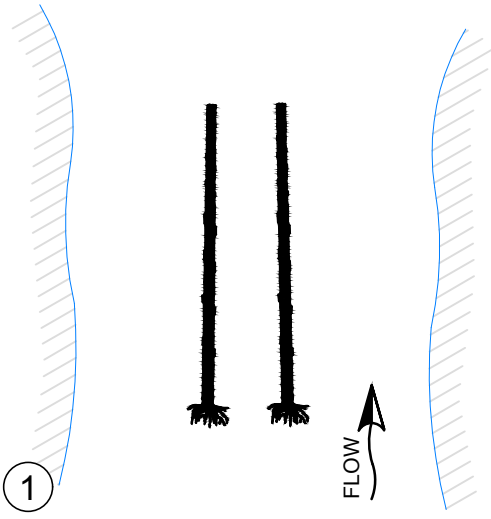
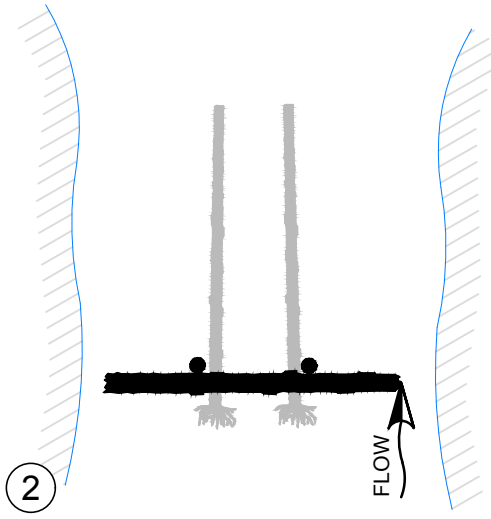
LOG JAM STRUCTURE - LOG PLACEMENT SEQUENCING

CONSTRUCTION QUANTITIES:

COMPONENT	DESCRIPTION	QUANTITY
LOG WITH ROOTWAD	18"+ DBH, 40 FT MIN	11
LOGS WITHOUT ROOTWAD	18"+ DBH, 40 FT MIN	6
VERTICAL PILING	12" - 18" DBH, 12 FT MIN	11
BOULDERS	3 FT MINIMUM	8
BALLAST	SPOILS/FLOODPLAIN ALLUVIUM	200 CY

LOG JAM STRUCTURE NOTES:

LWD Structure	Primary Purpose	Performance Criteria	Risk Assessment	Compensating Analyses or Measures	Habitat Benefits
Log Jam Structure	Promote lateral migration of main channel; Encourage flow splitting to facilitate side channel and floodplain reconnection	<ul style="list-style-type: none"> Maintain side channel inlet dimensions to withstand up to the proposed 100-year flood hydraulic conditions. 	<ul style="list-style-type: none"> The proposed side channels inlets require lateral stability to control side channel entry flow and maintain consistent inlet cross sectional area. Boater safety where necessary downstream of Box Canyon 	<ul style="list-style-type: none"> LWD stability calculations (To be provided at Permit Level Design). Bumper logs for boater safety. 	<ul style="list-style-type: none"> Provide complex pool habitat for adults and margin habitat for juveniles. Encourage lateral migration in straight sections when placed to act as deflectors. Local scour pools at edges of structure. Aggrade sediment downstream of structure.

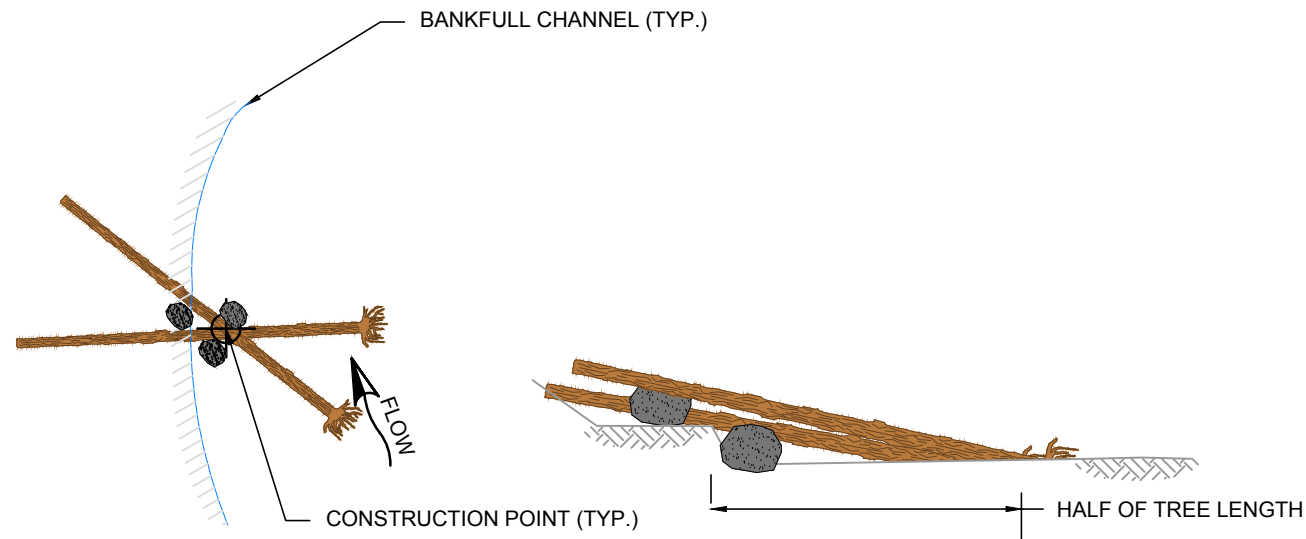
2-LOG CROSS STRUCTURE WITH BOULDERS - LEFT BANK PLAN AND SECTION VIEWS

7. BANKFULL LOCATION WITH RESPECT TO STRUCTURE LOCATION IS A TYPICAL REPRESENTATION AND MAY VARY AT EACH STRUCTURE LOCATION. FINAL CONFIGURATION OF STRUCTURE SHALL BE AS DIRECTED IN FIELD.

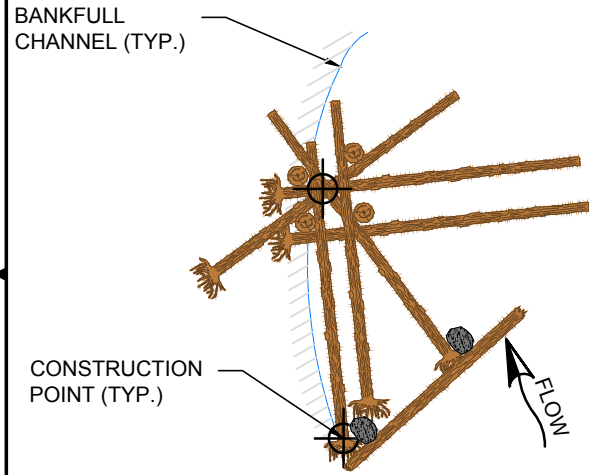
BANK JAM STRUCTURE - LEFT BANK PLAN AND SECTION VIEWS

BANK JAM STRUCTURE NOTES:

- FIRST TWO LOGS PLACED SHALL BE LARGEST OF SIX LOGS USED TO CONSTRUCT STRUCTURES.
- PLACE ROOTWAD OF LOGS PLACED IN SEQUENCE #1 1 TO 2 FEET FROM BANK FACE. PLACE VERTICAL PILING TO LOCK LOGS IN PLACE.
- PLACE ROOTWAD OF THIRD LOG ON TOP OF BANK. PLACE UPSTREAM OF ANY EXISTING VEGETATION.
- PLACE ROOTWAD OF FOURTH LOG IN CHANNEL THALWEG.
- PLACE ROOTWAD OF FIFTH LOG ON OPPOSITE EDGE OF WATER.
- PLACE ROOTWAD OF SIXTH LOG IN CHANNEL THALWEG.
- ADD BOULDER BALLAST AND BOLT BUMPER LOGS TO BOULDERS.
- BANKFULL LOCATION WITH RESPECT TO STRUCTURE ORIENTATION IS A TYPICAL REPRESENTATION AND WILL VARY AT EACH STRUCTURE LOCATION.

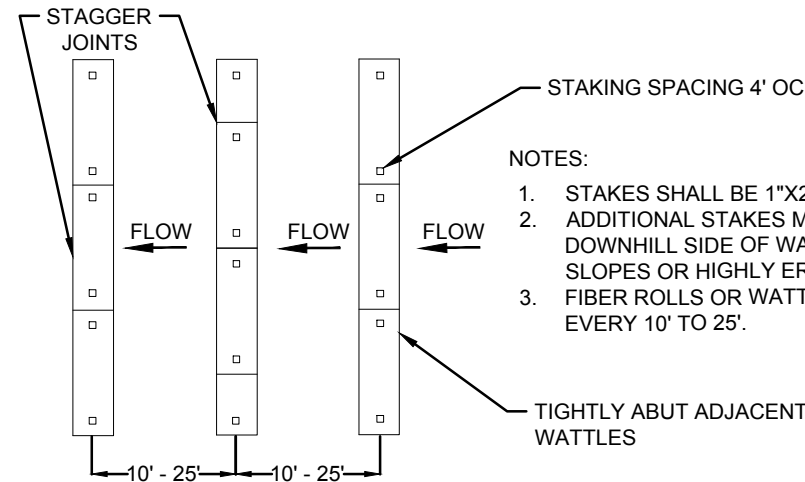
FIBER ROLLS/WATTLES - TYPICAL DETAIL
NTS

TIGHTLY ABUT ADJACENT WATTLES

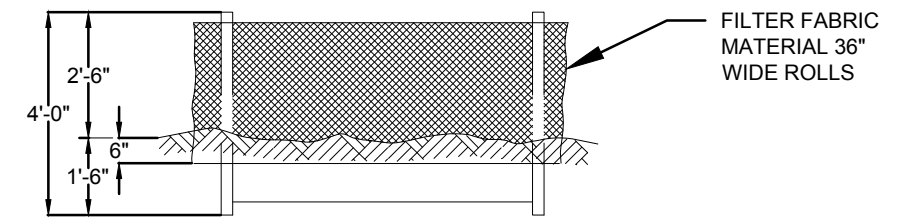
TEMPORARY SILT FENCE TYPICAL DETAIL
NTS

SEDIMENT FENCE NOTES:

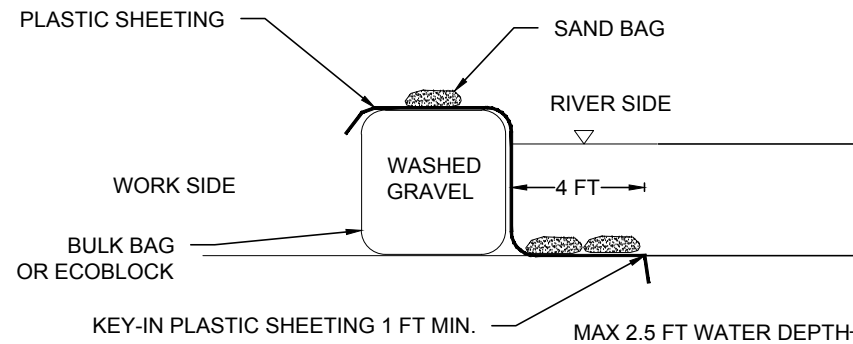
TEMPORARY COFFERDAM SECTION TYPICAL DETAIL
NTS

COFFERDAM NOTES:

1. ALL WORK IN CHANNEL SHALL ONLY OCCUR BETWEEN JULY 1 AND AUGUST 15.
2. IN-WATER WORK AREAS SHALL BE ISOLATED BY COFFERDAMS.
3. ISOLATED AREAS REQUIRE FISH SALVAGE ACTIVITIES PRIOR TO THE INITIATION OF CONSTRUCTION.
4. FISH SALVAGE TO BE PERFORMED BY QUALIFIED FISH BIOLOGIST.
5. FILL BULK BAG WITH WASHED GRAVEL.
6. SAND BAGS, ECO-BLOCKS, OR SIMILAR MAY BE SUBSTITUTED FOR WASHED GRAVEL BULK BAG.

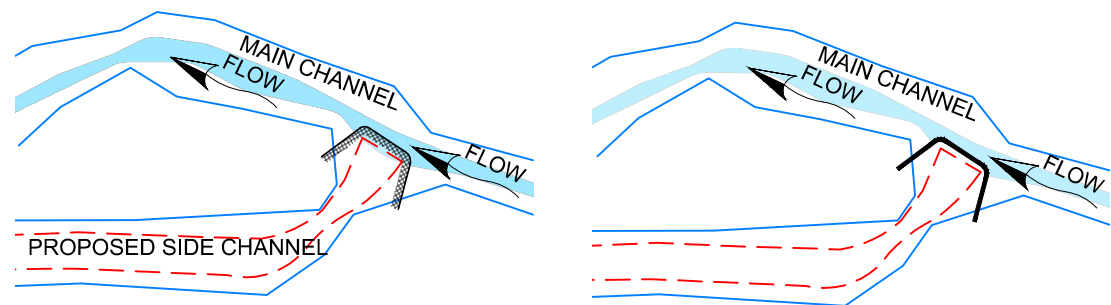
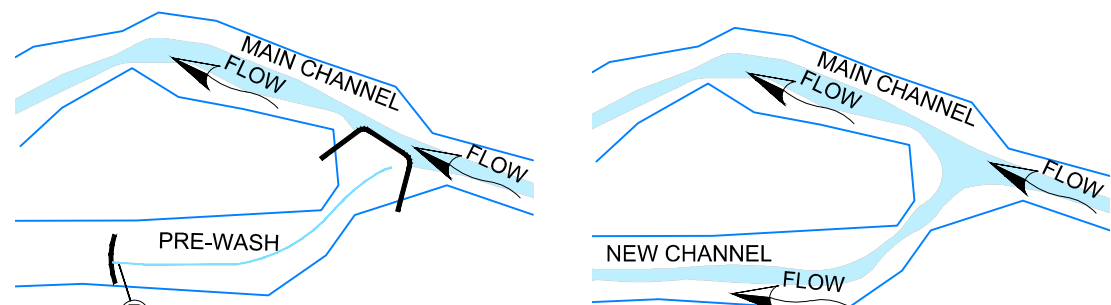
3. REWATERING: PERFORM STAGED REWATERING PROCESS WITH THE RECENTLY EXCAVATED CHANNEL. PREWASH EXCAVATED CHANNEL AND DETAIN AND RELEASE TURBID WATER TO THE FLOODPLAIN RATHER THAN FISH BEARING WATER. PREWASH CONSTRUCTED CHANNEL AND DETAIN AND RELEASE TURBID WATER TO THE FLOODPLAIN RATHER THAN FISH BEARING WATER. INSTALL SEINE AT UPSTREAM END OF CHANNEL TO PREVENT DOWNSTREAM FISH MOVEMENT UNTIL 2/3 OF TOTAL STREAMFLOW IS AVAILABLE IN THE CHANNEL. IN EARLY MORNING, INTRODUCE 1/3 OF FLOW INTO NEW CHANNEL OVER A 1-2 HOUR PERIOD. PERFORM TURBIDITY MONITORING PROTOCOL. INTRODUCE SECOND 1/3 OF THE FLOW OVER THE NEXT 1-2 HOURS. AFTER SECOND 1/3 IS INTRODUCED AND TURBIDITY IS WITHIN 10% OF THE BACKGROUND LEVEL, REMOVE SEINE NETS FROM THE NEW CHANNEL, AND ALLOW DOWNSTREAM FISH MOVEMENT.

4. SITE RESTORATION: STREAM BANKS AND DISTURBED AREA SHALL BE PERMANENTLY STABILIZED AS NECESSARY USING ONSITE NATIVE MATERIAL AND ALL PROJECT WASTE MATERIAL REMOVED.

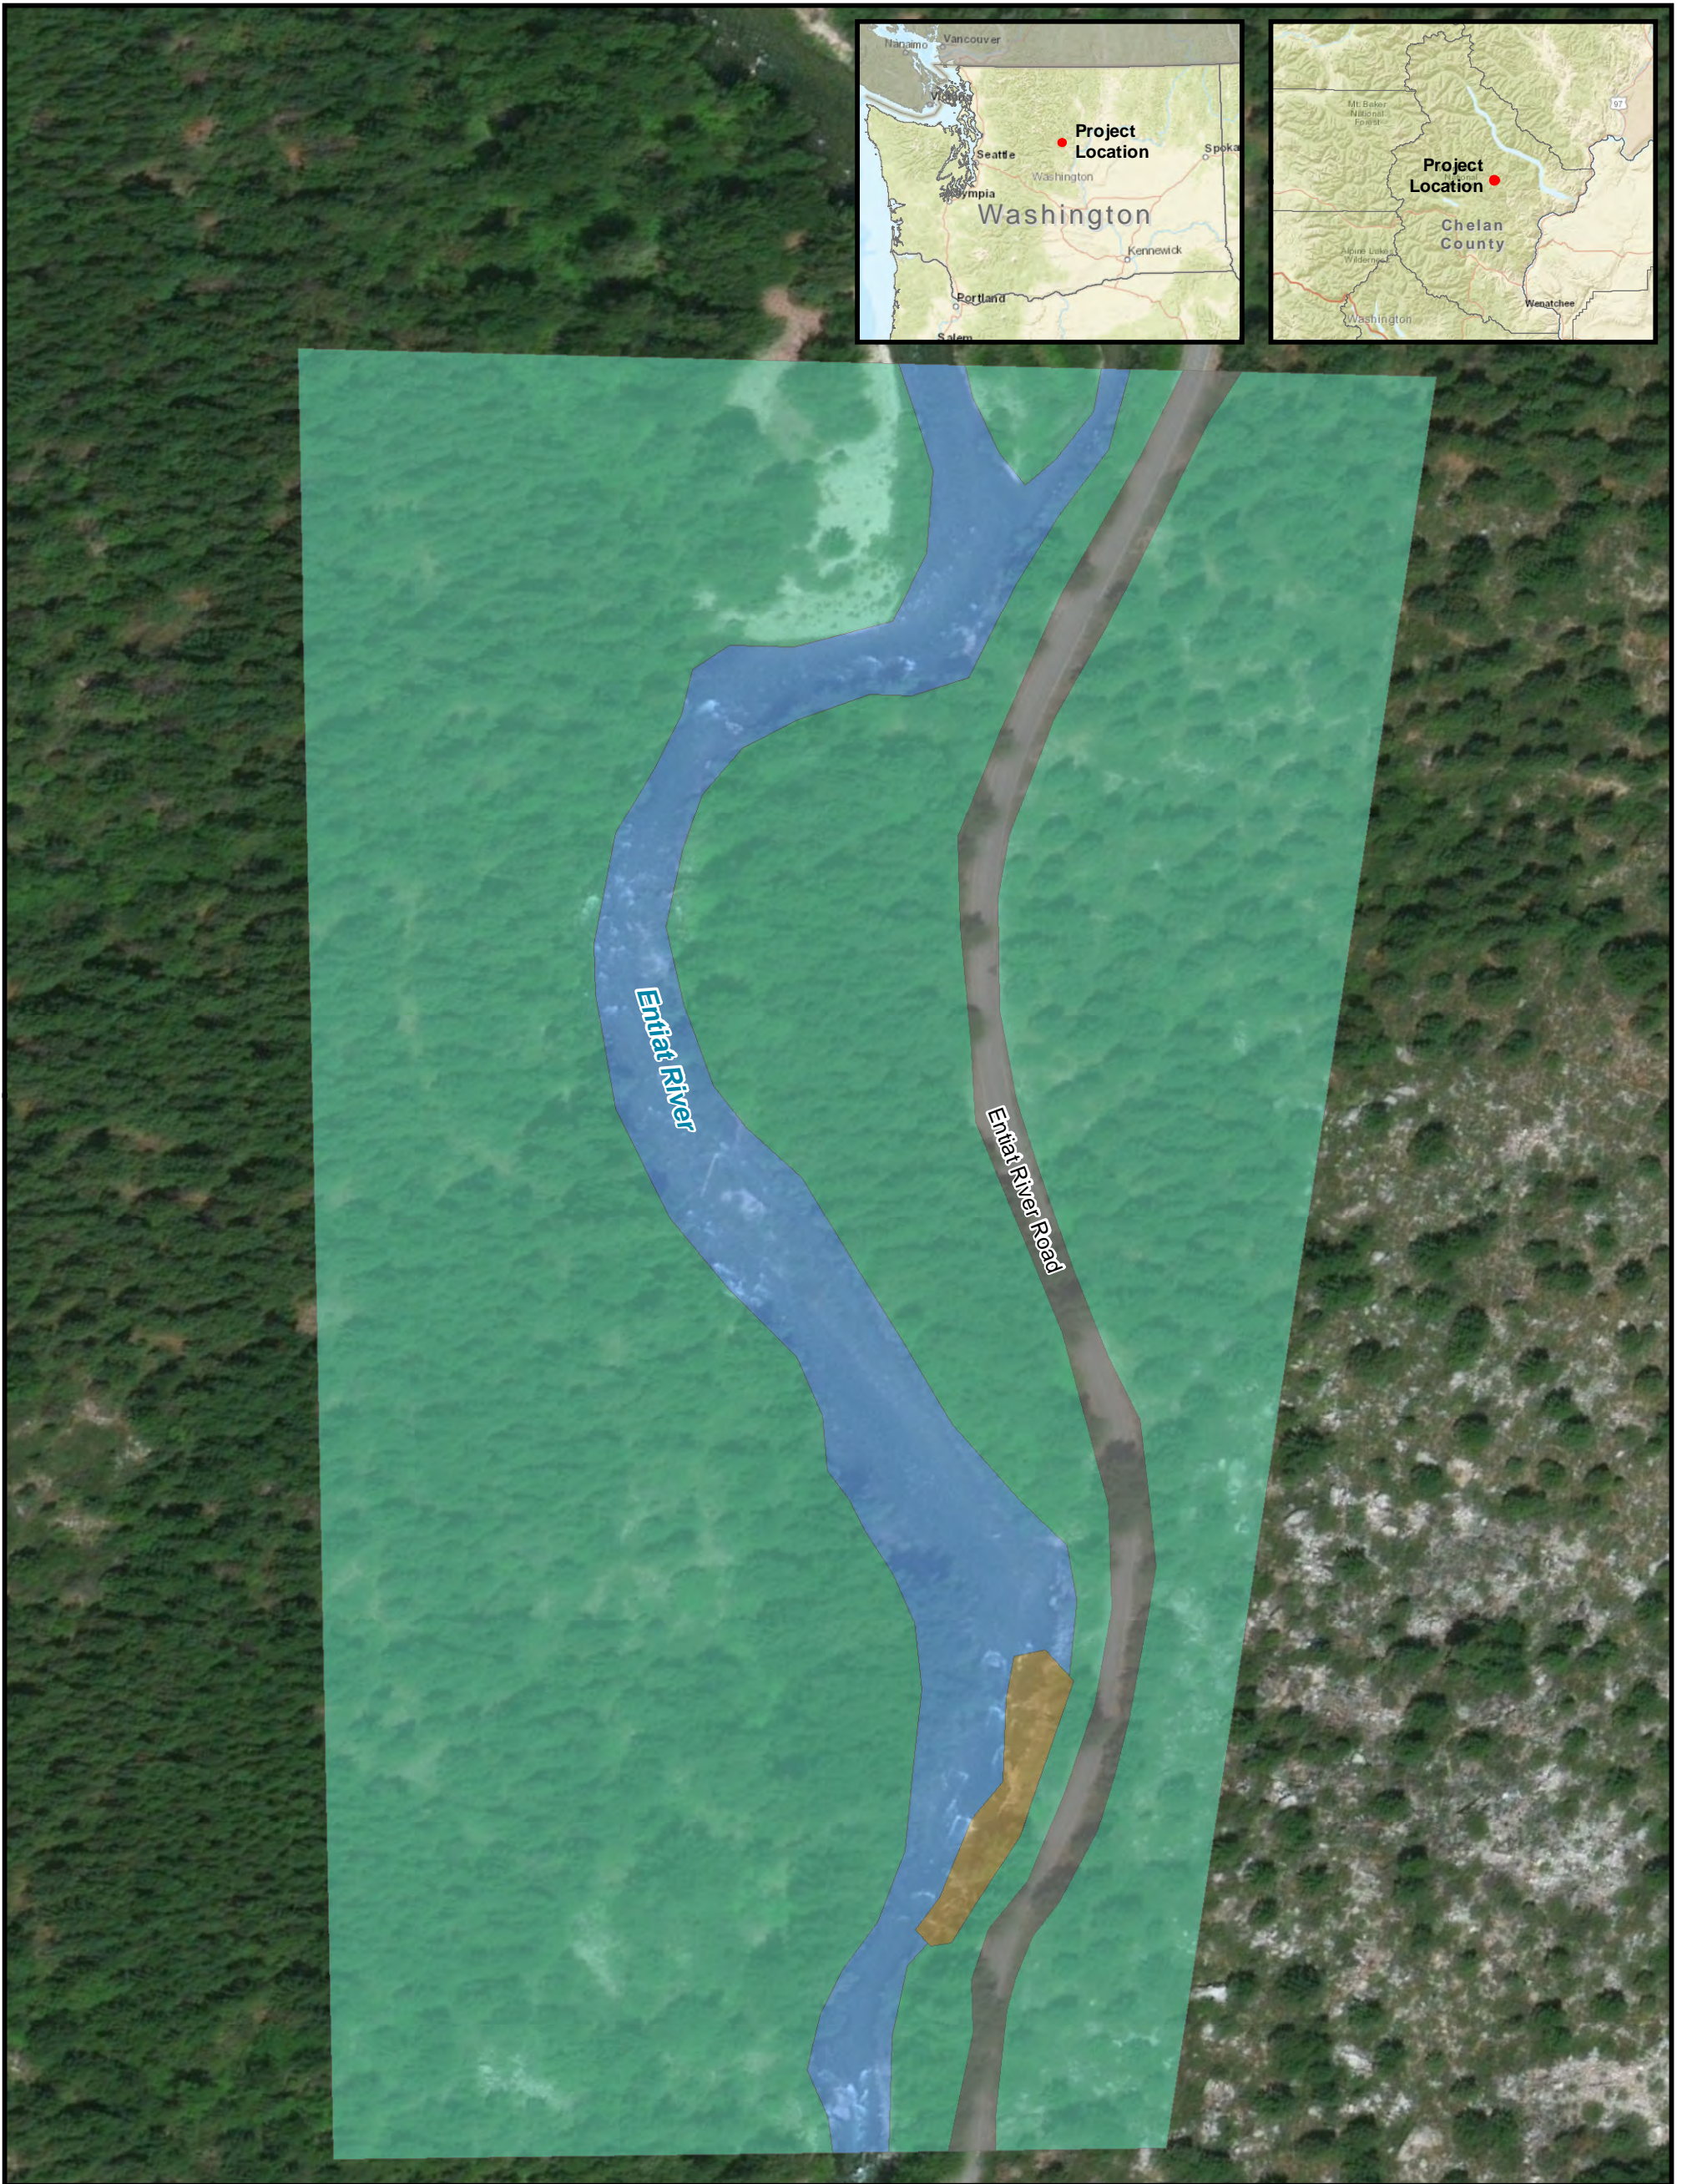
**Figure B-2-1
Land Use**

- Land Use
- Channel
 - Engineered Log Jam
 - Forested
 - Road

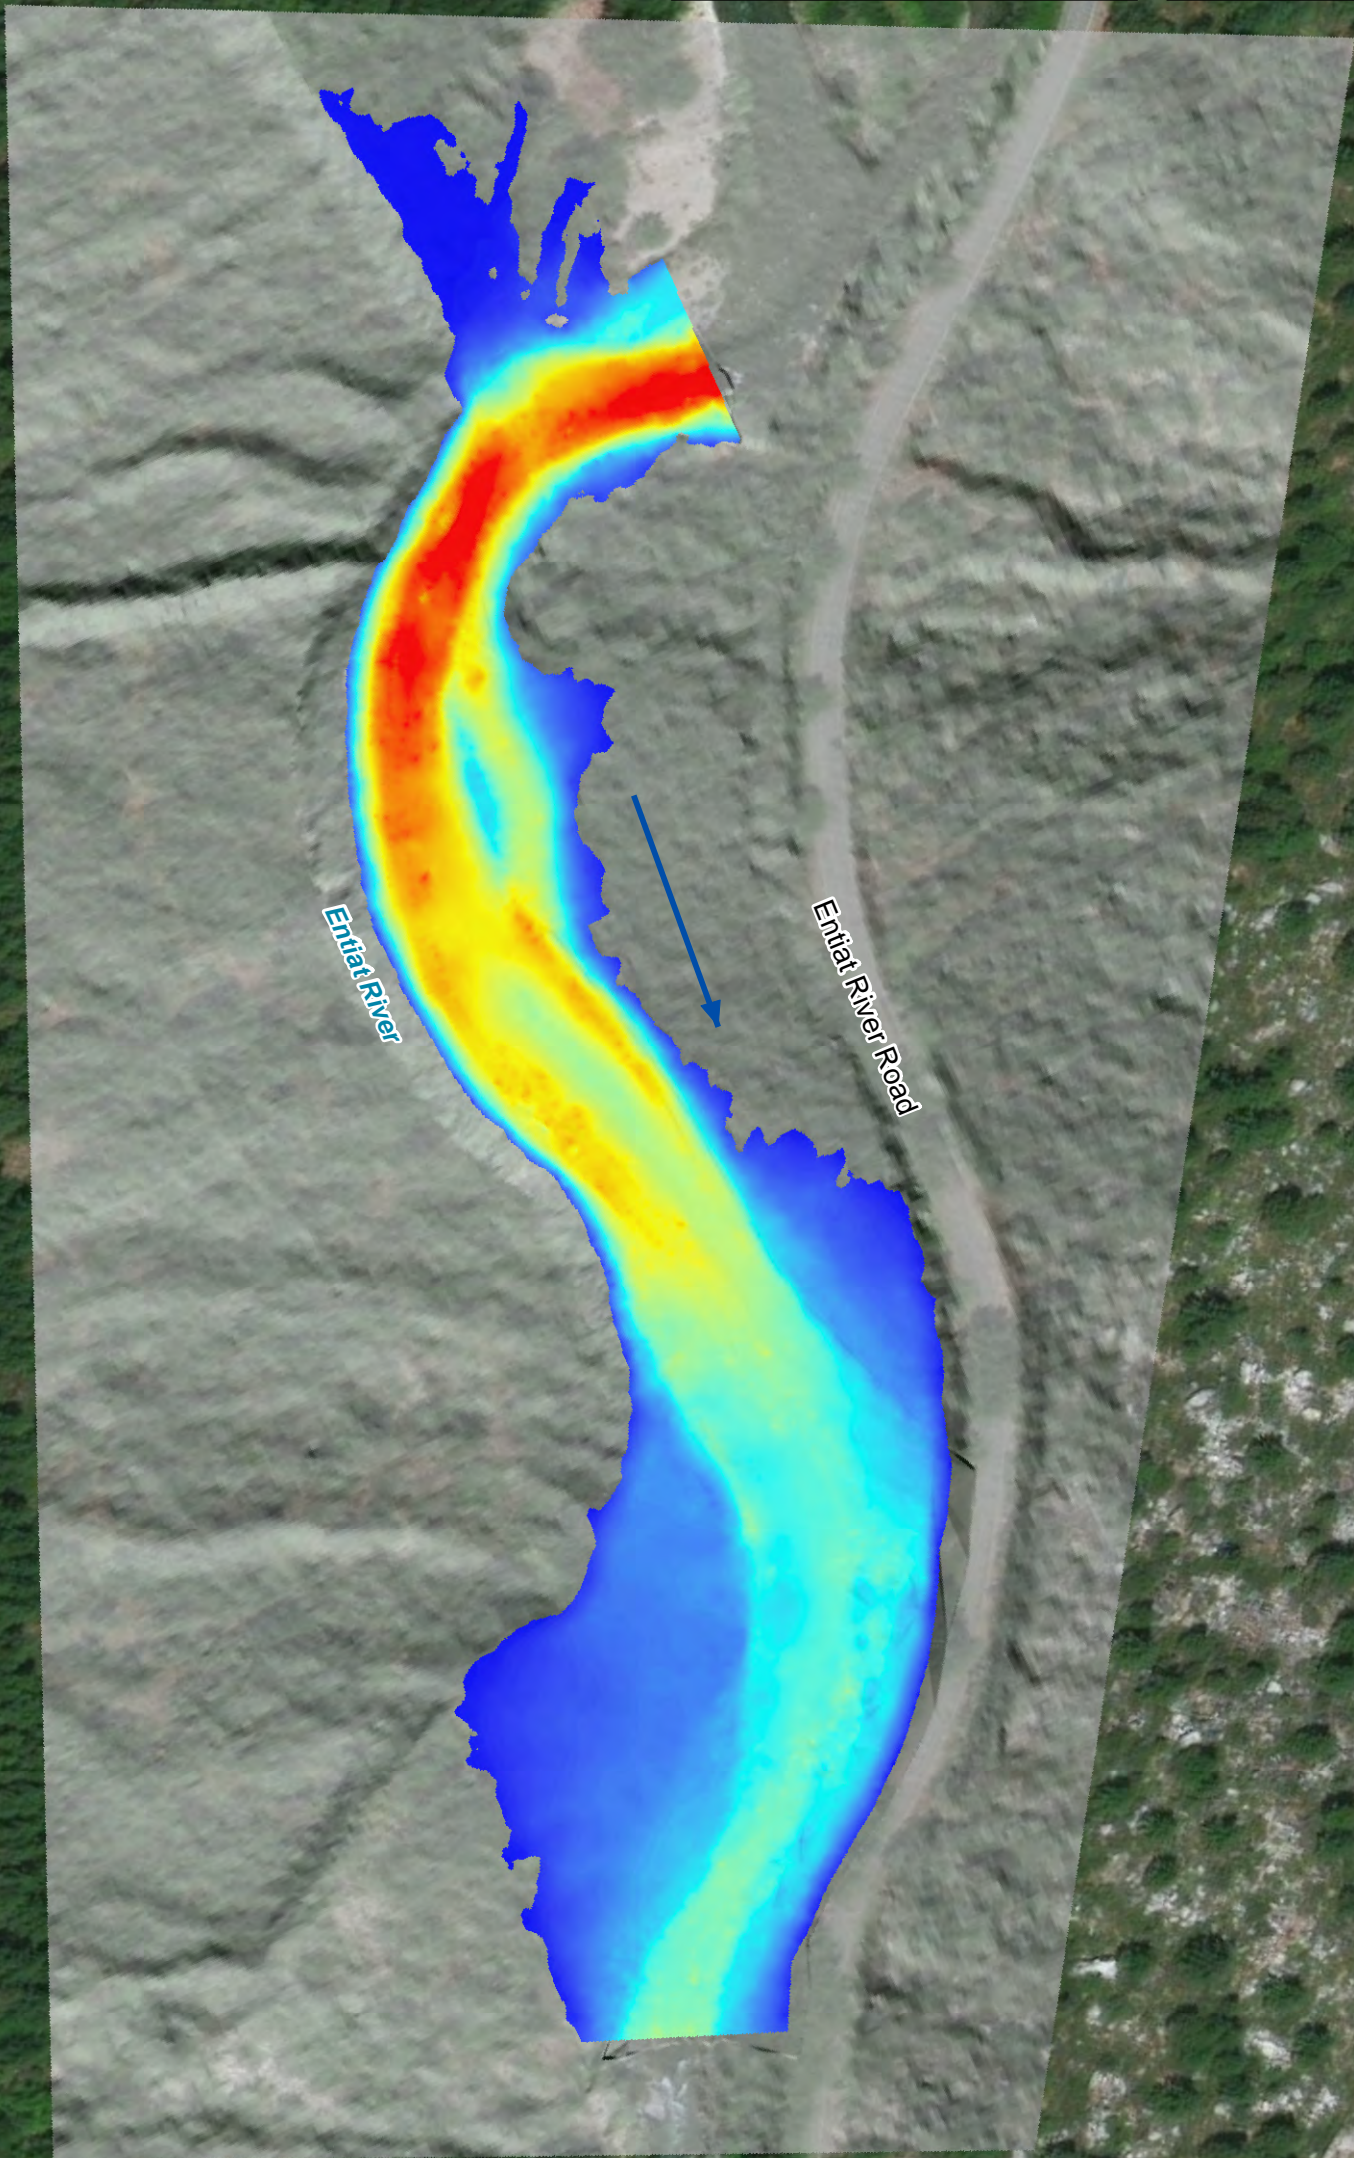
Figure B-2-6
100-year Flow
Existing Conditions
Hydraulic Model Inundation

Entiat River = 4,900 cfs

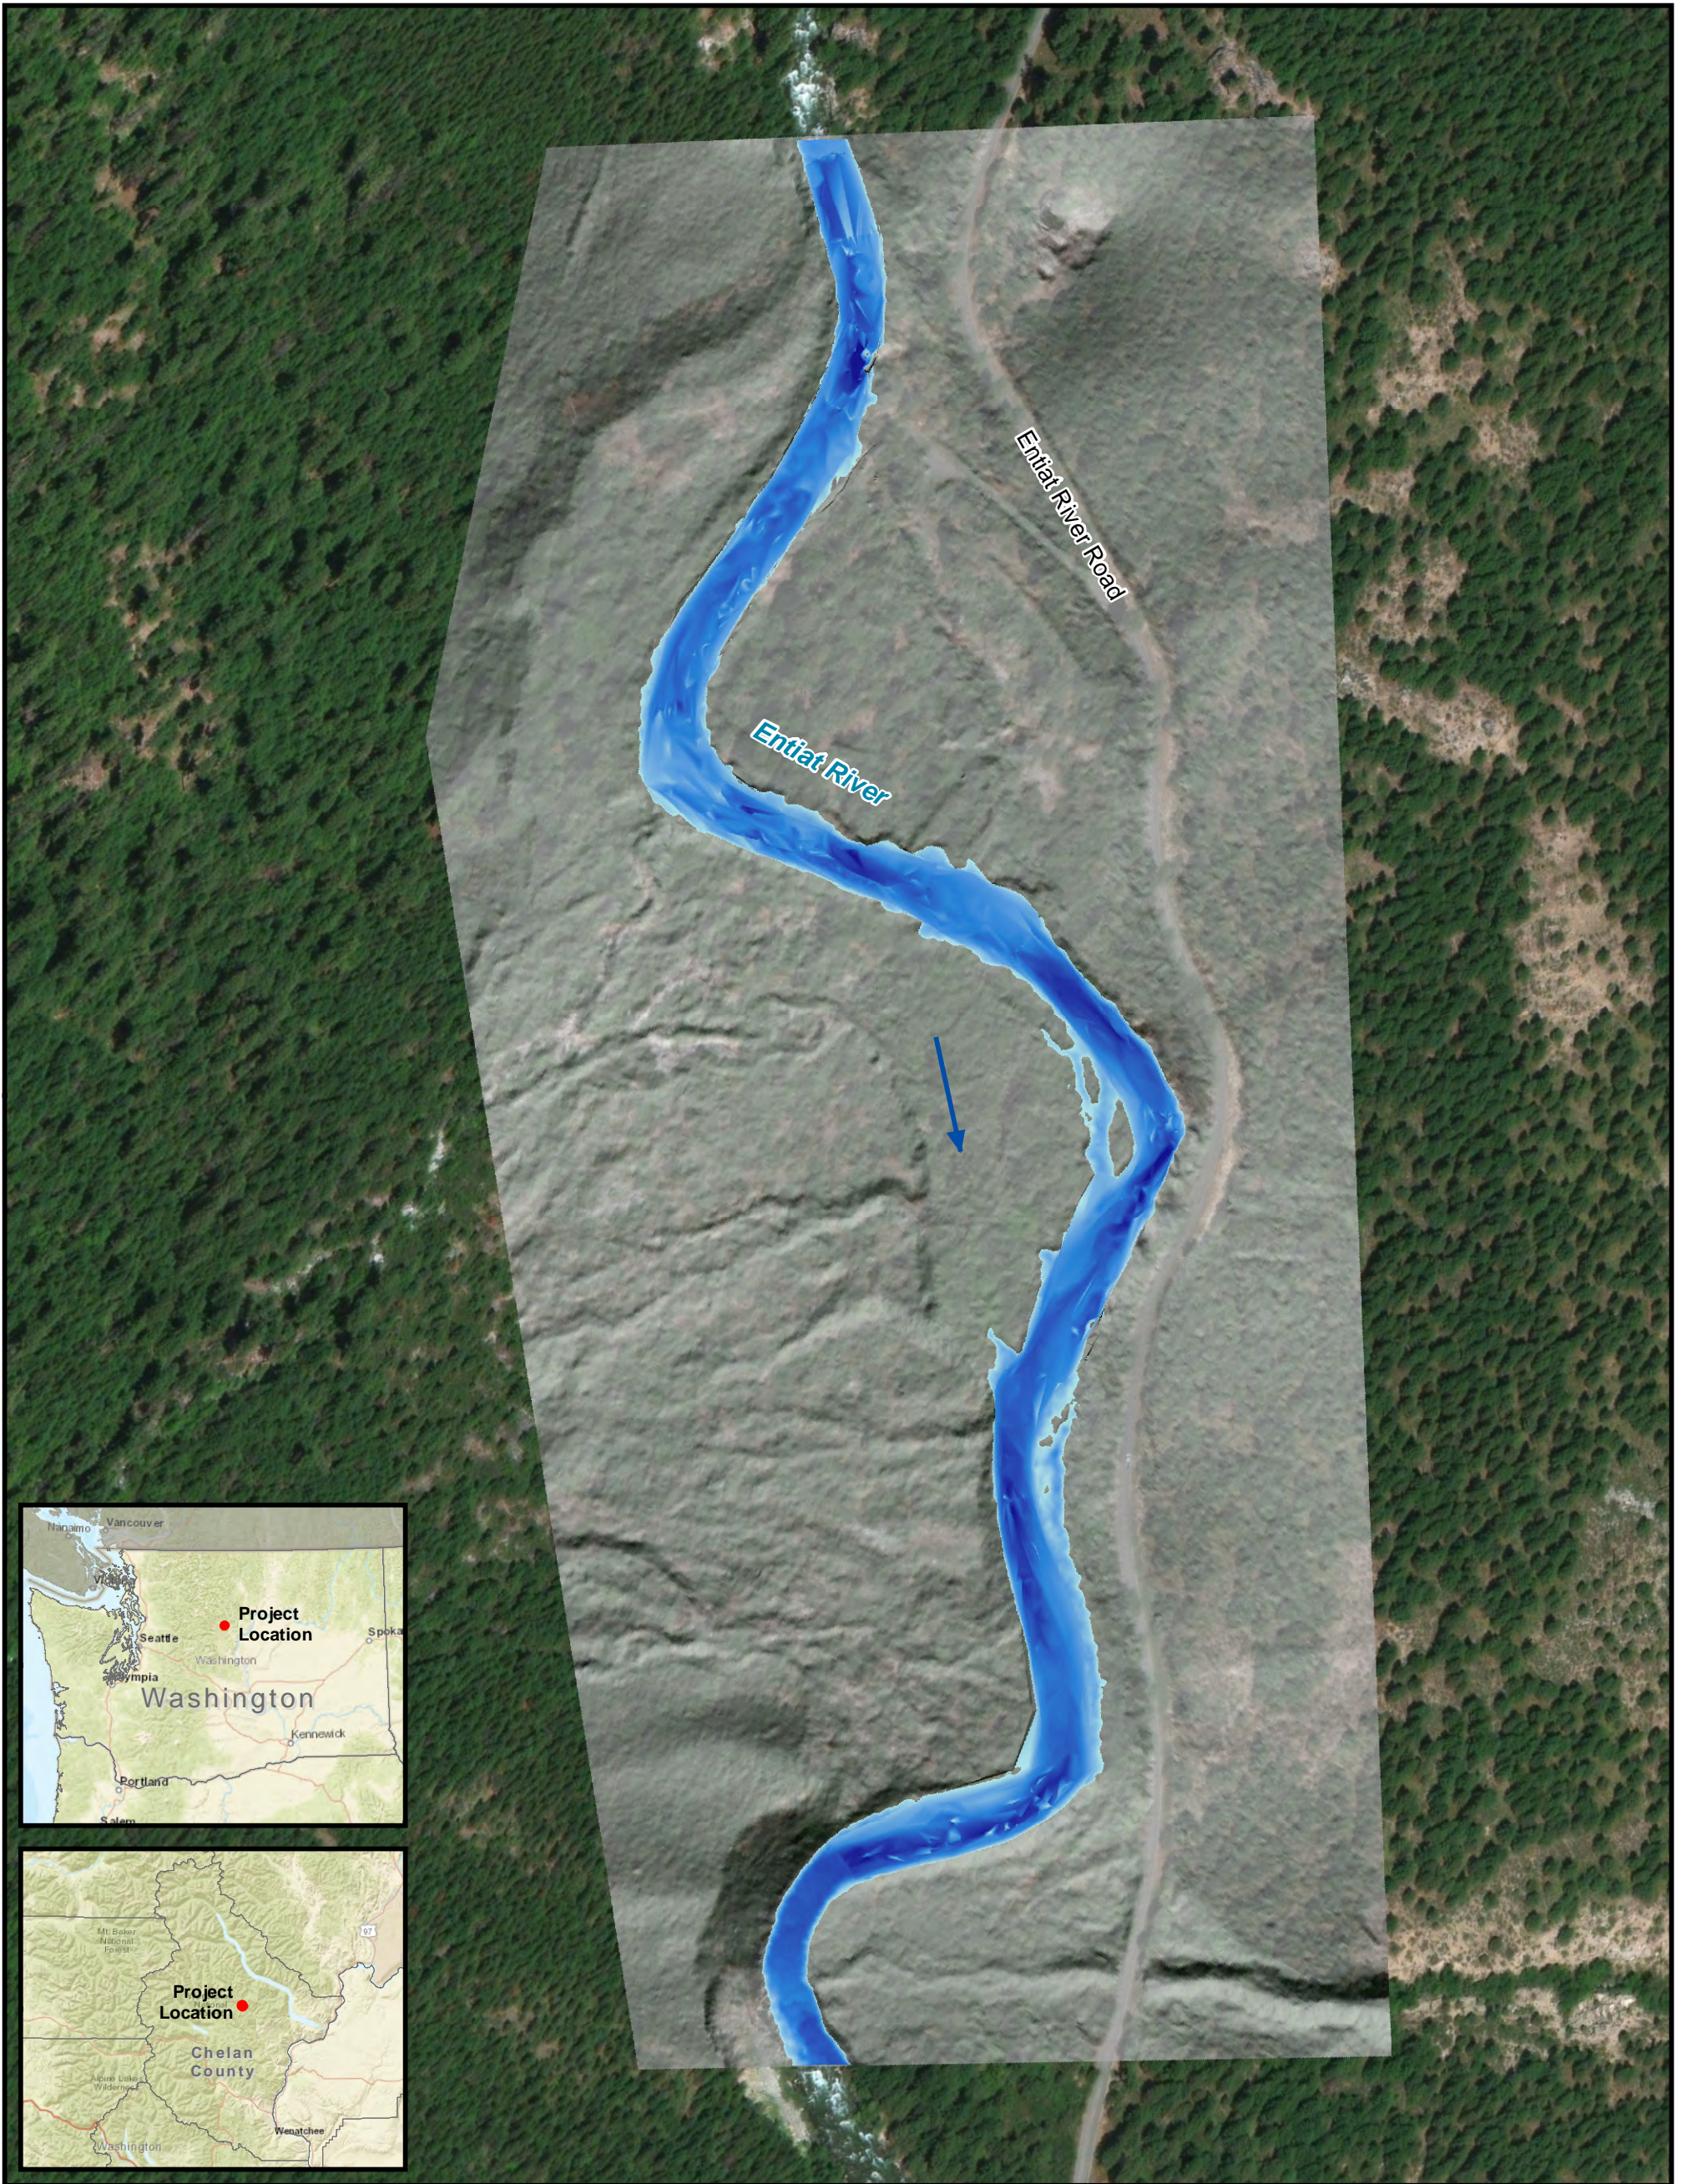
Figure B-3-3
2-year Flow
Existing Conditions
Hydraulic Model Inundation

Entiat River = 2,073 cfs

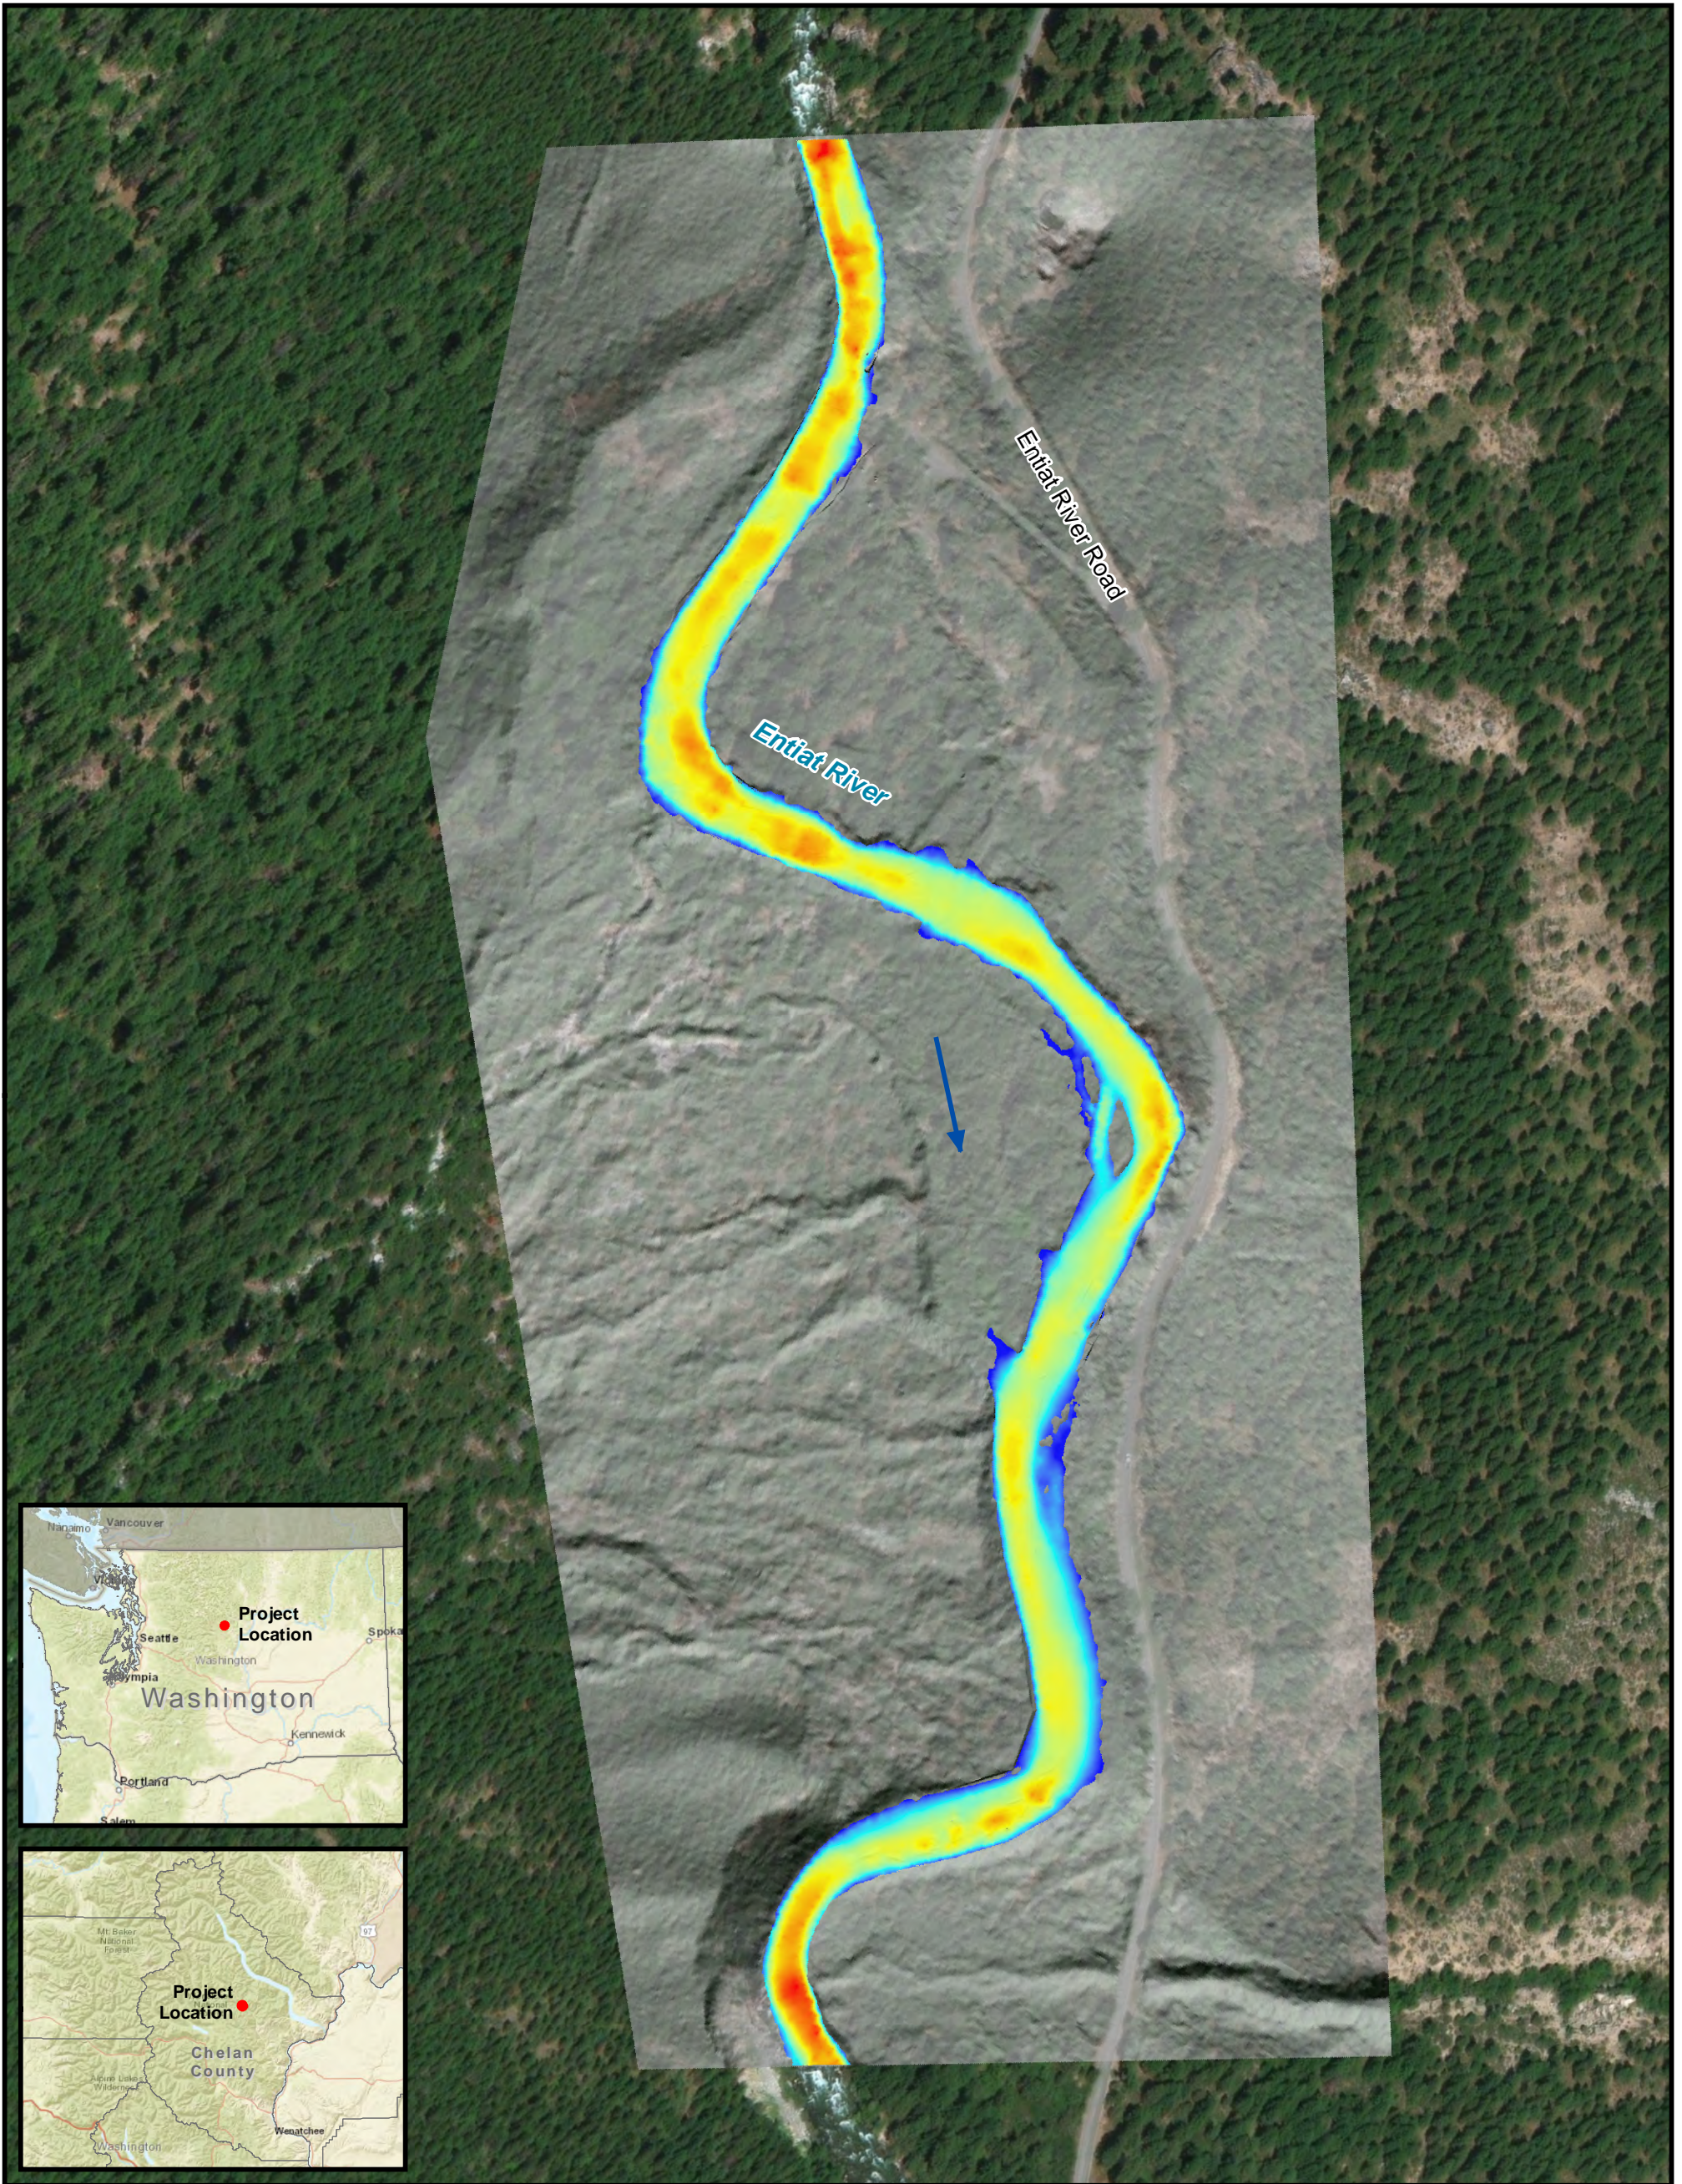
Figure B-3-4
2-year Flow
Existing Conditions
Hydraulic Model Velocity

Entiat River = 2,073 cfs
