ENTIAT RIVER RESTORATION DESIGN:

Upper Stillwaters Reach

CONCEPT LEVEL DESIGN

May 2018

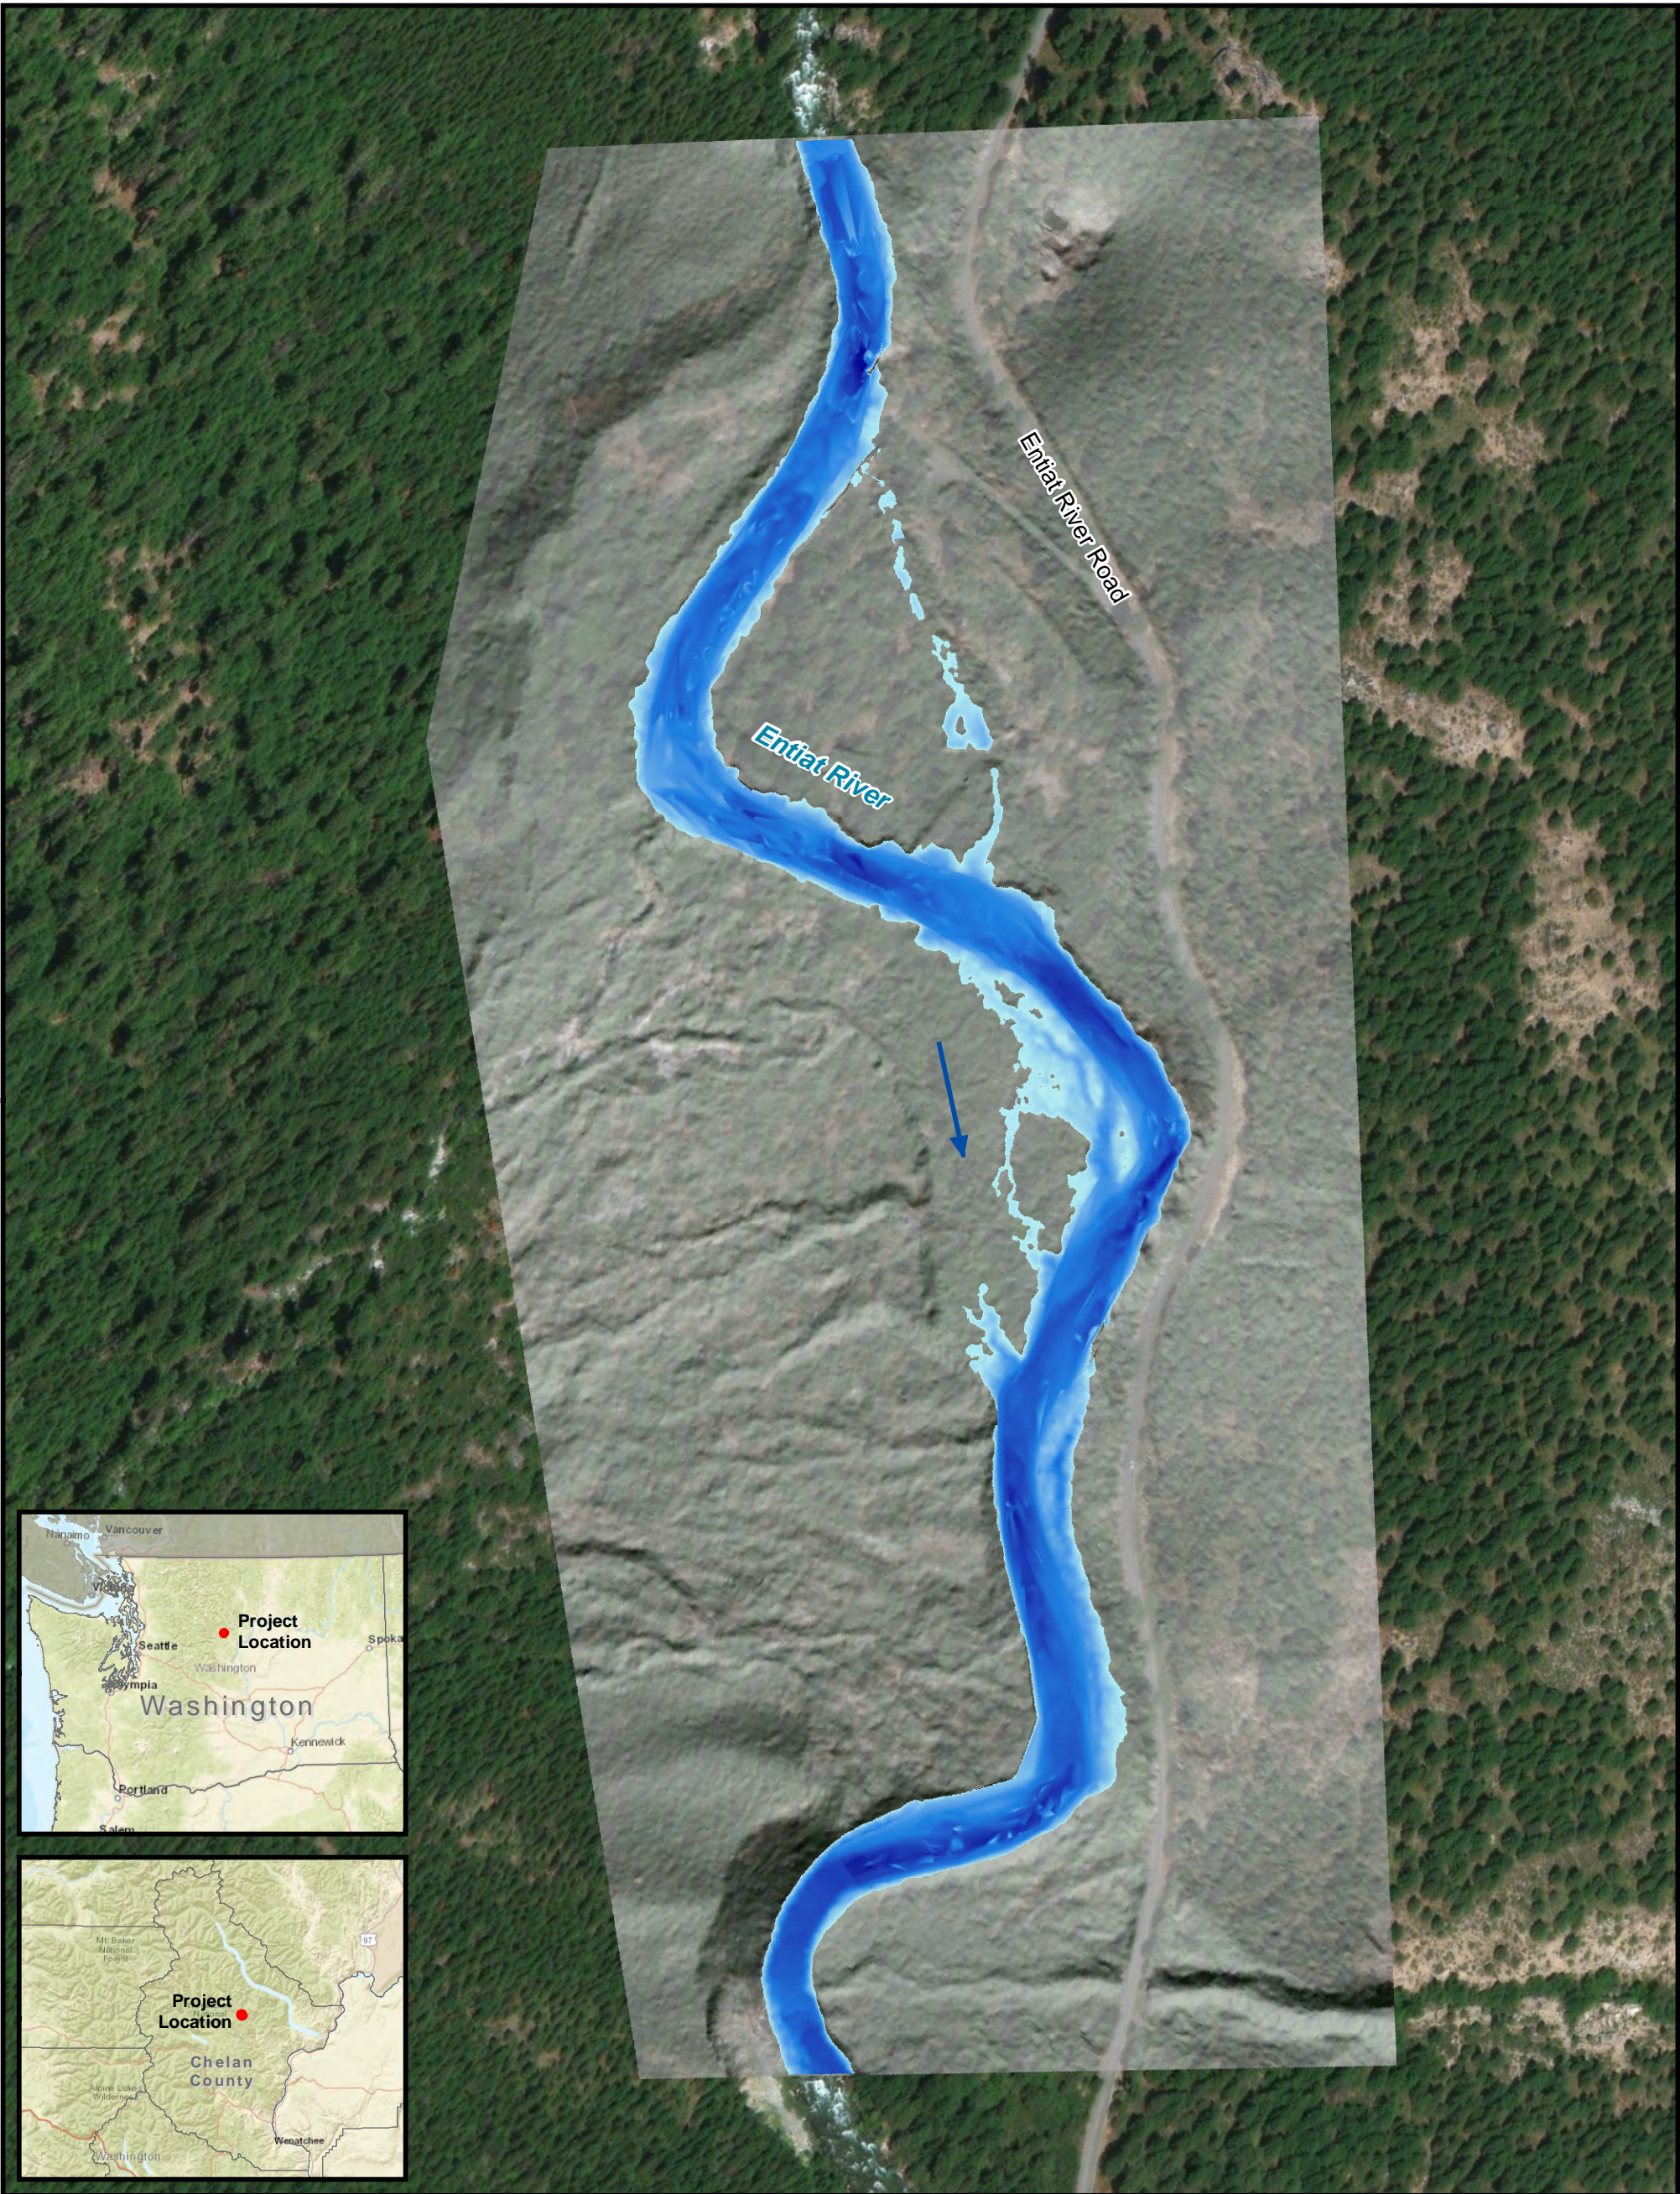
Figure B-3-6
100-year Flow
Existing Conditions
Hydraulic Model Inundation

Entiat River = 4,827 cfs

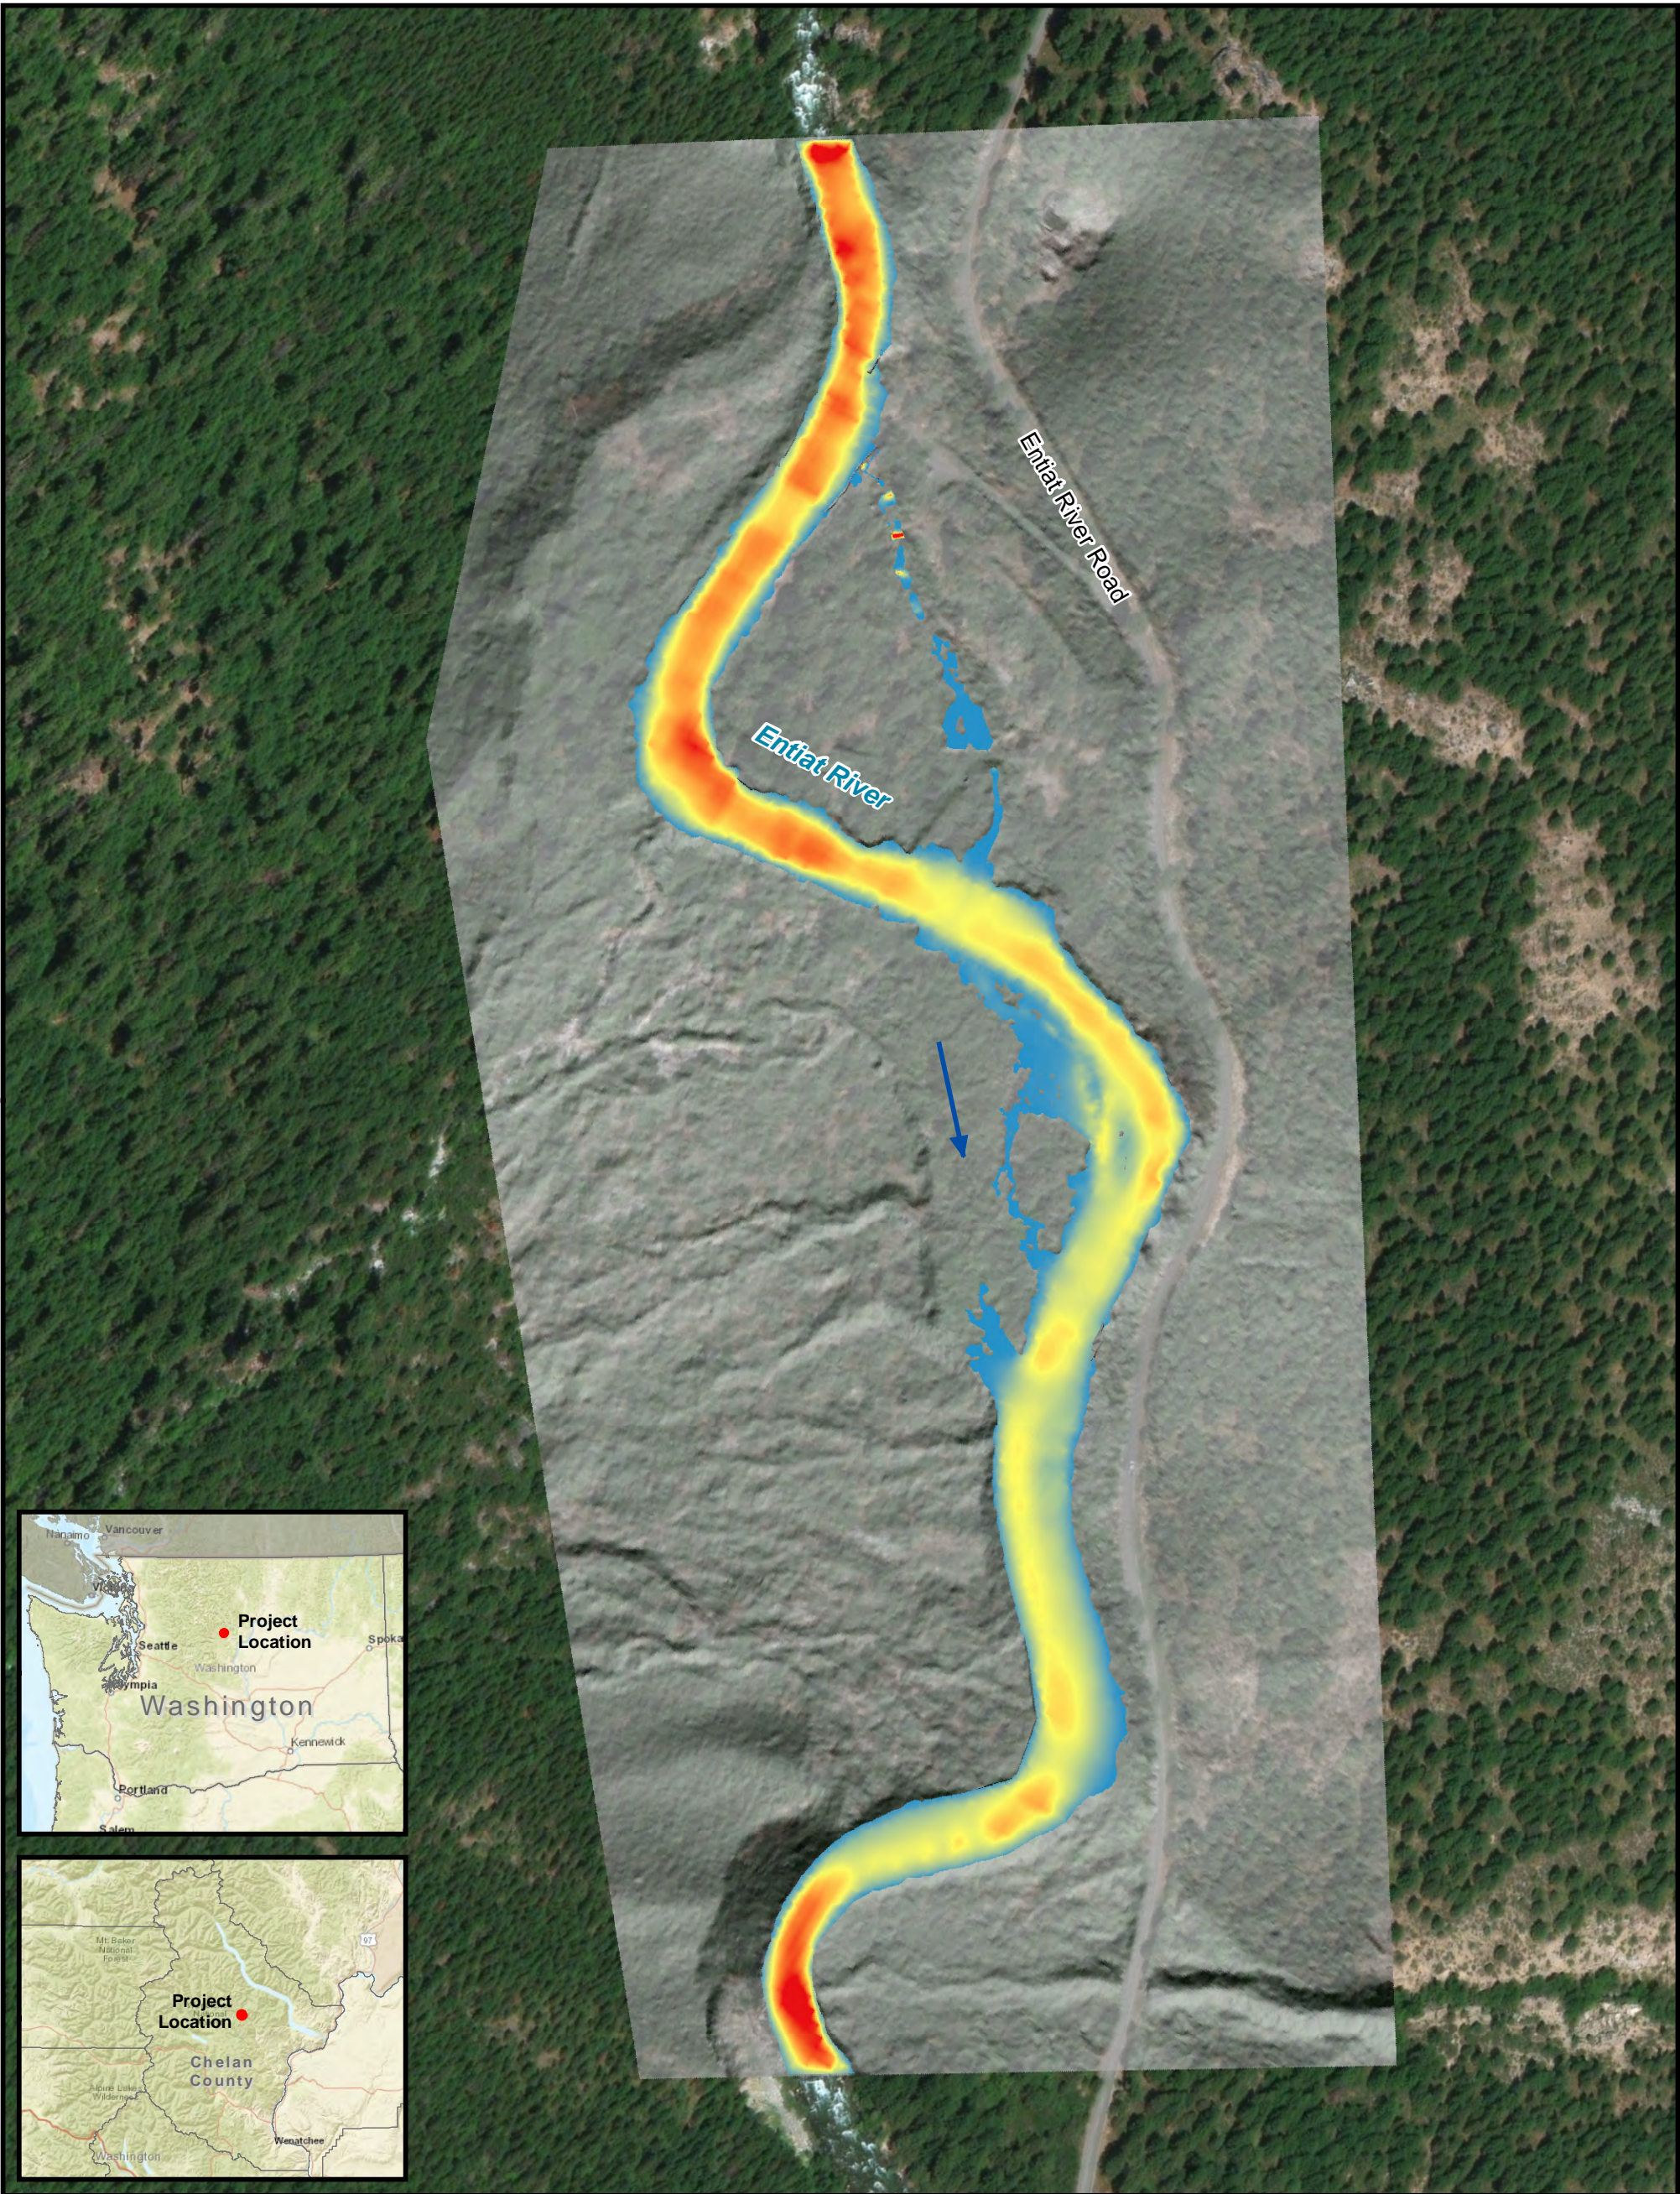
Figure B-3-8
100-year Flow
Existing Conditions
Hydraulic Model Shear Stress

Entiat River = 4,827 cfs
