Lower Wenatchee River REACH ASSESSMENT

December 2017

TETRA TECH

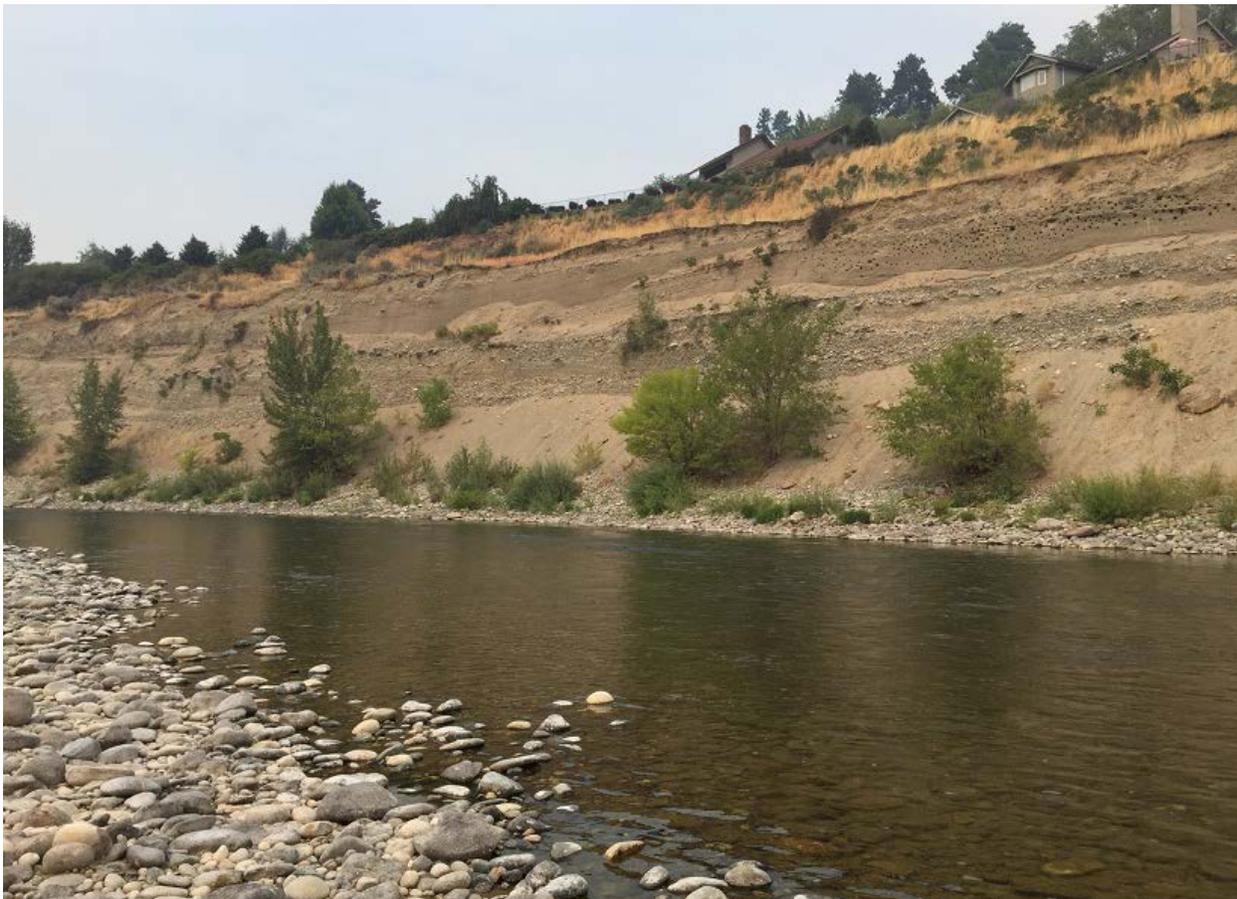
Figure 2-2. Photograph of Exposed Glacial Terrace in Reach 2 near RM 1.7

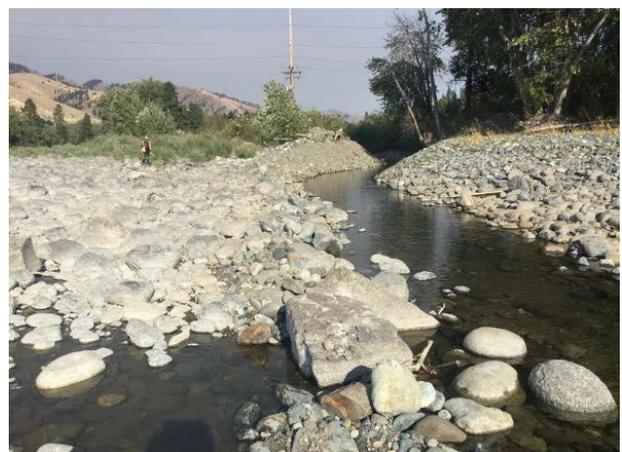
Figure 2-12. Example of an Irrigation Diversion near RM 13.7

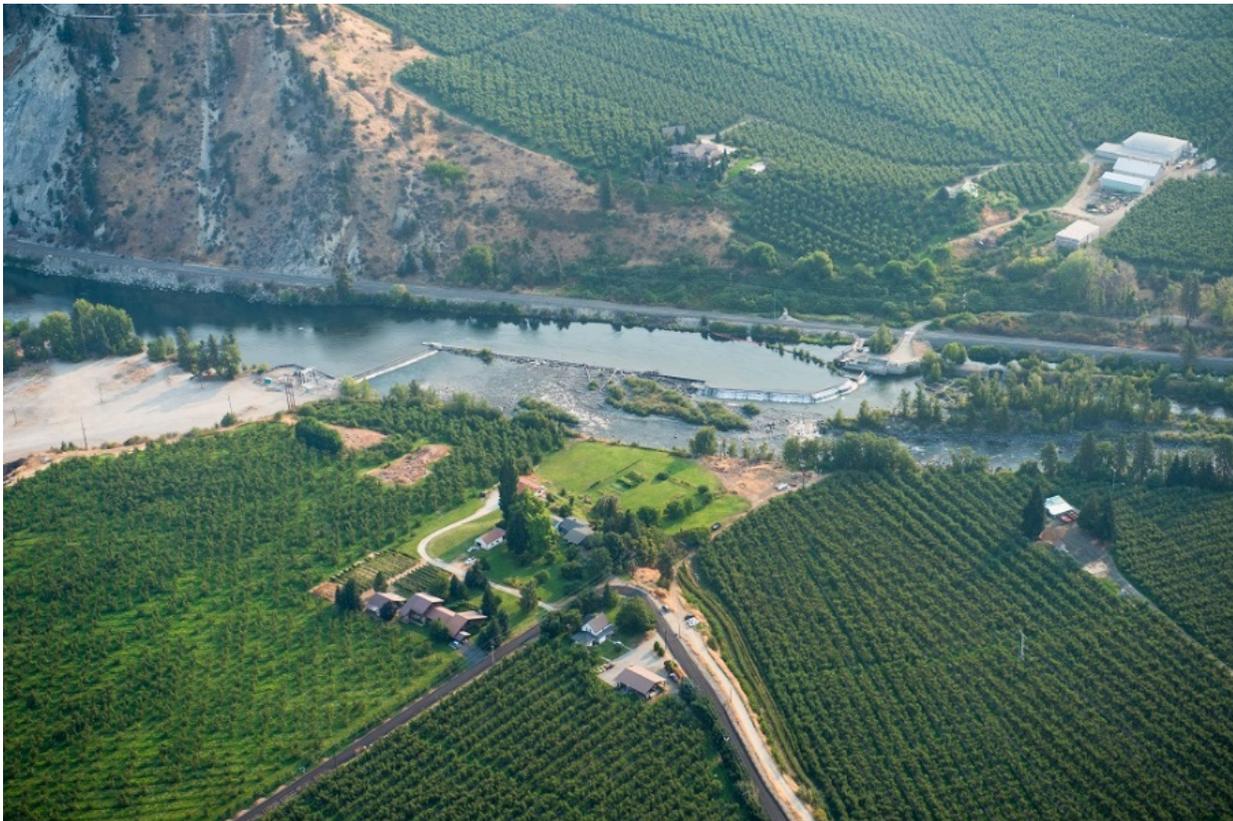
Figure 2-13. Oblique Aerial Photograph of the Dryden Diversion Dam (source: Shane Wilder of Icicle TV, flight provided by Lighthawk and the UCSRB)

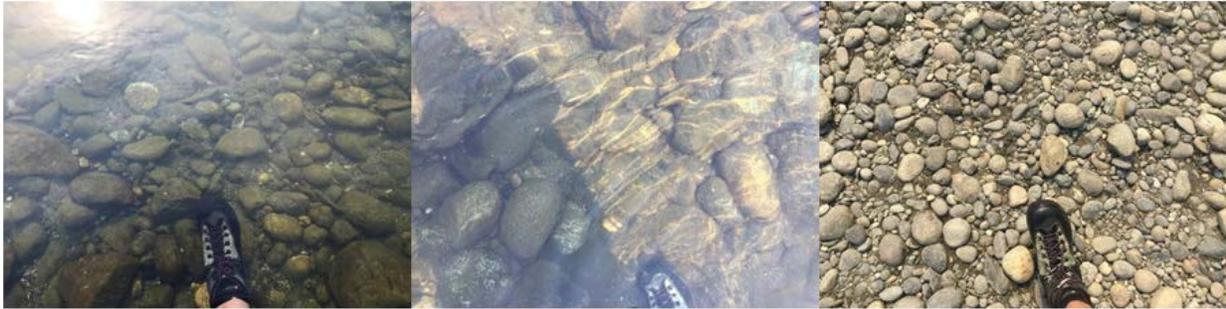
Figure 4-10. Photos of Typical Channel Substrate Conditions at 3 Locations Including RM 2.0 in Reach 2 (left), RM 19.1 in Reach 7 (middle), and RM 24.6 in Reach 9

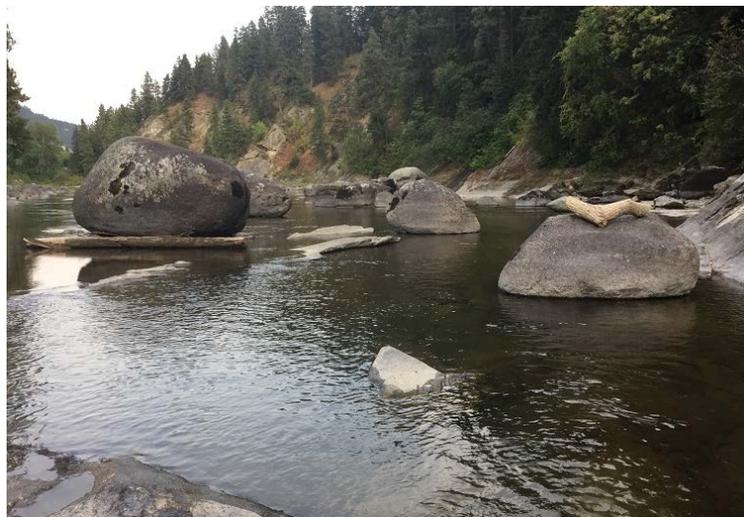
Figure 4-11. Boulders and Bedrock near RM 22.7 in Reach 8

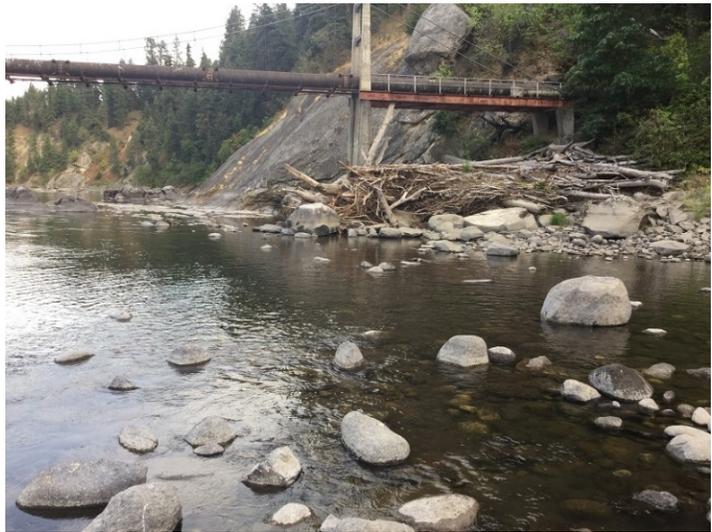
Figure 4-13. Photograph of Rare Log Jam Racked on a Crossing Abutment in Reach 8, near RM 22.8

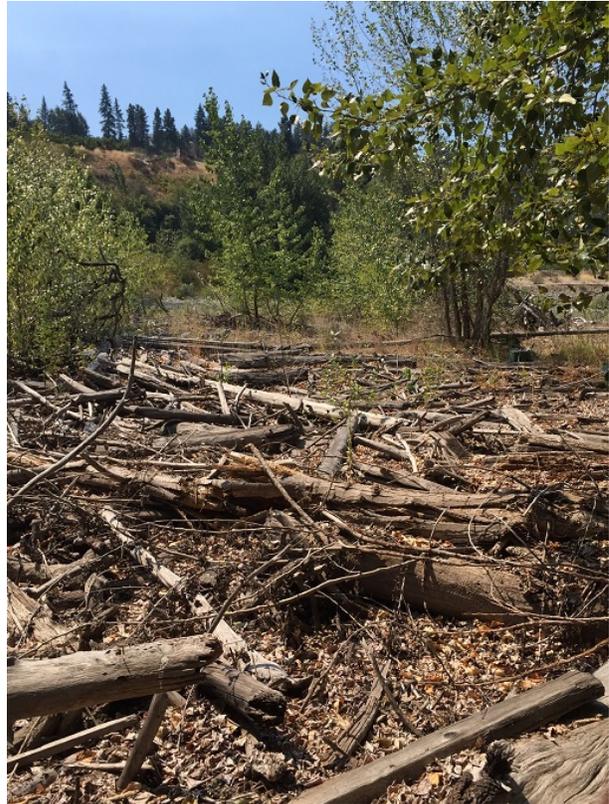
Figure 4-14. Photograph of Floodplain Jam at a Side Channel Inlet in Reach 5 at RM 12.0

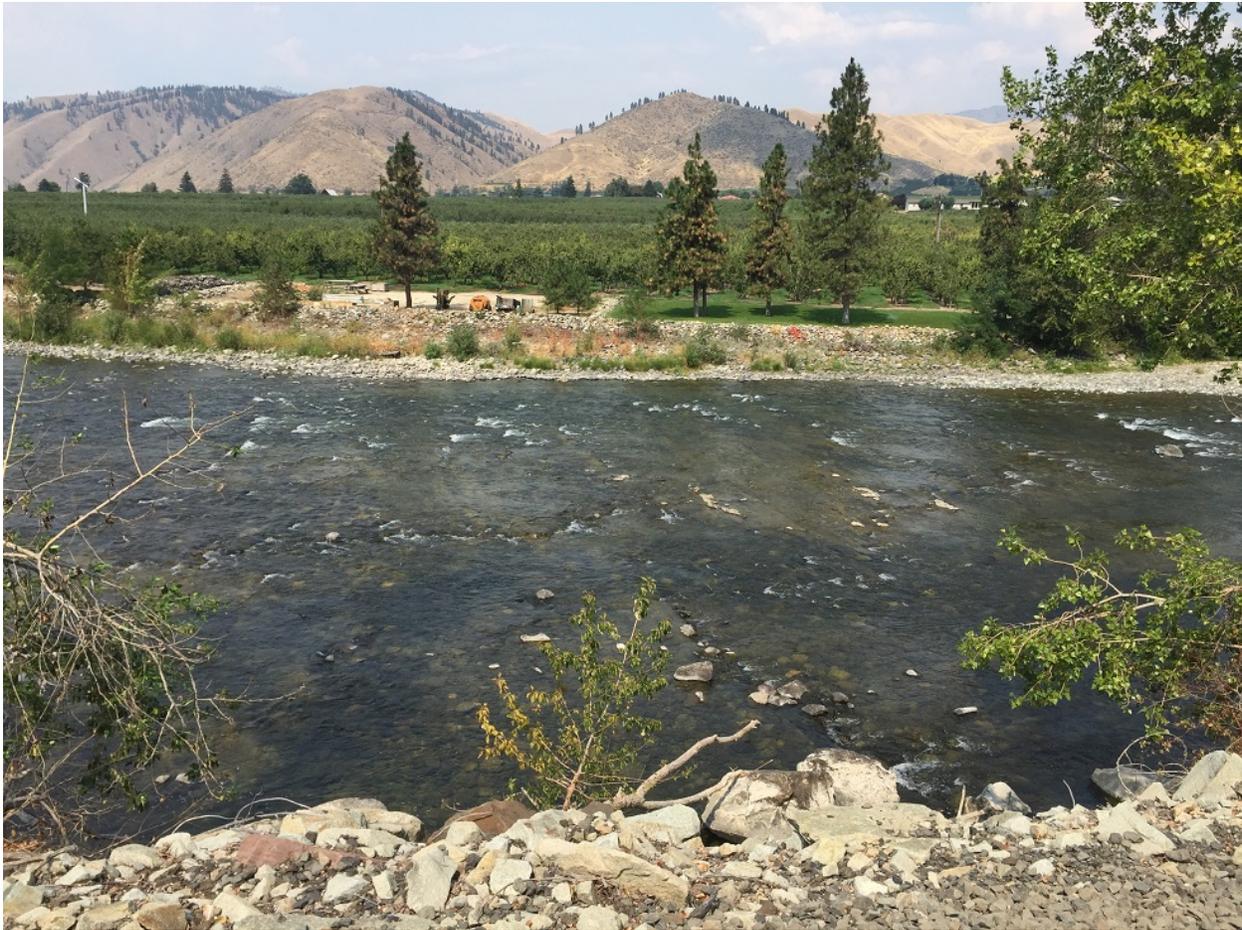
Figure 4-17. Example of an Existing Orchard in the Riparian Area near RM 7.7 in Reach 4
