## Stream Habitat Assessment

### Upper Methow River Reach Assessment

Habitat Inventory: Weeman Bridge (RM 61) to Trout Creek (RM 80)

*Survey: July 16 – August 14, 2014*

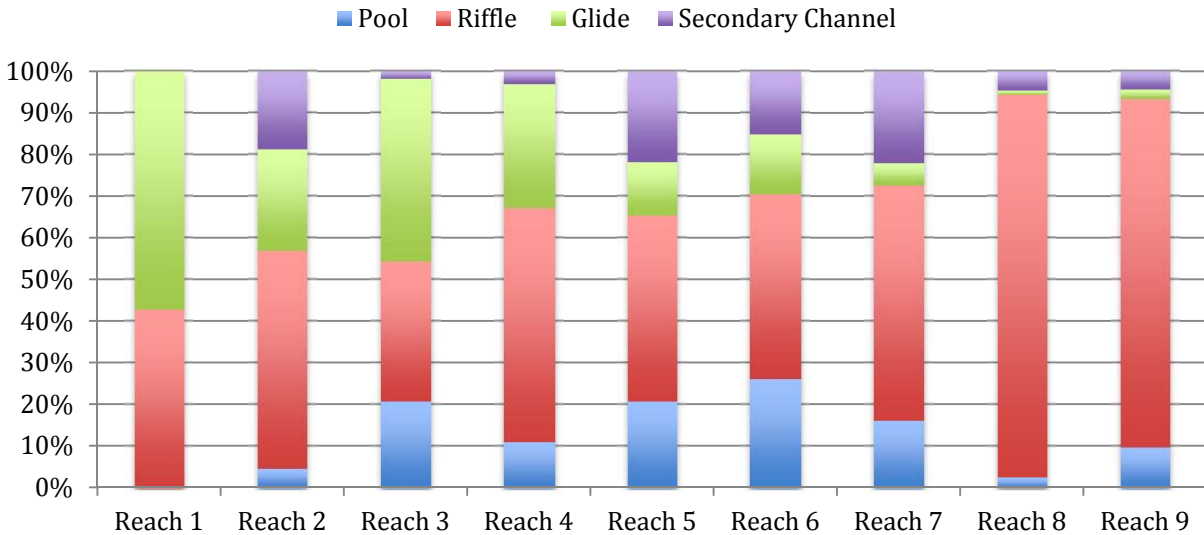
Figure 2. Habitat unit composition by reach.

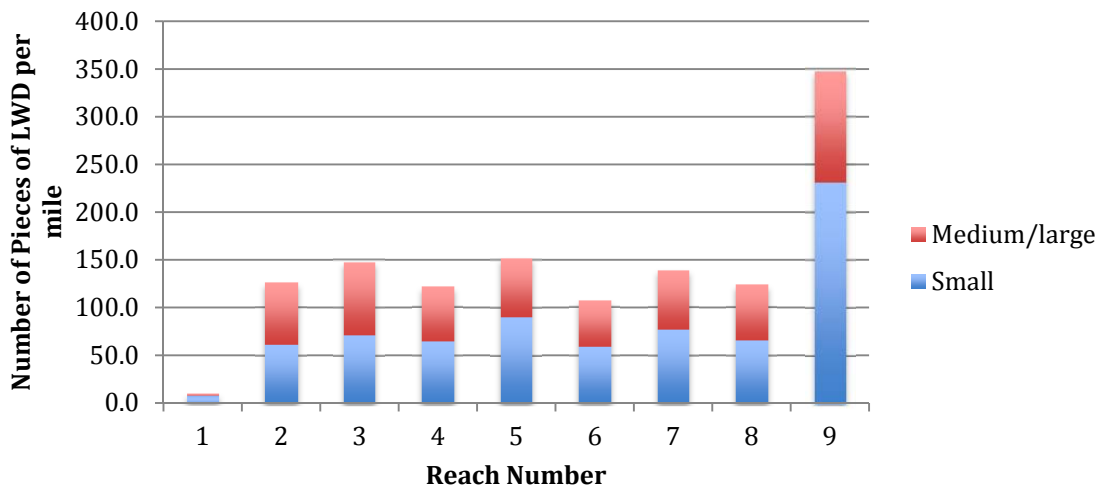
An average of 125 pieces of large wood per mile was counted in the project area; 56% were “small” pieces with diameters between 6 and 12 inches and lengths greater than 20 feet. Even though Reach 9 is a short reach at 1.3 miles, it maintains the highest wood count with a total of 467 pieces. This is more than double the wood per mile counts of the other reaches (Figure 6). The high wood count was largely due to several log jams at River Mile (RM) 79.75 that were caused by an avalanche in May 2014 that pushed hundreds of trees off the mountainside and into the Methow River. Reaches 2 – 8 maintain relatively similar large wood (LWD) densities, ranging from 107 – 152 pieces per mile.

Figure 6. Small and medium/large wood pieces per river mile for reaches 1-9.

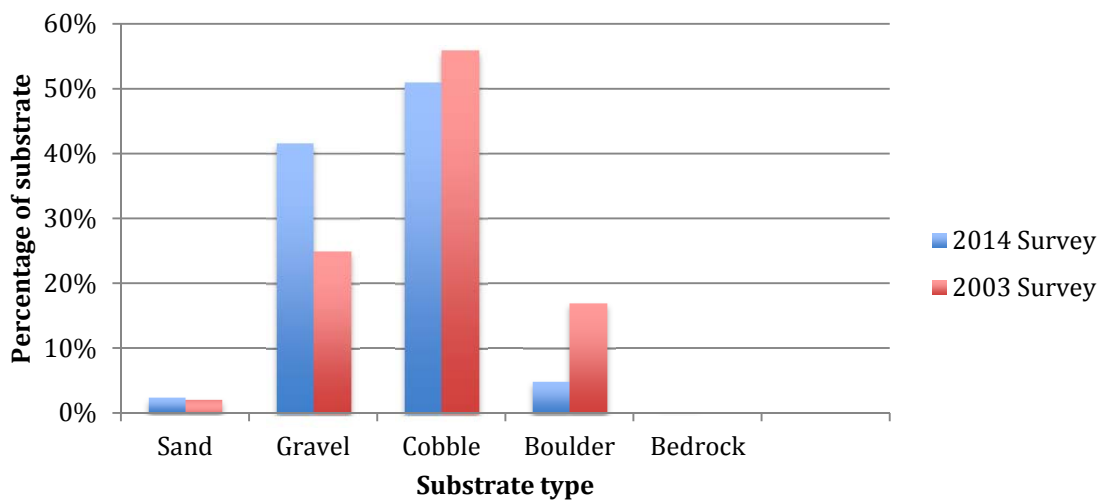
A comparison (Figure 14) of results from Wolman pebble counts of this reach between the two surveys indicates relatively equal numbers, and low amounts of fines in both surveys; there is more gravel and slightly less cobble in 2014. For the purposes of this assessment, the key finding from this comparison is that fines (<2mm) have remained relatively low (2% in both 2003 and 2014) – well below the “adequate guidelines” of ≤12% sand/fines (USBR 2012).

Figure 14. Gravel count comparison for Reach 7, 2003 and 2014 surveys.

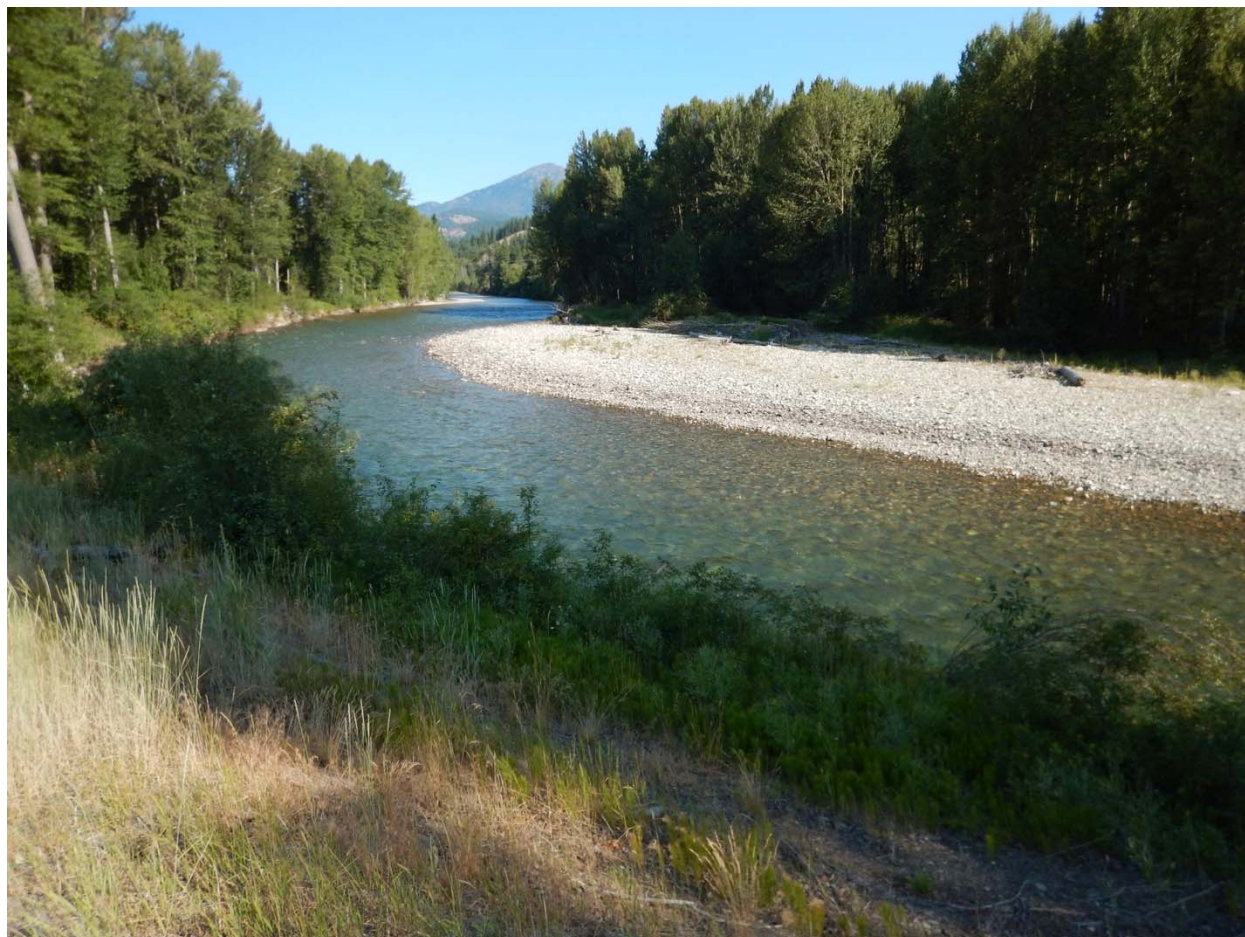
***Figure 17. Representative view of Reach 1. Only three channel units were recorded in Reach 1; all were fast water. Observations at the one  $n^{\text{th}}$  unit in Reach 1 identified both the overstory and understory as dominated by cottonwood, also visible in this photo.***

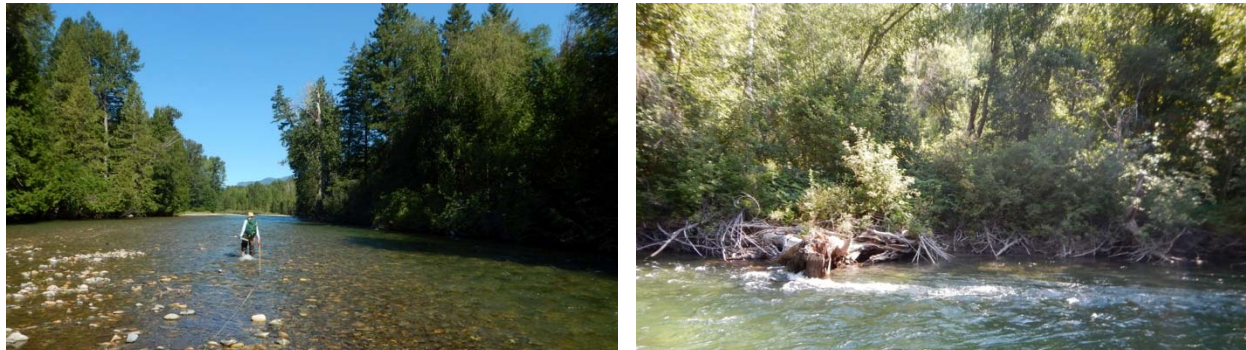
**Figure 21.** Substrate in Reach 1 is largely composed of gravel and cobble (left). Overall, Reach 1 is relatively deep and fast moving (right).

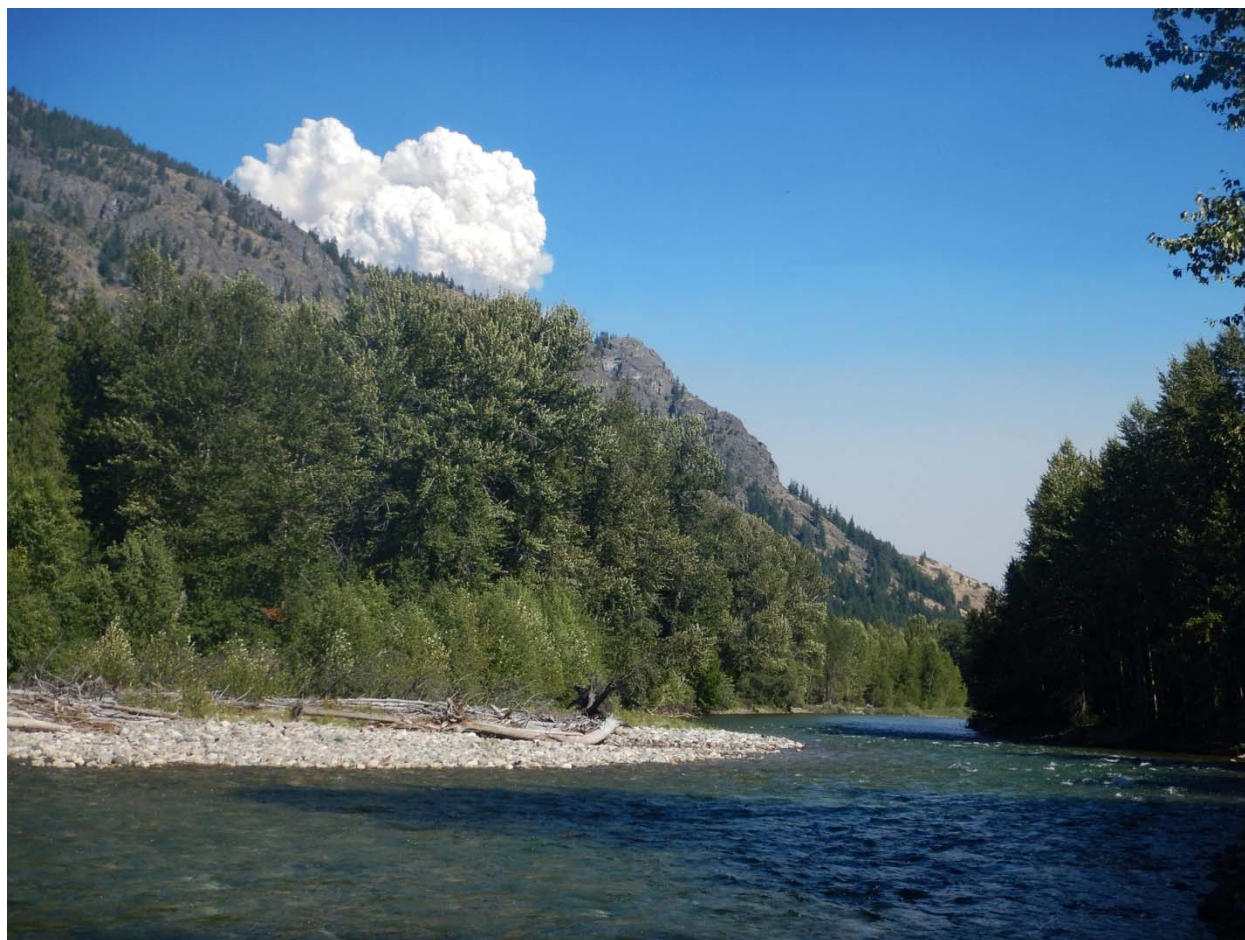
**Figure 24. Representative view of Reach 2. In the background smokes rises from the Carlton Complex Fire – creating a pyrocumulus cloud.**

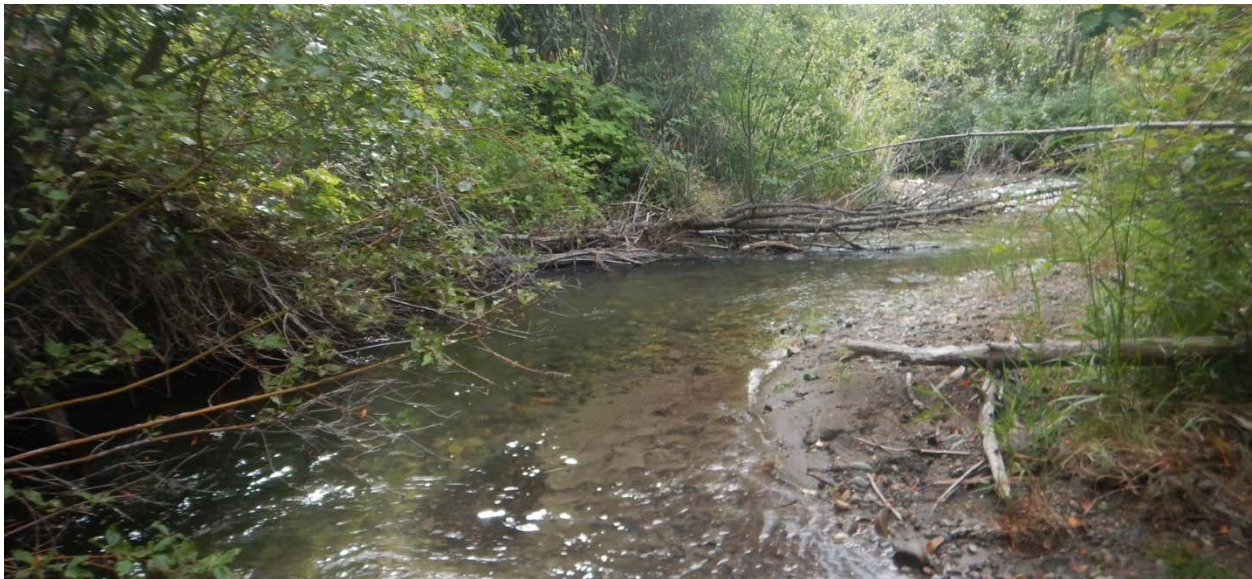
**Table 9. Three off-channels entered the Methow River between River Mile 64.3 - 64.5. Photo below is Side 9F.**

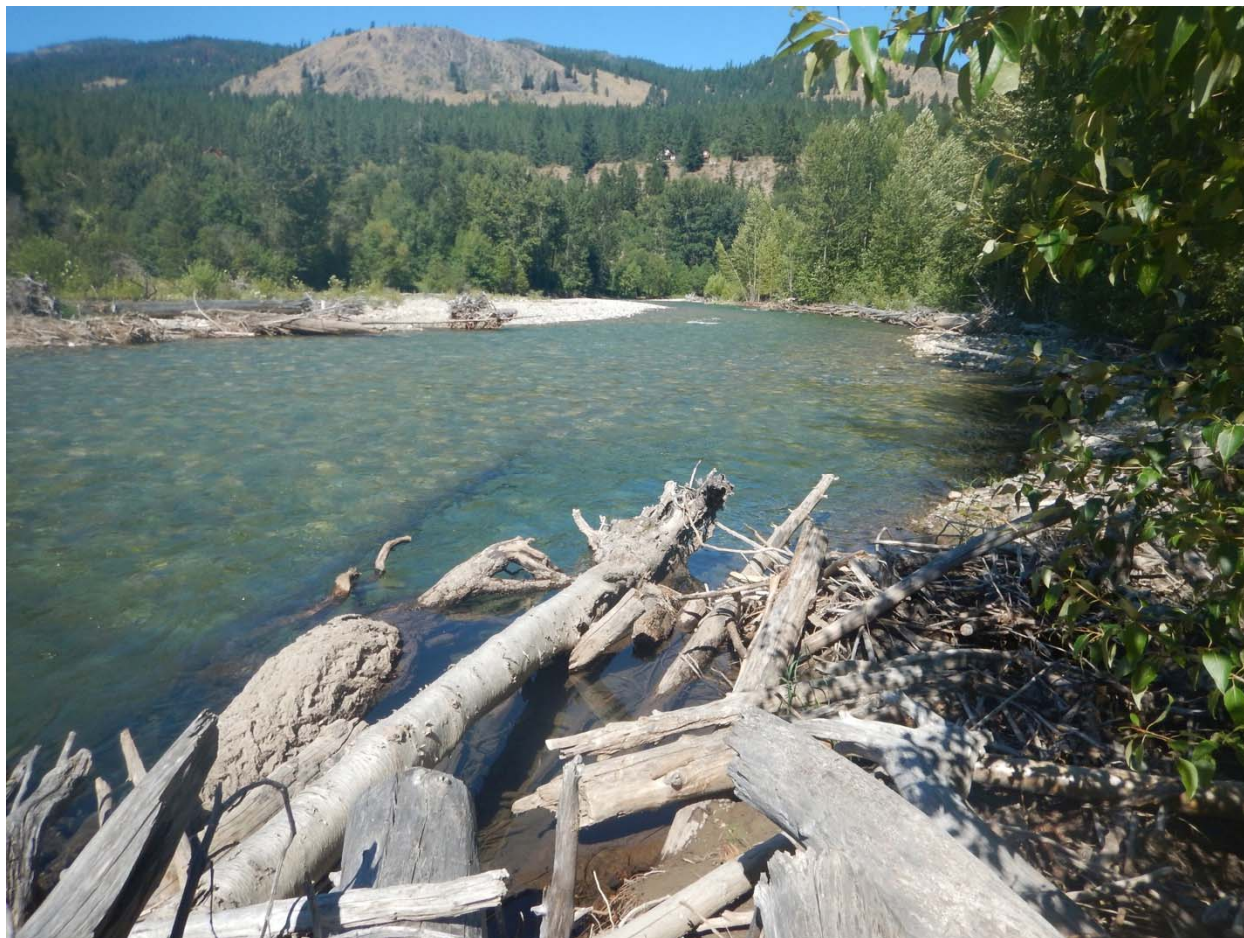
**Figure 28. Reach 2 pebble counts indicate a bed substrate of almost equal amount cobble and gravel, as well as a slightly higher than average count of LWD. The image above taken around RM 62.0 reflects these measurements.**

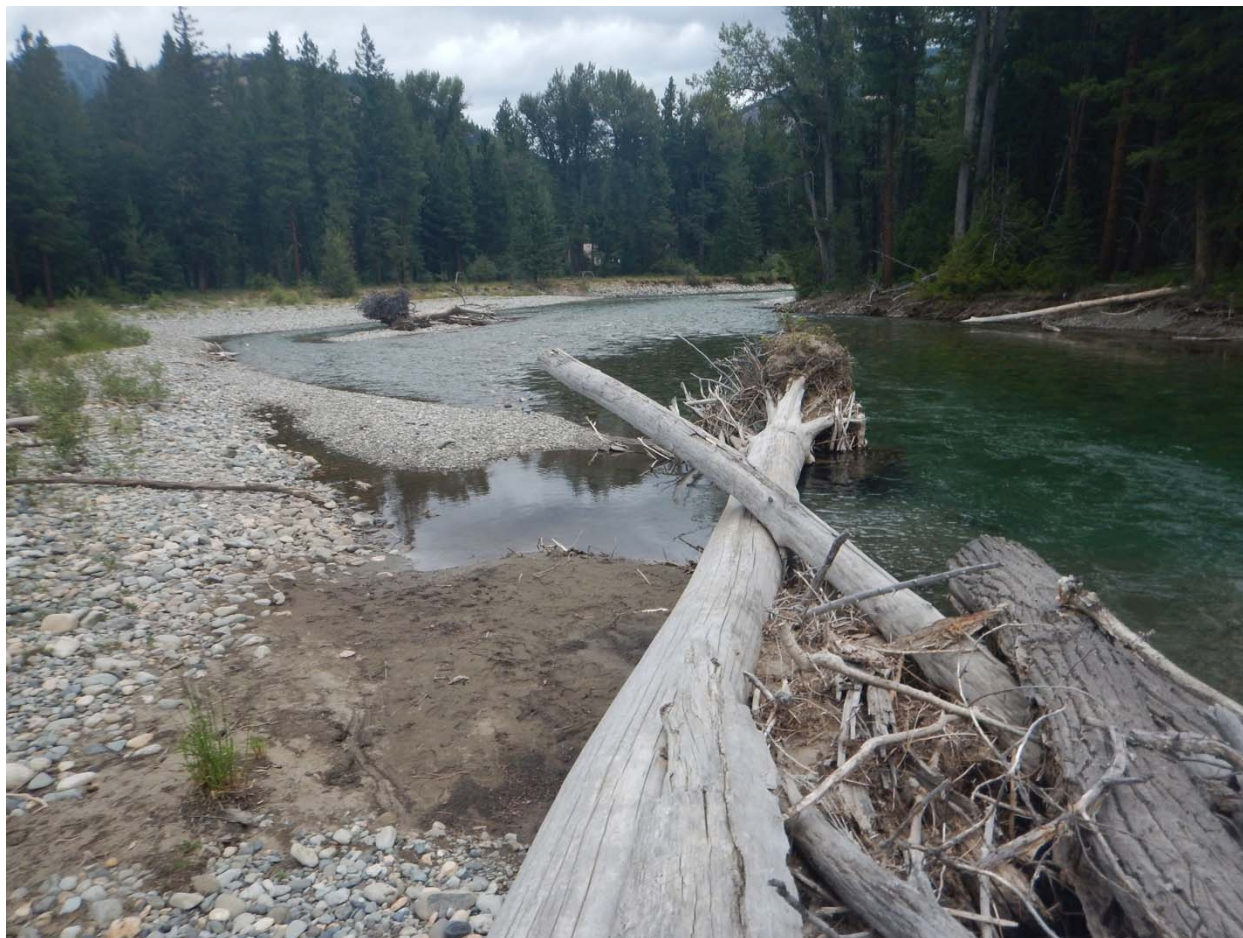
***Figure 33. Representative image of Reach 3, which had some of the highest wood counts and a higher than average pools per mile ratio.***

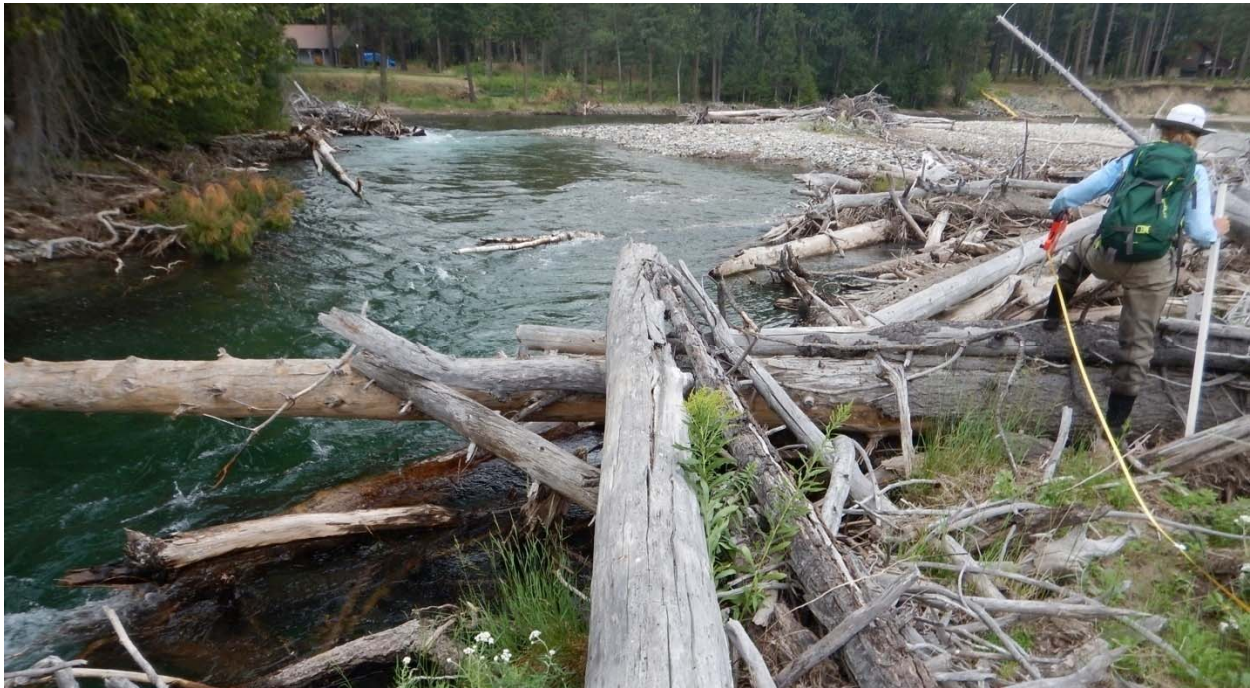
**Figure 37.** Reach 3 pools are deep, averaging a residual depth of 5.8 feet. Photo above of a pool a RM 65.1 and log jam on river left (right side of photo).

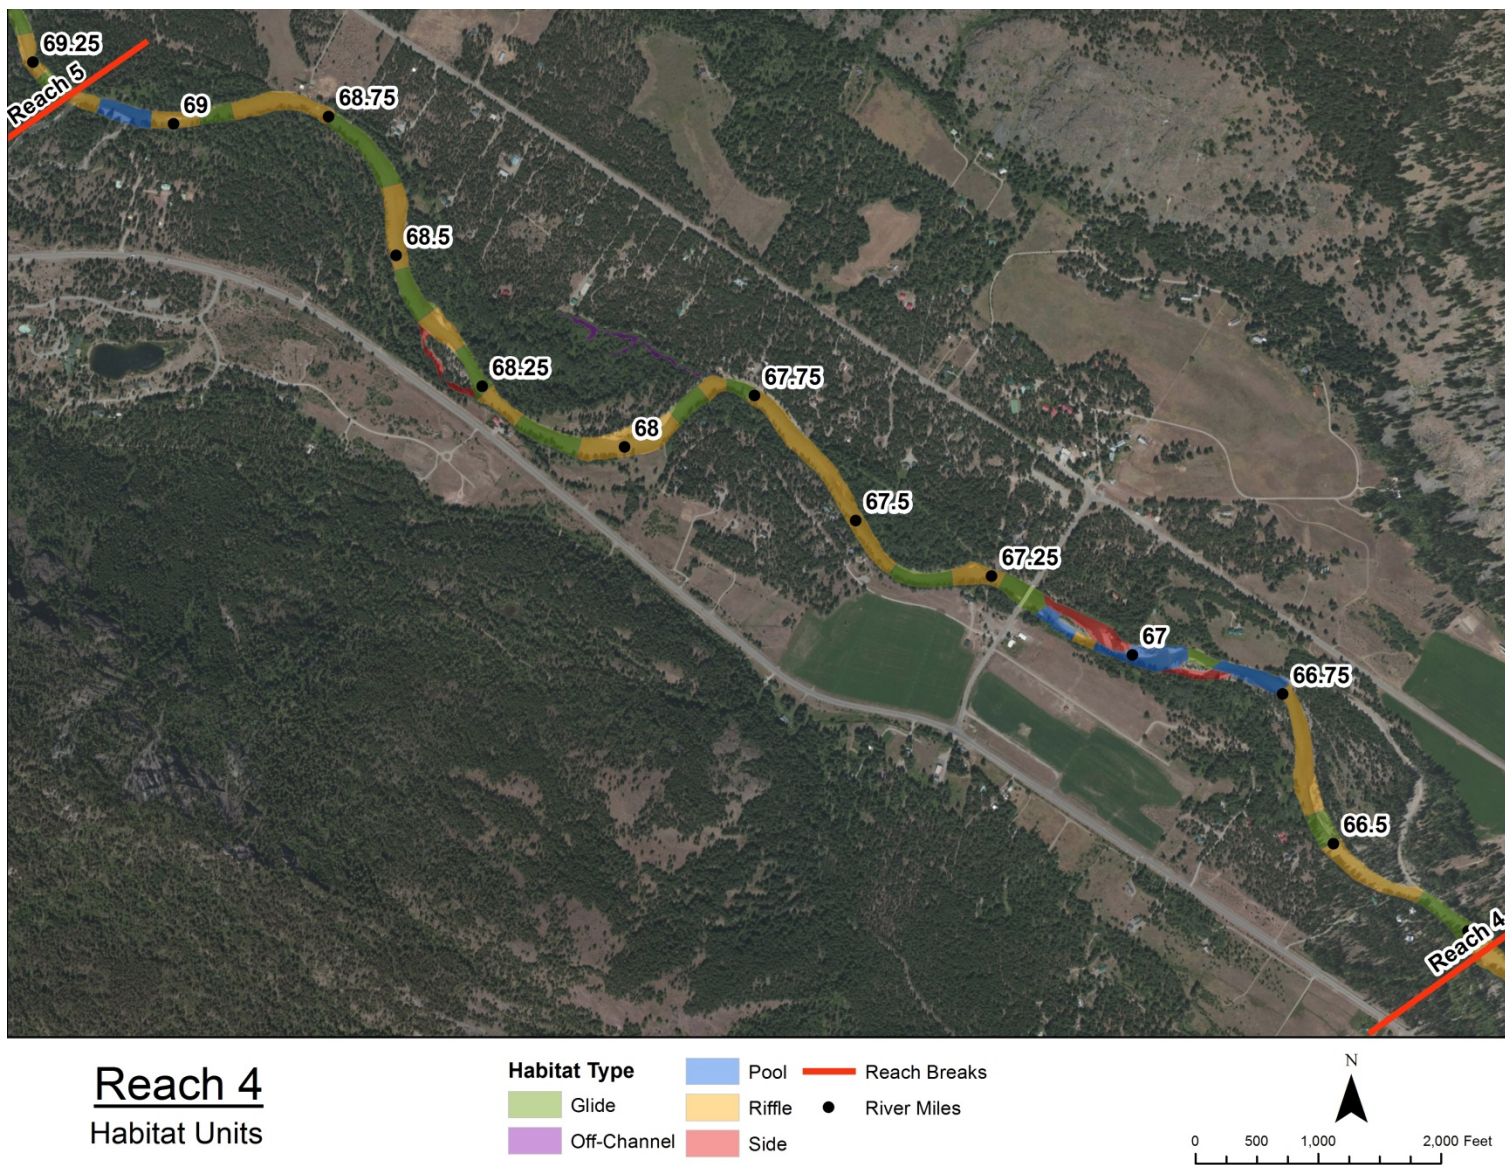
Figure 43. Overview of Upper Methow Reach 4 from RM 66.1 – RM 69.2 (Early Winters Creek).

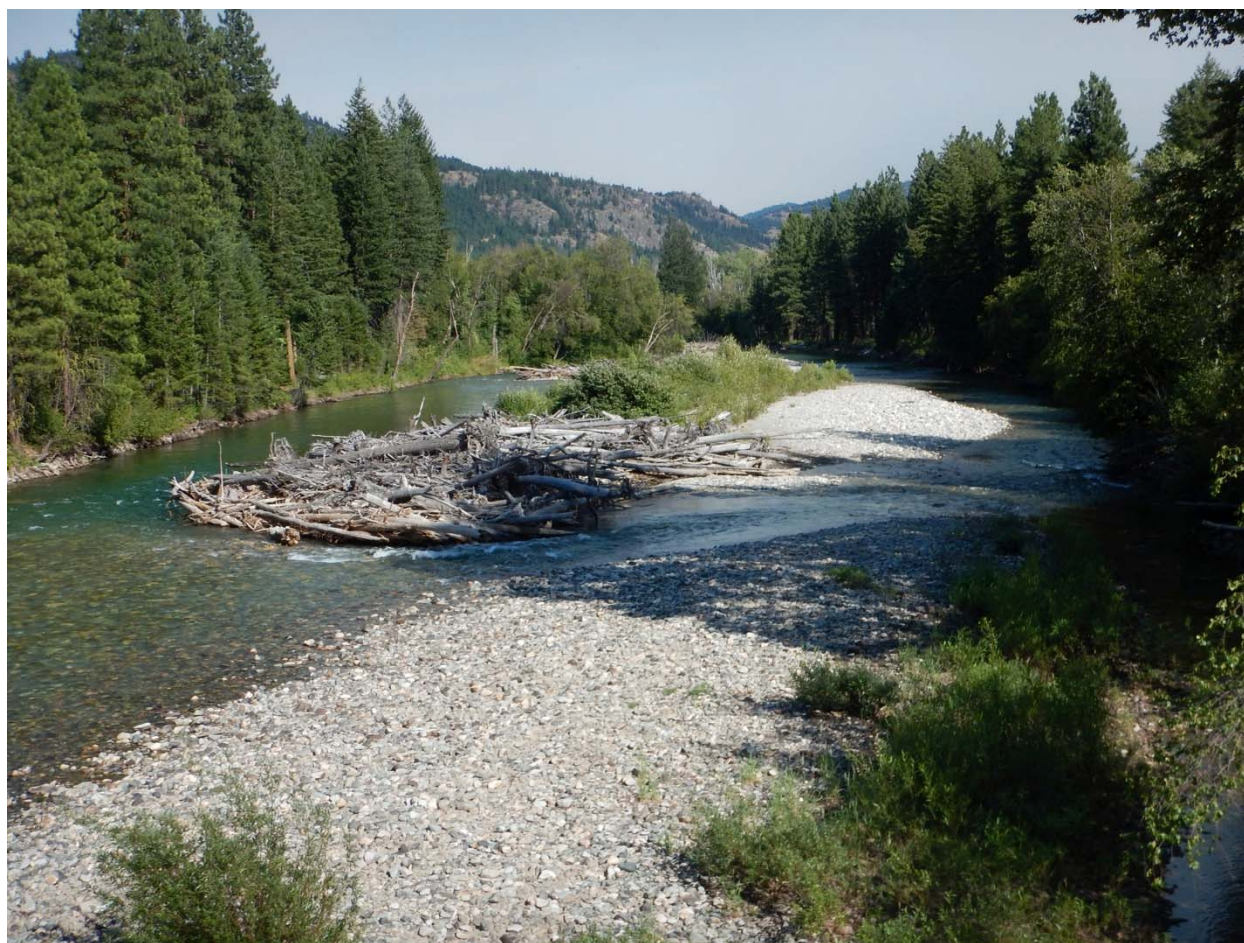
**Figure 46. Jam 17 in Reach 4 from the bridge on Lost River Road near the town of Mazama. The jam was estimated to have 100 small, 70 medium, and 30 large pieces of LWD.**

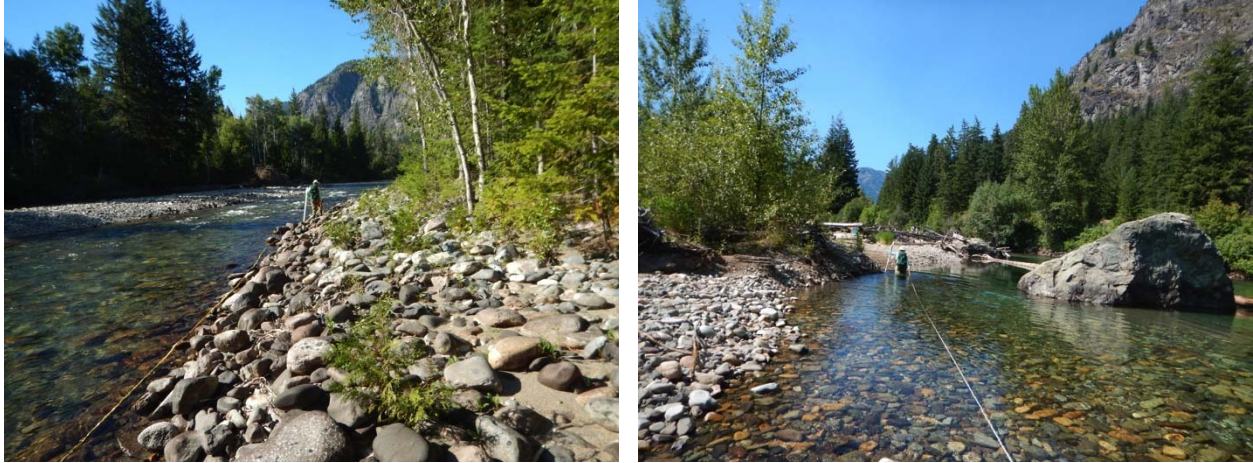
**Figure 50.** The first half of Reach 5 is mostly fast water with few pools, secondary channels or log jams (above photo left). The second half of Reach 5 contains seven log jams, high quality secondary channel habitat, and a high density of pools, (above photo right).

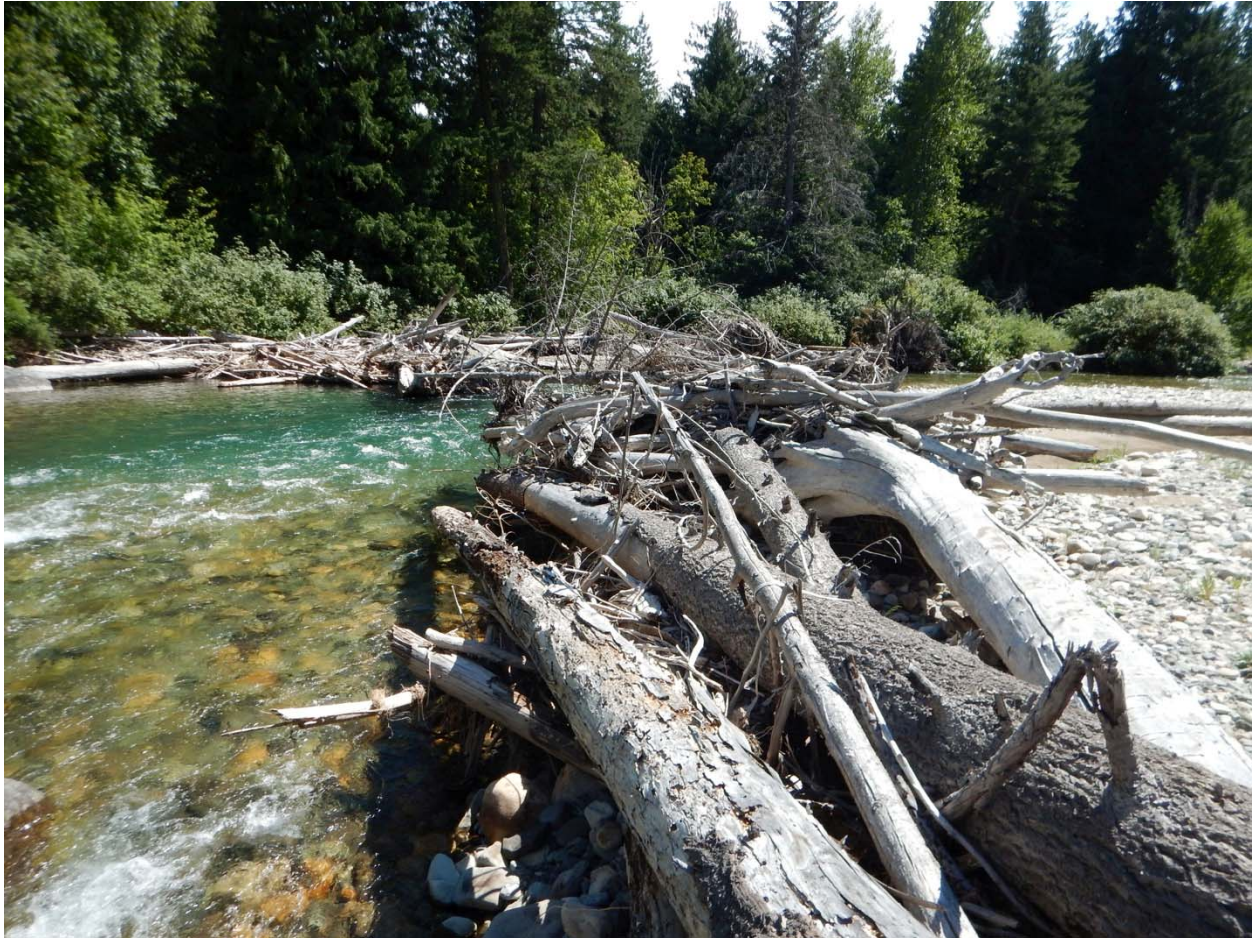
*Figure 54.. A 9-foot deep pool and log jams at RM 70.8.*

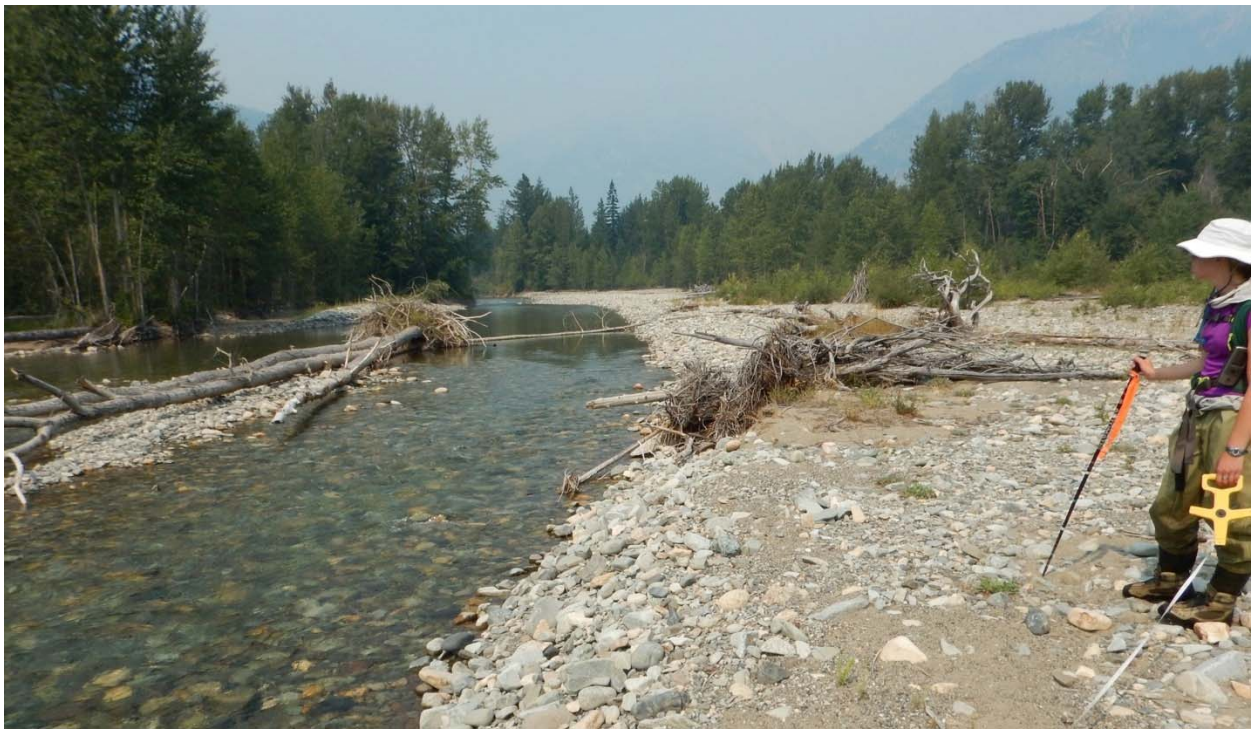
**Figure 63.** Reach 6 had 23 pools which together composed 27% of the habitat area within the reach. Photo above is a pool at RM 73.9.

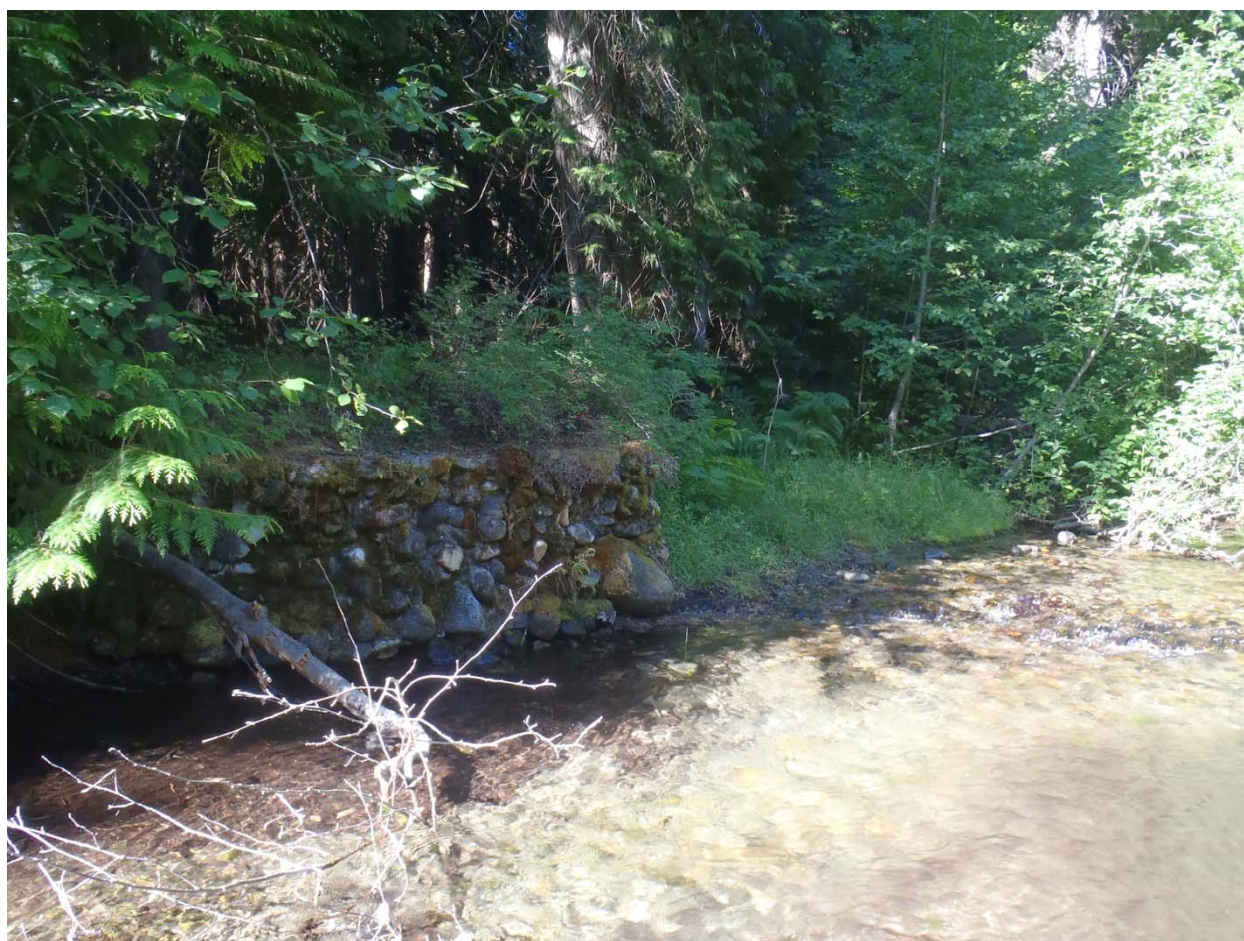
**Figure 64. Remnants of an old bridge along SIDE25S.**

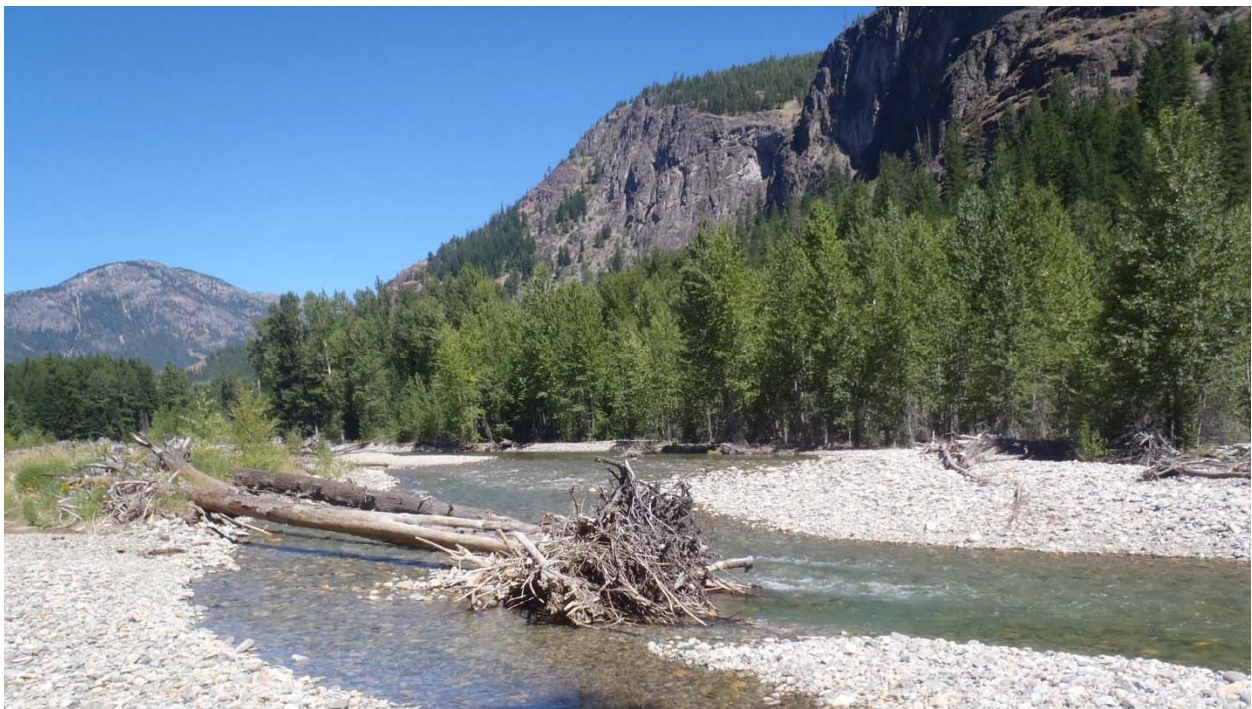
**Figure 69. Small trees measuring 9.0 – 20.9 in. diameter were the primary riparian vegetation (78%).**

Small trees measuring 9.0 – 20.9 in. diameter were again the primary riparian vegetation (78%) observed in Reach 6 over nine n<sup>th</sup> units (Figure 68). Large trees measuring 21 – 31.9 in. diameter and sapling/pole measuring 5 – 8.9 in. diameter were observed as well (11% each). Cottonwoods were the dominant overstory species with several other species composing the observed riparian overstory including aspen, cedar, Douglas fir, and ponderosa pine. Dogwood was the primary understory species with additional units of young cottonwood and cedar.

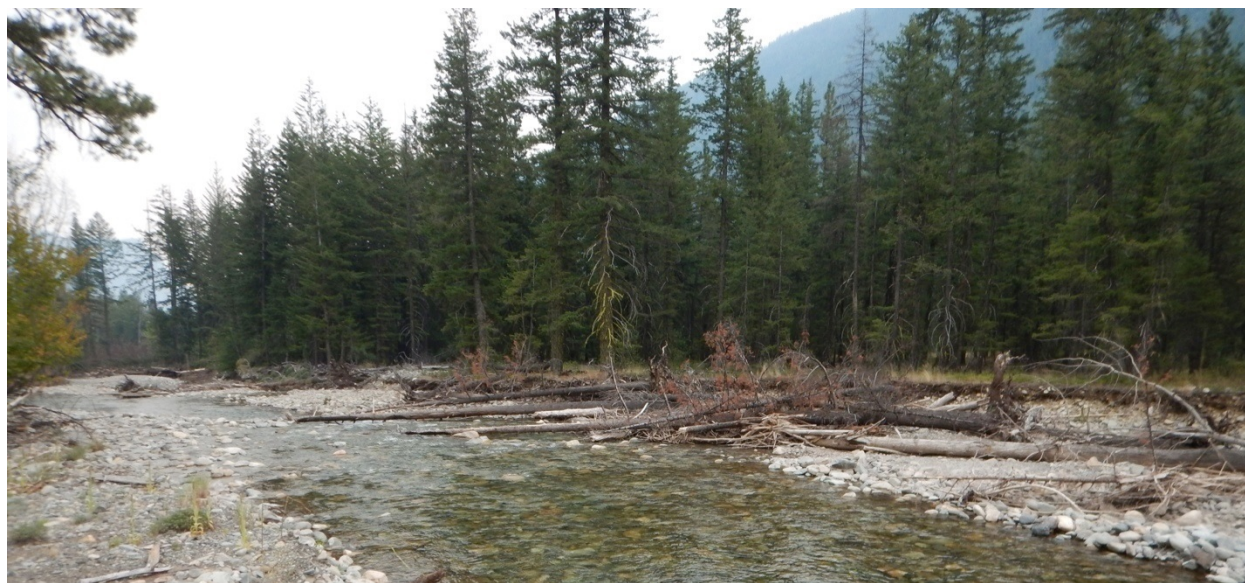
**Figure 74. Lateral channel migration resulted in increased LWD at RM 76.0.**

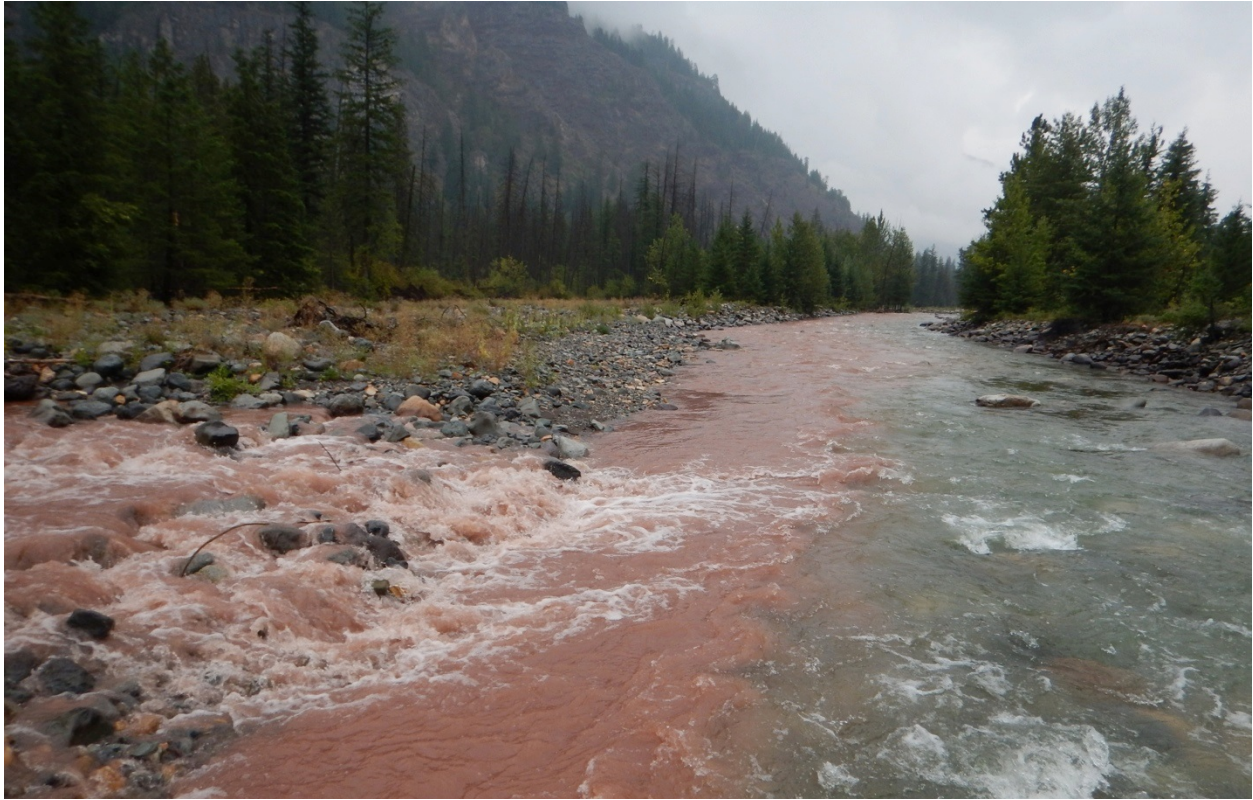
*Figure 76. Robinson Creek (left) meets the Methow at RM 76.5 following heavy rains*

Two pebble counts within Reach 7 identified substrate that was on par with the project area average and included 51% cobble, 42% gravel, 5% boulder and 2% sand (Figure 75). Robinson Creek is a significant contributor of bedload and suspended sediment to the reach (see Figure 76).

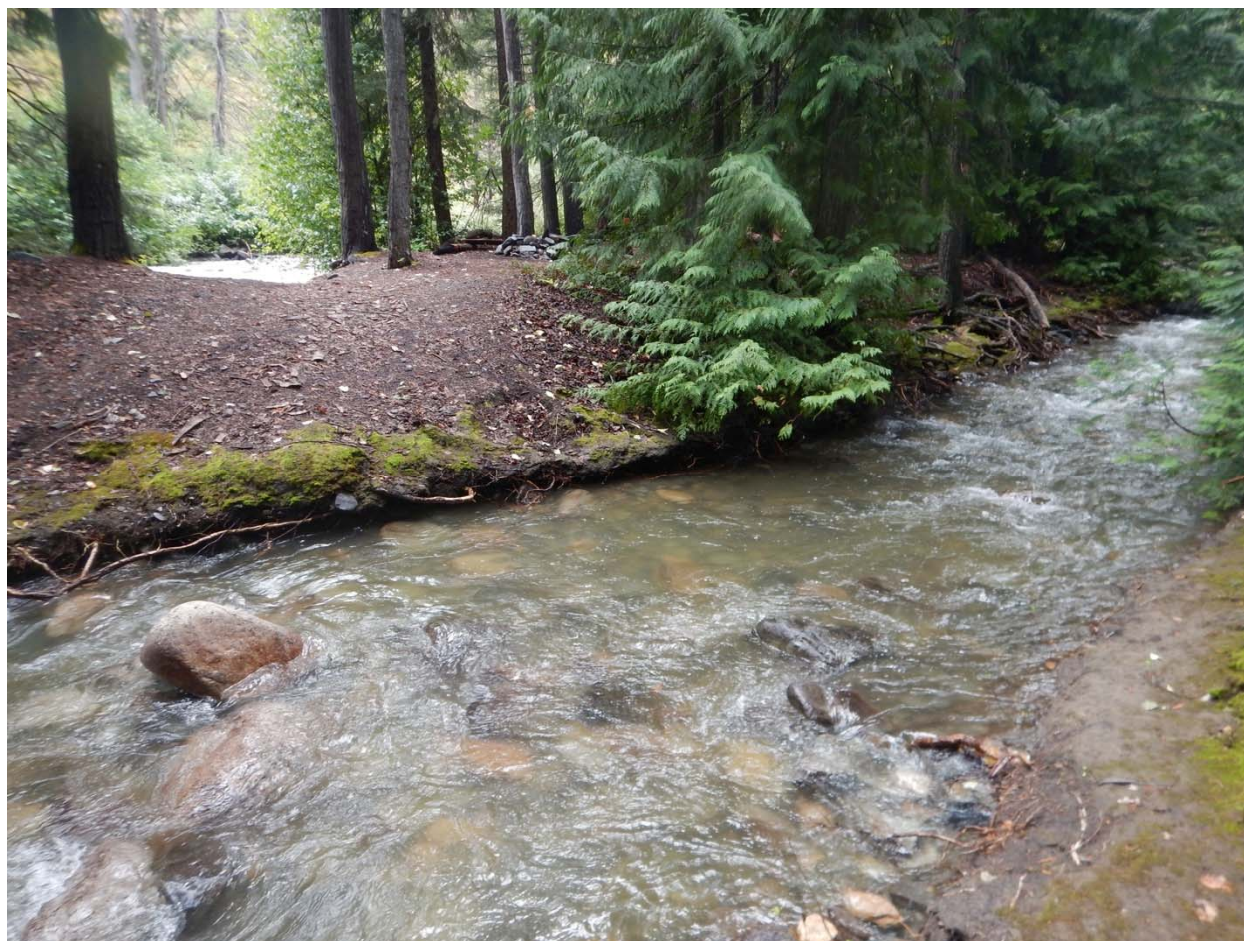
**Figure 82.** *SIDE40F with the mainstem Methow River in the background.*

Reach 8 has four side channels comprising approximately 1% of the secondary channel habitat within the project area. The longest side channel is SIDE40F (Figure 82), which maintained a variety of riffles and pools, as well as a large apex log jam at the head of the side channel.

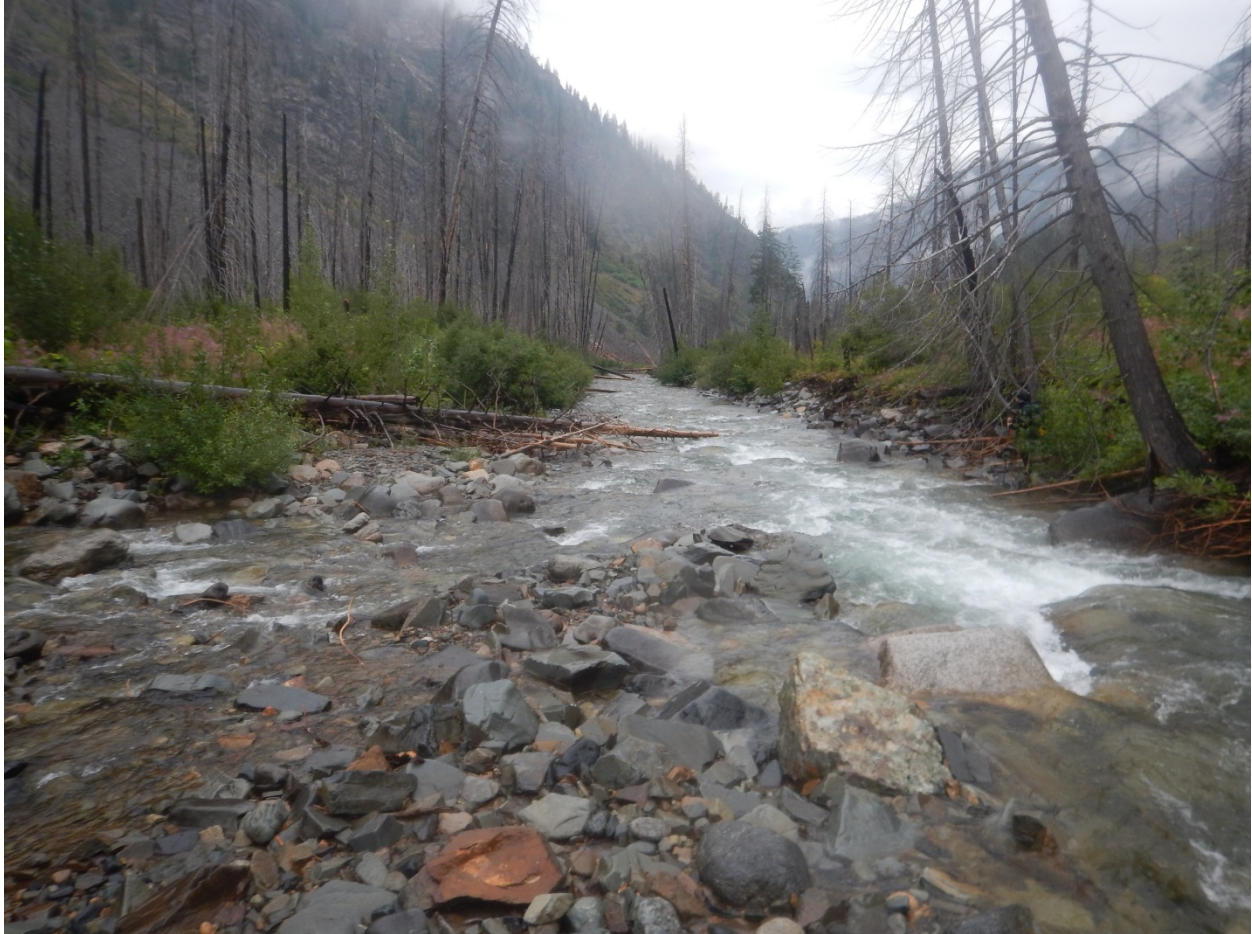
**Figure 84.** Representative view of Reach 9. Image is taken looking downstream from Trout Creek.

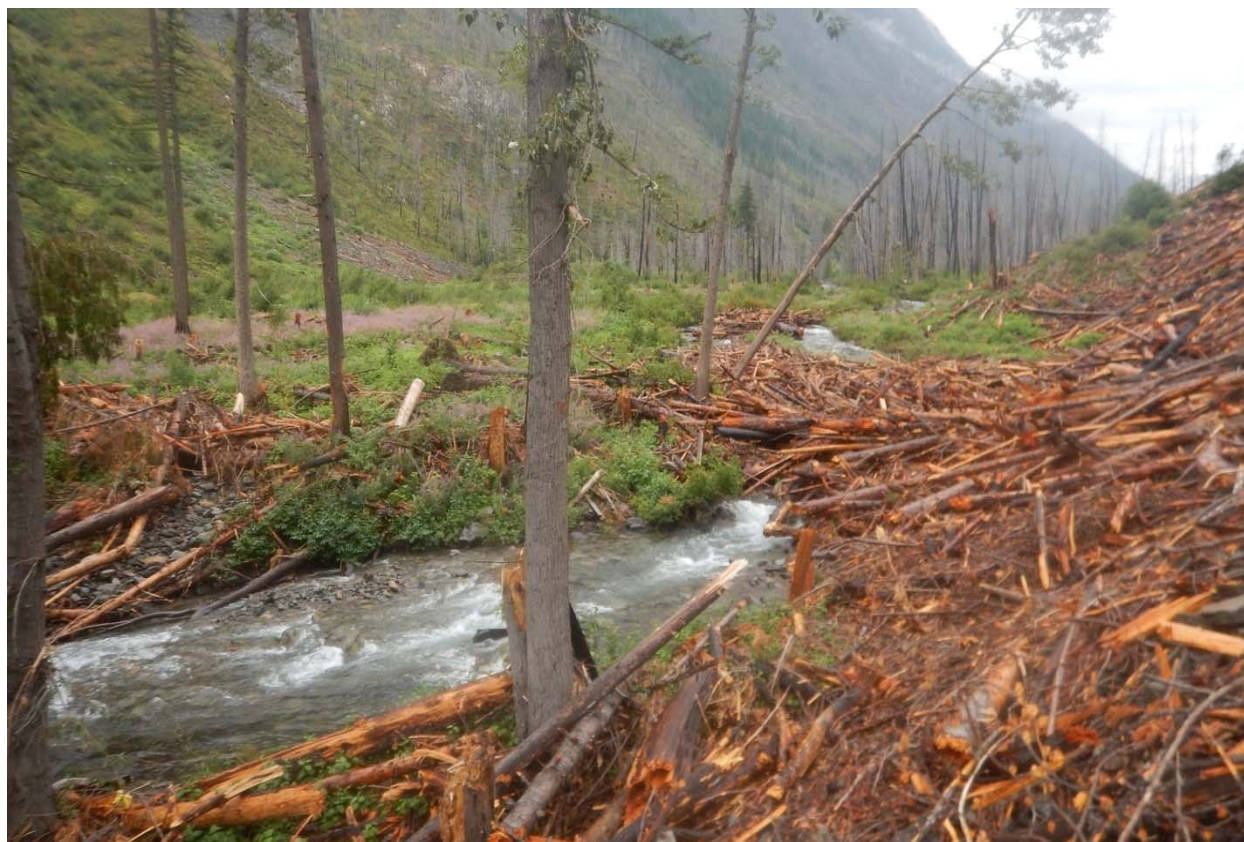
*Figure 88. Log jam at RM 79.75 caused by an avalanche in May 2014. Much of the wood was likely dead snags that had burned during the 2003 Needles Fire.*
