Middle Twisp River Reach Assessment & Restoration Strategy

SUBMITTED TO
Yakama Nation Fisheries Program

FEBRUARY 2015

PREPARED BY
Inter-Fluve, Inc.
501 Portway Ave, Suite 101
Hood River, OR 97031
(541) 386-9003

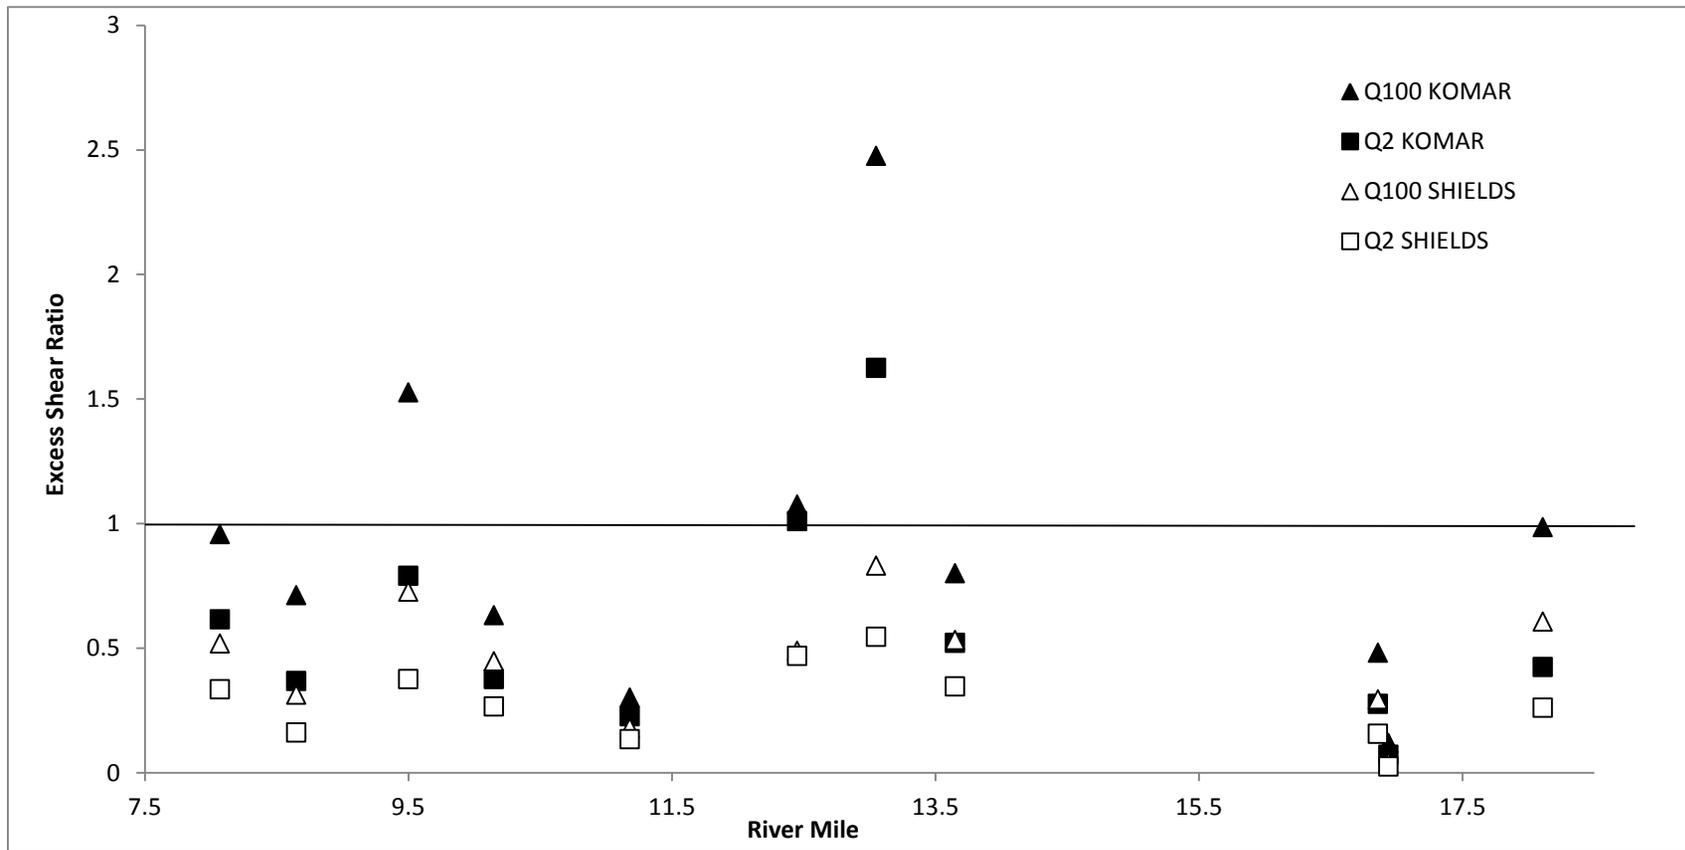
Figure 7. Excess shear ratio based on modeling and pebble count data for select locations in the study area.

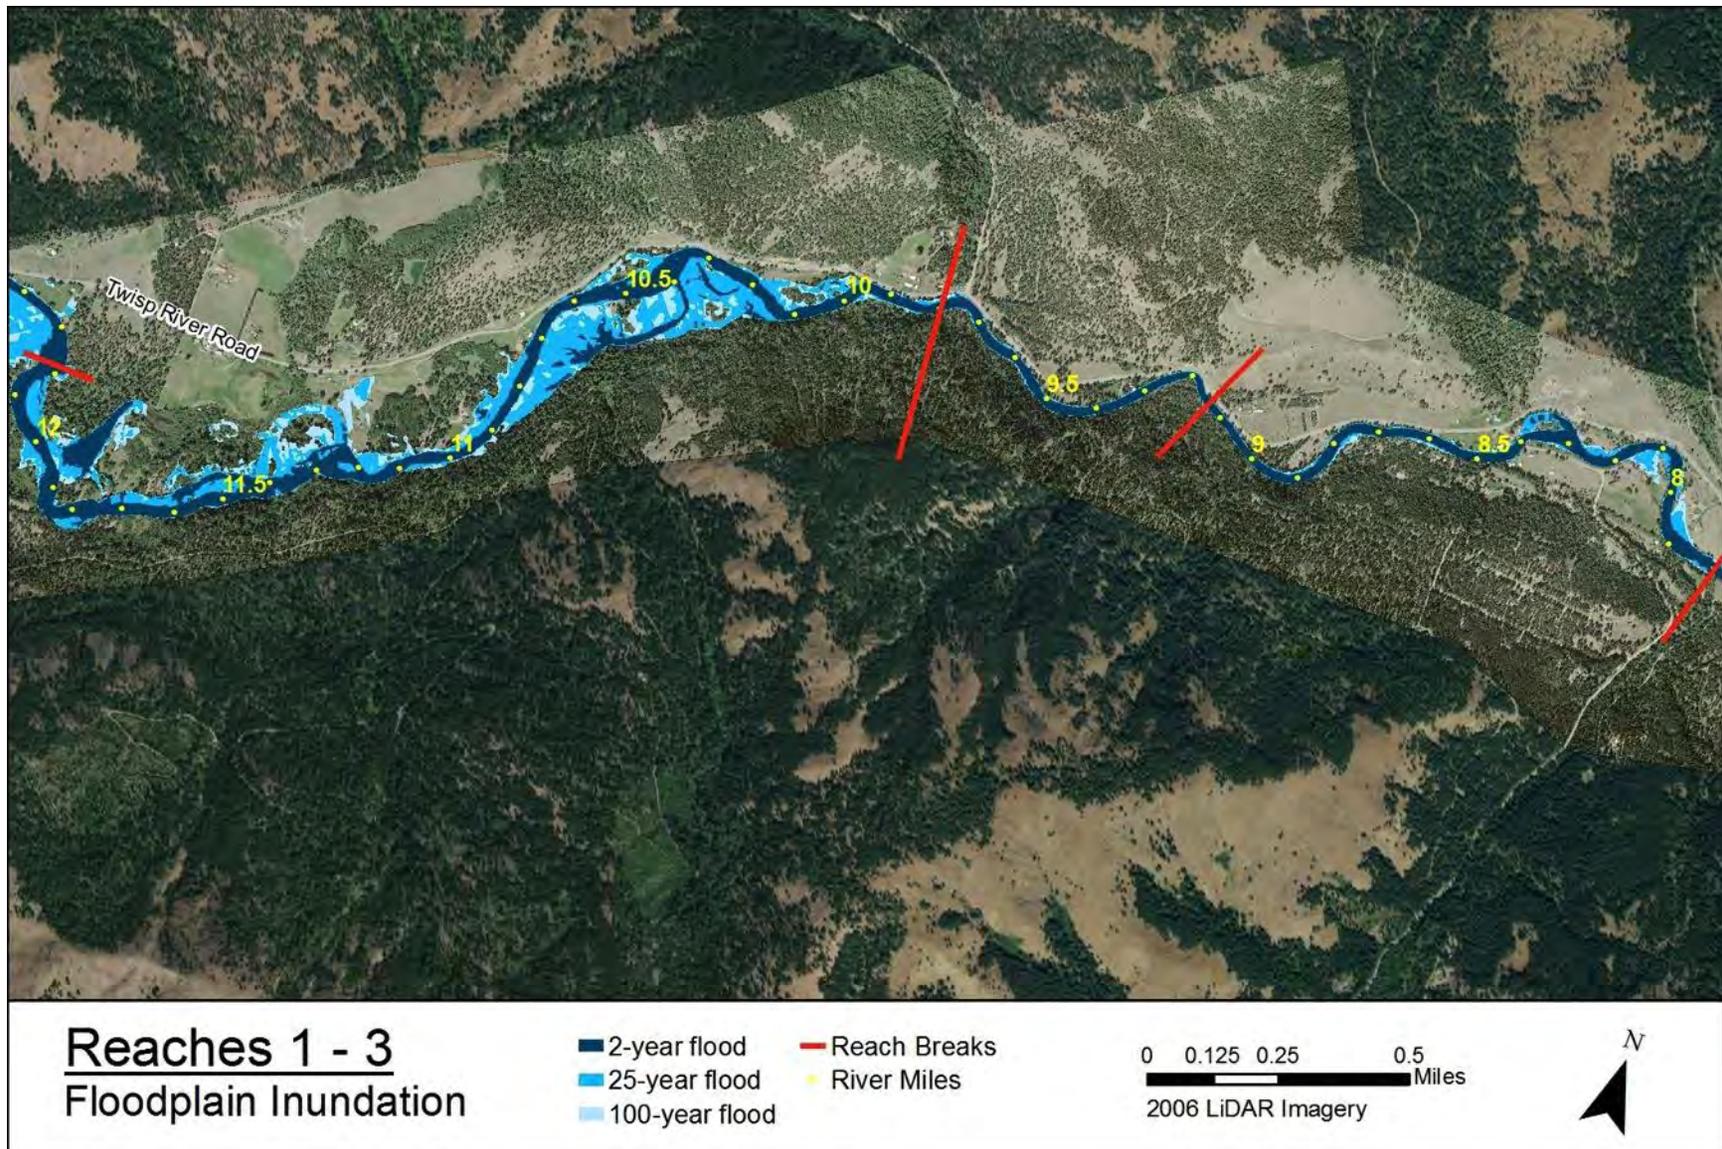
Figure 8. Reaches 1 -3 modeled floodplain inundation for the 2-, 25- and 100-year flood events.

The results of the hydraulic modeling indicate that Reaches 1 and 2 have the largest shear stresses and average velocities observed within the study area. These reaches also had the largest estimated stream power during flood events and low rates of floodplain inundation. The confined nature of the channel in this area, combined with the high stream energy and large shear stresses are associated with increased sediment transport capacity, which coincides with the transport nature of Reaches 1 and 2 noted in the geomorphic assessment. Conversely, greater floodplain inundation and lower stream energy was observed in the less confined reaches (Reaches 3 – 6), which is consistent with a more depositional system. Analyzing the hydraulic analysis in combination with the geomorphic and habitat assessments shows that current channel and floodplain complexity increases in reaches with greater floodplain inundation.

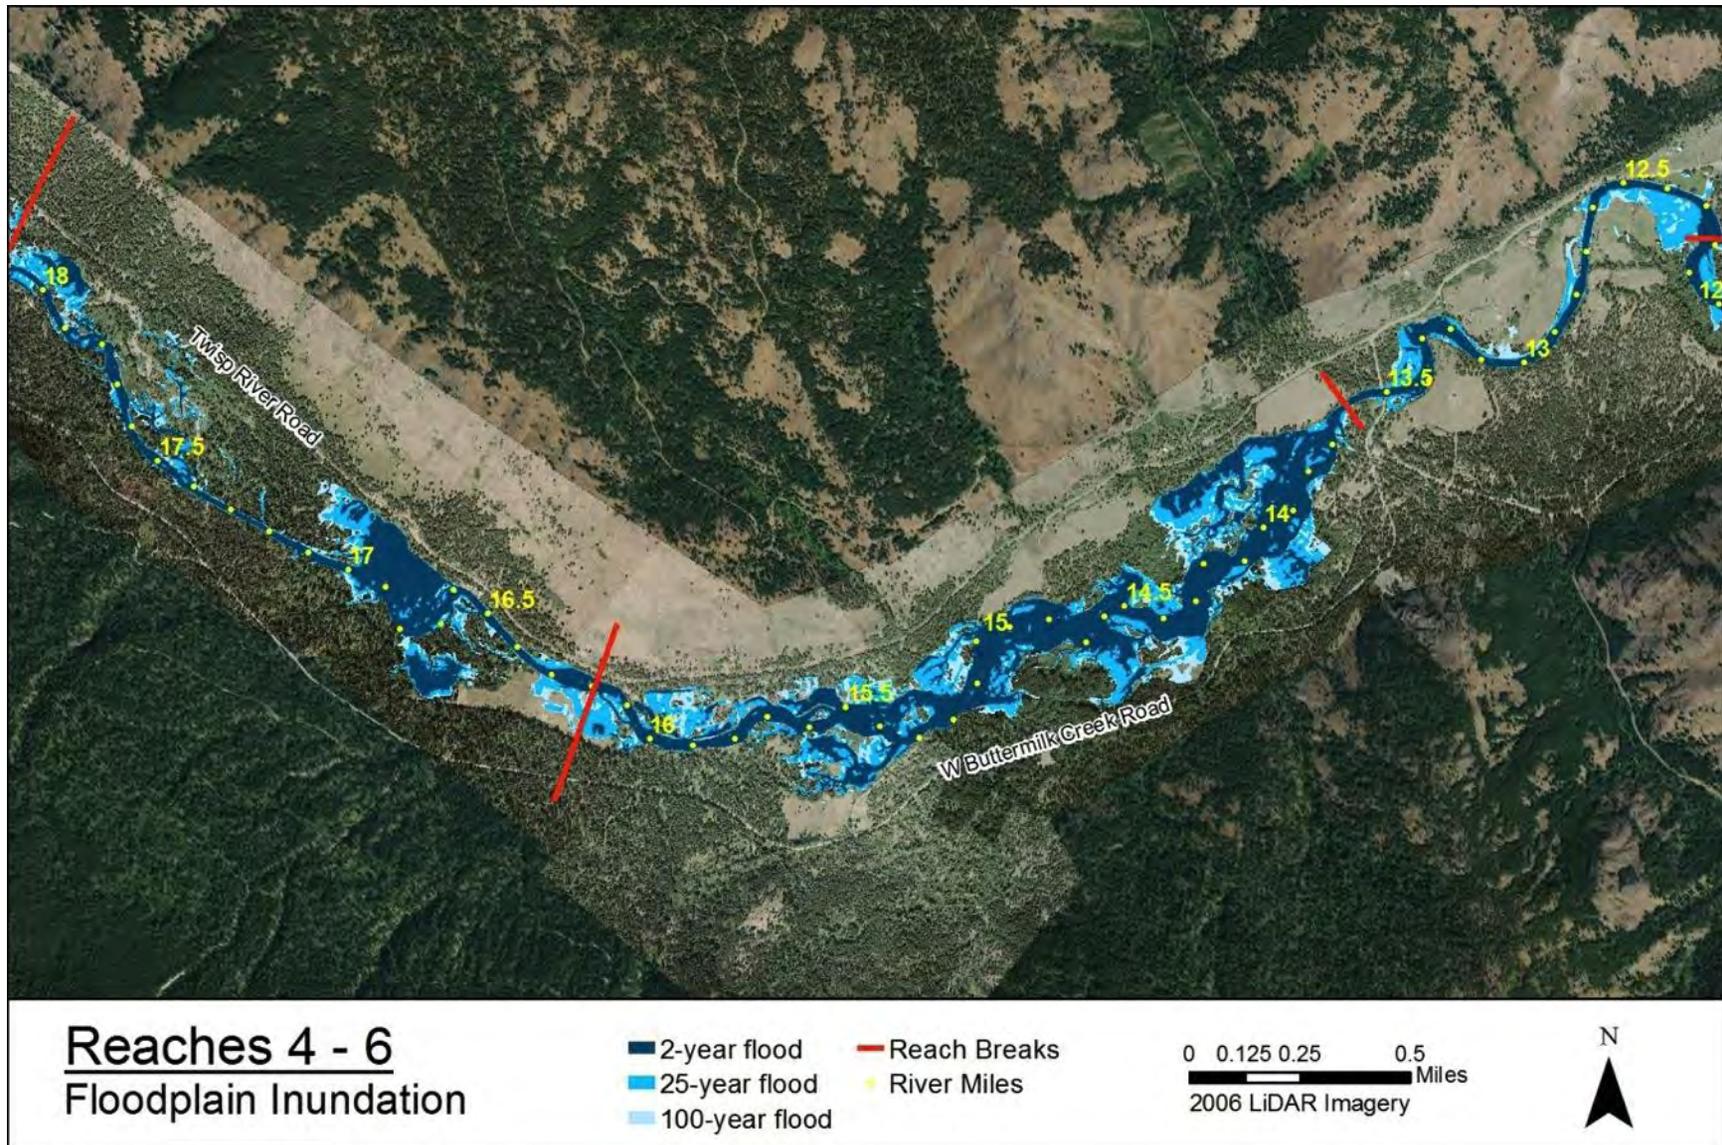
Figure 9. Reaches 4-6 modeled floodplain inundation for the 2-, 25- and 100-year flood events.

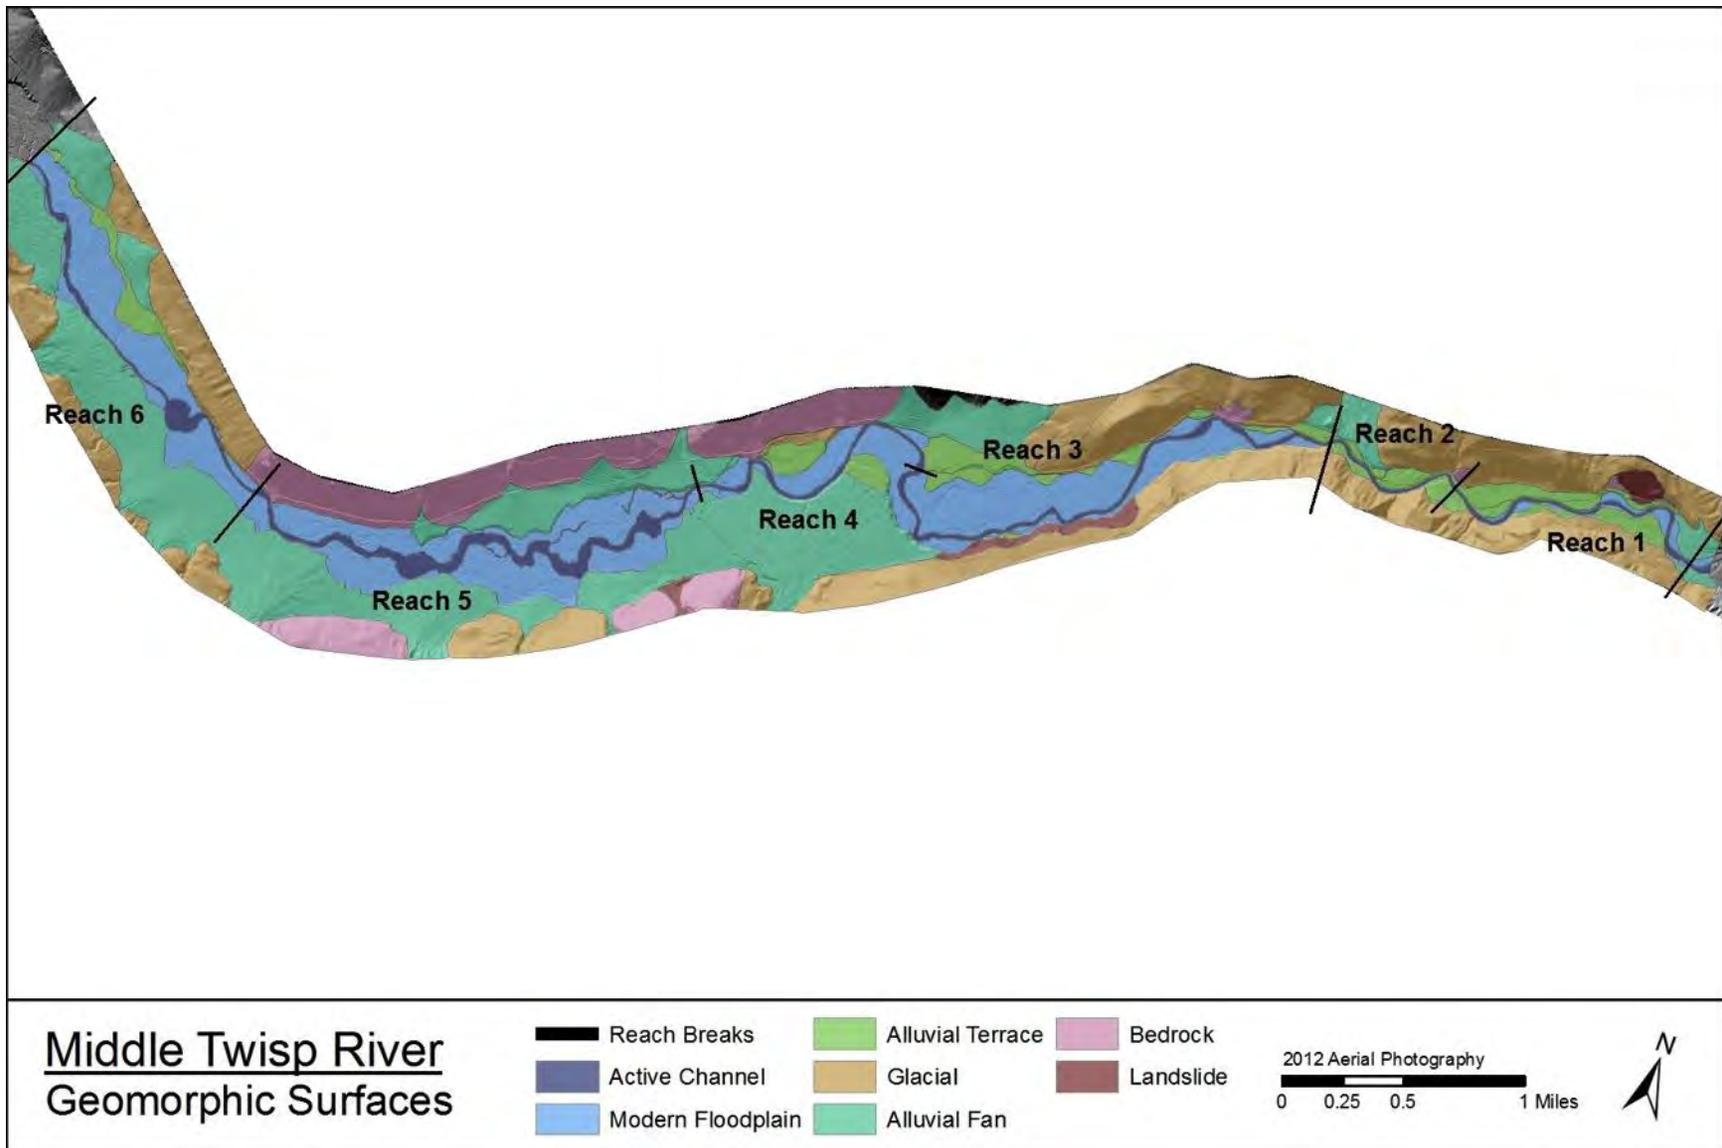
Figure 10. Geomorphic surfaces of the study area. These data are a refined version of the geomorphic surfaces data from USBR (2008), refined for the study area based on field surveys and hydraulics analysis to delineate the modern floodplain surface.

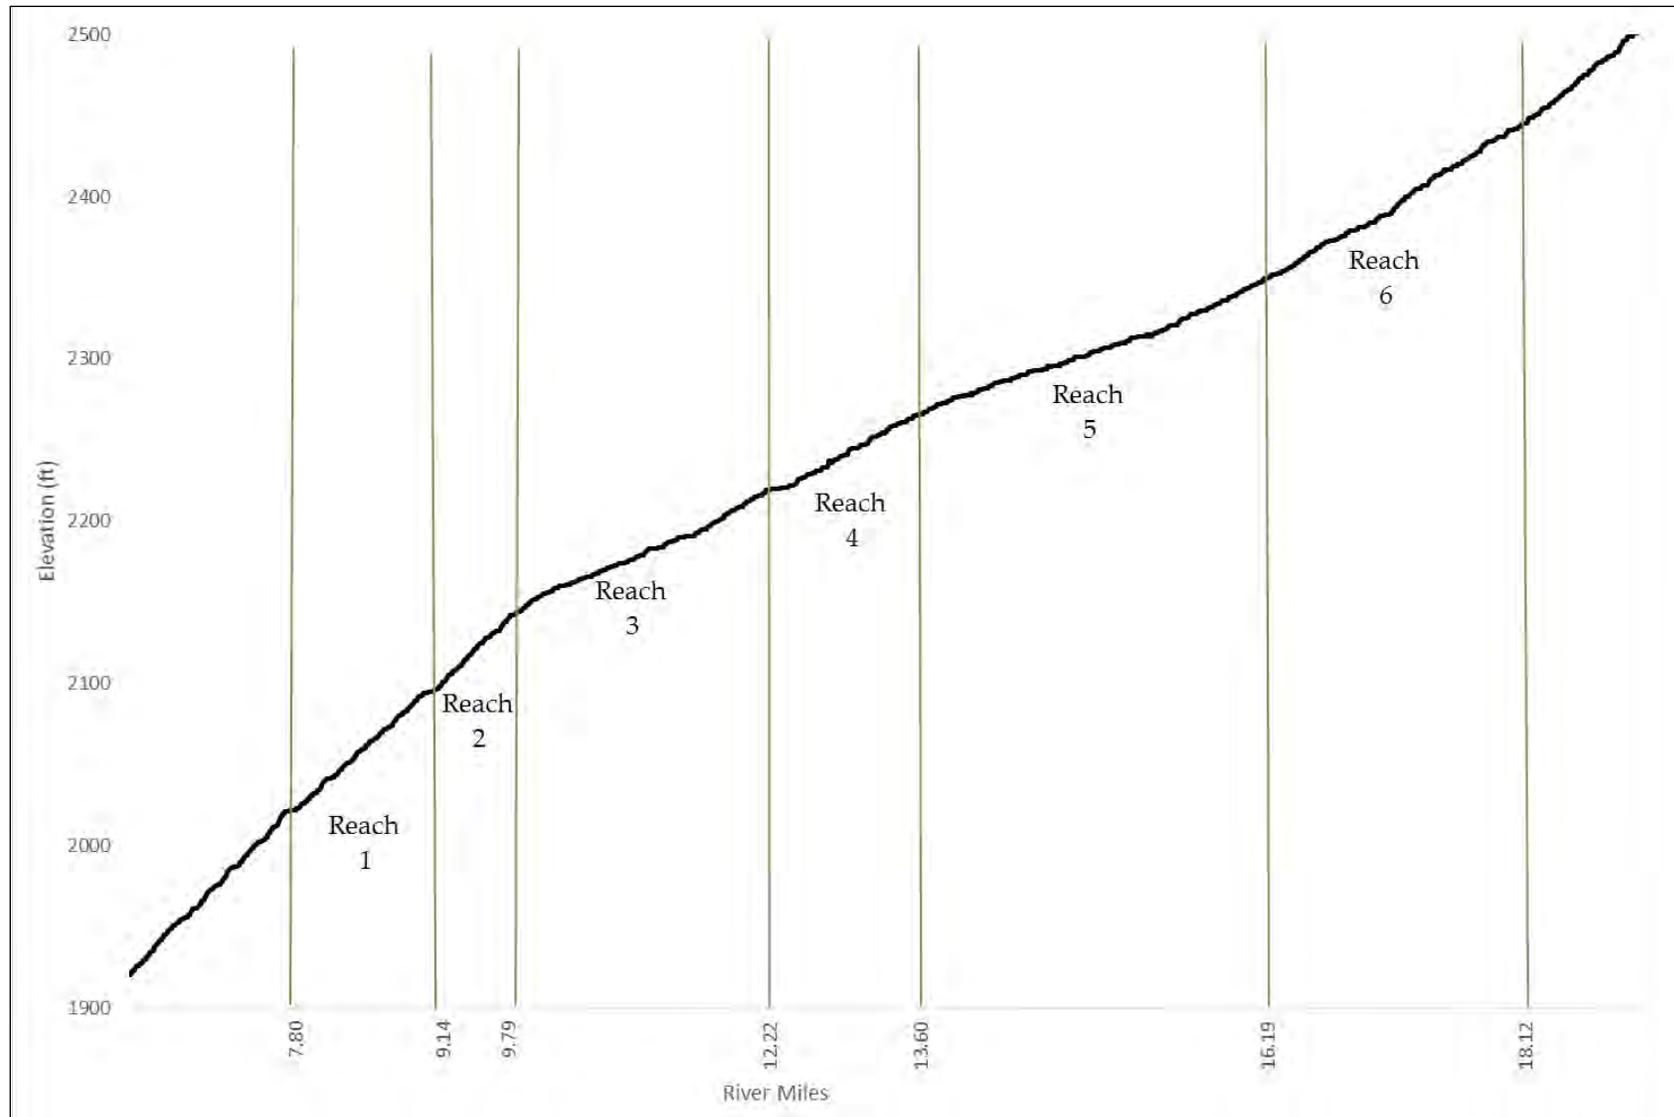
Figure 11. Longitudinal profile of the Middle Twisp Study Area. Elevation data derived from the 2006 LiDAR data.

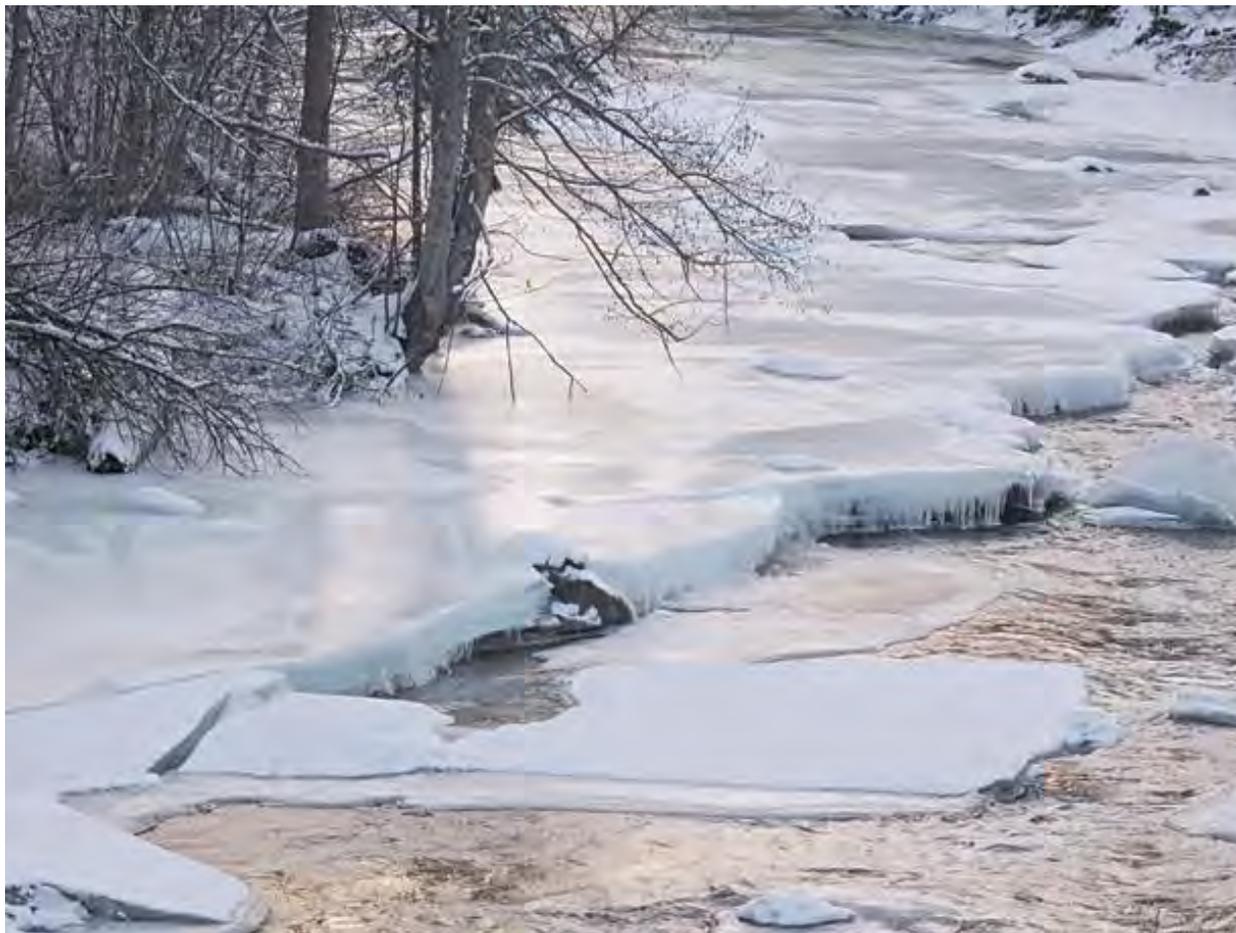
Figure 12. Photo of surface ice on lower Twisp River (Stamper 2013).

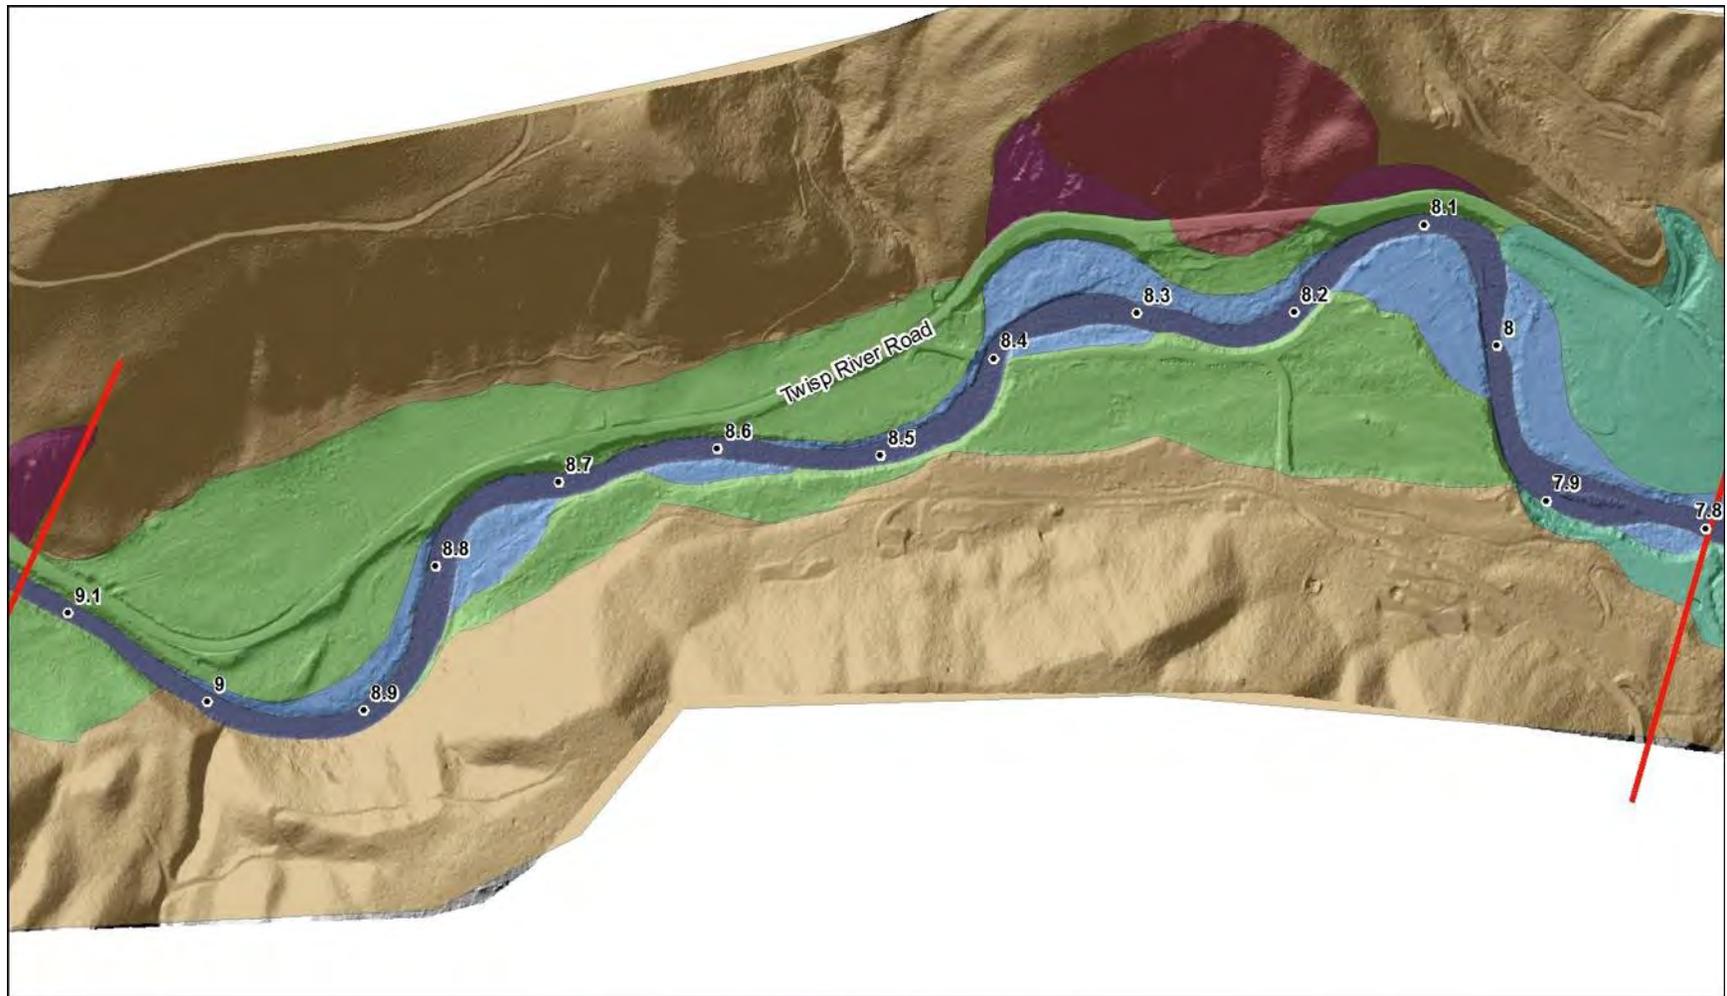
Reach 1
Geomorphic Surfaces

Figure 17. Geomorphic surfaces for Reach 1.

The reach has high vertical stability and is naturally laterally constricted by glacial terraces on both sides of the channel with a modern alluvial terrace on the intermediate surface on the river-left. The confinement limits lateral migration and sinuosity and the large substrate observed on the streambed (see Sediment section below) provides vertical stability for the channel. The single thread nature of the channel and lack of lateral migration is apparent when comparing the channel boundaries observed over the historical record (Figure 19).

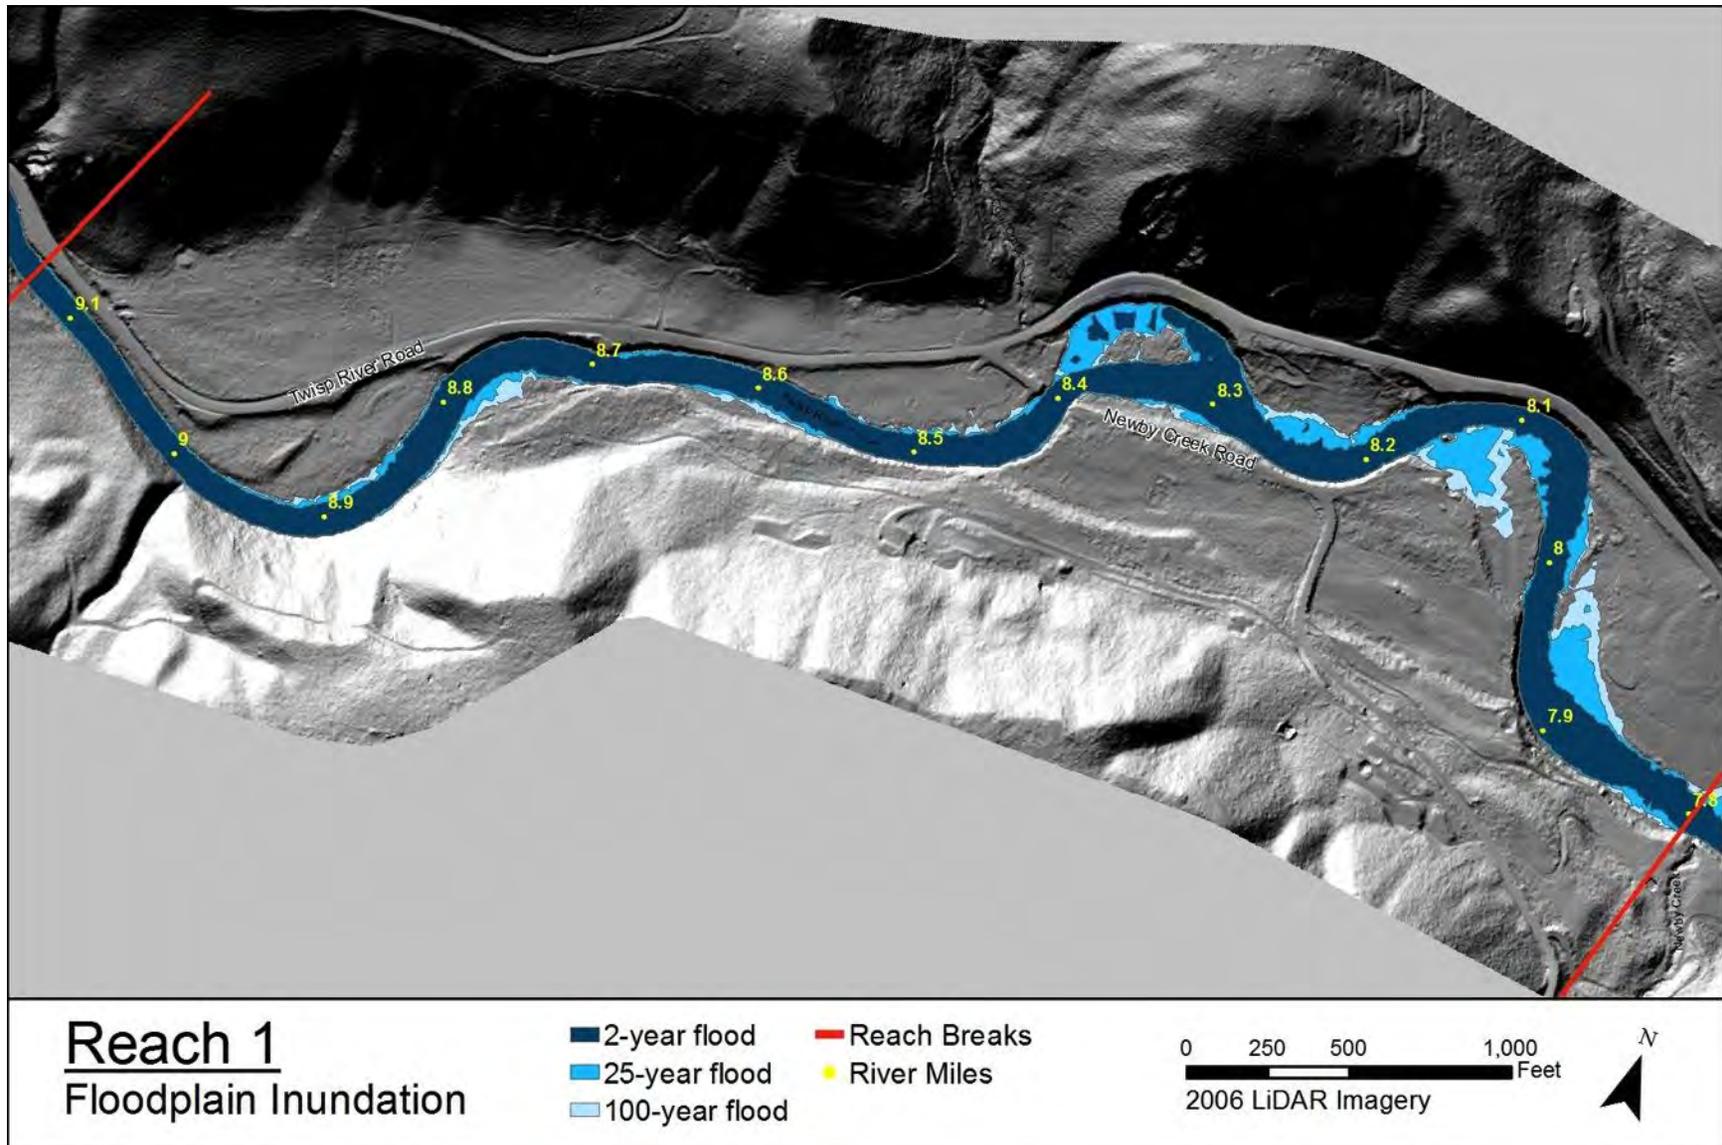
Figure 18: Floodplain inundation mapping for Reach 1

With the exception of a couple of discrete locations, a majority of the flood events are contained within the channel, including the 100-year event (Figure 18). The lack of floodplain inundation and single thread nature of the channel results in minimal habitat availability, especially in comparison with the braided channels downstream of this reach. Extensive amounts of riprap and numerous levees were constructed within this reach and much of the limited floodplain habitat that does exist has been cleared, filled and graded. The highest amount of human alterations in the study area occurred within this reach, but due to the natural channel confinement, these alterations have less of an impact on channel dynamics and habitat.

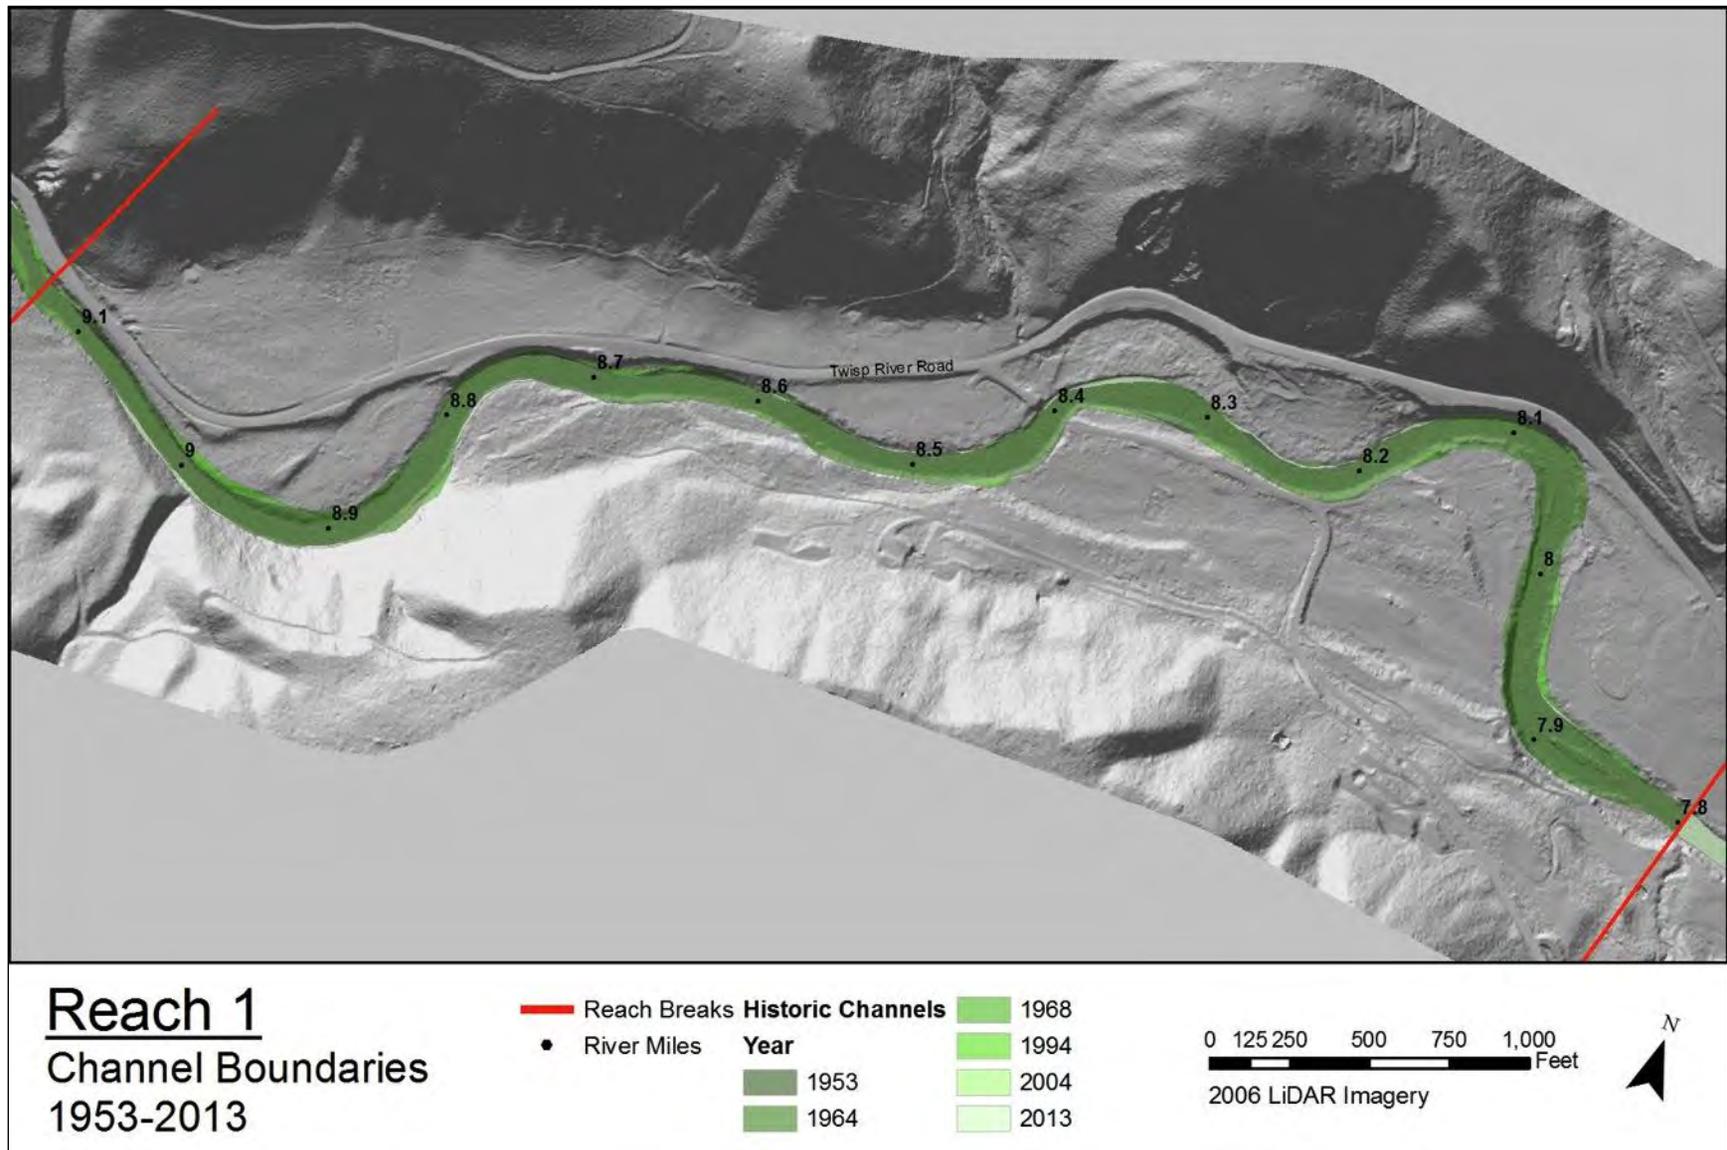
Figure 19. Historical Channel Boundaries for Reach 1.

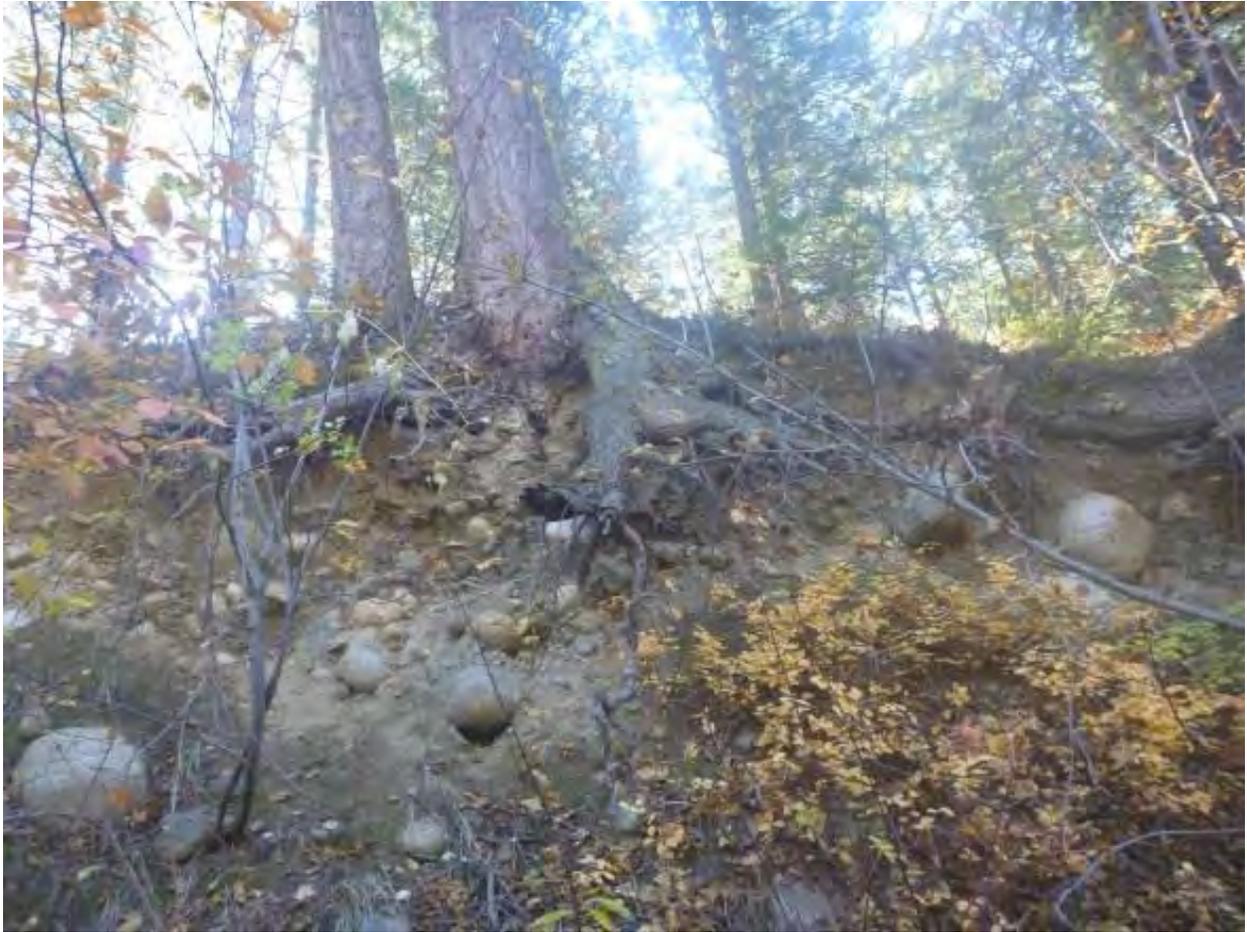
Figure 20 Potential for large wood recruitment along river-right terrace at RM 8.5. There are several mature conifers with exposed root masses on the edge of the terrace.

The upstream portion of Reach 1 has a high density of riparian vegetation along the south side of the channel with significant reduction of vegetation along the north side of the channel and the downstream portion of the south side of the channel. The majority of the riparian clearing was prevalent on the south side of the river for the first half of the reach, and on the north side of the river for the second half of the reach. Based on the habitat survey, Reach 1 had a variable riparian corridor with a majority of the reach composed of grassland/ forbes (75%) and small trees (25%). Species composition was variable with most of the understory identified as hawthorne, dogwood, and willow; the overstory was largely composed of cottonwood, Douglas fir, and ponderosa pine. The first return LiDAR image indicates that in areas where clearing did not take place, a majority of the overstory was between 25 and 100 feet tall. The channel banks were primarily composed of old growth conifers on the terraces that provide shade to the channel as well as act as a potential source for large wood recruitment to the channel (Figure 20).

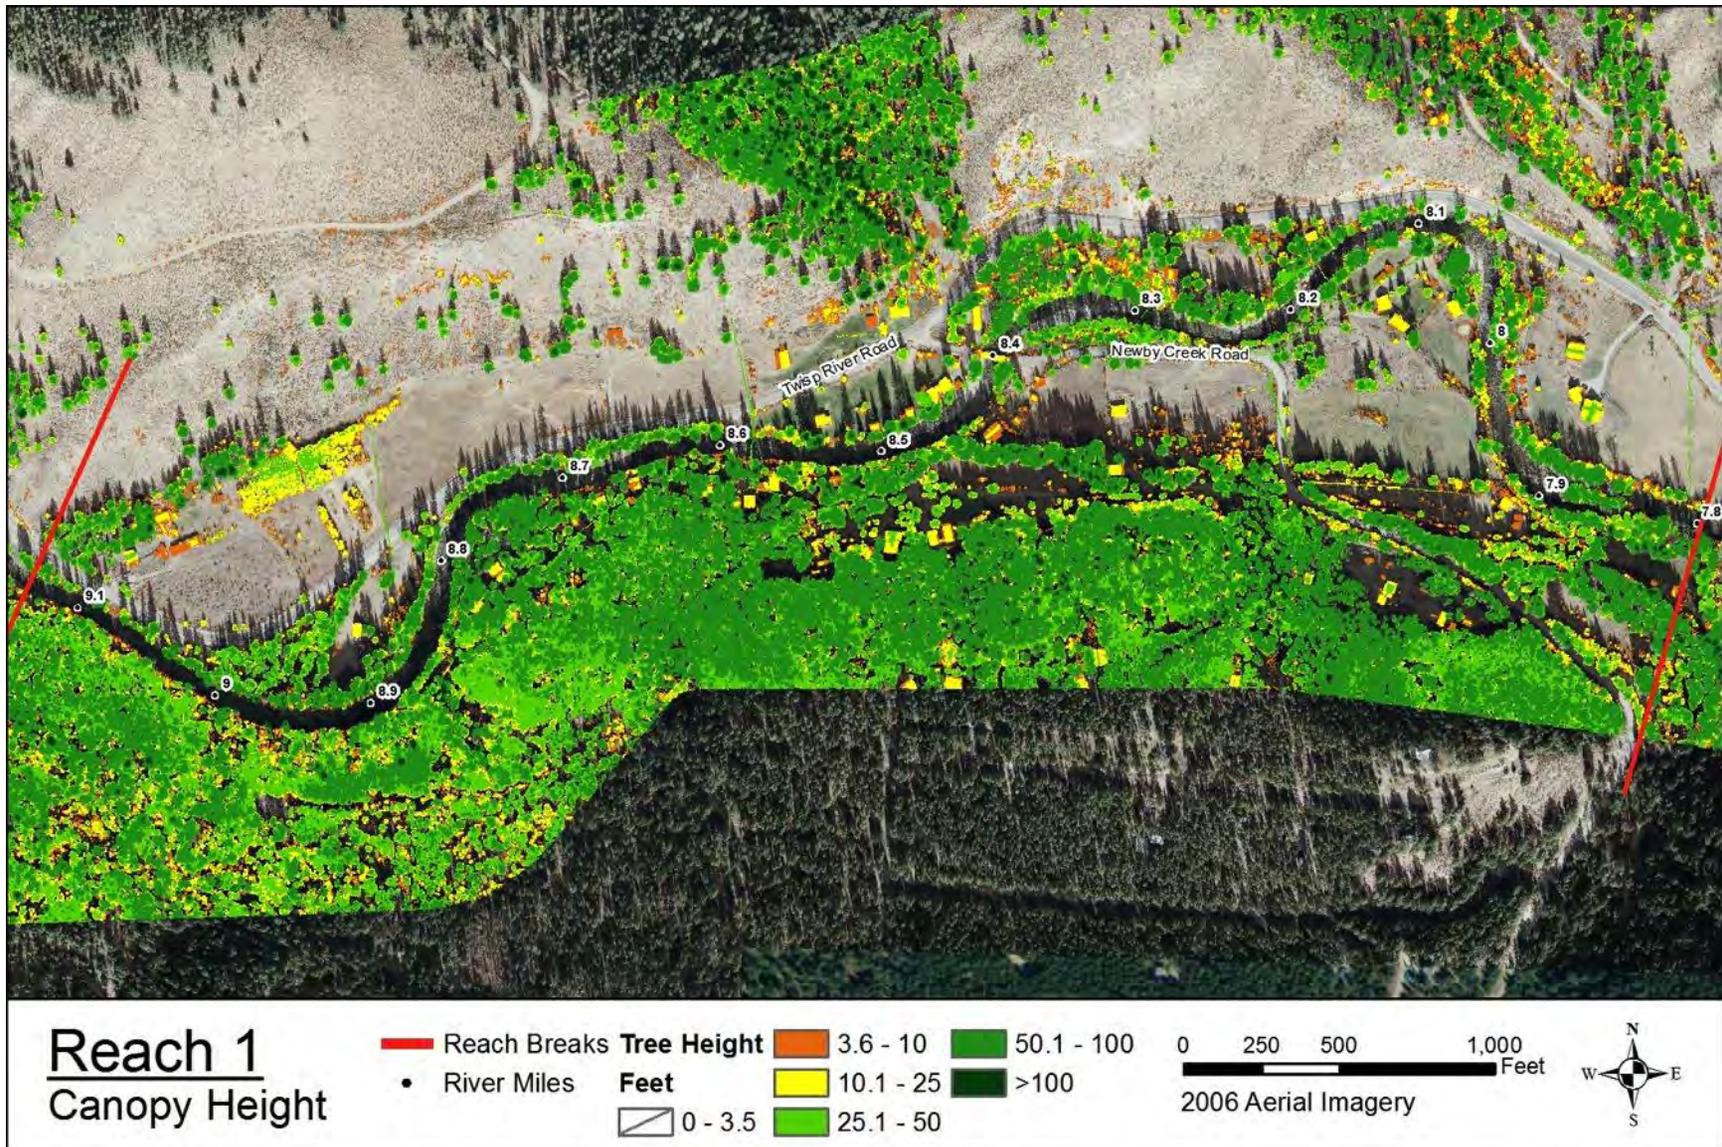
Figure 21. LiDAR first return (highest hit) data for Reach 1. These data show vegetation canopy heights. Buildings and other human infrastructure are also included in this data.

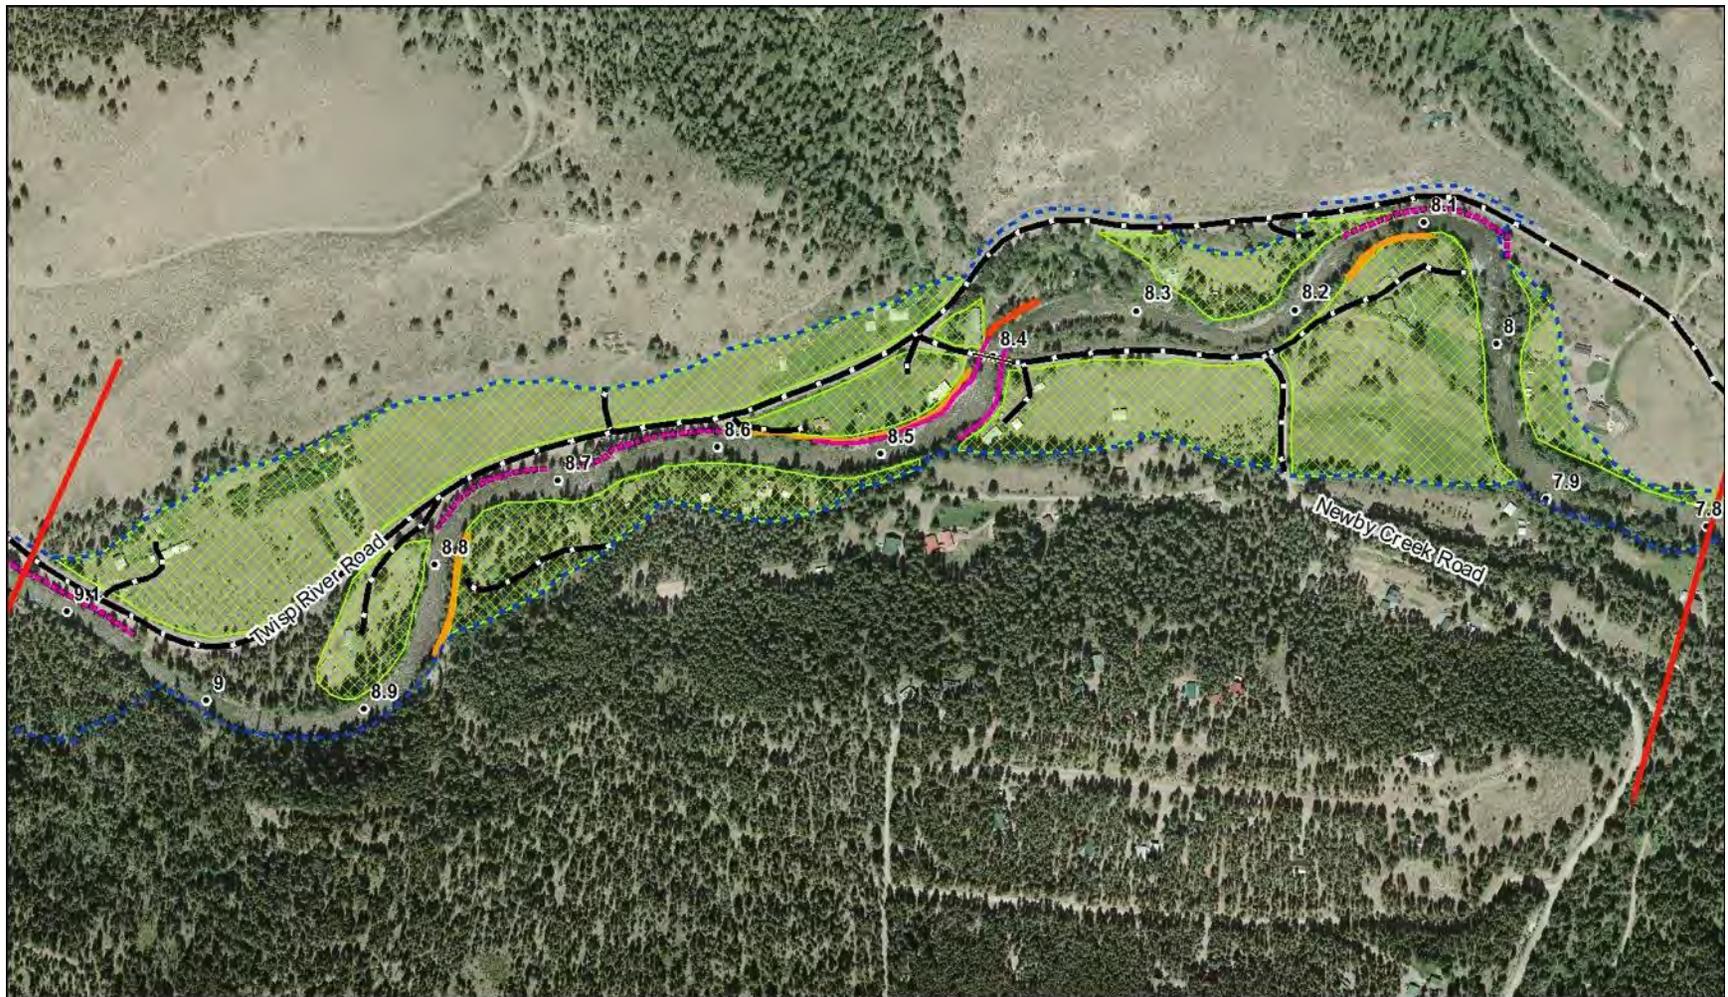
Reach 1 Human Features

Figure 22. Human features in Reach 1 that are within the low surface.

The roadway construction, embankment creation, and riprap installation that has occurred in Reach 1 impedes stream bank complexity but does not seem to greatly impact natural channel migration, as the channel is naturally confined. Lateral channel dynamics have been impacted by the bridge and its associated abutments at RM 8.4 (Figure 23). The bridge does not have piers in the channel and appears to be appropriately sized, but the riprap along both sides of the channel, up and downstream of the structure, is acting as a lateral constriction to the channel upstream of the bridge. Riprap was also installed to protect the property banks in locations where residential clearing and grading occurred (Figure 22). The use of riprap along those banks, as well as the pushup levee along river-right (RM 8.8), disconnects the river from the floodplain by reducing the frequency and extent of floodplain inundation.
