Middle Twisp River Reach Assessment & Restoration Strategy

SUBMITTED TO
Yakama Nation Fisheries Program

FEBRUARY 2015

PREPARED BY
Inter-Fluve, Inc.
501 Portway Ave, Suite 101
Hood River, OR 97031
(541) 386-9003

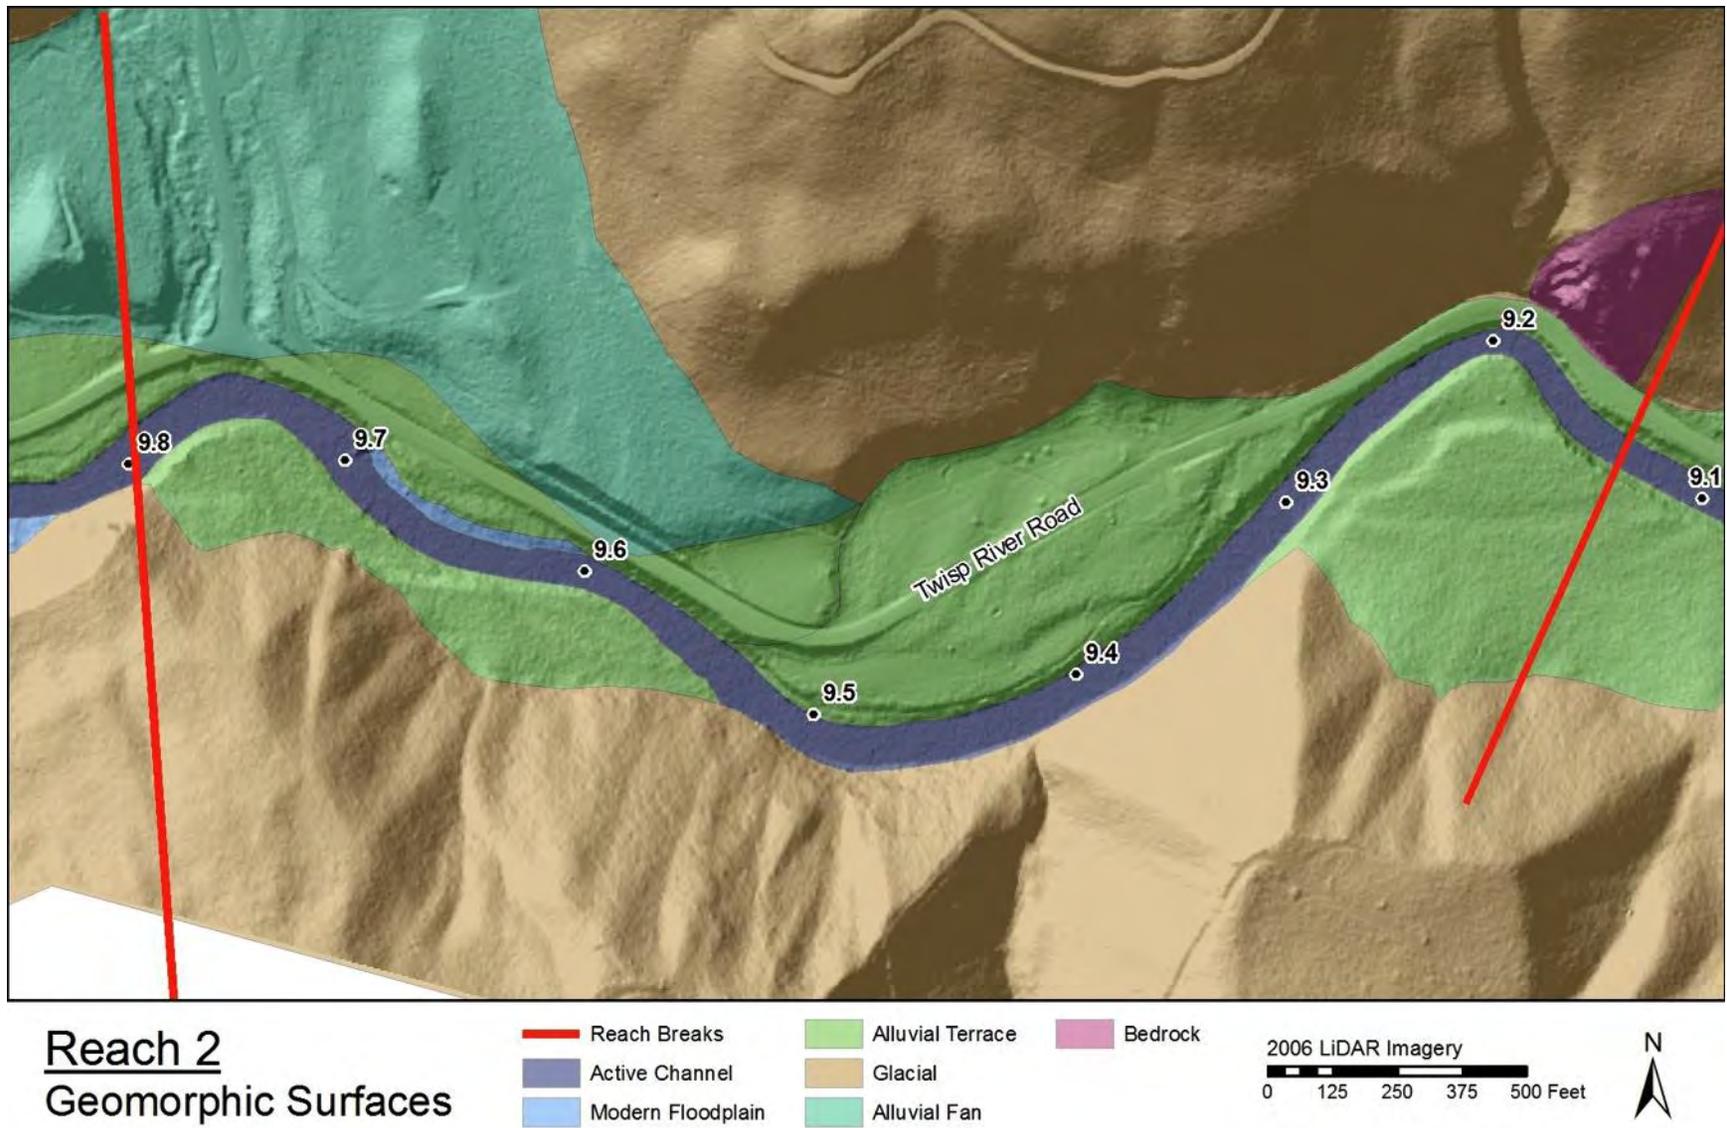
Figure 27. Geomorphologic surfaces map showing the natural confinement found on both sides of Reach 2.

Reach 2 is laterally constrained primarily by alluvial fan deposits generated from Little Bridge Creek along the north side of the valley and also by glacial terraces that form a steep bank along the south side (Figure 27). There is evidence of erosion along the toe of the alluvial fan in the downstream portion of the reach, but the intermediate surface has since been abandoned due to channel incision. The channel has generally maintained its current location throughout the period of record (through 1953). These geomorphic units lining the channel provide great lateral control through the reach, resulting in a single-thread morphology through this steep (1.16% gradient; Figure 26), riffle dominated (81%) reach. The lack of lateral migration is also evidenced in the low calculated sinuosity and low channel complexity in comparison with surrounding reaches.

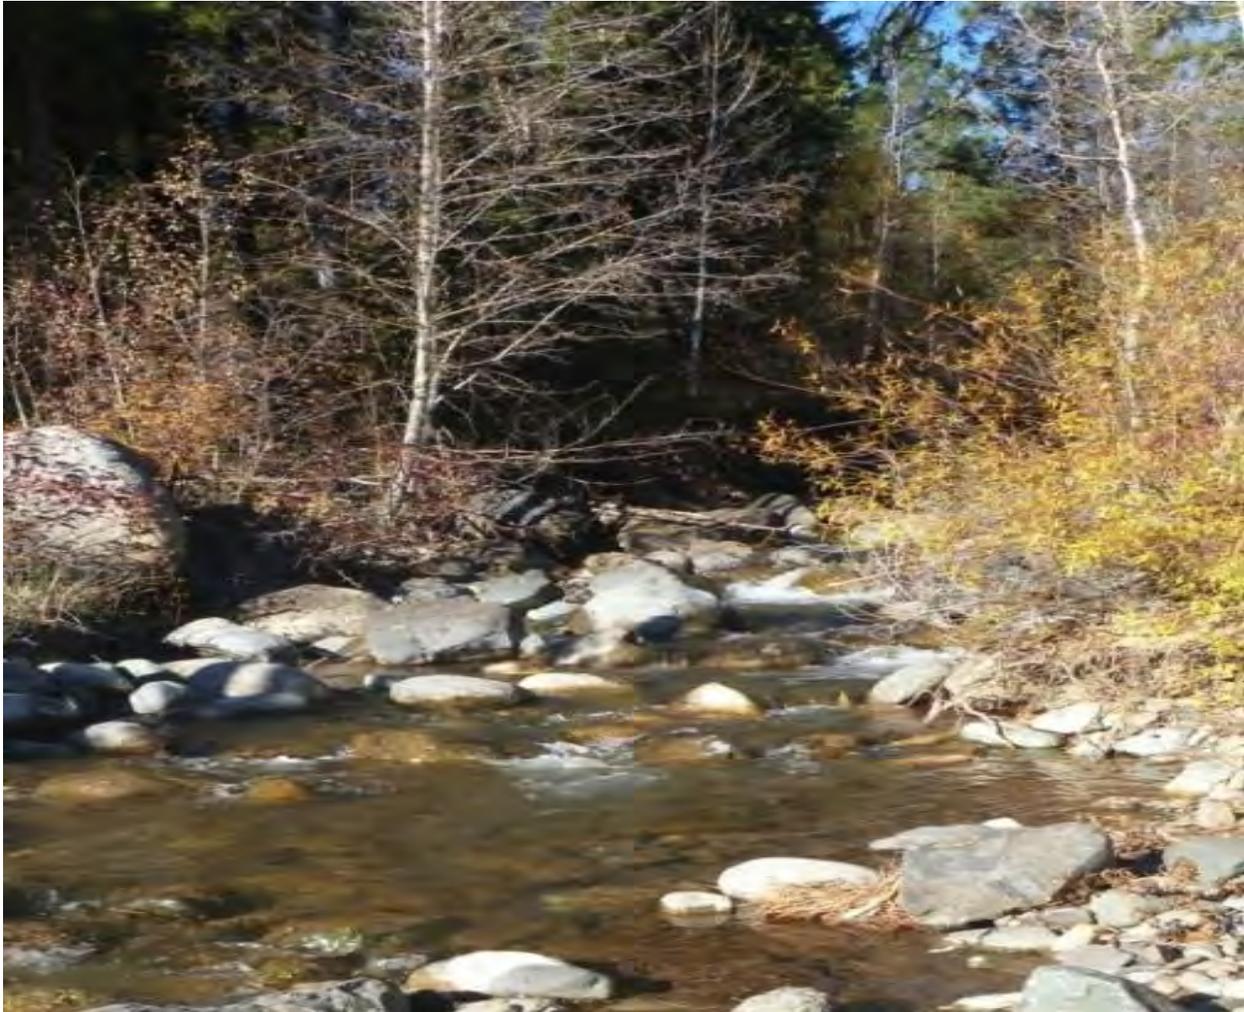
Figure 28 Looking upstream at Little Bridge Creek

Little Bridge Creek enters the main channel along the north side of the channel, in the upstream portion of this reach. It is connected to the mainstem of the Twisp River through a large bottomless arch culvert that runs under Twisp River Road. This tributary contributes about 10% of the flow to the Twisp River at this location. Little Bridge Creek is a naturally laterally and vertically confined boulder-step-pool system with a boulder-cobble bed. The aggradation observed within the culvert at the mouth of the tributary provides evidence that Little Bridge Creek is contributing sediment to the main channel (Figure 28).

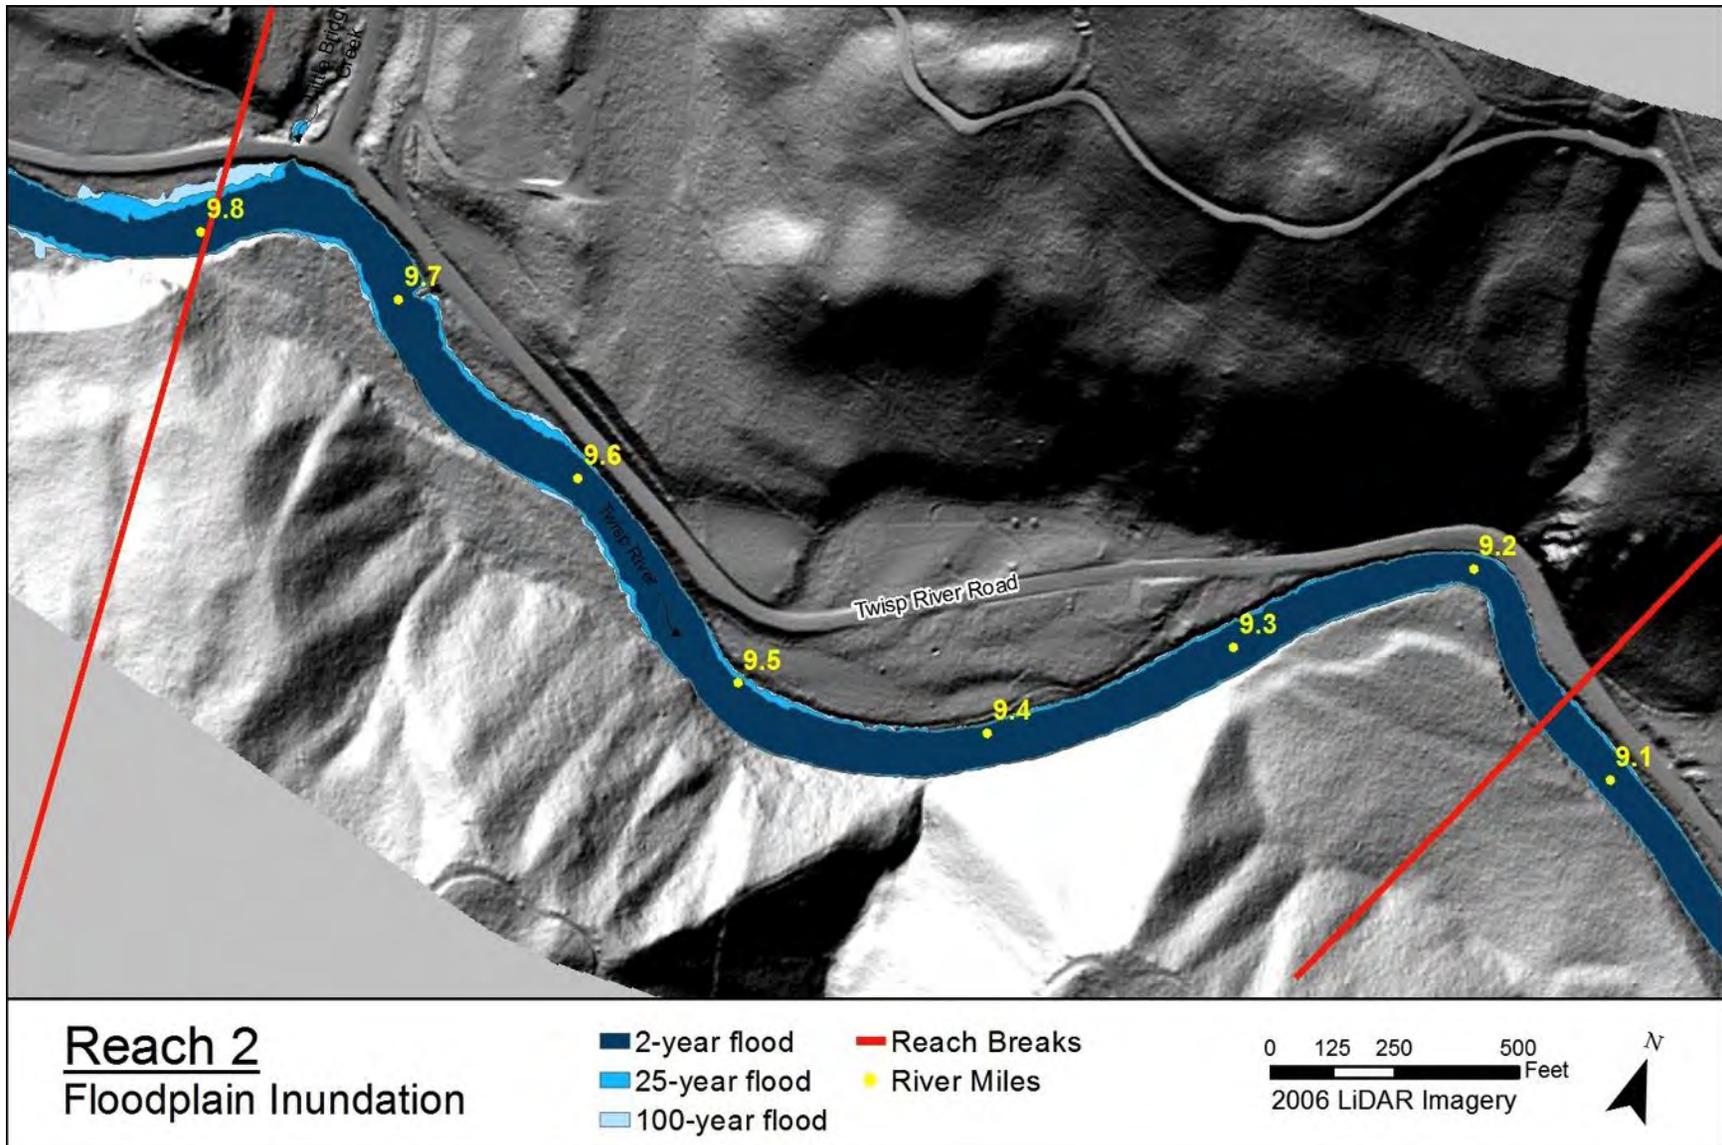
Figure 29. Floodplain inundation for selected years.

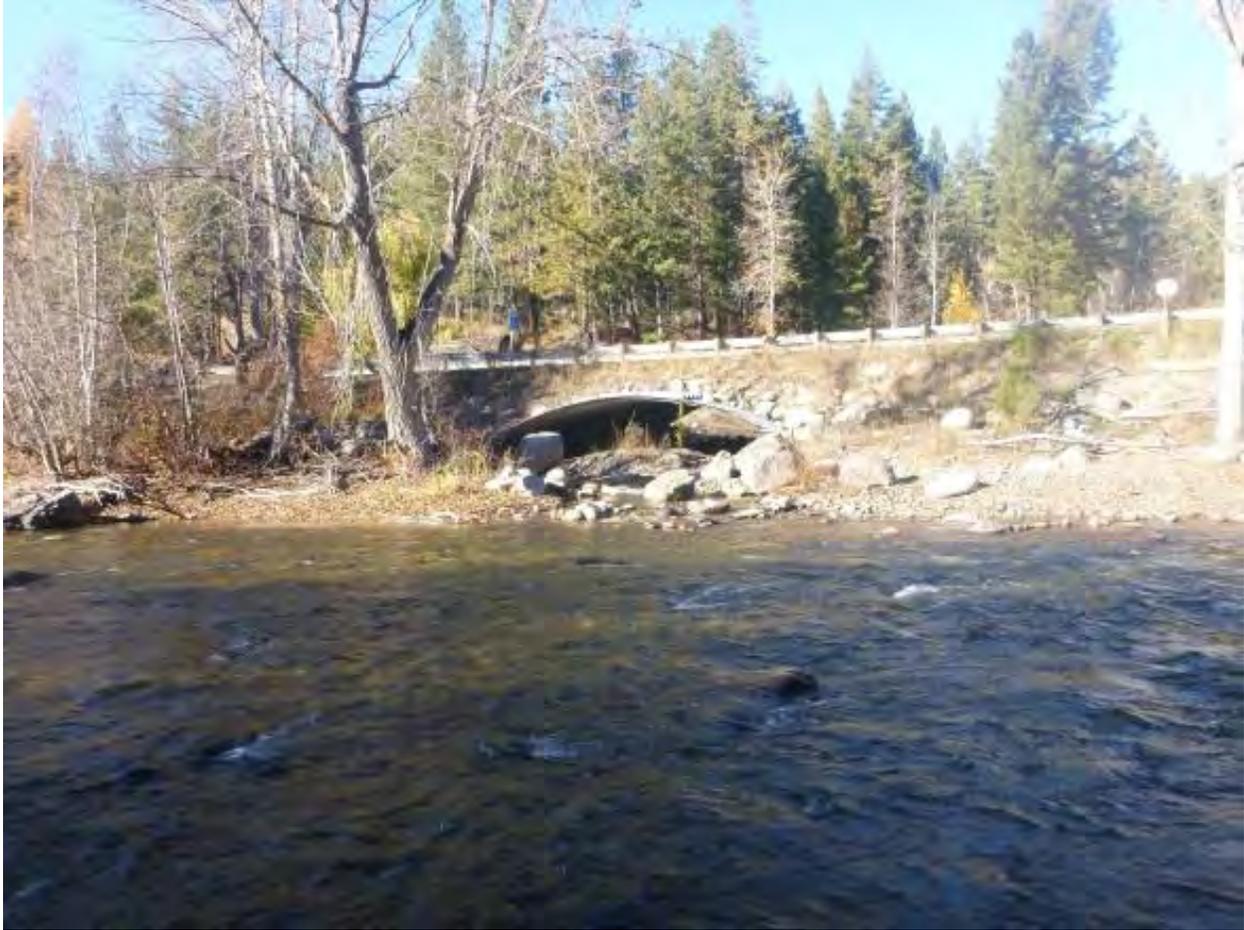
Figure 31 Sediment accumulation in the bottomless culvert at the confluence of the Little Bridge Creek tributary and the Twisp River.

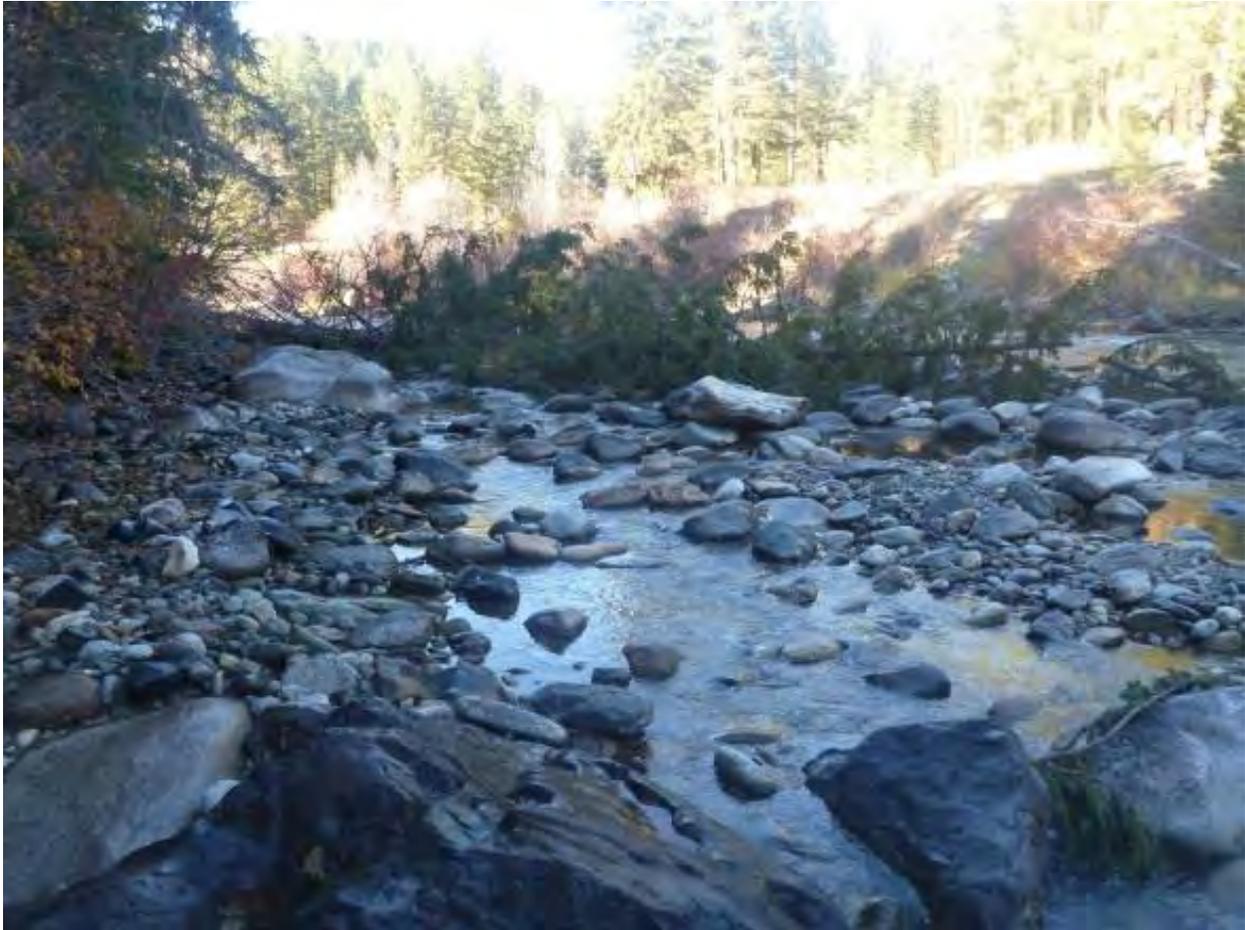
Figure 33 large wood recruitment at RM 9.7.

Reach 2 had the lowest wood counts of the entire study area (18 total pieces total) and did not have any log jams. A fallen conifer was noted in this reach at RM 9.7 (Figure 33) and resulted in an area of localized cobble accumulation, but the overall lack of wood in the reach, swift current, and large substrate are indicative of a transport reach that lacks instream habitat. The steep, heavily vegetated banks, primarily along the south side of the river, are potential sources of additional large wood recruitment to the system.

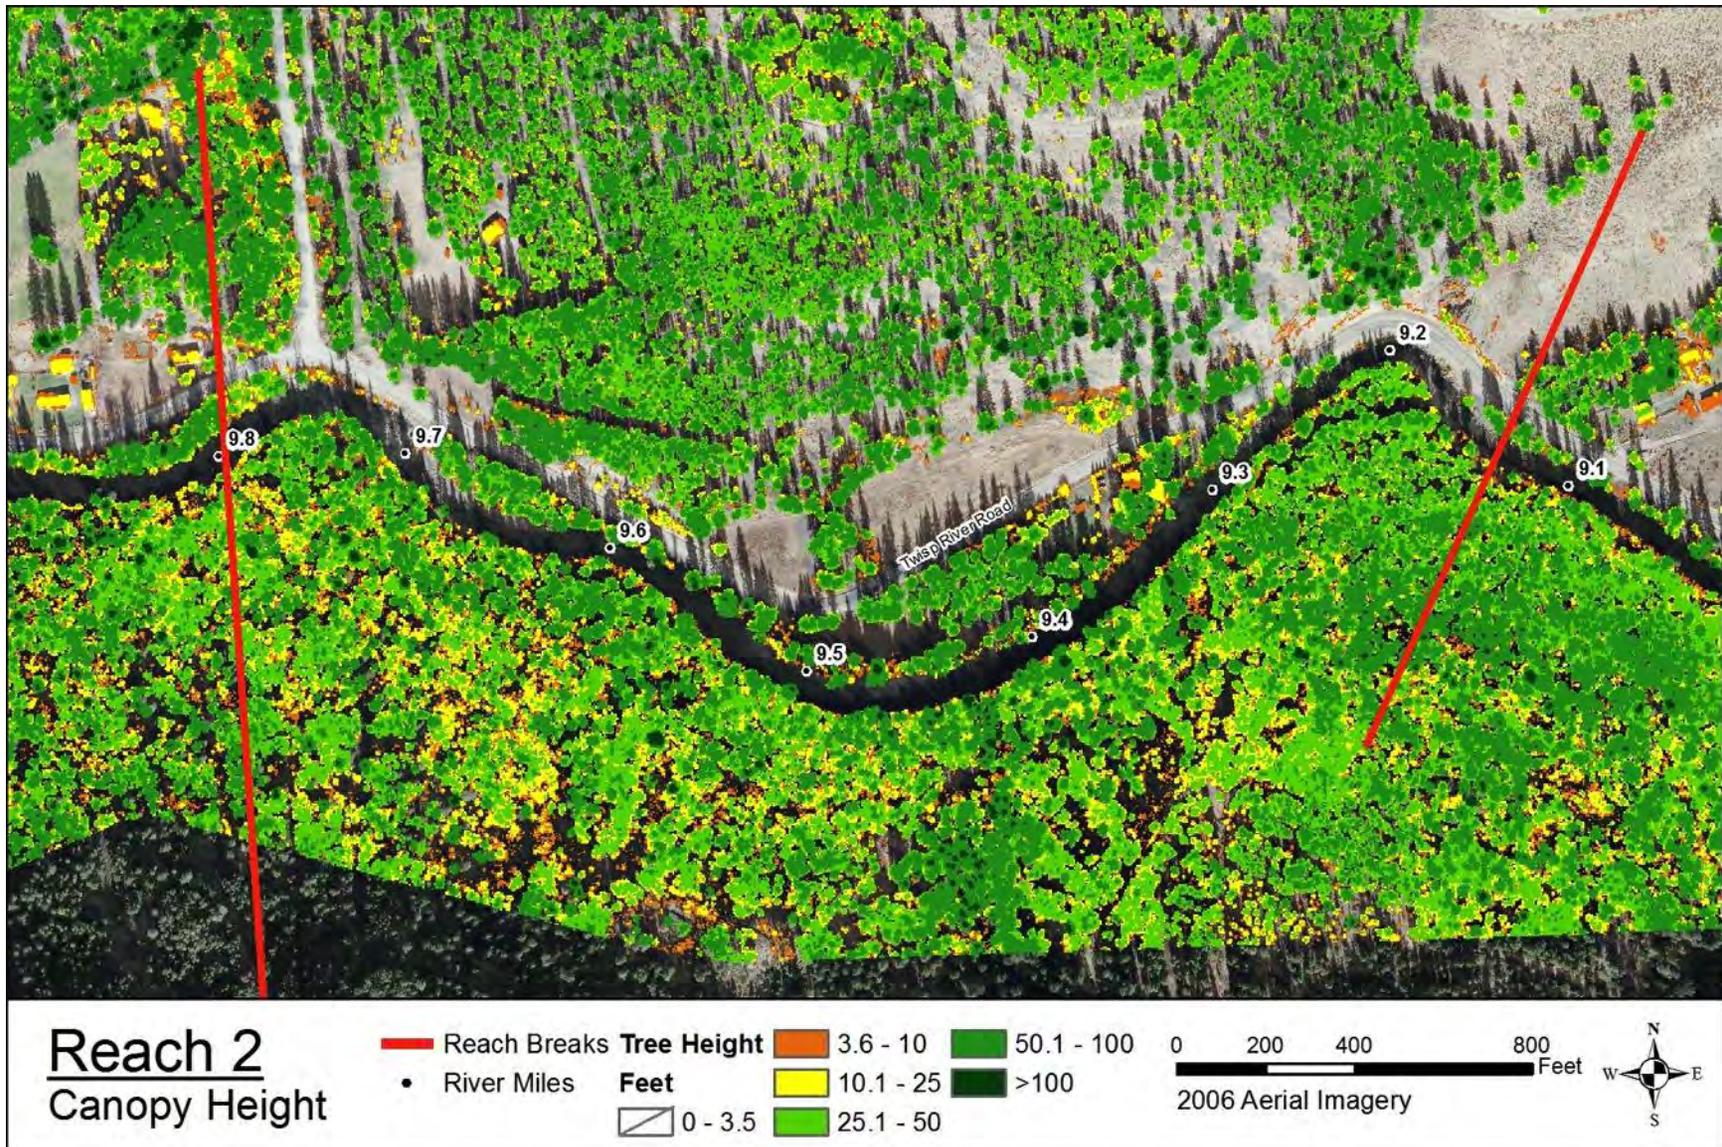
Figure 34. LiDAR first return (highest hit) data for Reach 2. These data show vegetation canopy heights. Buildings and other human infrastructure are also included in this data.

Figure 34 shows that a majority of the vegetation is less than 50 feet tall, with patches of trees up to 100 feet tall. There are several areas along the north side of the channel where the riparian corridor is very narrow and clearing has occurred up to the channel's edge. There are some fallen conifers in this reach, but wood recruitment is much lower than would be expected under undisturbed conditions. Past removal of riparian vegetation impacts biological and physical processes. The lack of a dense vegetative canopy reduces the amount of shade provided to the stream, increasing summer water temperatures and decreasing winter water temperatures. The removal of vegetation from the system has reduced the amount of wood available for future recruitment.

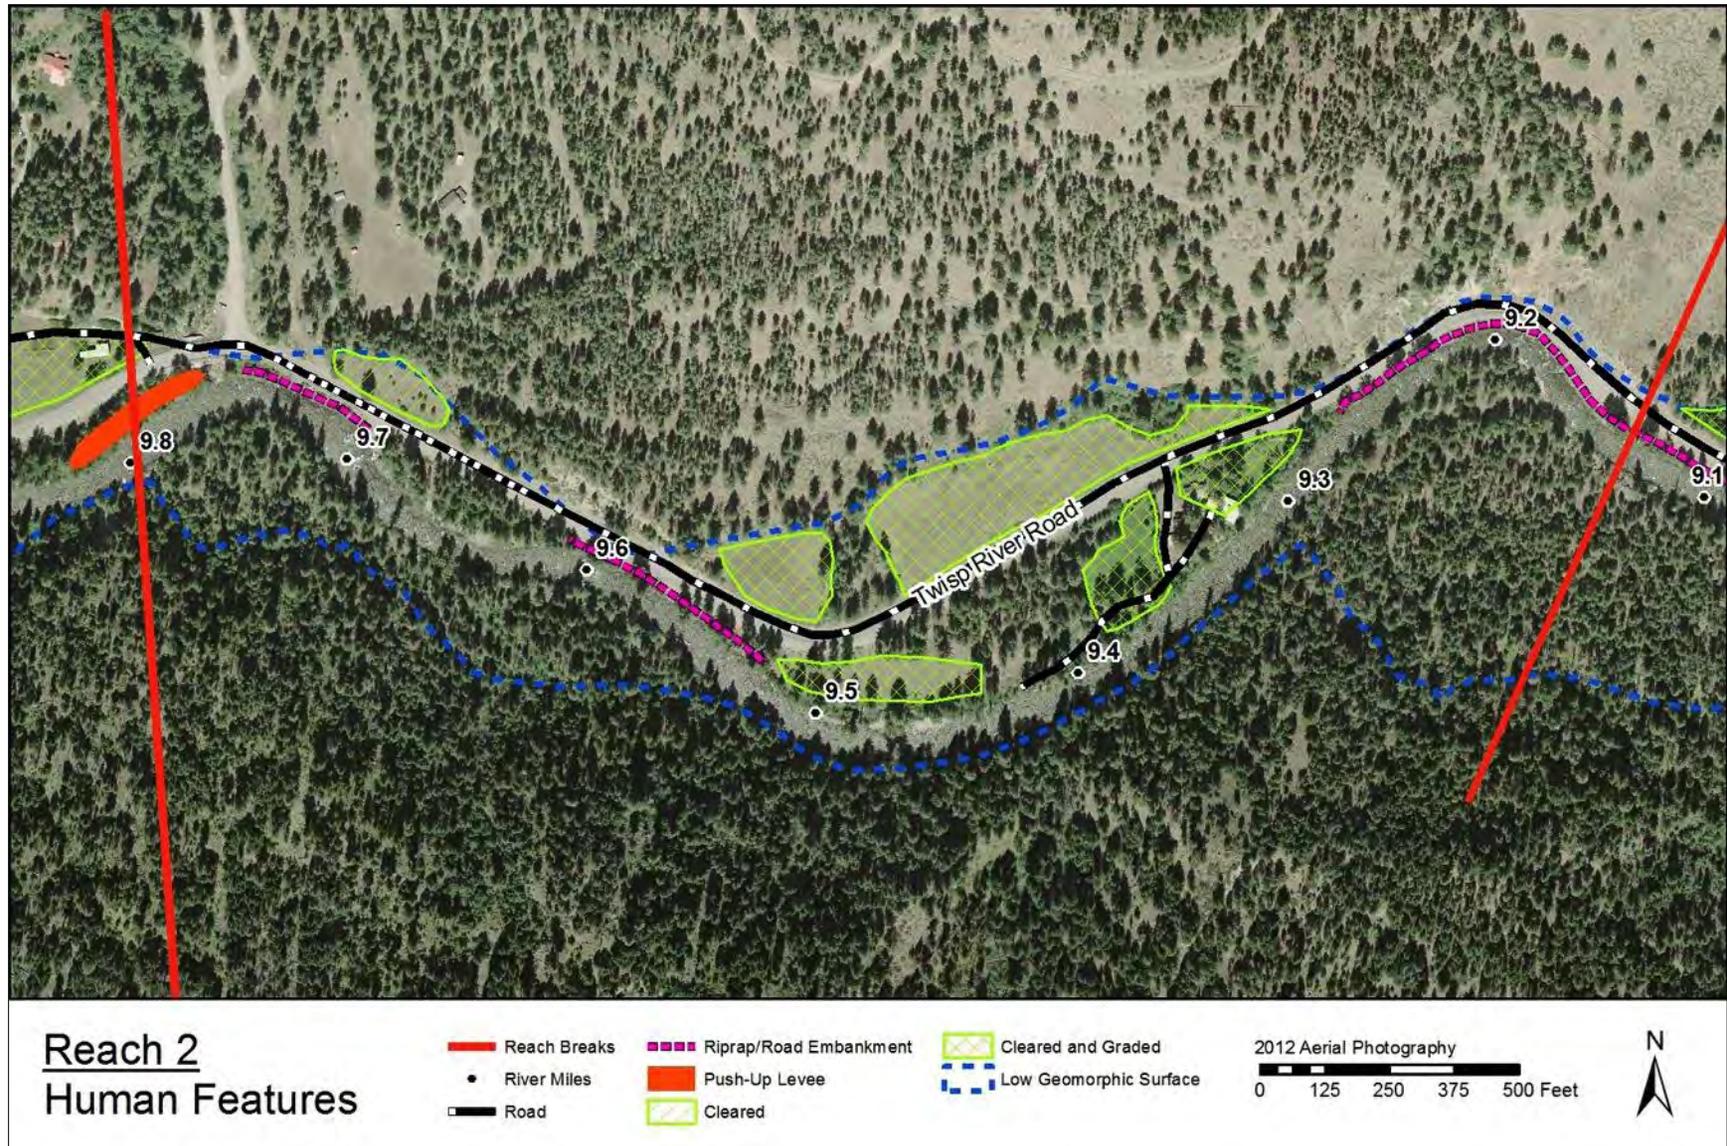
Figure 35. Human features in Reach 2.

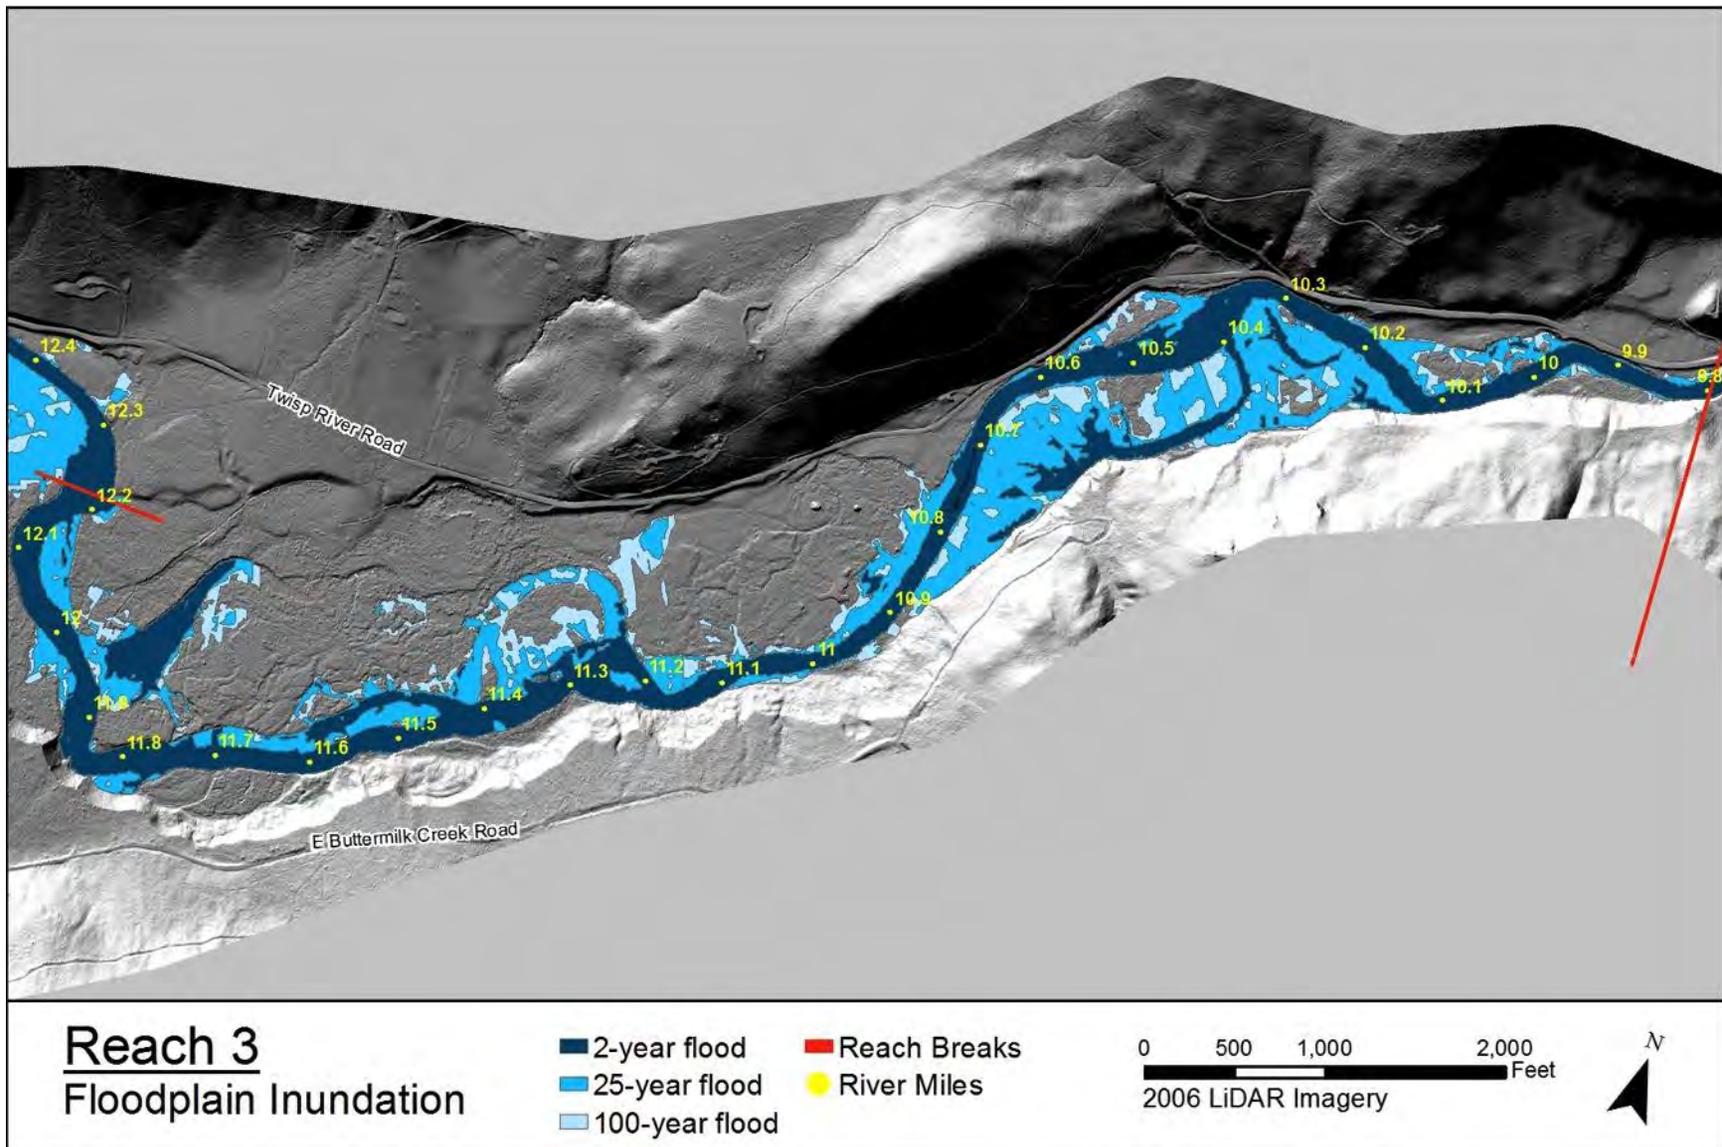
Figure 40 Extents of floodplain inundation for selected flood recurrence intervals in Reach 3. Flood inundations developed using HEC-GeoRAS based on the LiDAR surface.

The floodplain in Reach 3 is several hundred feet wide and is inundated semi-regularly (Figure 40). Channel sinuosity, complexity, and floodplain inundation are higher than in downstream reaches. In the upstream half of the reach, the river is against the south valley wall and there is a broad floodplain on the north side that is comprised of an extensive network of remnant oxbows that represent former channel locations. The channel migration zone in this location, at least historically, was very large. This surface has likely seen a reduction in floodplain inundation (and migration) due to channel incision caused by downstream floodplain development and channel constriction. This is described in more detail in the Human Alterations section. In the downstream half of the reach, the river runs primarily along the north side of the valley and there is a distinctive abandoned oxbow in the river-right floodplain near RM 10.5. This surface remains relatively well-connected to flood flows.

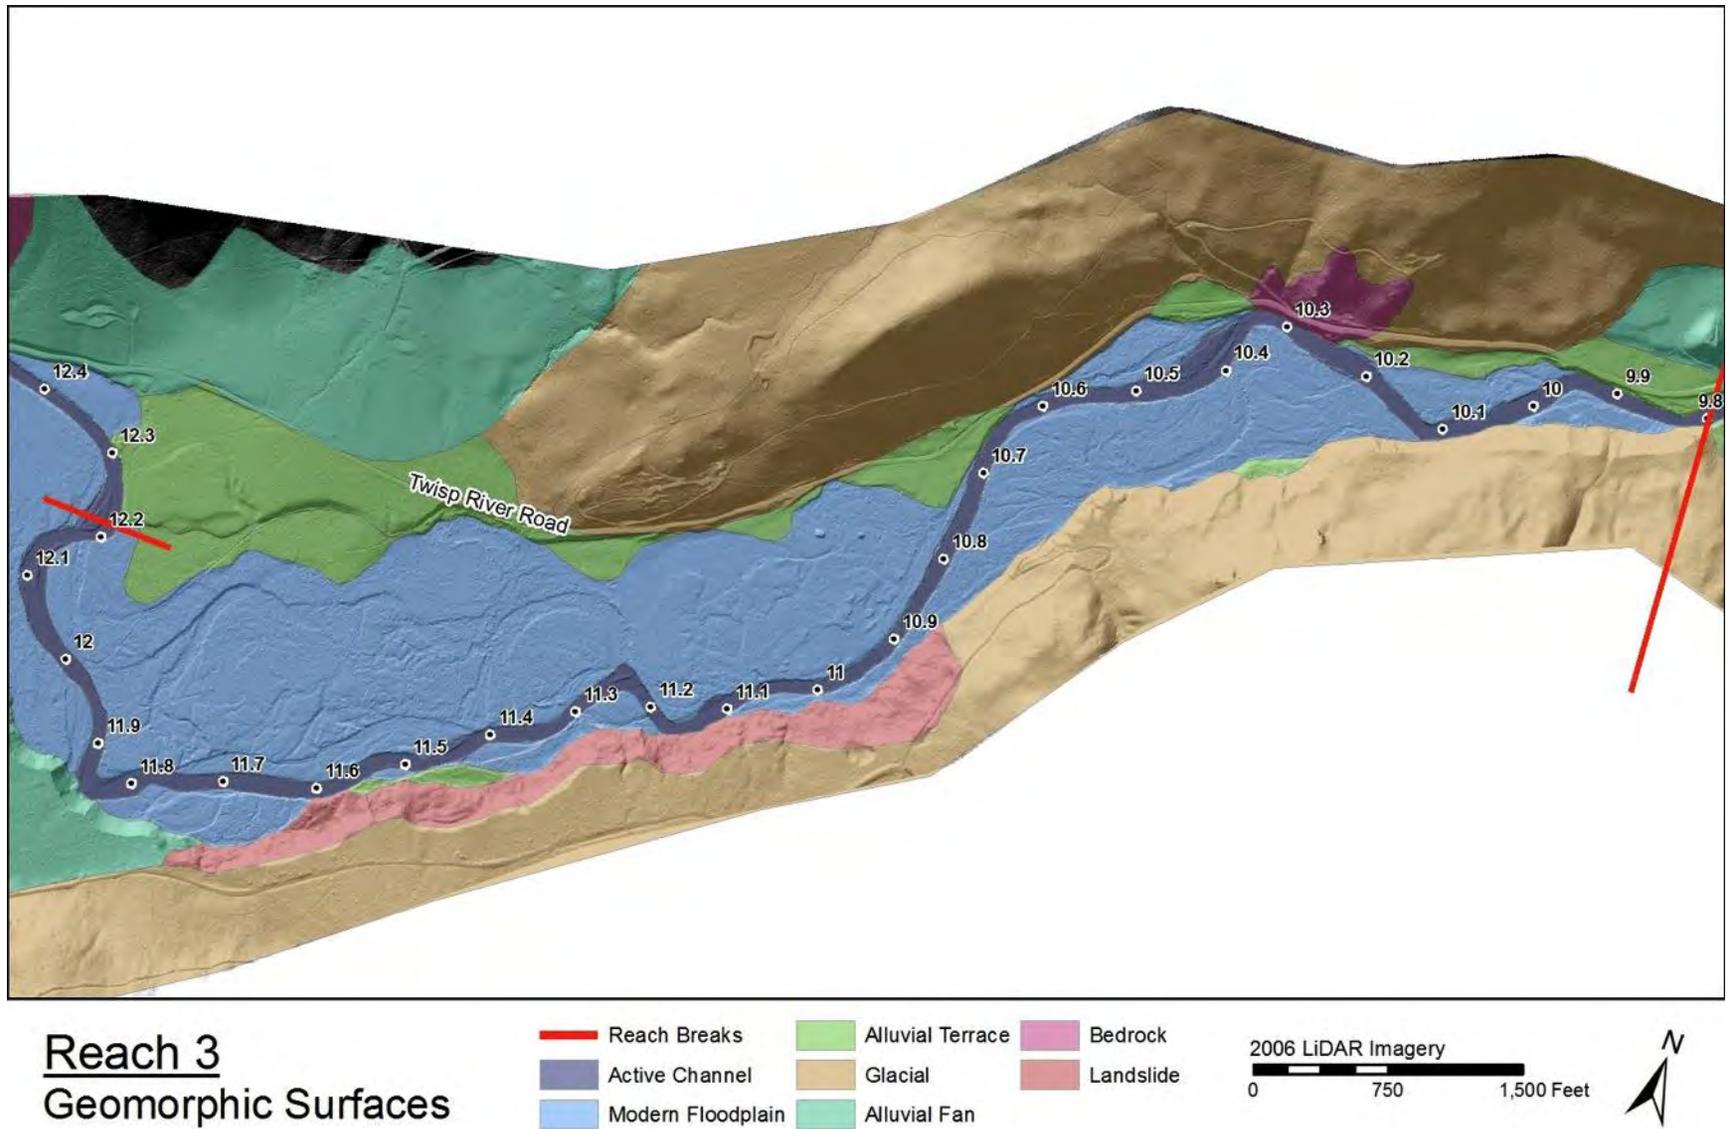
Figure 41. Geomorphic surfaces for Reach 3.

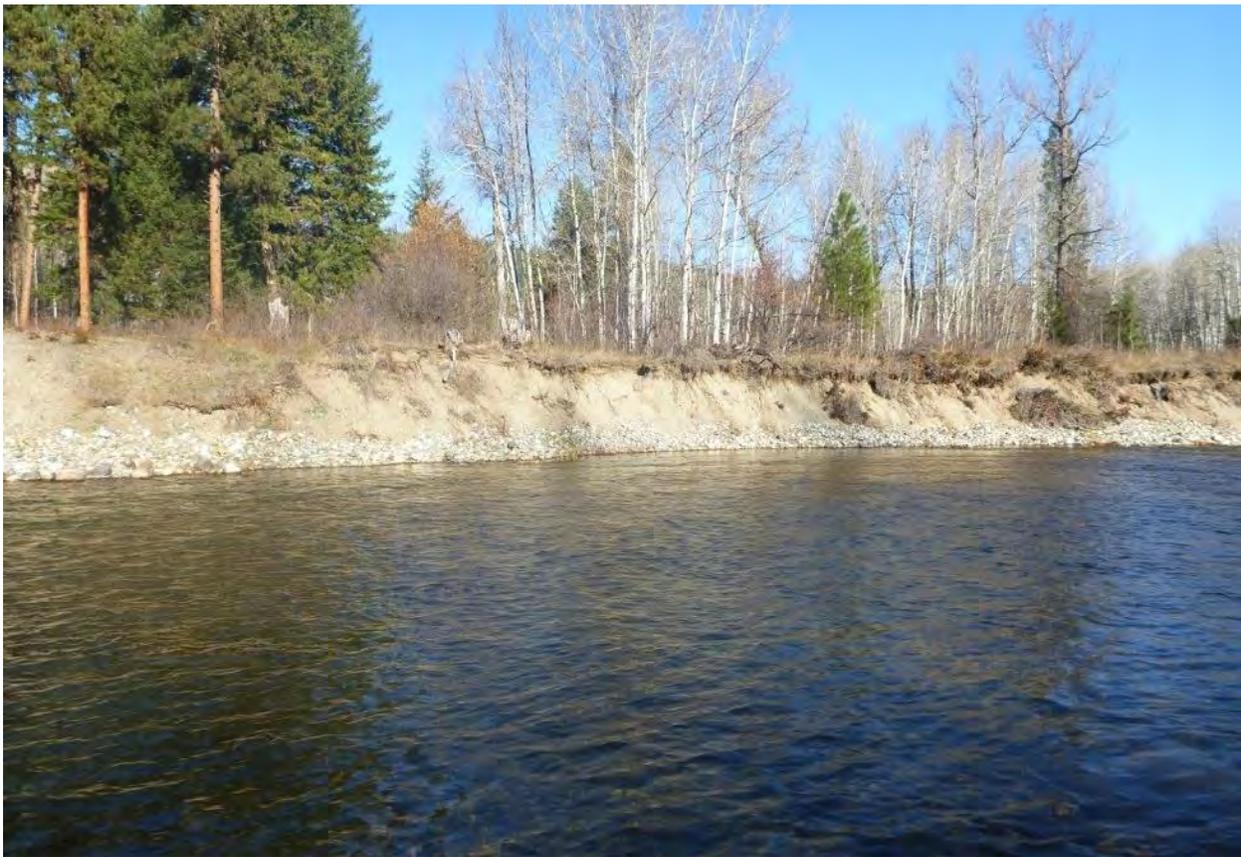
Figure 43. The high eroding banks with natural alluvium protecting the toe of the bank at RM 11.77 are acting as a source of fine sediment to the system.

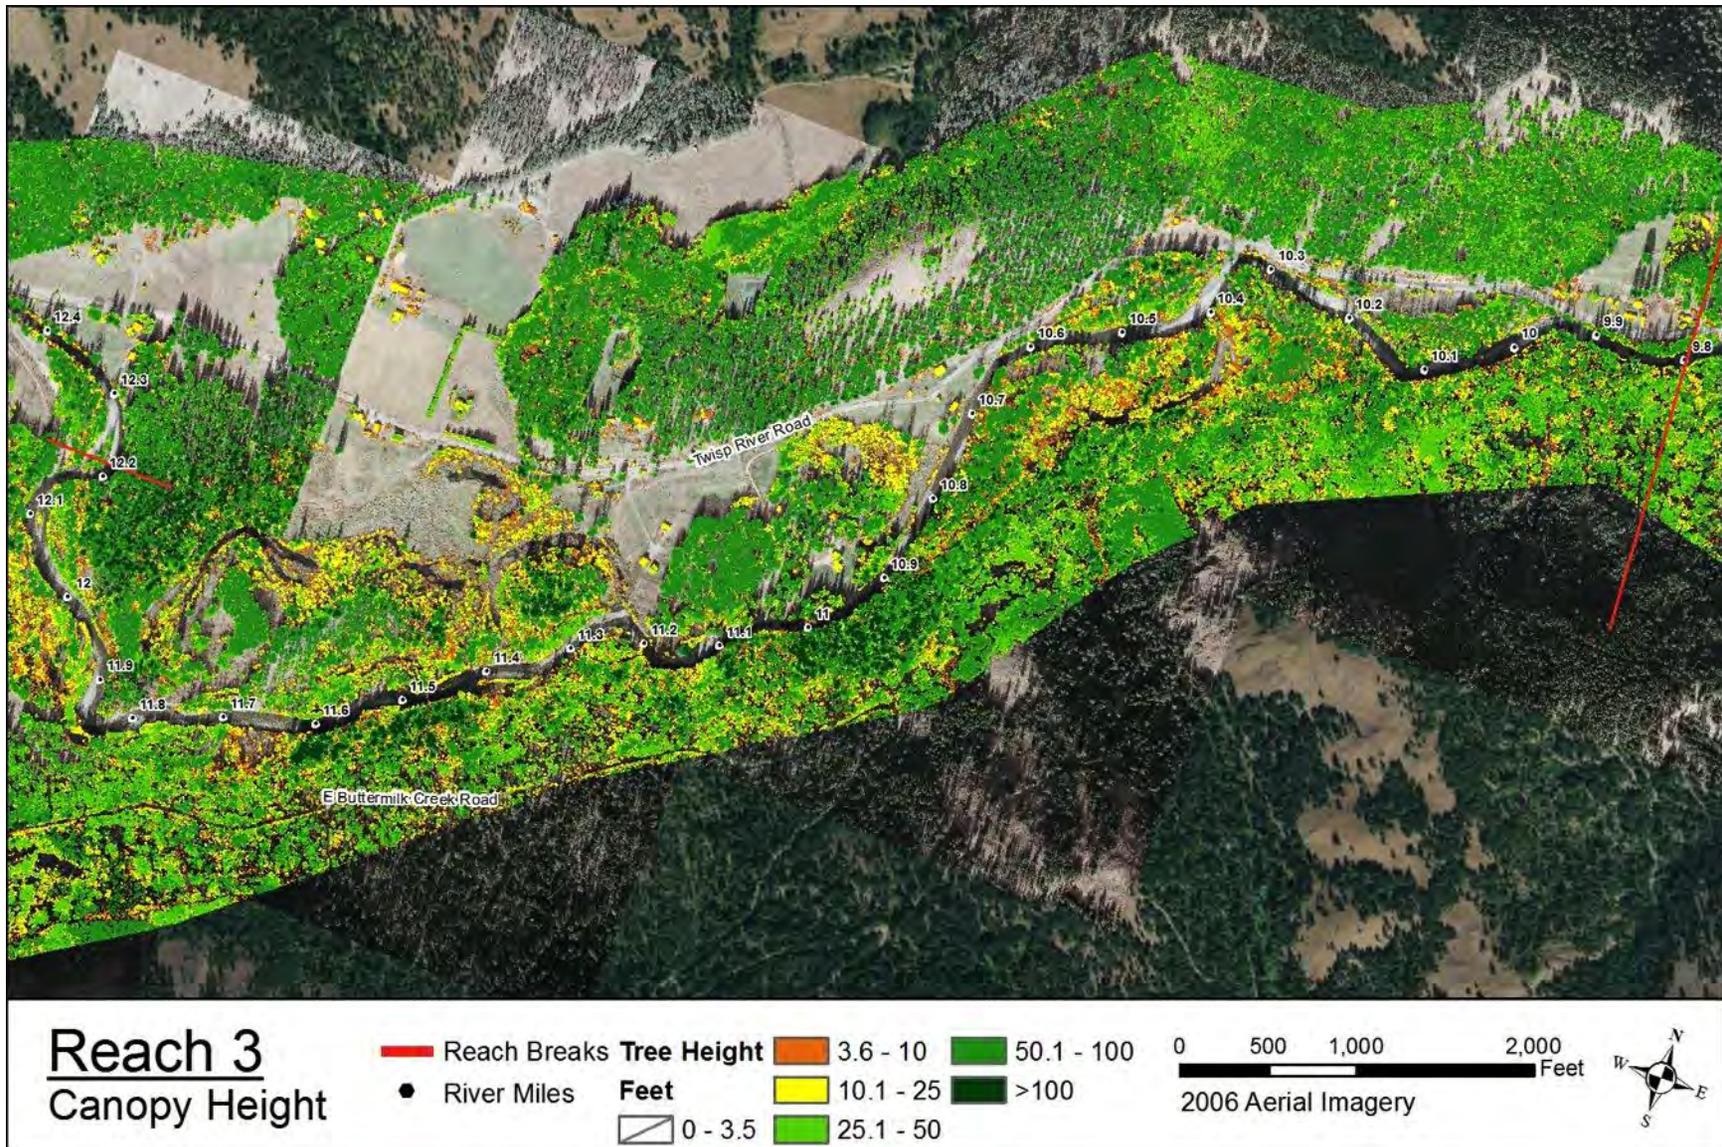
Figure 45. LiDAR first return (highest hit) data for Reach 3. These data show vegetation canopy heights. Buildings and other human infrastructure are also included in this data.

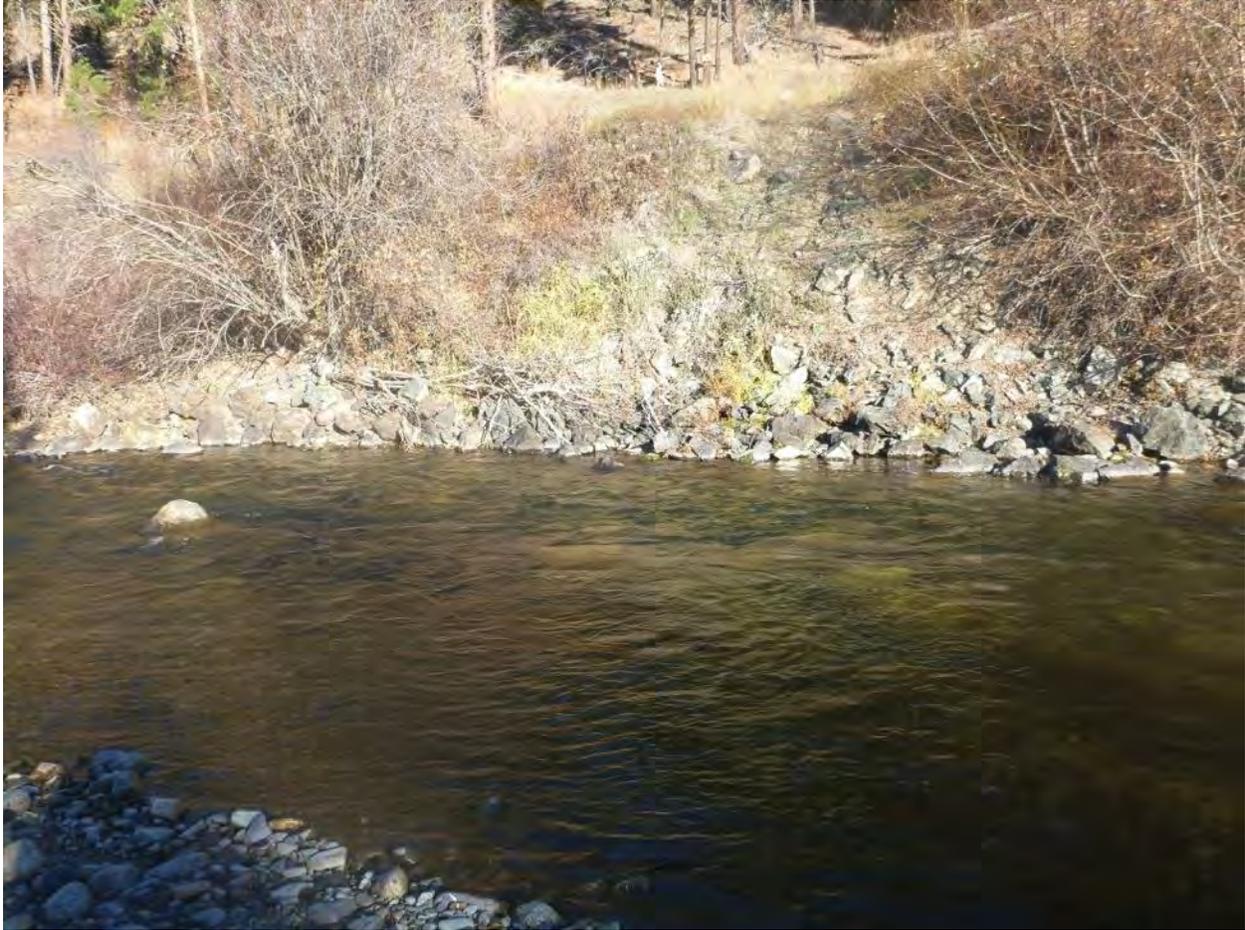
Figure 46. RM 10.27 river left, the road embankment and large angular riprap installed at the bank toe.

Large angular riprap has been installed along the base of the road embankment along river-left (Figure 36). The riprap likely does not have a significant impact on channel migration due to the confined nature of the reach, but it does have some effect on gravel and large wood recruitment processes along the channel margins. There is a large bottomless culvert at the confluence of Little Bridge Creek and the Twisp River (approximately RM 9.75) along river-left (Figure 31). Sediment deposition within the culvert has occurred, which is a result of the change in profile of Little Bridge Creek as it meets the Twisp.

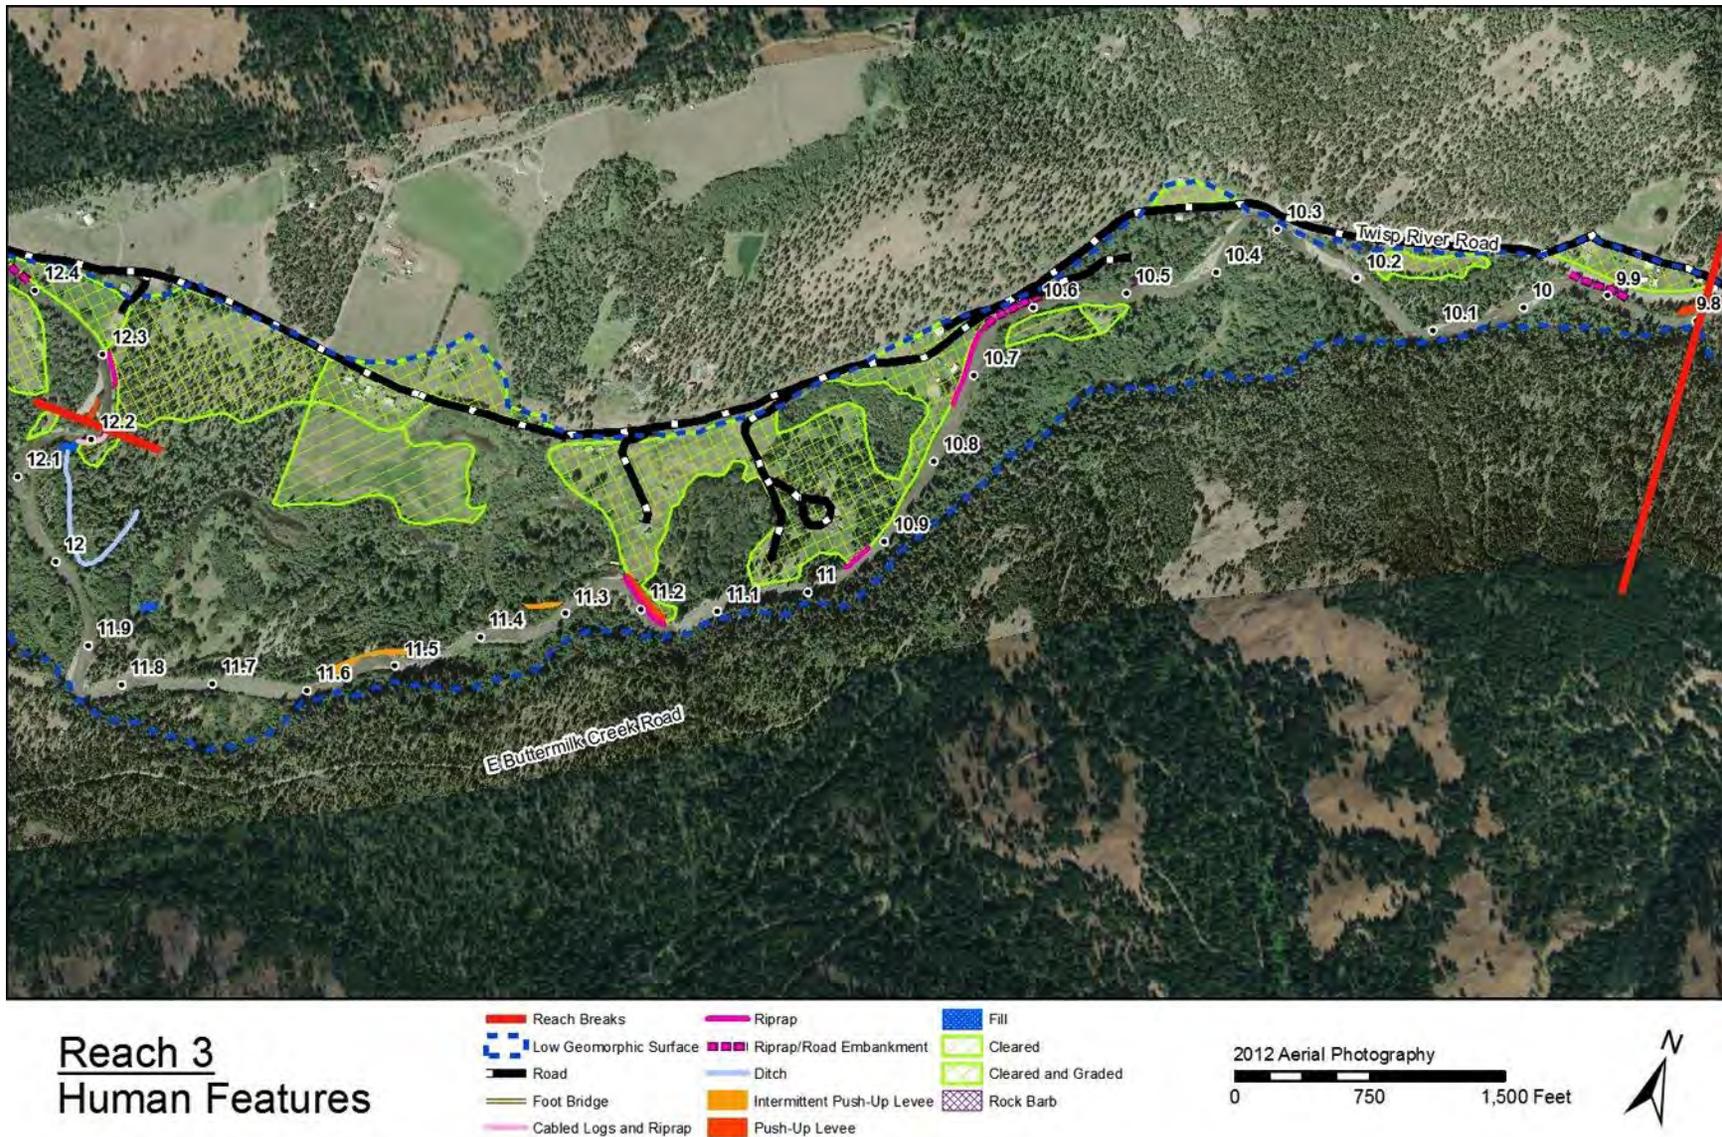
Figure 47 Human features in Reach 3.
