Middle Twisp River Reach Assessment & Restoration Strategy

SUBMITTED TO
Yakama Nation Fisheries Program

FEBRUARY 2015

PREPARED BY
Inter-Fluve, Inc.
501 Portway Ave, Suite 101
Hood River, OR 97031
(541) 386-9003

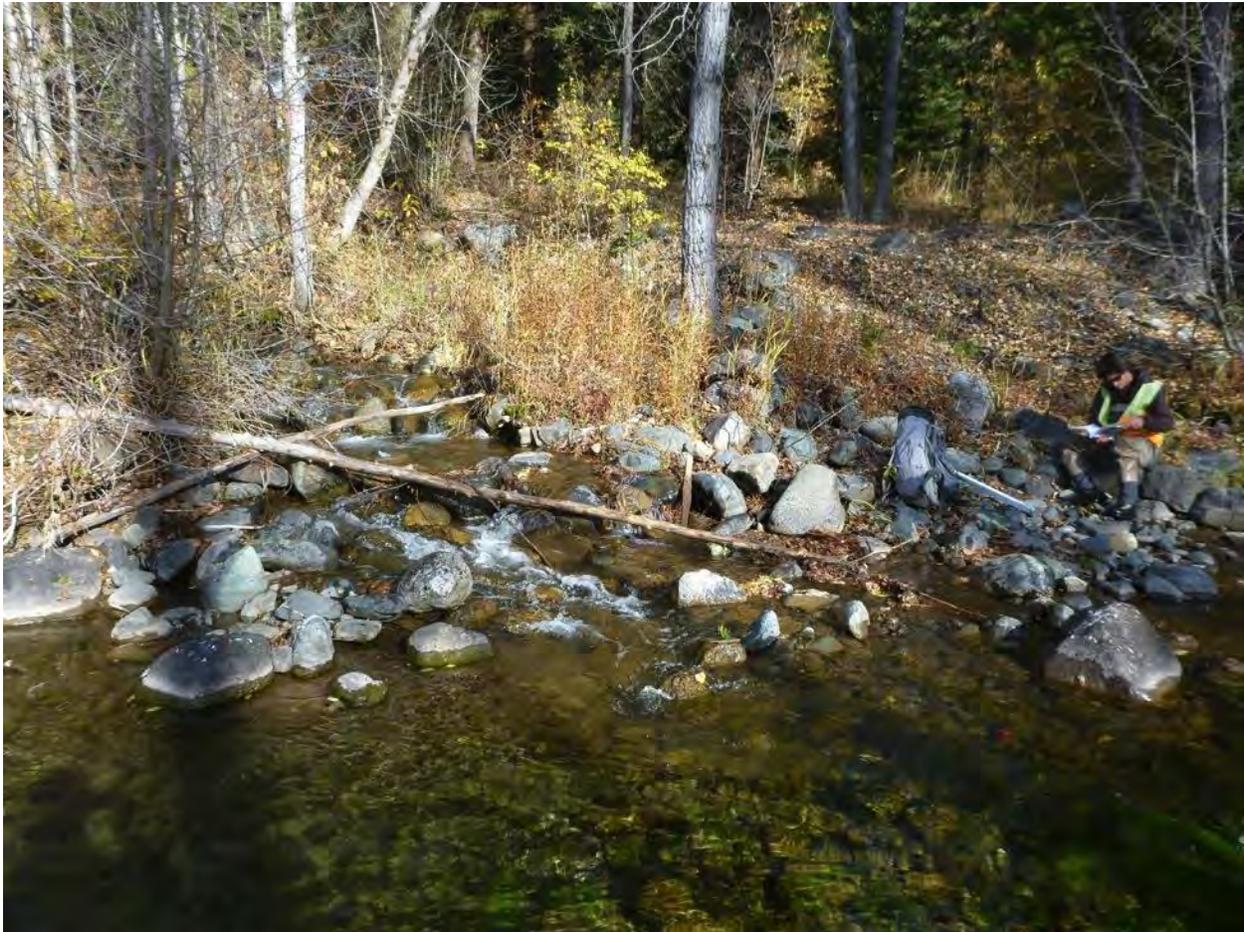
Figure 53. Mouth of Canyon Creek showing large cobble and boulder material contributed to the mainstem Twisp.

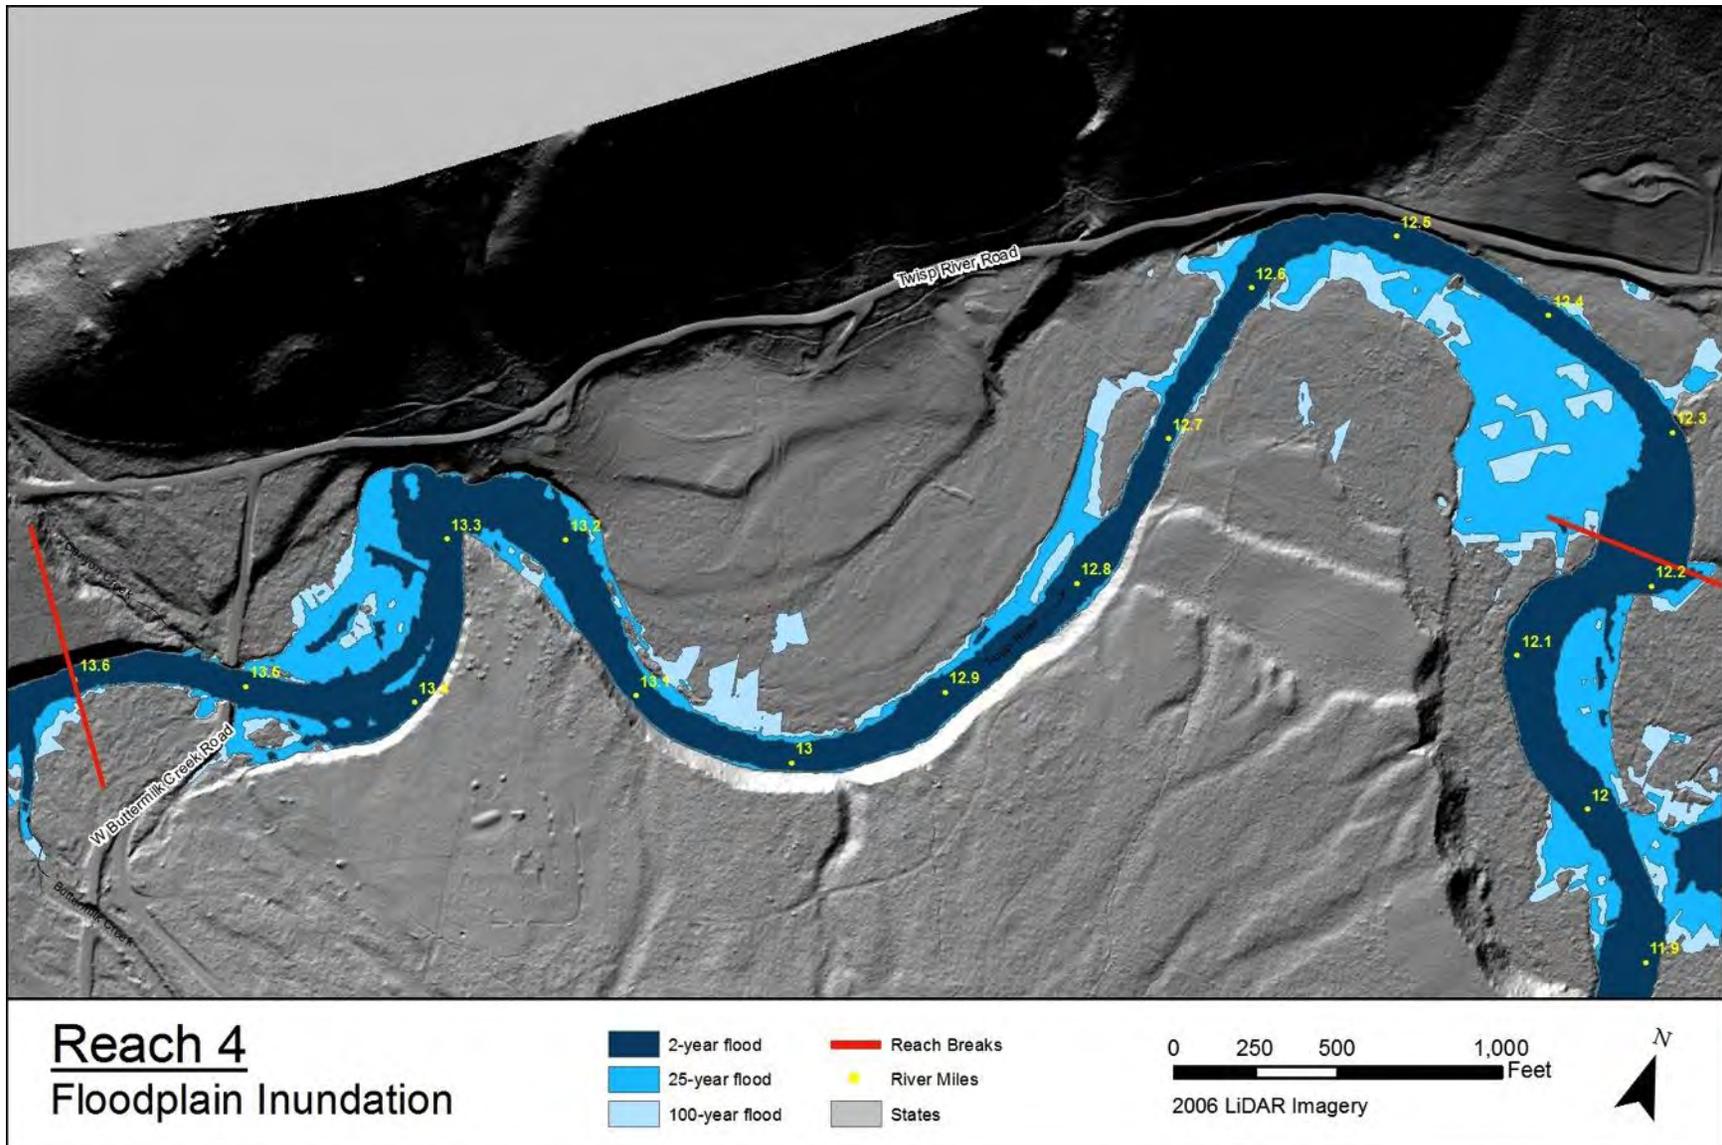
Figure 54. Extents of floodplain inundation for selected flood recurrence intervals in Reach 4. Flood inundations developed using HEC-GeoRAS based on the LiDAR surface.

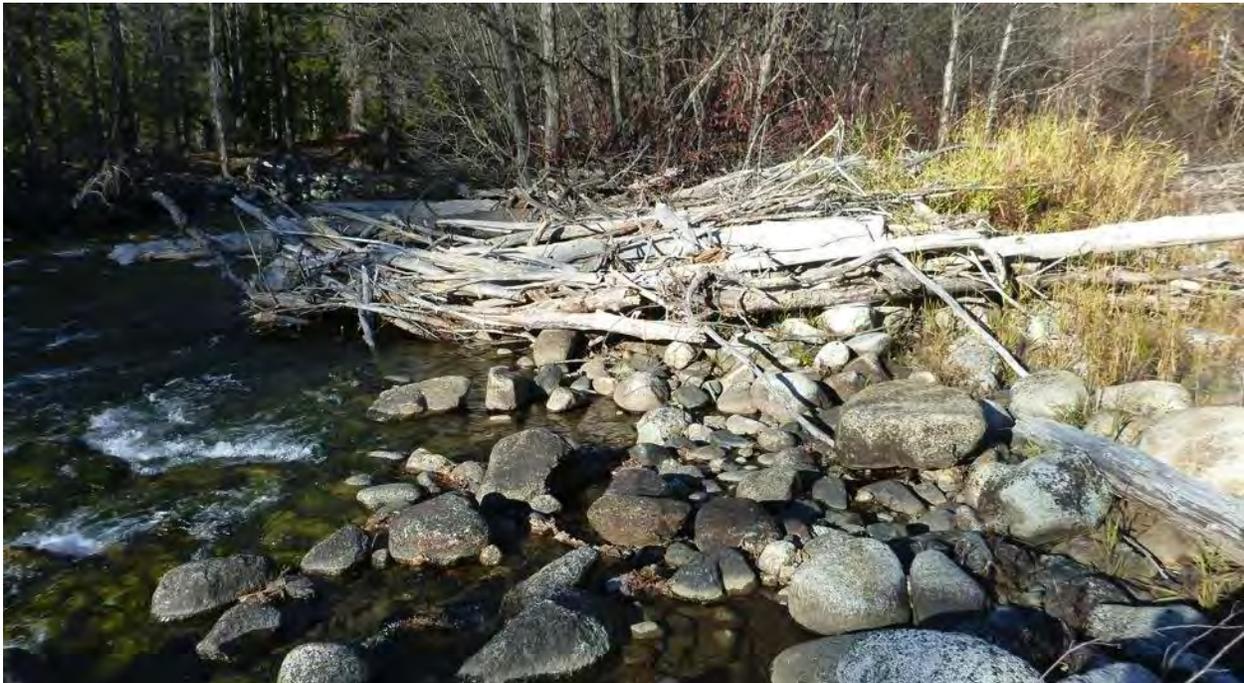
Figure 58. Bar apex log jam near RM 12.8 in Reach 4. This is one of only two log jams in the reach. Both jams were comprised primarily of the 'small' size class of large wood.

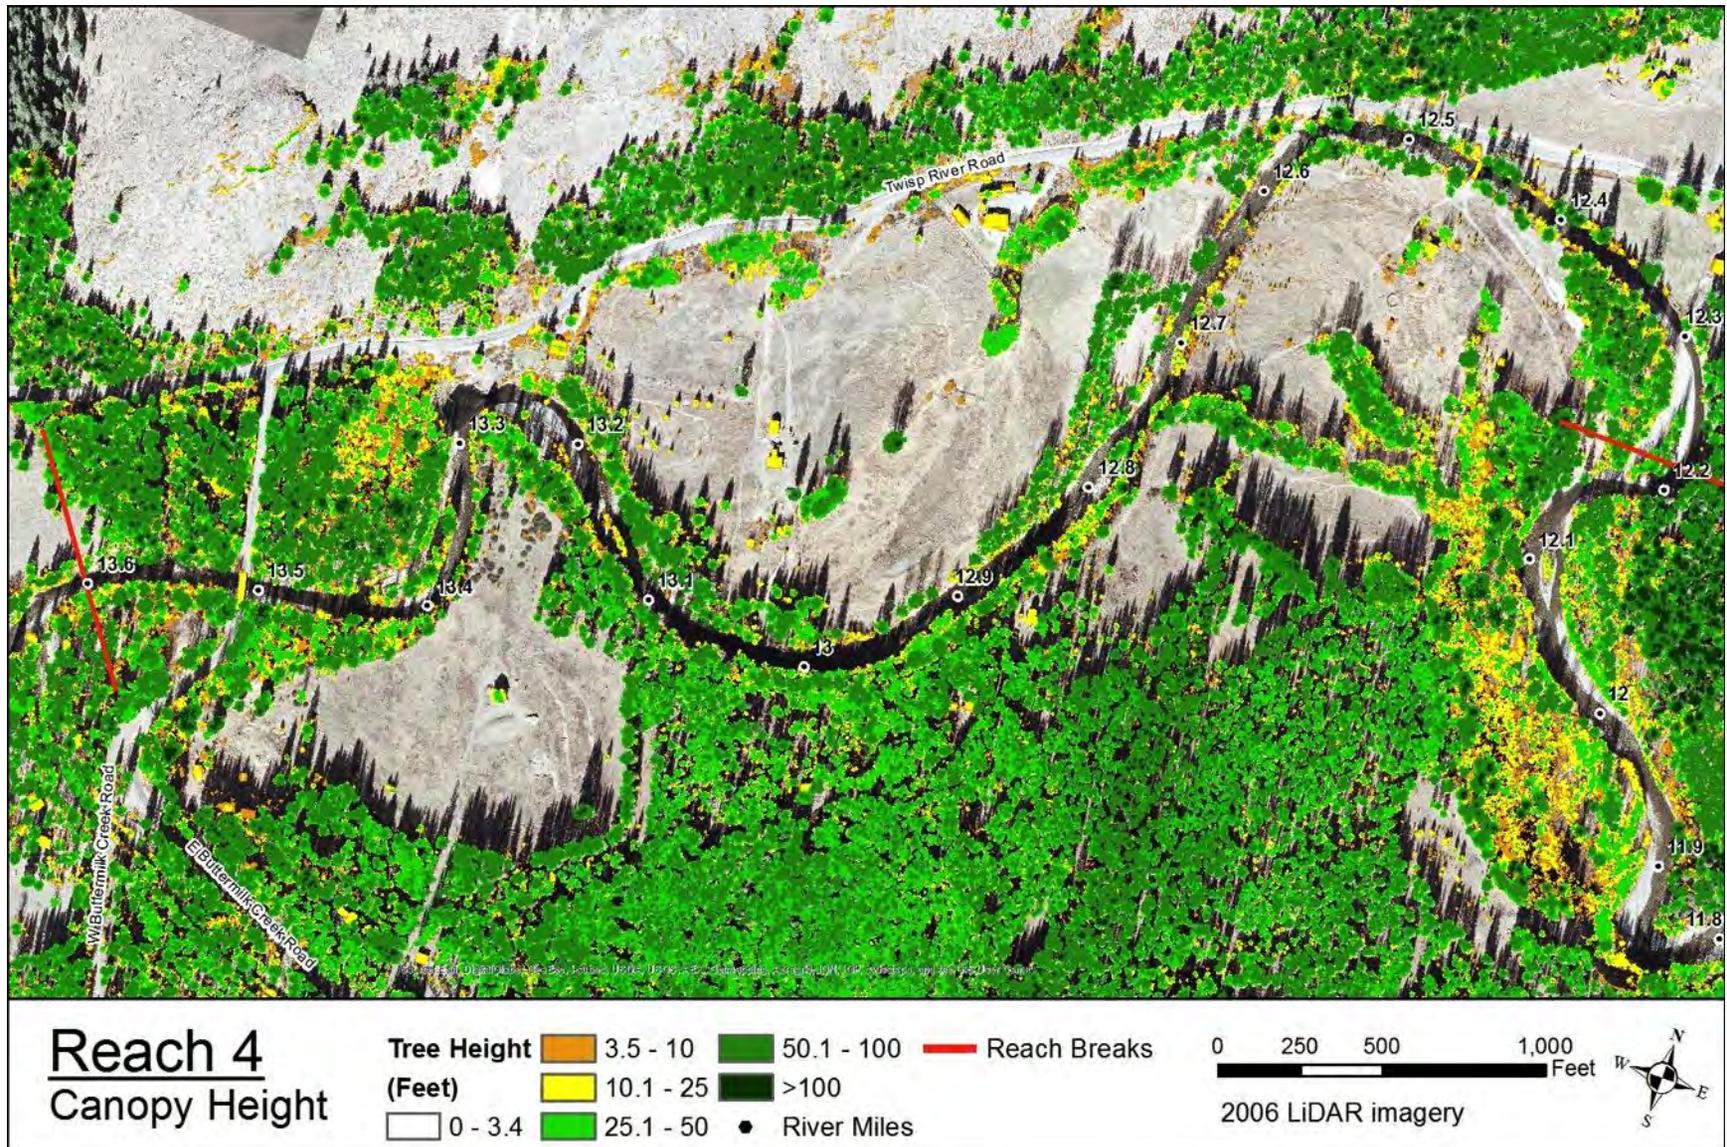
Figure 59. LiDAR first return (highest hit) data for Reach 4. These data show vegetation canopy heights. Buildings and other human infrastructure are also included in this data but there are only a few occurrences in the reach.

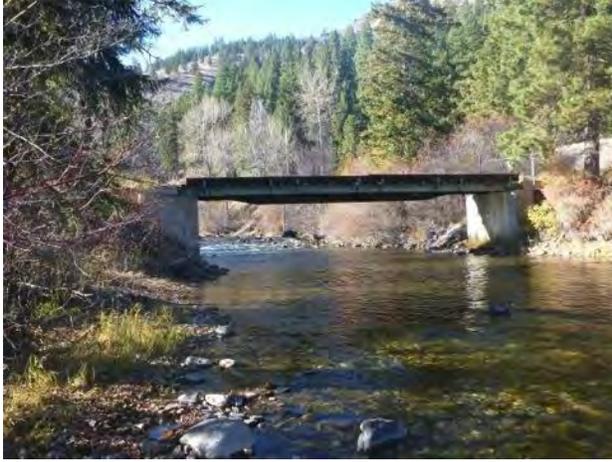
Figure 60. A small single lane bridge with abutments on the channel margin at RM 12.46.

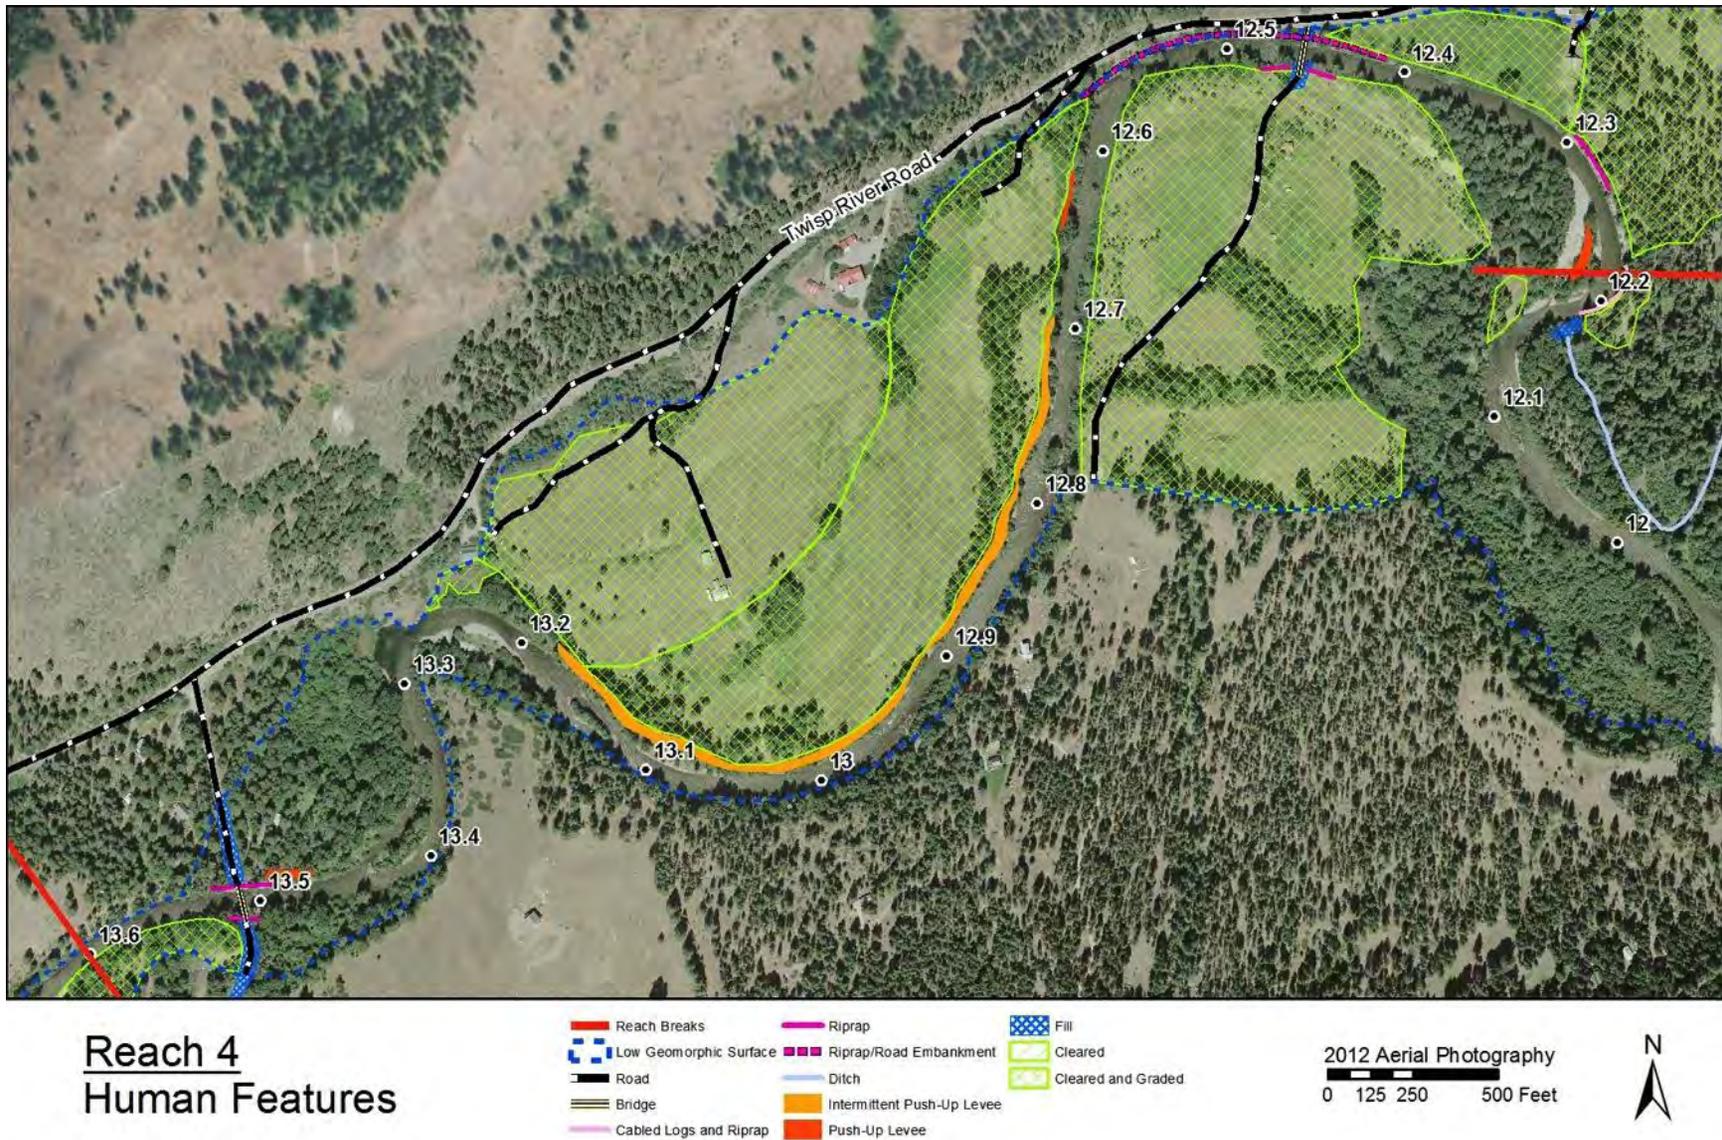
Figure 62. Human features in Reach 4.

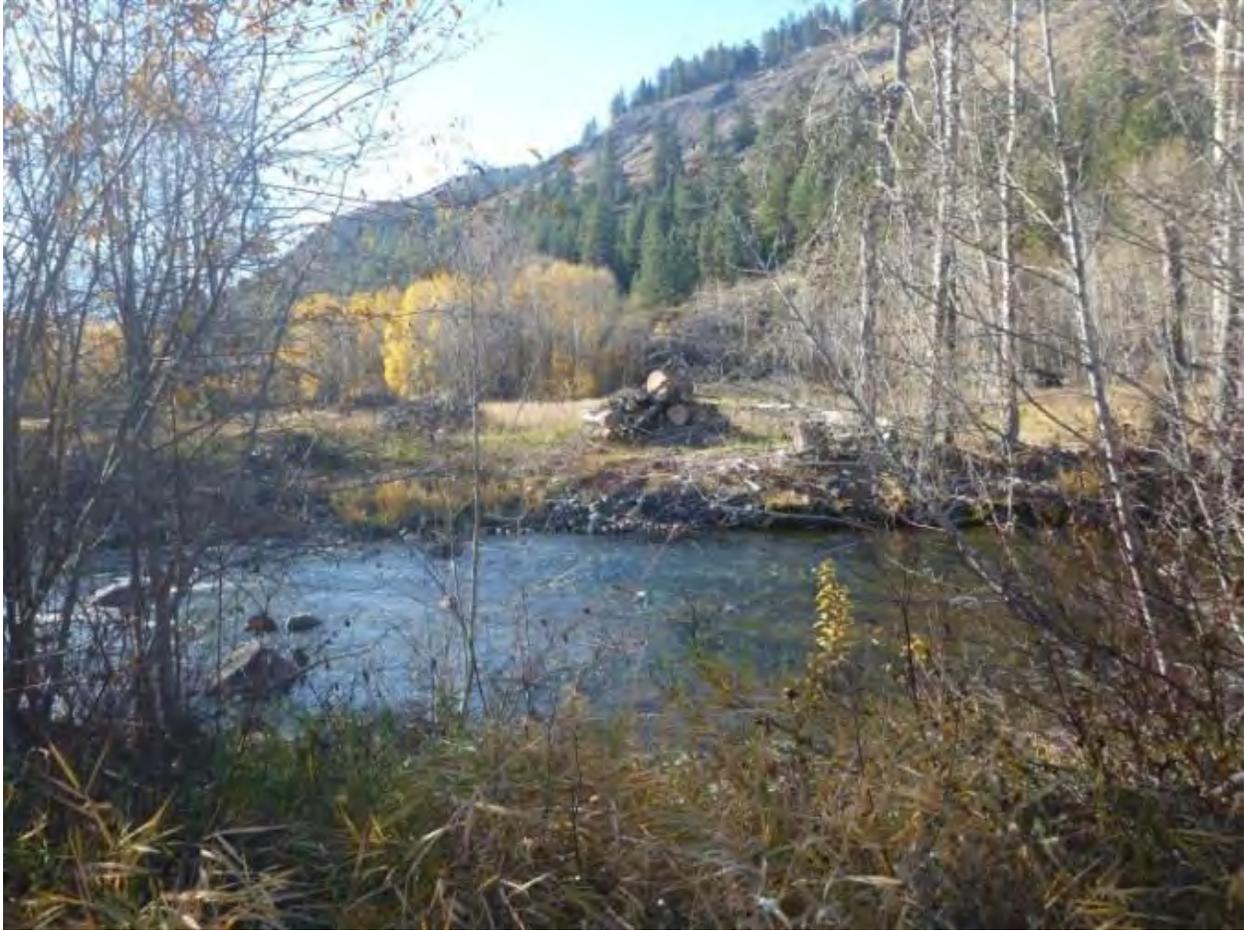
Figure 63. View of river-left bank near RM 12.65 showing evidence of active clearing of riparian and floodplain vegetation.

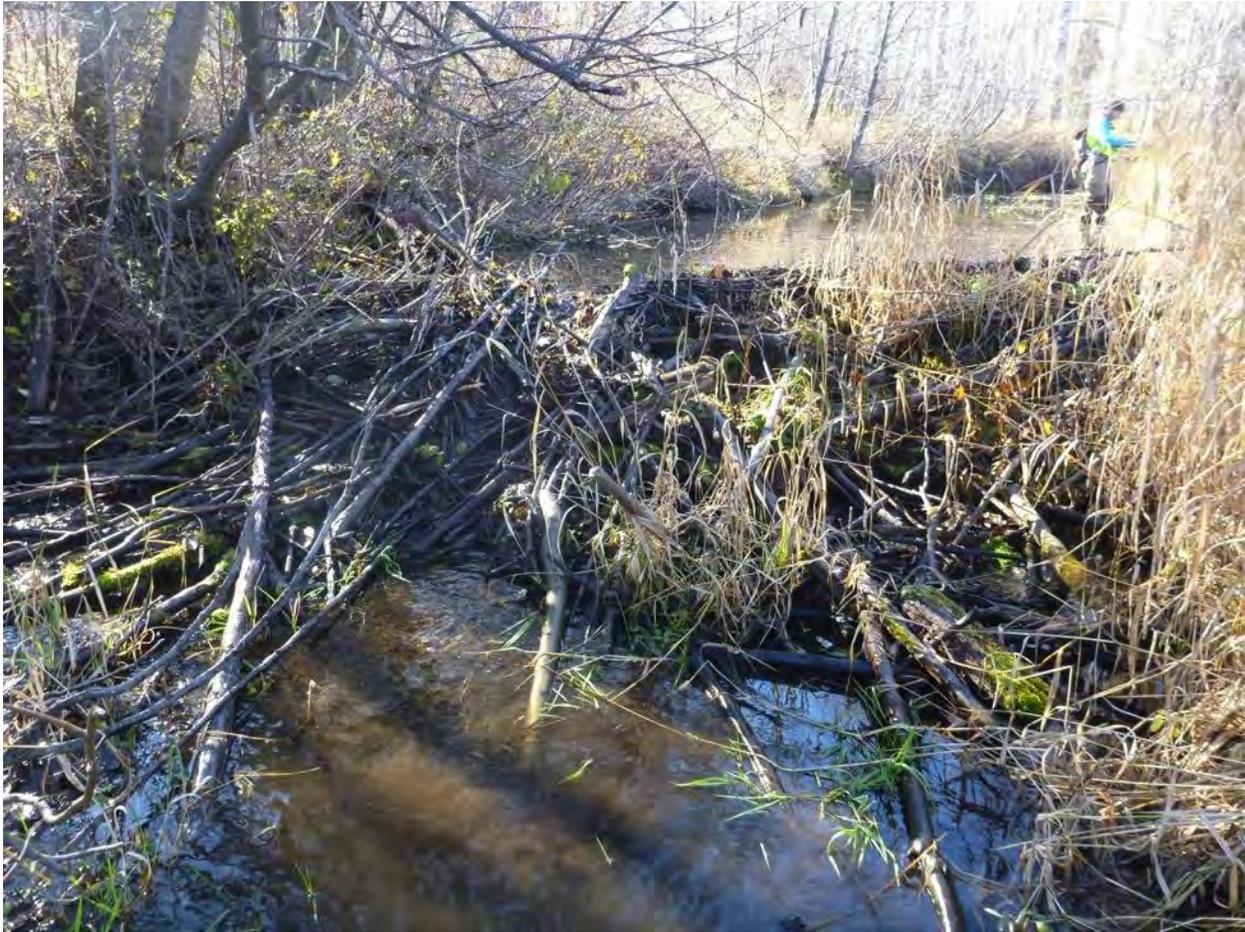
Figure 70. River right at RM 14.4 there is a beaver dam creating a backwater alcove.

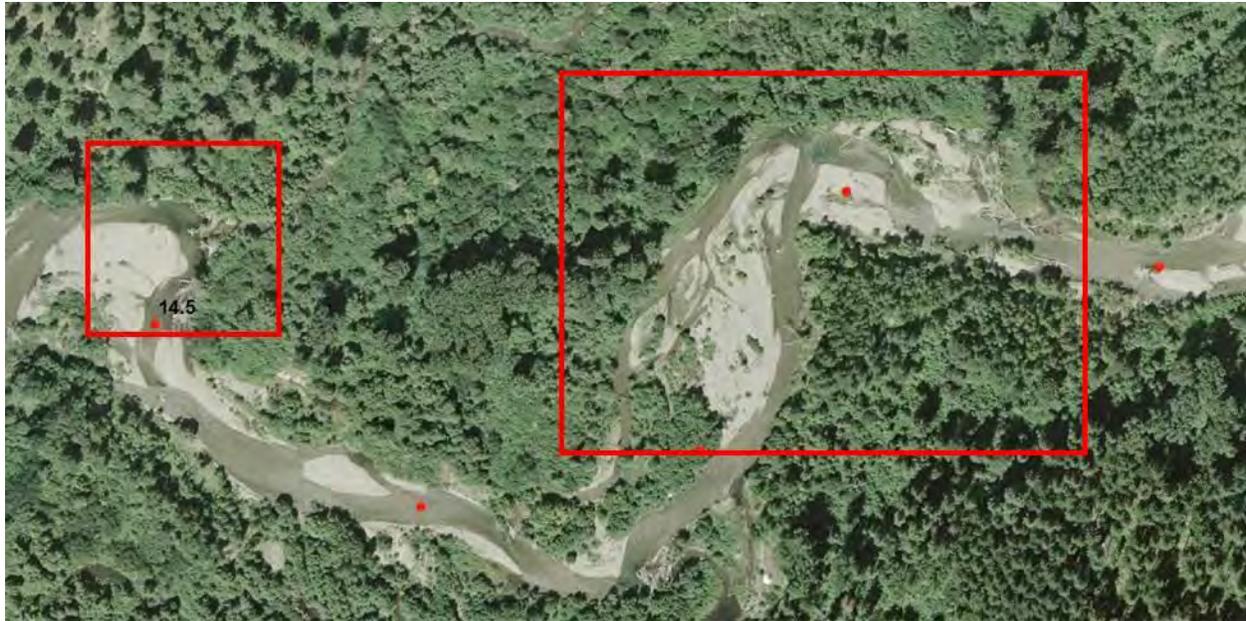
Figure 73. Large amounts of LWD have accumulated throughout this reach especially in the areas highlighted in red boxes.

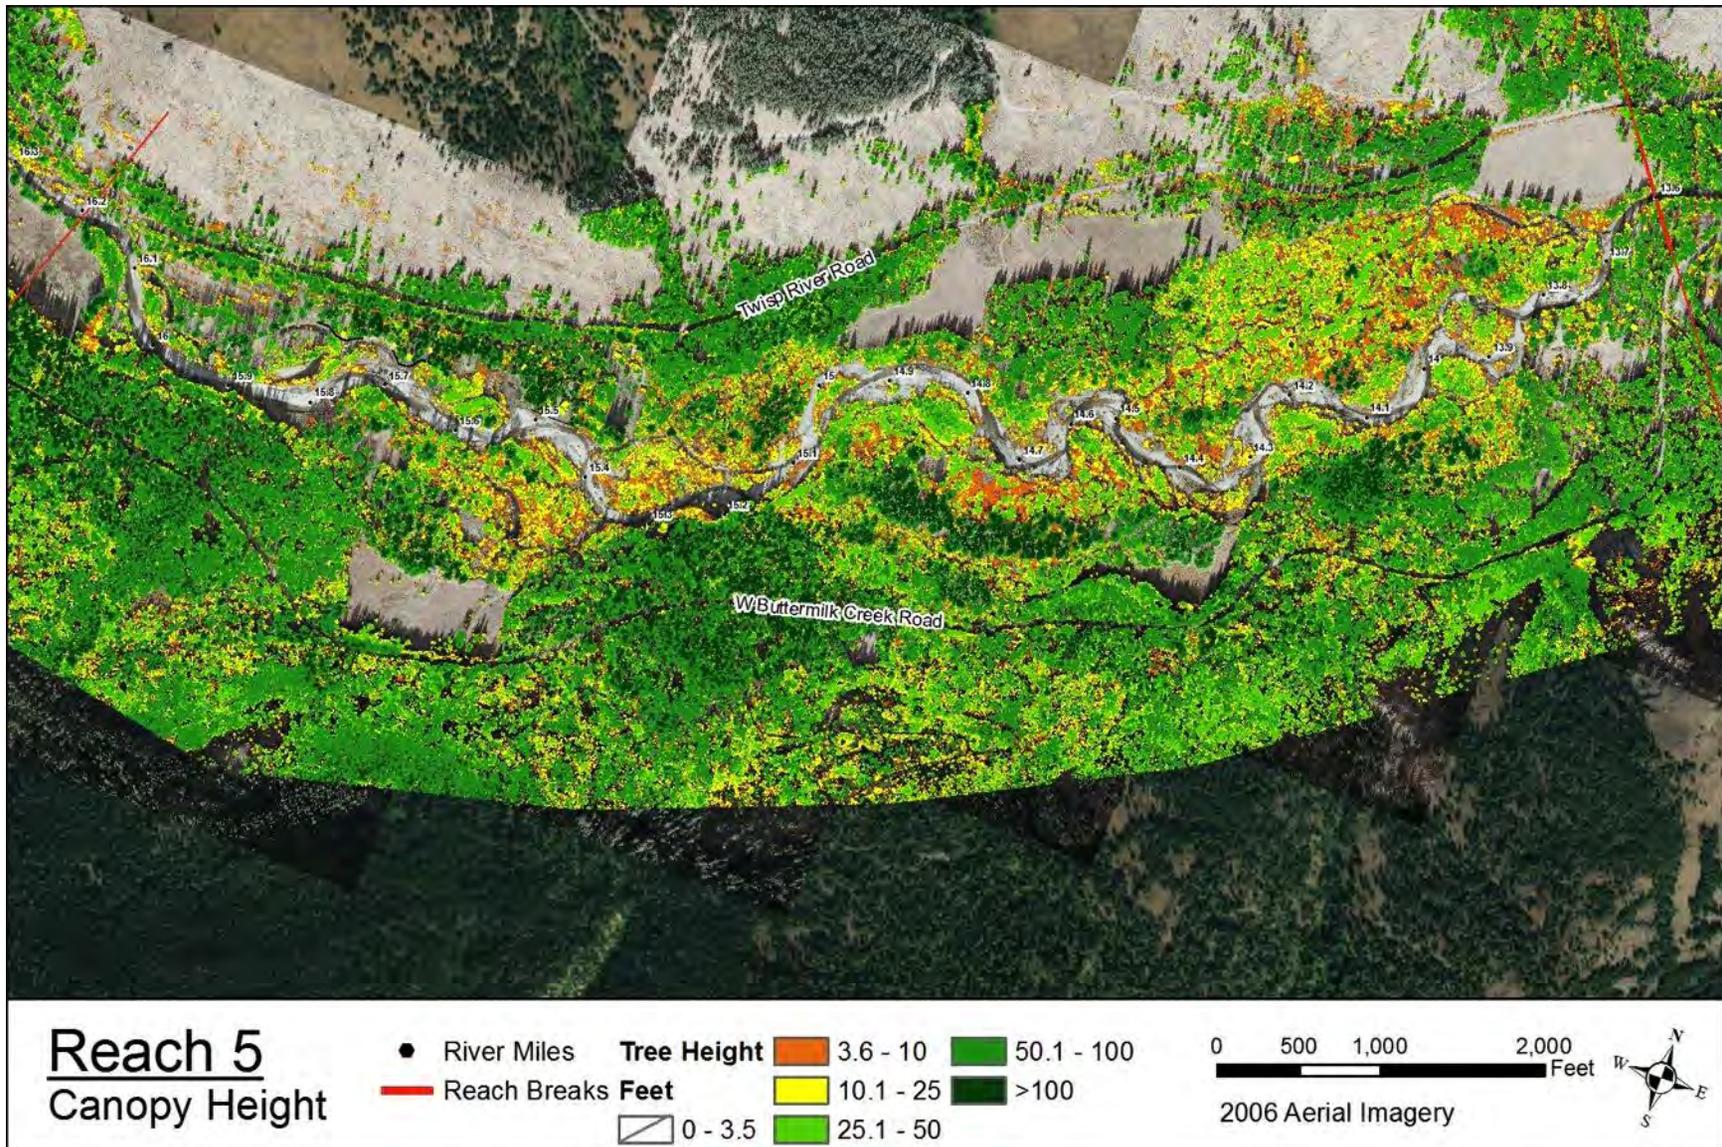
Figure 75. LiDAR first return (highest hit) data for Reach 5. These data show vegetation canopy heights. Buildings and other human infrastructure are also included in this data but there are only a few occurrences in the reach.

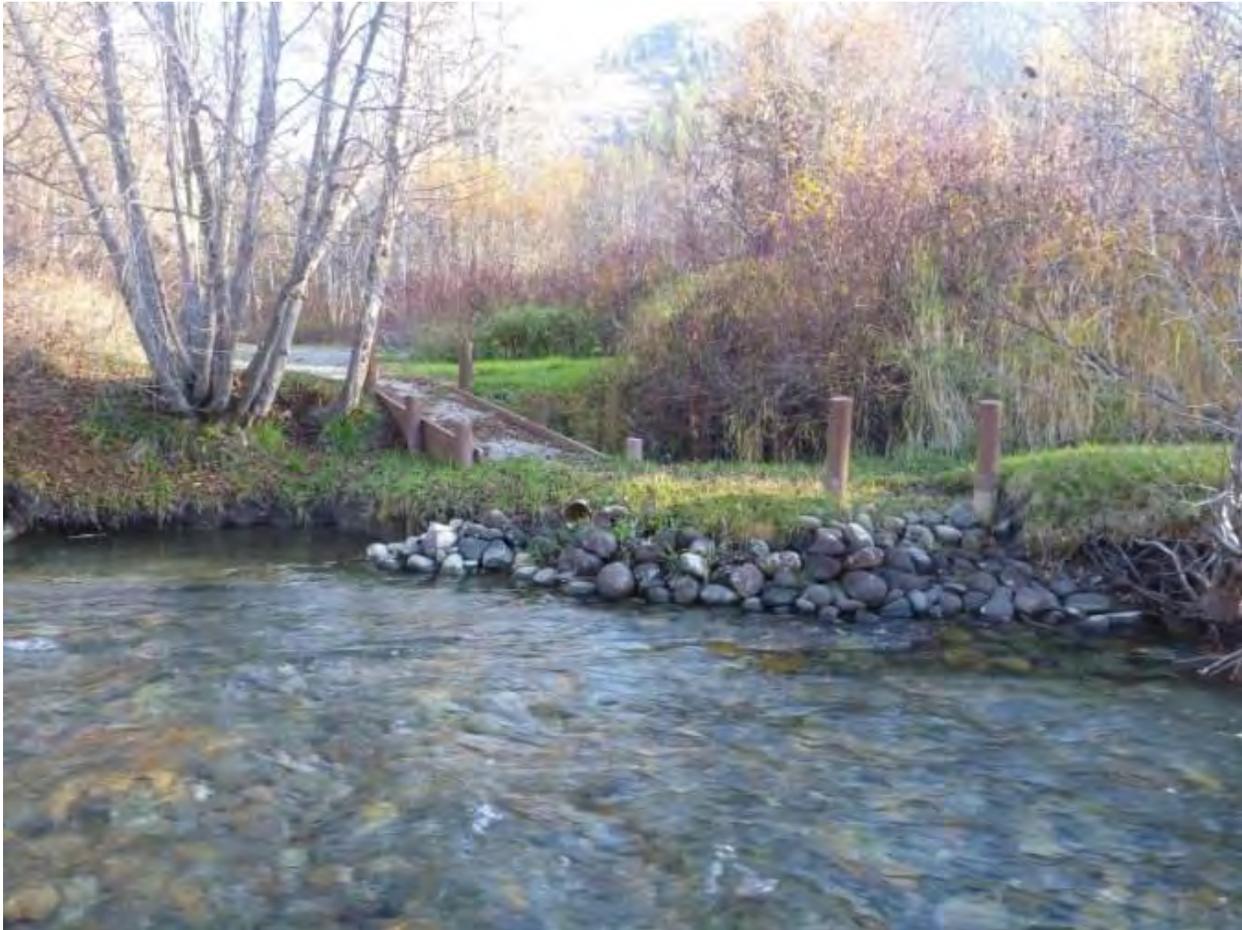
Figure 76. RM 13.8 riprap with large posts and a constructed footbridge constructed along river right opening to a gravel clearing.

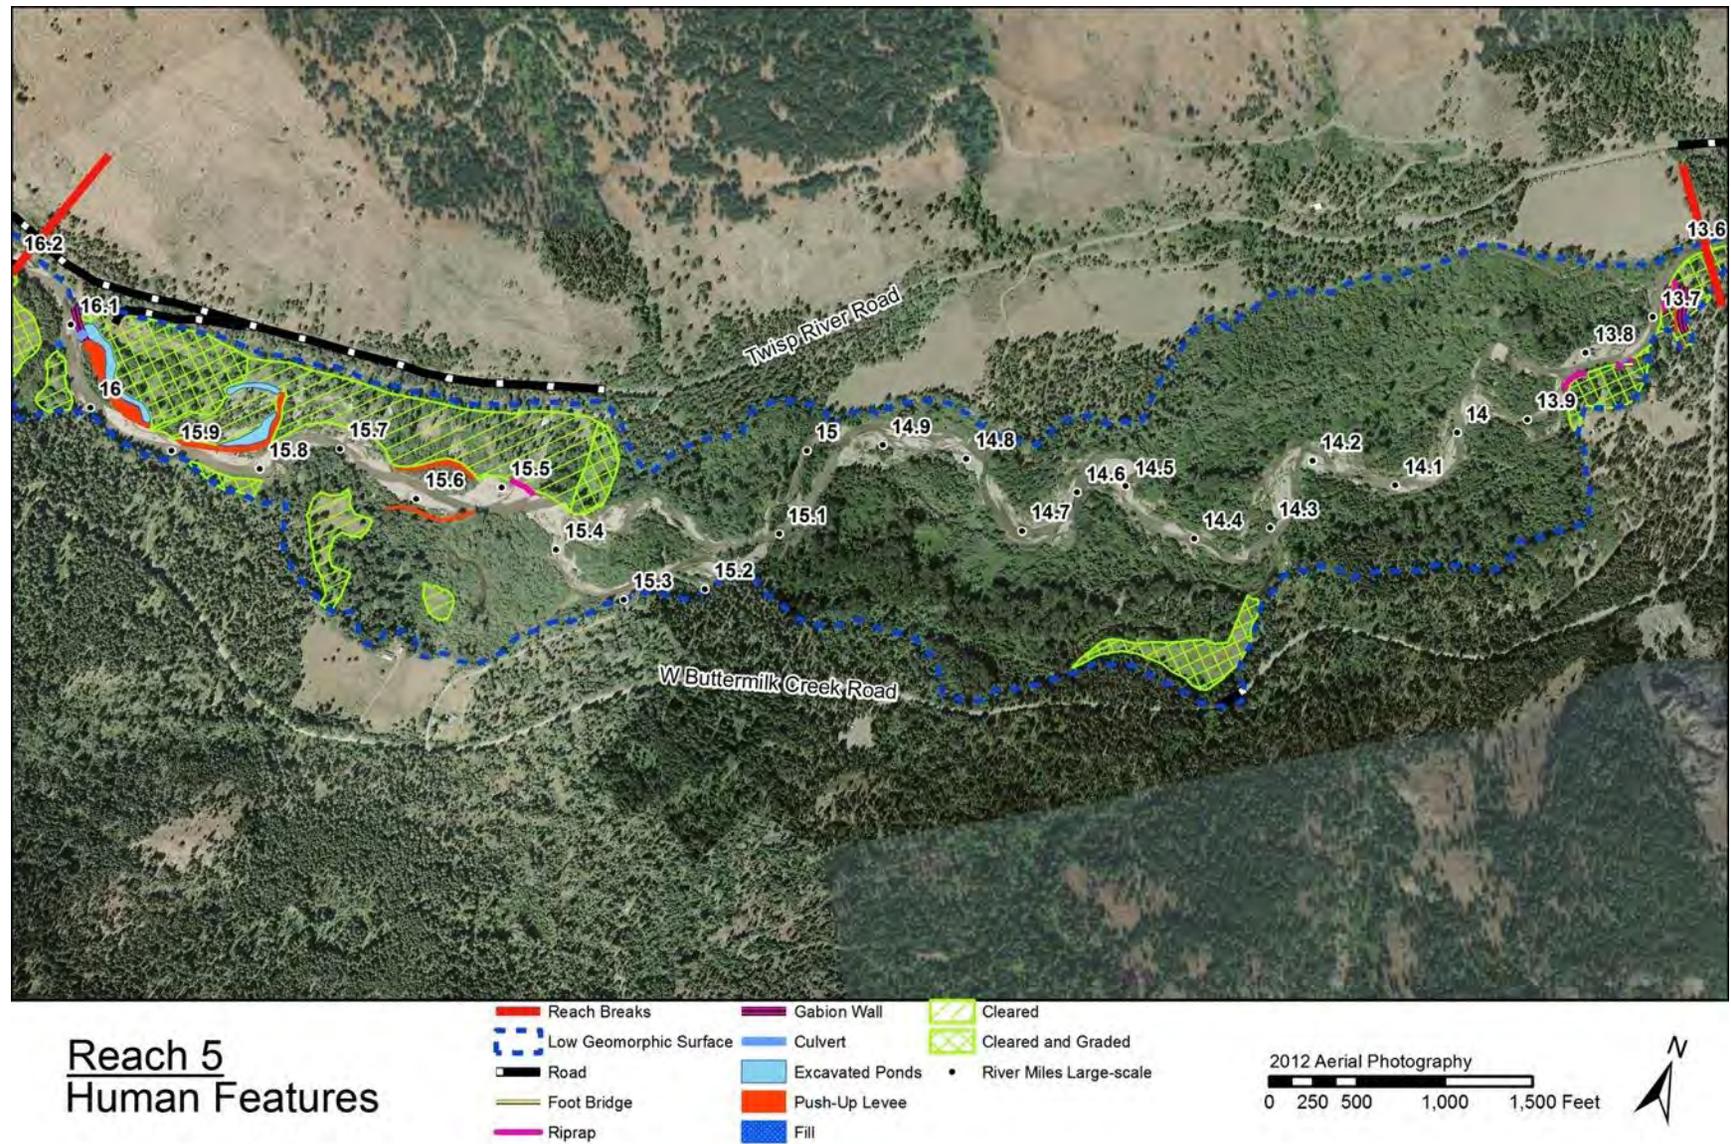
Figure 81. Human features in Reach 5.

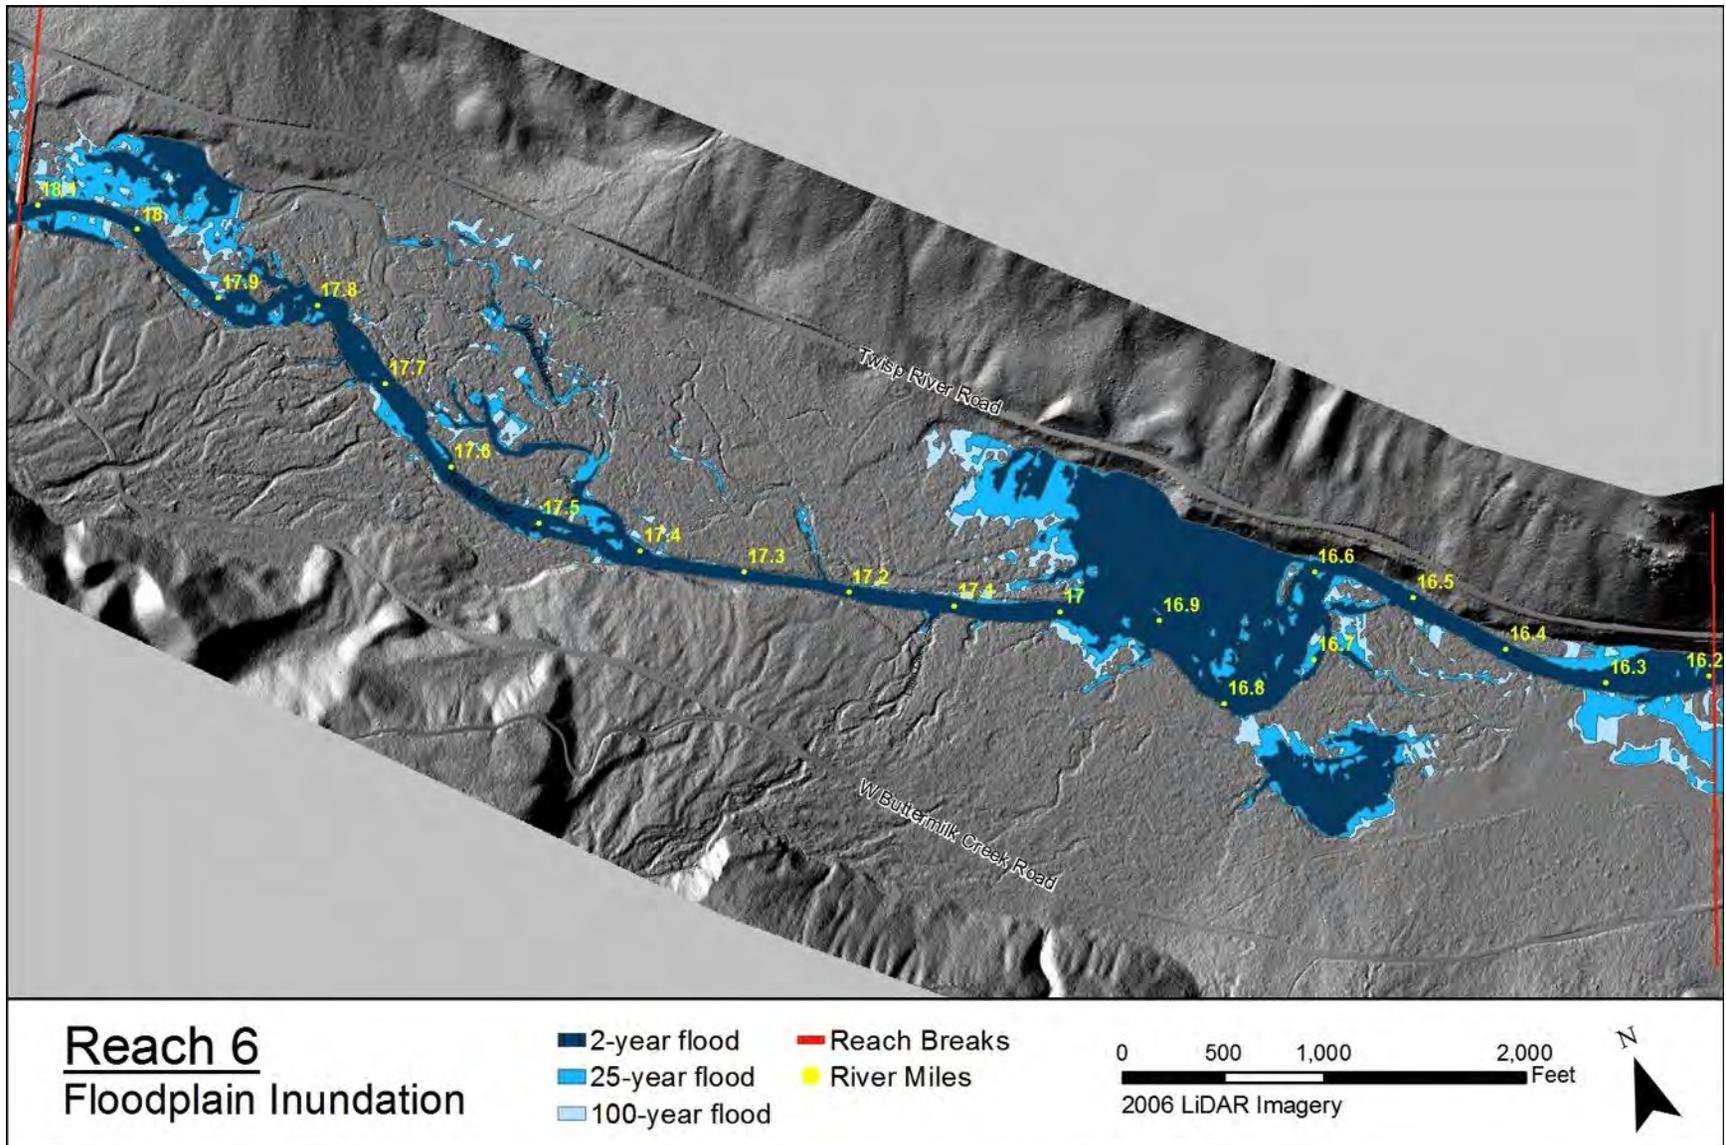
Figure 87. Floodplain inundation mapping for Reach 6.

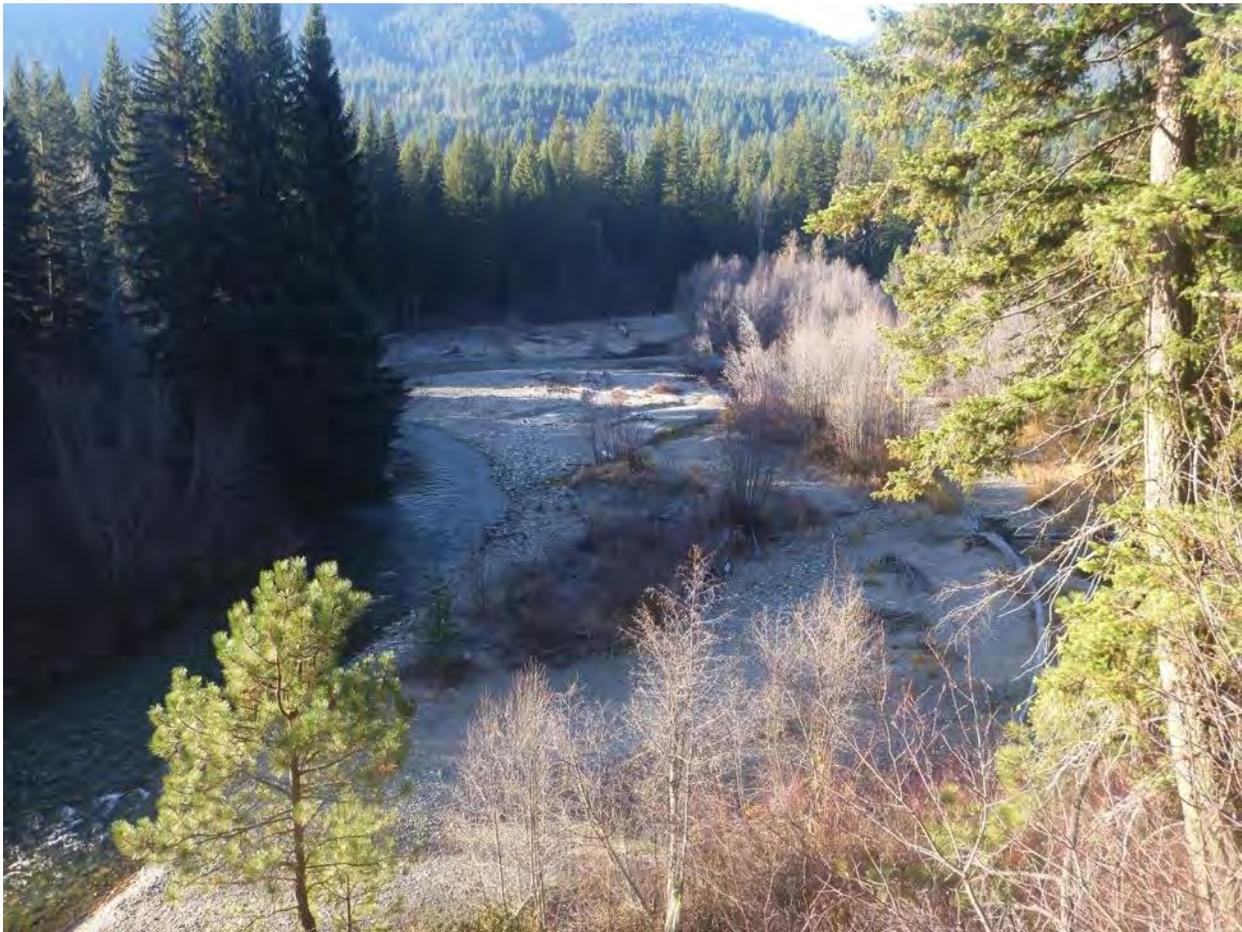
Figure 89. Looking upstream at RM 16.6, the highly dynamic nature of this portion of the reach is evidenced by the exposed gravels and high flow channels.

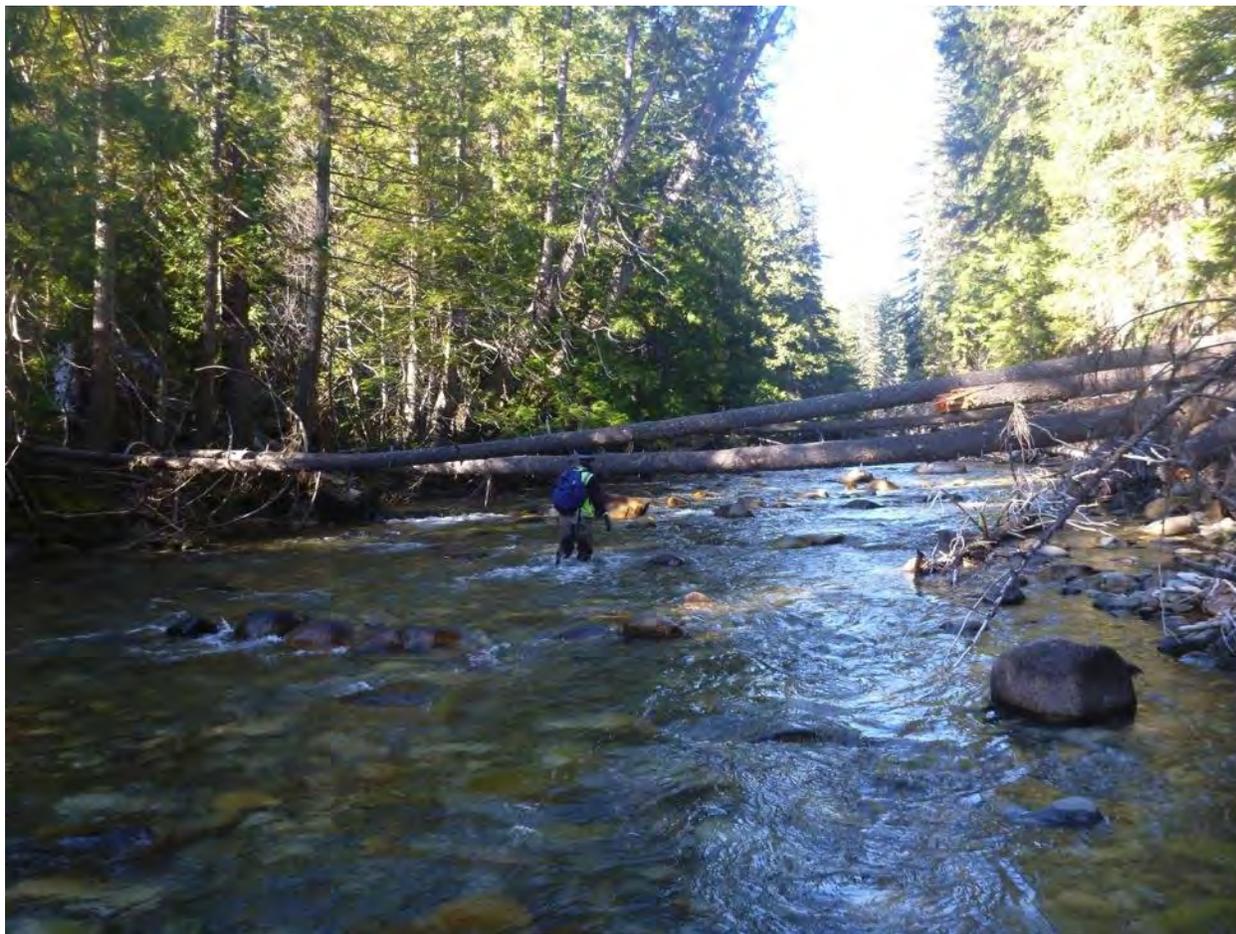
Figure 90. RM 17.25 looking upstream. Channel spanning woody debris and highly vegetated banks that have the potential for future recruitment.

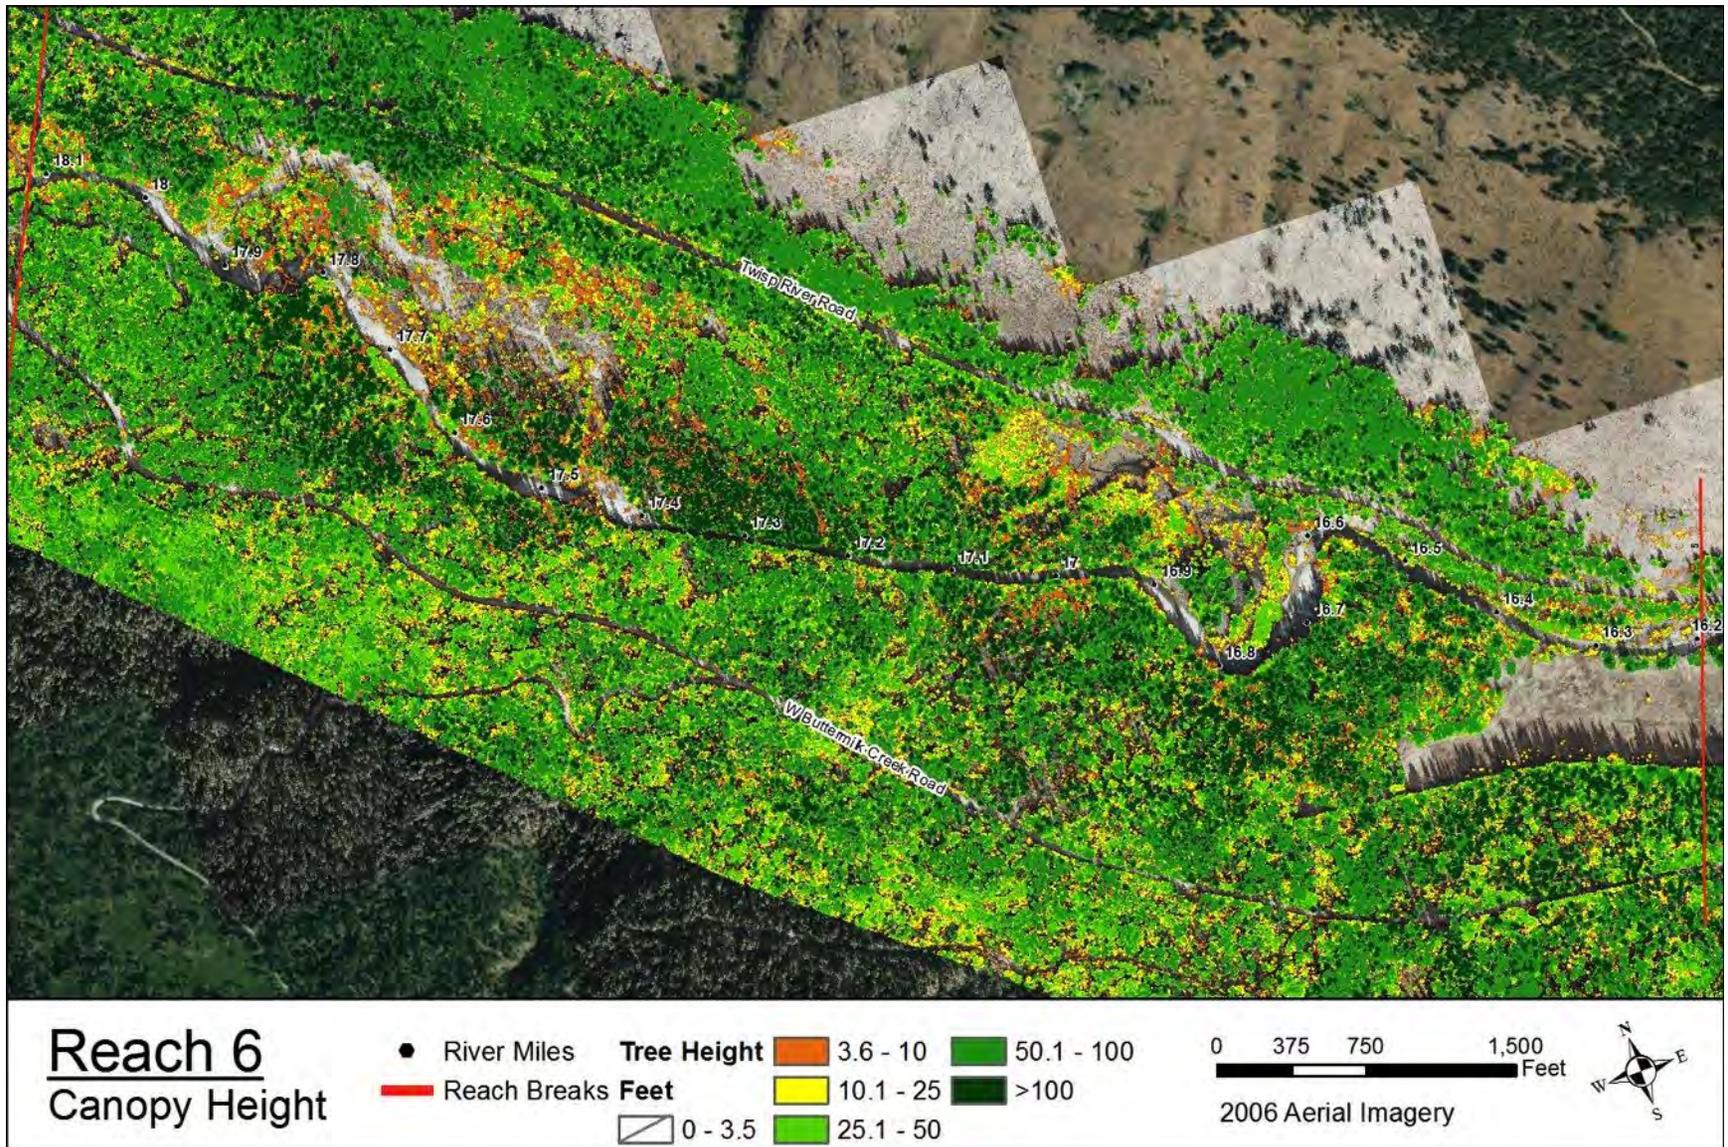
Figure 91. LiDAR first return (highest hit) data for Reach 6. These data show vegetation canopy heights. Buildings and other human infrastructure are also included in this data but there are only a few occurrences in this reach.
