Middle Twisp River Reach Assessment & Restoration Strategy

SUBMITTED TO
Yakama Nation Fisheries Program

FEBRUARY 2015

PREPARED BY
Inter-Fluve, Inc.
501 Portway Ave, Suite 101
Hood River, OR 97031
(541) 386-9003

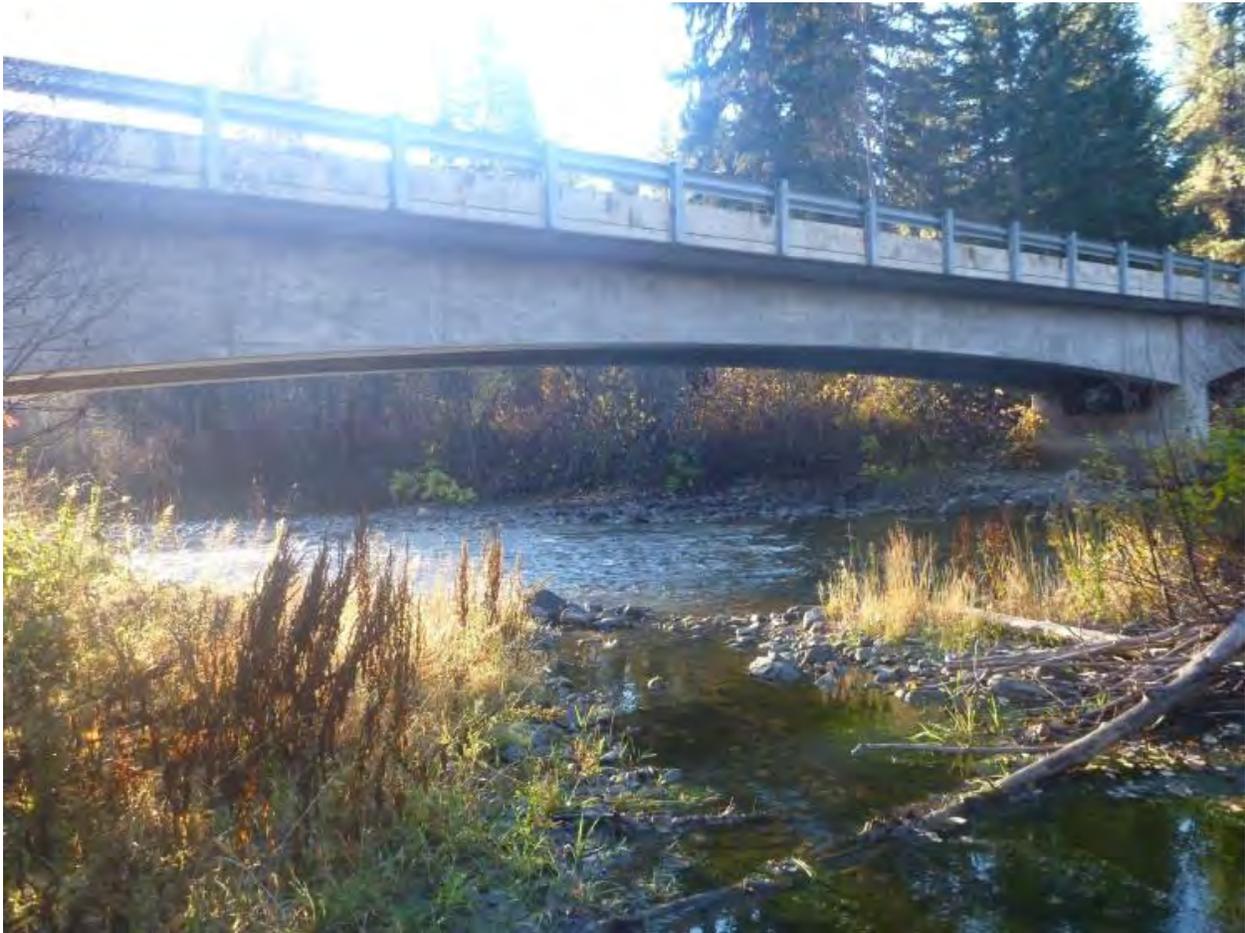
Figure 92. Channel spanning bridge at RM 18.12, the upstream extent of this geomorphic study.

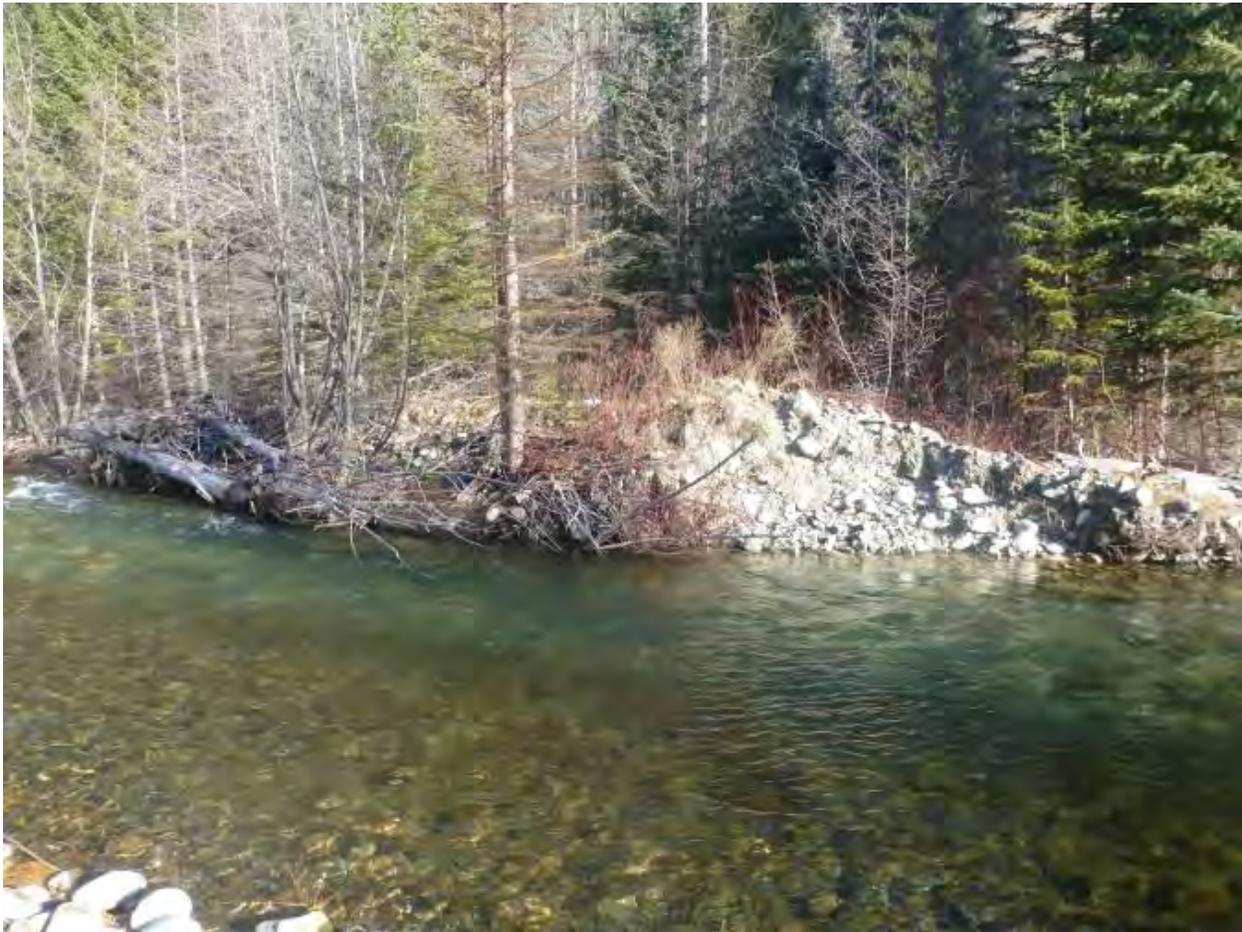
Figure 93. The push-up levee on river left at RM 16.8 is composed of cobbles and sands.

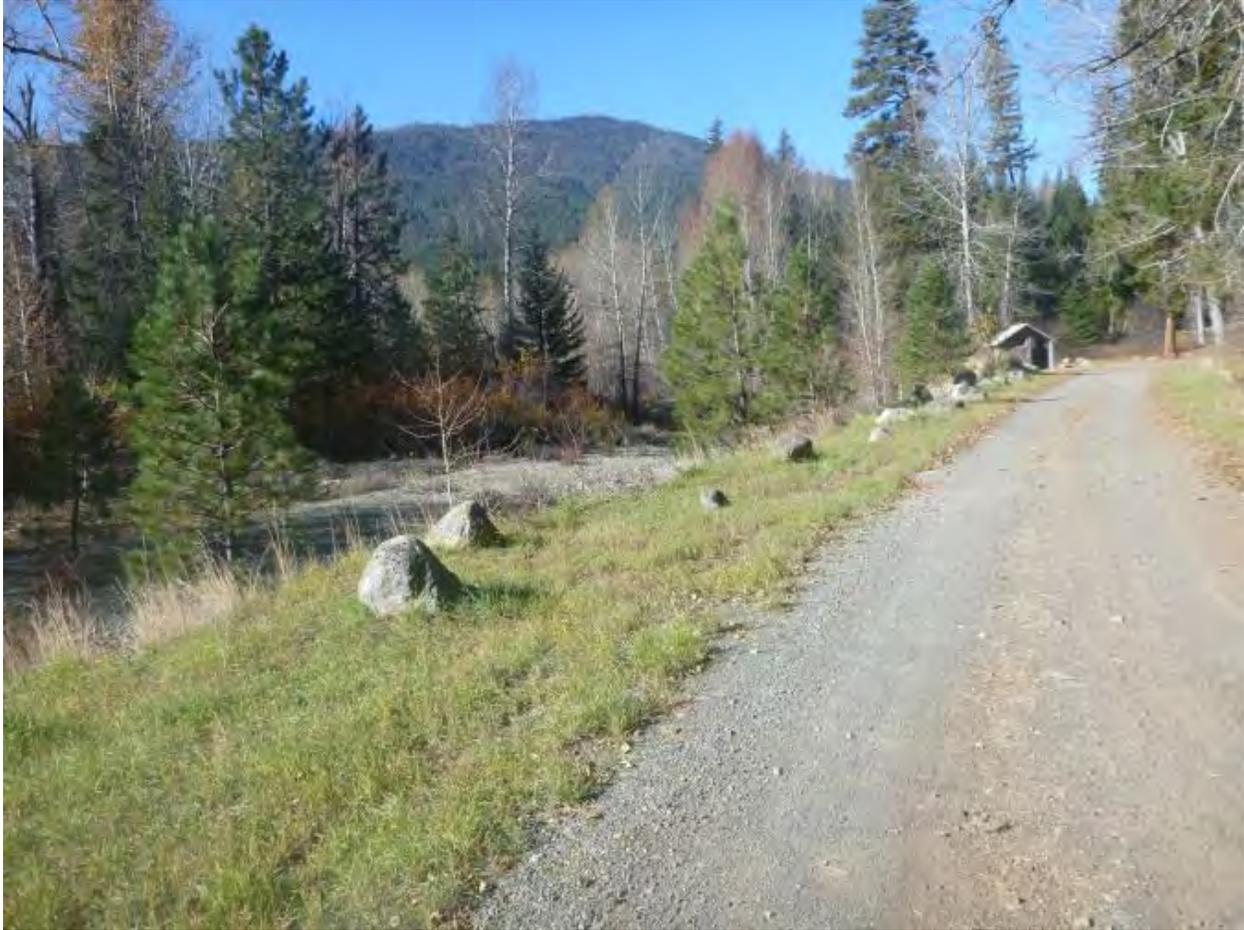
Figure 94. Gravel road and clearing and grading along river left corresponding to RM 17.8 to 18.0
