Appendix B: Chewuch Project Opportunities

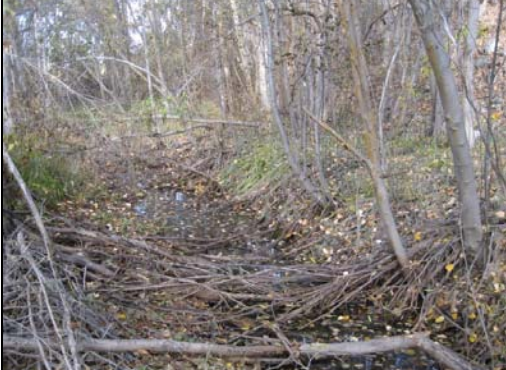
2b	Project RM 6.8L	Outer Zone 2 (OZ-2)	Off-Channel Habitat Enhancement	Wetland habitat enhancement	In this area there is a network of high-flow channels that appear to receive infrequent flood inundation. Habitat and process connection could be enhanced by excavating off-channel habitat. A groundwater gallery might potentially draw enough sub-surface water to create perennial flow at the downstream end of the project.

<p>Floodplain wetlands near RM 6.75 that could be enhanced to provide off-channel habitat. November 2009.</p>

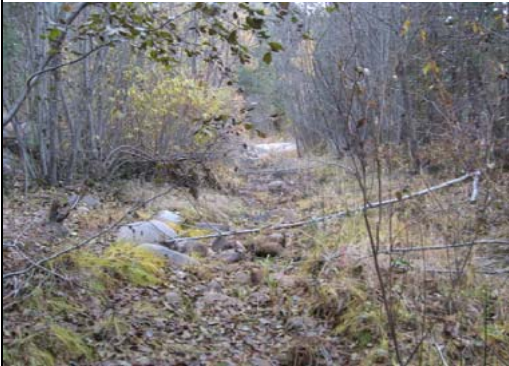
3b	Project RM 9.05L	Inner Zone 2 (IZ-2)	Re-Connect Stream Channel Processes	LWD enhancement and side-channel habitat reconnection	This project involves increasing connection between the main channel and an existing high flow side-channel. The side-channel shows evidence of being scoured frequently, but does not provide habitat at low flow. LWD at the inflow and outflow points, and excavation as needed would connect the channel over a wider range of flows. This is a highly dynamic section of channel and floodplain where the longevity of restoration work would need to be carefully considered in planning any restoration activities.

View looking north in the upstream direction at a side-channel near RM 9.05 (November 2009).
4a	Project RM 9.5C	Inner Zone 1 (IZ-1)	In-Stream Habitat Enhancement	LWD enhancement	Between RM 9.45 and 9.5 there are multiple opportunities for bank LWD jams. Near RM 9.5 there is an existing glide along river-right. There is existing overhanging vegetation and small root masses. A log jam here would provide cover and potentially increase bed scour to form pool habitat. RM 9.45 just upstream of a grade break where the channel steepens at the alluvial fan of Boulder Creek. The backwater created upstream of this grade break has boulders along the bank providing limited habitat. LWD placed in this pool would enhance habitat cover and complexity.

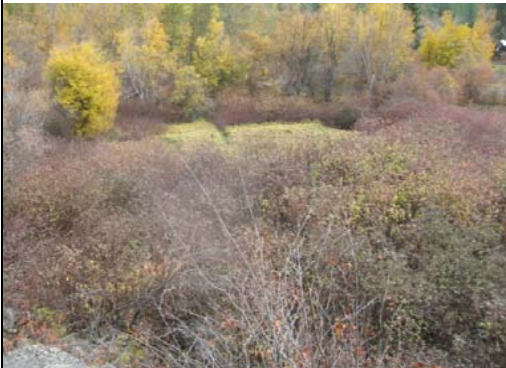
Reach	Project Number	Sub-Unit	Strategy Category	Project Name	Description	Photo
4b	Project RM 9.88R	Disconnected Outer Zone 1 (DOZ-1)	Off-Channel Habitat Enhancement	Wetland habitat enhancement	At this site, there is an older wetland that appears to have filled in naturally over time. There is no open water, but there are wetland plant species and a topographic depression that holds water seasonally. There is a channel that provides connectivity between the wetland and the inner-zone at high flow. The surface connection could be enhanced to provide connectivity at a wider range of discharges. The wetland would need to be excavated to increase availability of fish habitat; LWD could be added to increase cover.

<p>View to the east at an old floodplain wetland north of the channel near RM 9.85 that has naturally filled in over time (November 2009).</p>
4b	Project RM 9.9L	Inner Zone 1 (IZ-1)	Off-Channel Habitat Enhancement	Alcove habitat enhancement	LWD would be utilized at this location to enhance the habitat quality of an existing pool. The pool has depth created by scour around a large boulder at the downstream end. LWD would add cover, increase overall reach complexity, and potentially increase scour adding greater residual depth to the pool. Overall, these actions would create a high-quality off-channel backwater for rearing and migrating fish.

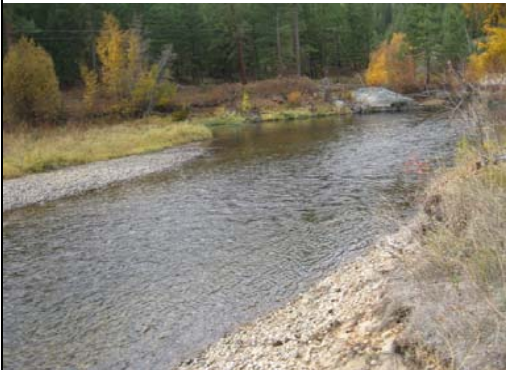
<p>View to the west in the downstream direction at a backwater pool near RM 9.9 (November 2009).</p>

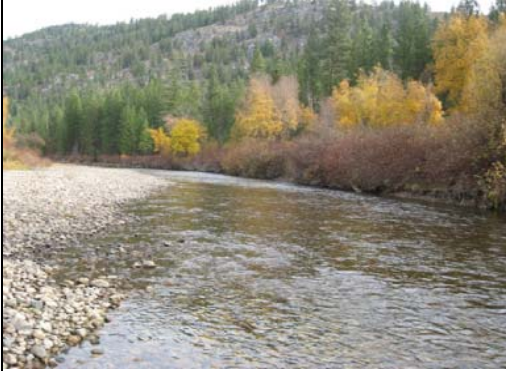
4b	Project RM 10.1C	Inner Zone 1 (IZ-1)	In-Stream Habitat Enhancement	LWD enhancement	There are multiple opportunities to place LWD along both sides of the channel between RM 9.99 and 10.19. At the upstream end of this project area, there is a location for the placement of meander bend LWD jams along the river-left bank to increase habitat cover and complexity. There is very little habitat complexity in this portion of the river. The placement of several log jams would serve to increase pool development and maintenance and improve overall habitat quality. Another jam placement would be possible at RM 10.1 on river right. At RM 10.04 the river takes a right turn and has scoured a deep pool on the outside of the bend. There is riparian vegetation around the margin of the pool but LWD would increase cover and the quality of this pool habitat. Downstream of this pool, the bank is eroding at the toe of a glacial terrace. Additional LWD may be desired to protect the houses at the edge of the terrace. Several log jams could be placed on both sides of the river near RM 9.99 to increase overall cover and habitat quality in this reach. This would also encourage more active inner-zone geomorphic processes that support sustained habitat formation.

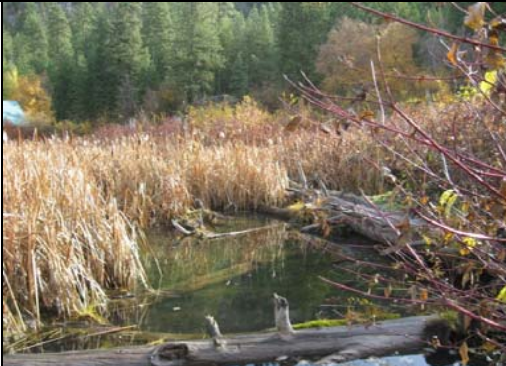
Reach	Project Number	Sub-Unit	Strategy Category	Project Name	Description	Photo
4b	Project CR_Prj-10.2 (USBR 2008b)	Outer Zone 1 (OZ-1)	Off-Channel Habitat Enhancement		This area has been identified by the USBR as a location for to restore a wetland or network through restoration of cleared areas and assessment of impacts to connectivity.	
4b	Project RM 10.35L	Inner Zone 1 (IZ-1)	Off-Channel Habitat Enhancement	Wetland habitat enhancement	There is a large floodplain wetland formed by old beaver dams at this site. There is a channel connecting this feature to inner-zone habitats, but it does not provide passability at all flow levels. Some excavation would be needed to provide fish passage into the off-channel habitat at lower flows. Wood could also be added to provide cover for rearing fish.

<p>View to the north at a wetland located near RM 10.35 (November 2009).</p>
4b	Project RM 10.37L	Inner Zone 1 (IZ-1)	Riparian Restoration	Riparian restoration and LWD enhancement	This bank is directly downstream of the riprap section referred to in Project RM 10.46L. The bank is slumping and appears to be eroding at an accelerated rate due to riparian clearing. There is some LWD recruitment taking place where a large cottonwood has fallen. The uniform, eroding bank could be enhanced with several jams along the bank to provide erosion control and habitat cover and complexity. There is also an opportunity to re-establish a forested riparian buffer along this section.

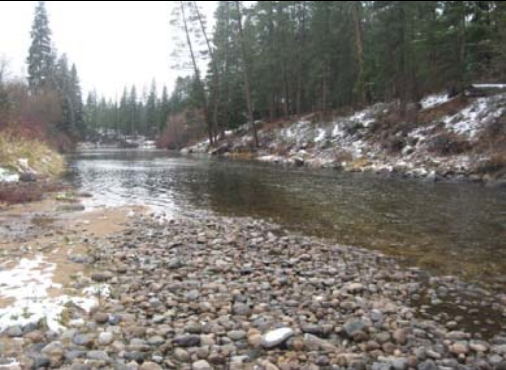
<p>View to the east at riprap and floodplain clearing along the river-left bank near RM 10.46 (November 2009).</p>
4c	Project RM 10.6R	Inner Zone 1 (IZ-1)	In-Stream Habitat Enhancement	LWD enhancement	This project involves LWD placement to increase local habitat quality and cover. This channel section is straight and currently lacks habitat complexity.

<p>View to the south in the downstream direction at a low complexity stretch of river near RM 10.6 (November 2009).</p>

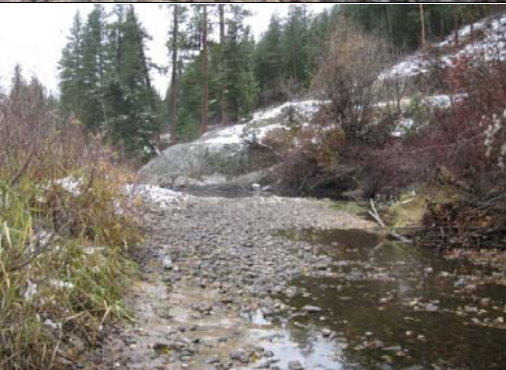
4c	Project RM 10.73C	Inner Zone 1 (IZ-1)	Reconnect Stream Channel Processes	Re-establish channel LWD dynamics	Between RM 10.7 and 10.75 there are two opportunities to place bar apex jams that will enhance split-flow locations. This Near RM 10.75 there is an existing split-flow location by placing a bar apex log jam and side-channel wood to increase habitat quality. Upstream of this site, the river trends to the southwest. A bedrock outcrop near RM 10.75 turns the river south and creates the split flow. There is a deep pool at the bedrock outcrop which is at the downstream end of the split flow. Near RM 10.7 a bar apex log jam could be constructed on a natural wood deposition site. A log jam at the head of the island would increase habitat complexity through pool scour and increasing habitat cover. The site is a mid-channel bar with active split flow around either side.

<p>View to the southwest in the downstream direction at a side-channel and bedrock outcrop near RM 11.75 (November 2009).</p>

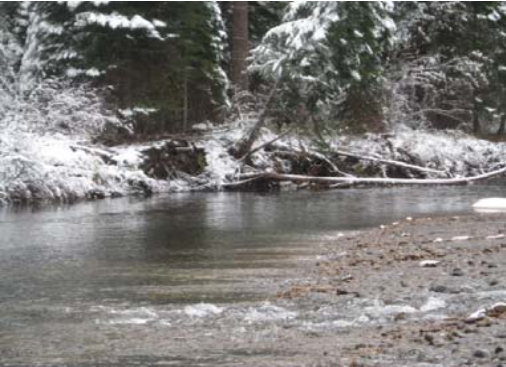
<p>View to the southeast in the downstream direction at a riffle, pool, and LWD on the river left bank near RM 12.12 (November 2009).</p>

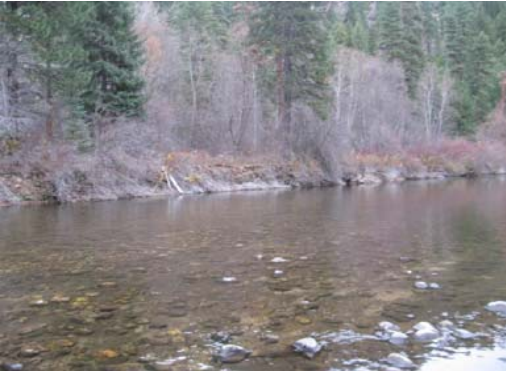
5a	Project RM 12.63L	Inner Zone 1 (IZ-1)	Reconnect Stream Channel Processes	LWD placement to enhance lateral connectivity	Between RM 12.59 and 12.66, there are two opportunities for log jam placements to enhance split-flow processes and bank habitat. Near RM 12.66, there is a potential bank log jam placement with the goal of enhancing in-stream habitat along a high eroding bank that currently provides very little cover. On the opposite side of the valley, there are networks of high-flow channels providing connectivity between inner and outer zone habitats. Log jam placement would be optimized to push water to the west and onto the floodplain. Near RM 12.59 is a bar apex jam at a location where split flow occurs as stage rises annually. The project is intended to enhance split flow over a wide range of discharges and to orient flow towards river right to increase lateral migration and scour of an existing cut-bank and pool.

<p>View to the southeast in the downstream direction at the river left bank near RM 11.66 (November 2009).</p>

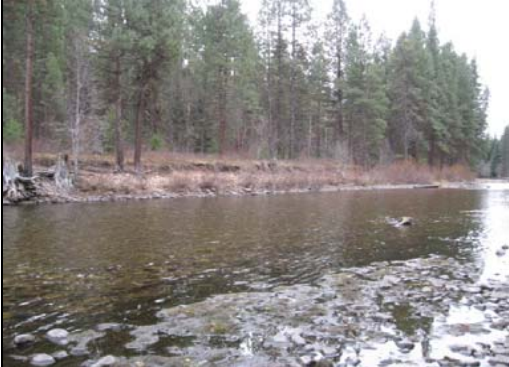
Reach	Project Number	Sub-Unit	Strategy Category	Project Name	Description	Photo
5b	Project RM 13.0L	Inner Zone 2 (IZ-2)	In-Stream Habitat Enhancement	LWD enhancement	A lateral log jam on the left bank would increase habitat complexity within an existing glide.

View to the southeast in the downstream direction at the river-left bank near RM 13.0 (November 2009).
5b	Project RM 13.24L	Inner Zone 2 (IZ-2)	In-Stream Habitat Enhancement	LWD enhancement	There are two potential LWD placements between RM 13.21 and 13.27 along the river left bank. The site near RM 13.21 is on the outside of a bend where the river is eroding a high terrace to the southeast. There is large material eroded out of the bank that has provided natural protection of the toe of the slope. Some small wood has fallen in as well. Several jams could be placed along the river-left bank to take advantage of the hydraulics on the outside of the bend to create scour pools and provide cover. At the downstream end of the same bend, a LWD placement would increase cover and habitat quality.

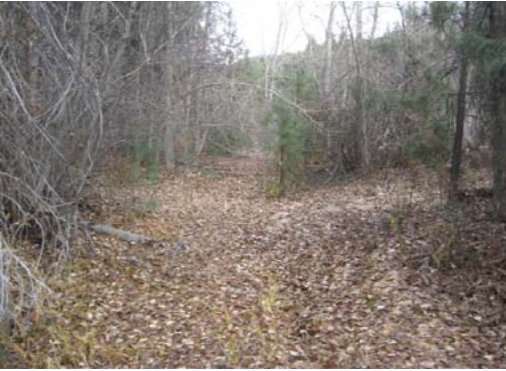
Reach	Project Number	Sub-Unit	Strategy Category	Project Name	Description	Photo
5b	Project RM 13.59R	Inner Zone 1 (IZ-1)	Side-Channel habitat enhancement	Side-Channel habitat enhancement	This side-channel runs along river-right between RM 13.53 and 13.63. This is a low energy side-channel with sand deposits. There are well established trees in the channel suggesting that flow rarely has the power to scour the bed. A large apex log jam at the upstream end would encourage flow into the side-channel, scouring the bed and coarsening sediment. With the addition of wood and other habitat features throughout the side-channel, habitat conditions would be improved for rearing, migrating, and spawning fish. Increased flow in the side-channel also has the potential to increase connectivity to a network of floodplain channels to the west.

<p>View to the south in the downstream direction at a river-right side-channel near RM 13.59 (November 2009).</p>

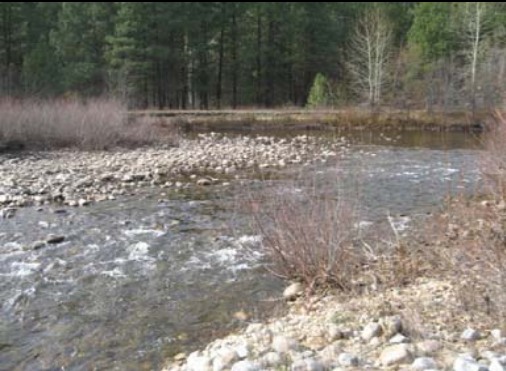
5b	Project RM 13.6C	Inner Zone 1 (IZ-1)	Reconnect Stream Channel Processes	LWD placement to enhance lateral connectivity	The area of the reach from RM 13.45 to RM 13.92 has multiple split flow locations with stable bars and islands. There are opportunities to load the entire stretch of river with wood and re-establish natural geomorphic elements and channel dynamics. Near RM 13.92 a large bank log jam would work with the natural sinuosity of the reach to move water laterally and encourage channel migration. The jam would also increase cover along the bank and create scour pool formation. AT RM 13.78 there is a bar apex log jam placement opportunity. This is a suitable location as wood naturally tends to accumulate on bar apexes, enhancing split flow, lateral channel migration, and habitat complexity. There is a split-flow location near RM 13.73 with opportunities for bank jams on both sides of the river. These jams would add complexity and enhance the split-flow condition. Near RM 13.62, a left-bank log jam would increase habitat quality and cover. There is bank erosion and modest LWD recruitment at this location that would be enhanced by the wood placement. A well-connected, active side-channel that extends from RM 12.4 to 12.54 could be enhanced with several log jams. The side-channel is an example of the effects of LWD on habitat complexity and abundance. There are scour pools around existing jams that provide good habitat when water is flowing through the channel. More wood could be added to increase the quality of habitat in the side-channel.

<p>View to the northwest in the upstream direction at split flow around a gravel bar near RM 13.78 (November 2009).</p>

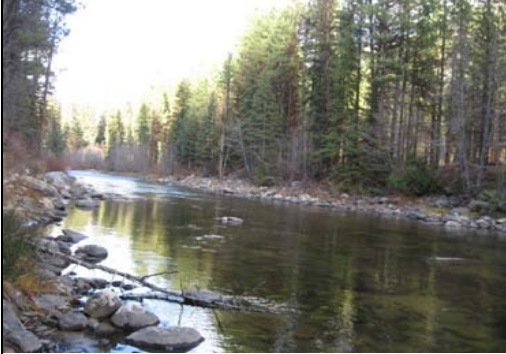
<p>View to the northeast in the upstream direction at a bend in the river near RM 14.76 (November 2009).</p>
7	Project RM 15.15C	Inner Zone 2 (IZ-2)	In-Stream Habitat Enhancement	LWD enhancement	Between RM 15.34 and 14.93 there are opportunities to enhance instream habitat with bank log jams on both sides of the channel. Near RM 15.34 there is a long, straight section with little habitat availability. Several log jams could be placed along both banks in order to provide habitat cover and complexity. Near RM 15.21 is a right bank log jam opportunity meant to increase cover and habitat complexity. The bank is high and eroding, exposing several large root masses. There are pines that could be recruited as LWD. A log jam near RM 15.14 would alternate with the jam at RM 15.21, increasing overall density of cover and creating a location of potential pool scour on the opposite side of the channel. Bank conditions are similar with ongoing erosion of a terrace and potential for LWD recruitment. Near RM 14.93 there are several log jam opportunities in stream banks on both sides of the river. As with the inner zone upstream of this site, there is very little habitat complexity and there is an opportunity at this location to improve it.

<p>View to the north in the upstream direction at a low complexity section of the reach near RM 15.34 (November 2009).</p>

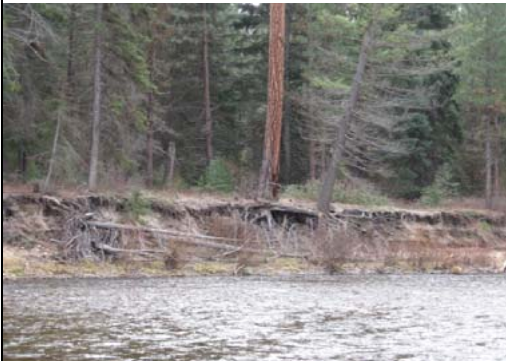
<p>View to the northwest in the upstream direction at the river right bank near RM 15.21 (November 2009).</p>

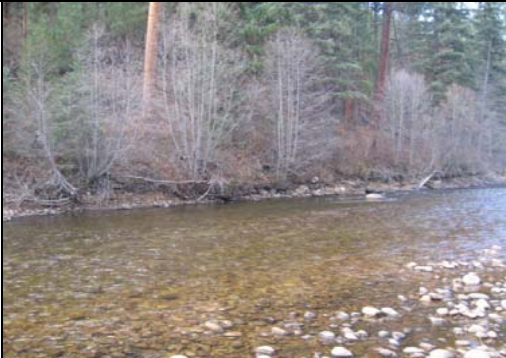
7	Project RM 15.54R	Inner Zone 1 (IZ-1)	In-Stream Habitat Enhancement	LWD enhancement.	This site is at the tail-out of an upstream riffle that orients flow to the west toward the river-right bank resulting in erosion and overhanging root wads. The addition of LWD along the bank would increase scour and pool formation as well as provide cover.

<p>View to the northwest in the upstream direction at the river-right bank near RM 15.54 (November 2009).</p>

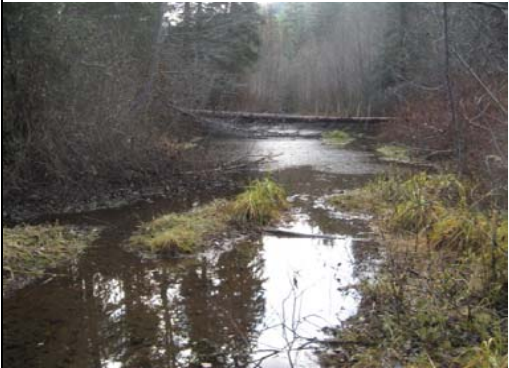
Reach	Project Number	Sub-Unit	Strategy Category	Project Name	Description	Photo
8	Project RM 16L	Outer Zone 8 (OZ-8)	Reconnection Floodplain Processes	Off-channel habitat reconnection	There are large floodplain wetlands and high-flow channel networks throughout this sub-unit. This project would involve creating points of inflow to the floodplain with excavation and log jam construction along the channel margin. Excavation would create low points along the bank where high flow could access the floodplain network. Log jams would help to orient flow onto the floodplain and scour the mouths of the high-flow channel inlets. The downstream connectivity of the outlet may also need to be enhanced to ensure fish passage at lower flows and habitat access. The degree to which this habitat could be allowed to develop is varied. On the one end of the spectrum it appears possible to avulse the entire Chewuch into this relatively mature and complex valley segment. Doing so would greatly increase habitat and complexity in this segment of the valley. However, it would require substantial large wood resources in the current mainstream channel to develop these habitats. Future conceptual design work and preliminary hydraulic analysis will determine various project design options and benefits.

<p>View to the northeast in the upstream direction at a river-left floodplain wetland with marginal connectivity near RM 15.9 (November 2009).</p>

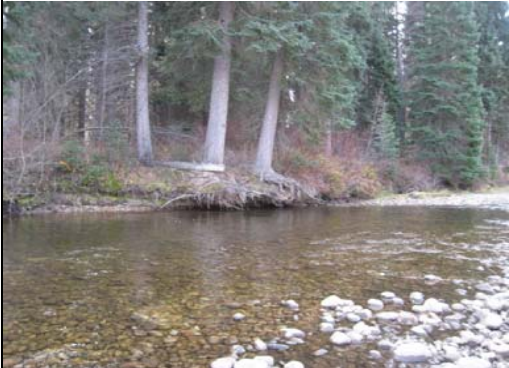
8	Project RM 16.22C	Inner Zone 2 (IZ-2)	In-Stream Habitat Enhancement	LWD enhancement	Log jam placements on both sides of the channel near RM 16.27 could increase the amount of cover and improve the overall quality of in-stream habitat. A site near RM 16.3 has some good existing cover in the form of under-cut root masses. A site near RM 16.22 is without cover, and a bank log jam would greatly increase the quality of habitat in that area. Near RM 16.17, a riffle orients flow into the right bank, creating scour and a pool with good residual depth. LWD could be added to the bank to increase cover and habitat quality in the existing pool.

<p>View to the east at overhanging pool cover along river-left near RM 16.3 (November 2009).</p>
8	Project RM 16.4R	Inner Zone 2 (IZ-2)	Reconnect Stream Channel Processes	LWD placement to enhance lateral connectivity	This log jam project is located at the apex of a large gravel bar that is forming along river-right. The bar apex jam would be placed to take advantage of existing sinuosity and push water to the left to encourage greater lateral migration and sustained habitat formation.

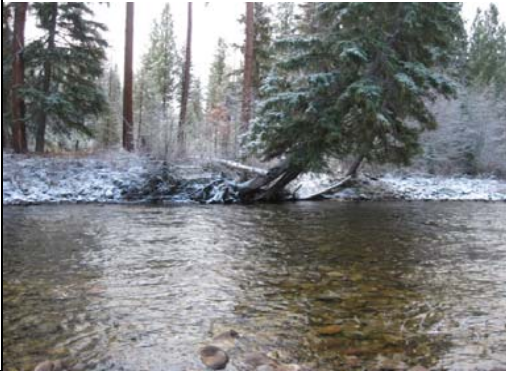
Reach	Project Number	Sub-Unit	Strategy Category	Project Name	Description	Photo
8	Project RM 17.4L	Inner Zone 2 (IZ-2)	In-Stream Habitat Enhancement	LWD enhancement	This project location is at the tail of a riffle where there is moderate pool development. A mature hemlock overhangs a portion of the pool, providing limited cover. A log jam placement would enhance the cover provided by the hemlock and potentially increase scour to provide greater residual pool depth.

<p>View to the southwest in the downstream direction at the river-left bank near RM 17.4 (November 2009).</p>
8	Project RM 17.4R	Inner Zone 2 (IZ-2)	Off-Channel Habitat Enhancement	Side-channel habitat enhancement	This site is on the outside of a bend where the river turns south near RM 17.45. There is a network of high-flow channels across a gravel bar and the adjacent floodplain to the west. A large bar apex jam would be placed near RM 17.45 to move water into the high-flow channel network and increase connectivity between the main channel and side-channel habitat. Some channel excavation and installation of wood and riffle-pool sequences may also benefit habitat in the side-channel.

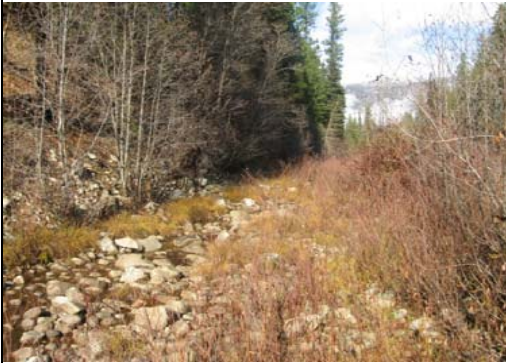
Reach	Project Number	Sub-Unit	Strategy Category	Project Name	Description	Photo
9	Project RM 18.5C	Inner Zone 2 (IZ-2)	Reconnect Stream Channel Processes	LWD placement to enhance lateral connectivity	This project area includes several log jams along both sides of the channel with the goal of increasing habitat complexity and lateral dynamics in the active channel. The stretch of river between RM 18.6 and 18.45 is relatively complex with large stable bars, active split flow, and moderate amounts of LWD. This area presents the opportunity to install multiple habitat features. At the upstream end of the project area near RM 18.6, there is an existing bar apex jam that could be enhanced to move more water into the seasonally dry river-right channel. Near RM 18.55, LWD could be added along the left bank to enhance existing root masses and overhanging trees to increase cover in a pool. Another bar apex jam opportunity exists at RM 18.5. There is a significant amount of wood that is naturally racking up on the bar and across the left channel of the split flow around the bar. The bar forms a riffle and a high quality pool in the right side-channel. LWD added along the bank would enhance cover. Downstream at RM 18.45 there is a location along river-left where LWD recruitment is taking place. Addition of some large wood jams across the channel could increase the rate of recruitment and add complexity to the channel.

<p>View to the north in the upstream direction at a river-right side-channel near RM 18.6 (November 2009).</p>

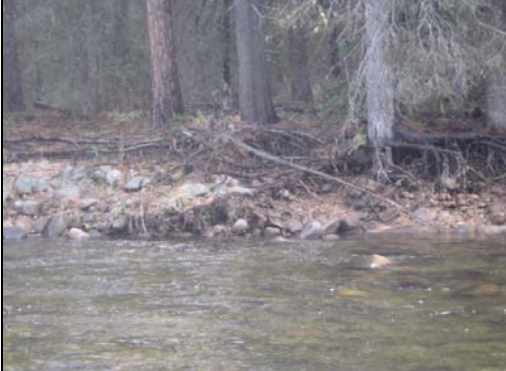
9	Project RM 18.65L	Inner Zone 2 (IZ-2)	In-Stream Habitat Enhancement	LWD enhancement	This location has some bank erosion and exposed root masses that could be enhanced to provide greater cover and available habitat along the bank. The channel morphology is currently a glide. Large wood jams along this bank would enhance cover and likely establish quality pool habitat.

<p>View to the east at the river-left bank near RM 18.65 (November 2009).</p>
9	Project RM 18.75R	Inner Zone 2 (IZ-2)	Reconnect Stream Channel Processes	Riprap removal or modification	Around the mid-channel bar described in Project RM 18.81, there are riffle-glide sequences on both sides of the split flow. The right side flows against riprap at the toe of the road embankment. LWD placed along the bank would provide cover and increase habitat complexity. There is also the potential for scour to form pools over time.

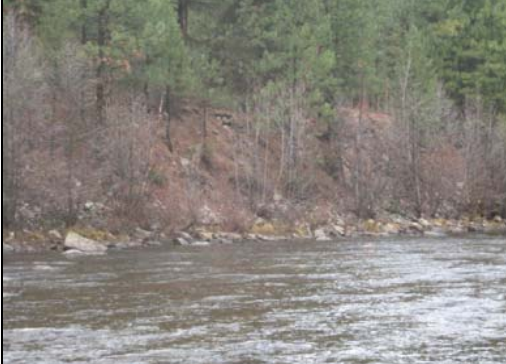
<p>View to the northwest in the upstream direction at the river-right bank near RM 18.75 (November 2009).</p>

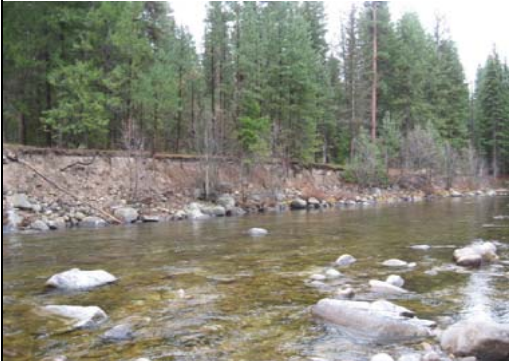
View to the southeast in the downstream direction at the river-left bank near RM 18.9 (November 2009).

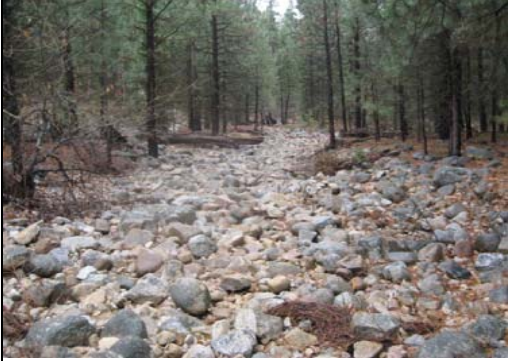
9	Project RM 18.9R	Outer Zone 3 (OZ-3)	Off-Channel Habitat Enhancement	Off-channel/side-channel habitat enhancement	At this project site, there is a high-flow channel along the hillslope margin the entire length of the sub-unit. This channel has clean cobble substrate that suggests relatively frequent conveyance of high-flow. Farther downstream, flood flow becomes dispersed on the floodplain and the channel loses definition. Connectivity between the active channel and this floodplain channel could be increased through excavation and log jam construction at the inflow. A backwater pool could be created at the downstream end, which would also require excavation.

View to the south in the downstream direction at a high-flow channel on river-right near RM 18.9 (November 2009).
9	Project RM 19C	Inner Zone 2 (IZ-2)	Reconnect Stream Channel Processes	Abandoned bridge abutment removal and LWD enhancement	This project involves using LWD to enhance several areas on both sides of the channel between RM 18.96 and 19.1. Near the upstream end of this stretch at RM 19.1, there is a pool on river-left with overhanging vegetation that provides a moderate amount of cover. A log jam along the bank would improve habitat quality. A glide near RM 19.05 provides an opportunity for log jams on both sides of the river to instigate pool formation. At the downstream end of this project area near RM 18.96, there is an old bridge pier in the channel and an abutment on the bank. The old bridge concrete could be removed or kept in place to form the foundation of a large log jam that would increase cover and extend the size and depth of the existing pool feature.

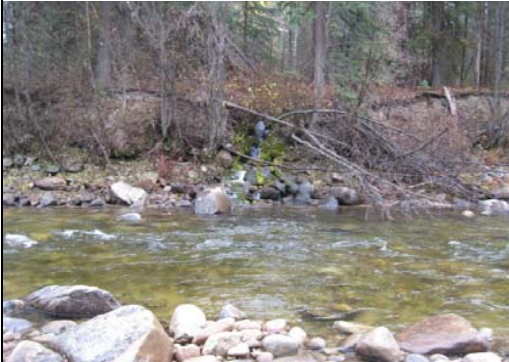
View to the east at the river-left bank near RM 19.1 (November 2009).

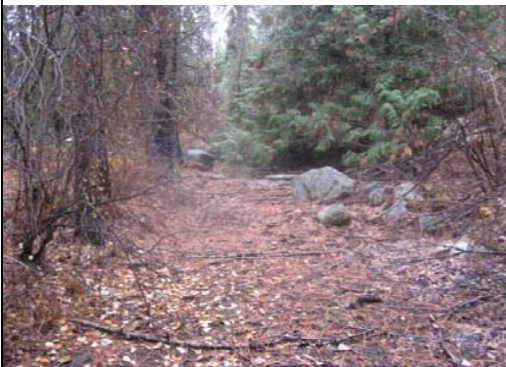
Reach	Project Number	Sub-Unit	Strategy Category	Project Name	Description	Photo
9	Project RM 19.05R	Outer Zone 3 (OZ-3)	Off-Channel Habitat Enhancement	Off-channel/side-channel habitat enhancement.	Between RM 18.96 and 19.1, there is an old high flow channel that runs along the toe of the hillslope the entire length of the sub-unit. Geomorphic evidence suggests little connectivity between this floodplain feature and channel processes. A well-connected side-channel or groundwater-fed off-channel could be created here. At the downstream end, a backwater surface connection could also be excavated. This project could be combined with the previously presented mainstem log jam work at the island apex. The extent of side-channel excavation versus large wood additions to establish flow down the side-channel would be determined during conceptual project development and following preliminary hydraulic analysis.

<p>View to the south in the downstream direction at an abandoned high-flow channel along river-right near RM 19.05 (November 2009).</p>

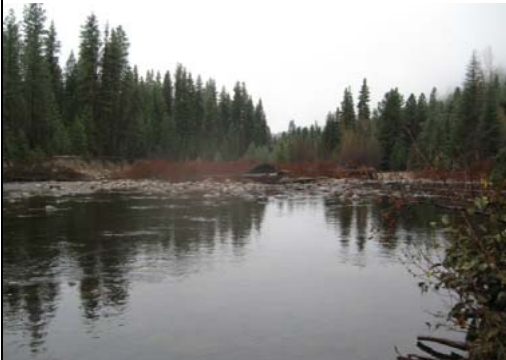
9	Project RM 19.25R	Inner Zone 2 (IZ-2)	Reconnect Stream Channel Processes	Enhance side-channel habitat connectivity	This area of the inner zone is very active with mid-channel bar formation, split-flow, and LWD recruitment along river-left where the channel is eroding the toe of an alluvial fan. A bar apex jam has naturally formed on the mid-channel bar. This feature could be enhanced to maintain split flow and habitat complexity. The apex jam could be designed to encourage LWD recruitment along the river-left bank downstream. To the far river-right there is a high flow channel that extends between RM 19.1 and 19.35, with a well-connected off-channel backwater at its downstream end. The apex jam would maintain flow through this feature, and several smaller log jams could be placed to add habitat and cover to the backwater. Upstream of the apex jam near RM 19.2 is a bank log jam opportunity on the outside of a slight bend in the river where there is slow water that could be enhanced to provide better habitat. There is very little habitat in the main channel upstream of the side-channel. Large logs could be placed to provide cover and potentially drive scour-and-fill to form a pool and provide substrate smaller than the cobbles and boulders that dominate now.

<p>View to the south in the downstream direction at a bar apex log jam near RM 19.25 (November 2009).</p>

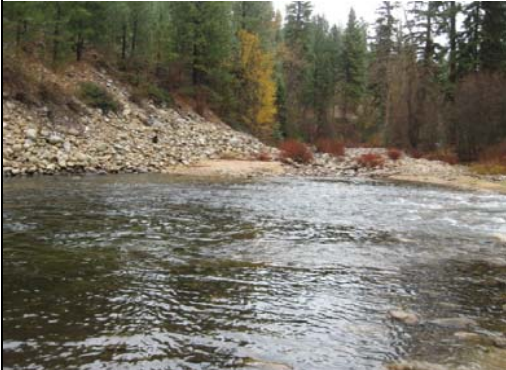
9	Project RM 19.4R	Inner Zone 2 (IZ-2)	In-Stream Habitat Enhancement	LWD enhancement	At the bottom of the riffle just downstream of Project RM 19.45L, there is a relatively large pool on the outside of a bend. The river flows directly against the hillslope and there is a road above. The outlet of an active side-channel is at the top of the pool. This project would place a large log jam in the pool, and at the outlet of the side-channel to increase cover and scour that will maintain pool depth and side-channel connectivity.

<p>View to the north in the upstream direction at a pool and side-channel outlet on river-right near RM 19.4 (November 2009).</p>

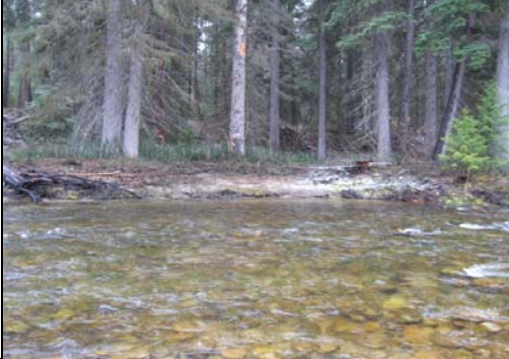
Reach	Project Number	Sub-Unit	Strategy Category	Project Name	Description	Photo
9	Project RM 19.45L	Inner Zone 2 (IZ-2)	In-Stream Habitat Enhancement	LWD enhancement	The goal of this project is to provide cover and increase scour in a short glide. A gravel bar creates a riffle just upstream that orients flow towards the river-left bank creating a short glide where the riffle tails out. Velocity soon increases into another riffle just downstream. LWD would enhance cover and potentially create a scour pool along the bank.

<p>View to the south at the river-left bank near RM 19.45 (November 2009).</p>
9	Project RM 19.6L	Inner Zone 2 (IZ-2)	Reconnect Stream Channel Processes	LWD placement to enhance side-channel connectivity	The main channel in this vicinity provides very little habitat. The channel is plane-bed morphology and there is no LWD. This project would place LWD along the left bank to increase local cover and habitat complexity. As an extension of this work, a larger scale log jam would be constructed at the head of a large forested island. By occluding flow in the mainstem at the island apex, the log jam would enable more water to flow down a western side channel (valley right). Within this side channel 2-3 large log jams along the right bank would be constructed to protect the existing valley bottom road and enhance habitat.

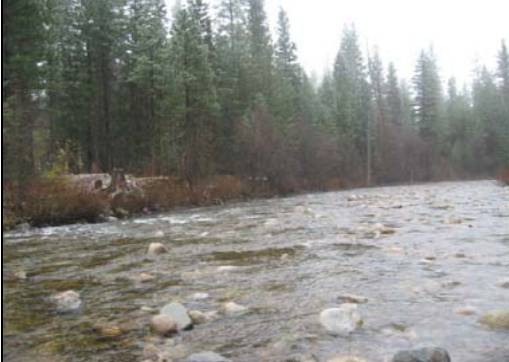
<p>View to the southeast in the downstream direction at the river-left bank near RM 19.6 (November 2009).</p>
