Chewuch River Reach Assessment

Provided for:

Yakama Nation Fisheries Program

JUNE 2010

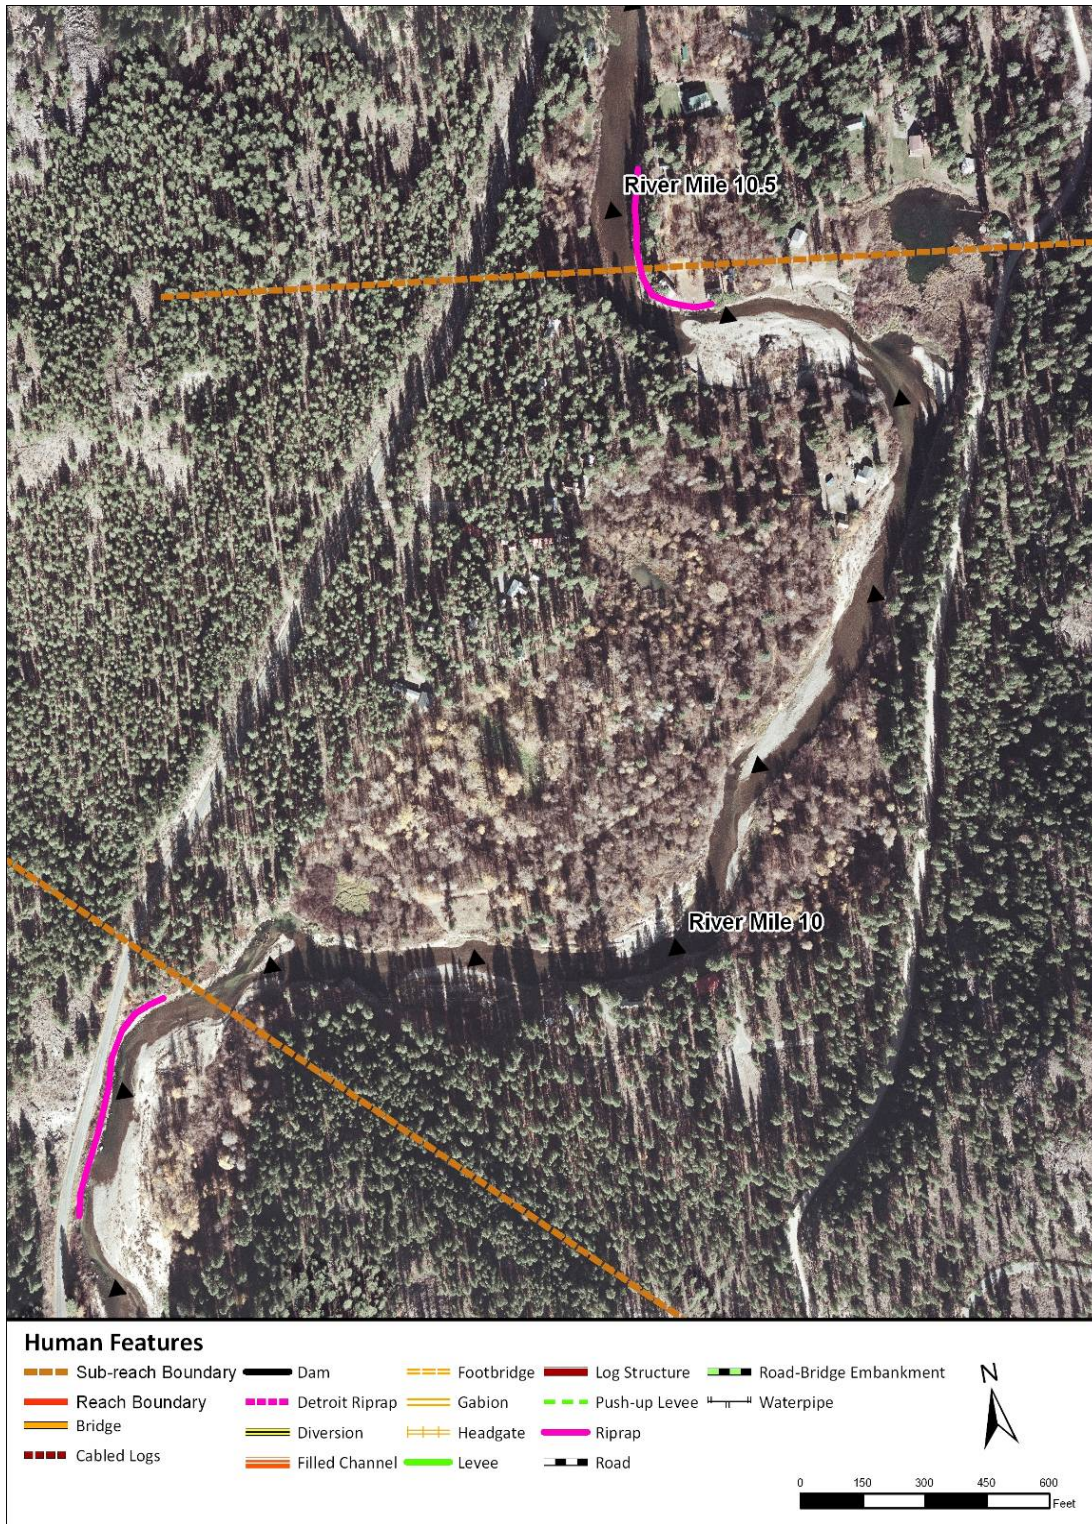
Figure 26. Aerial photo showing human features in Reach C4b. Flow is from north to south.

There is residential development on both sides of the channel at the upstream end of the reach (Figure 26). Streamside riparian vegetation has been cleared and in some areas the banks have been hardened with riprap. There is also residential development of the floodplain along the west side of the valley. A few structures have been built and a long access road is located on the surface. There is relatively little riparian clearing involved with this development. In some locations, streamside vegetation has been removed and improvised riprap has been placed on the bank.

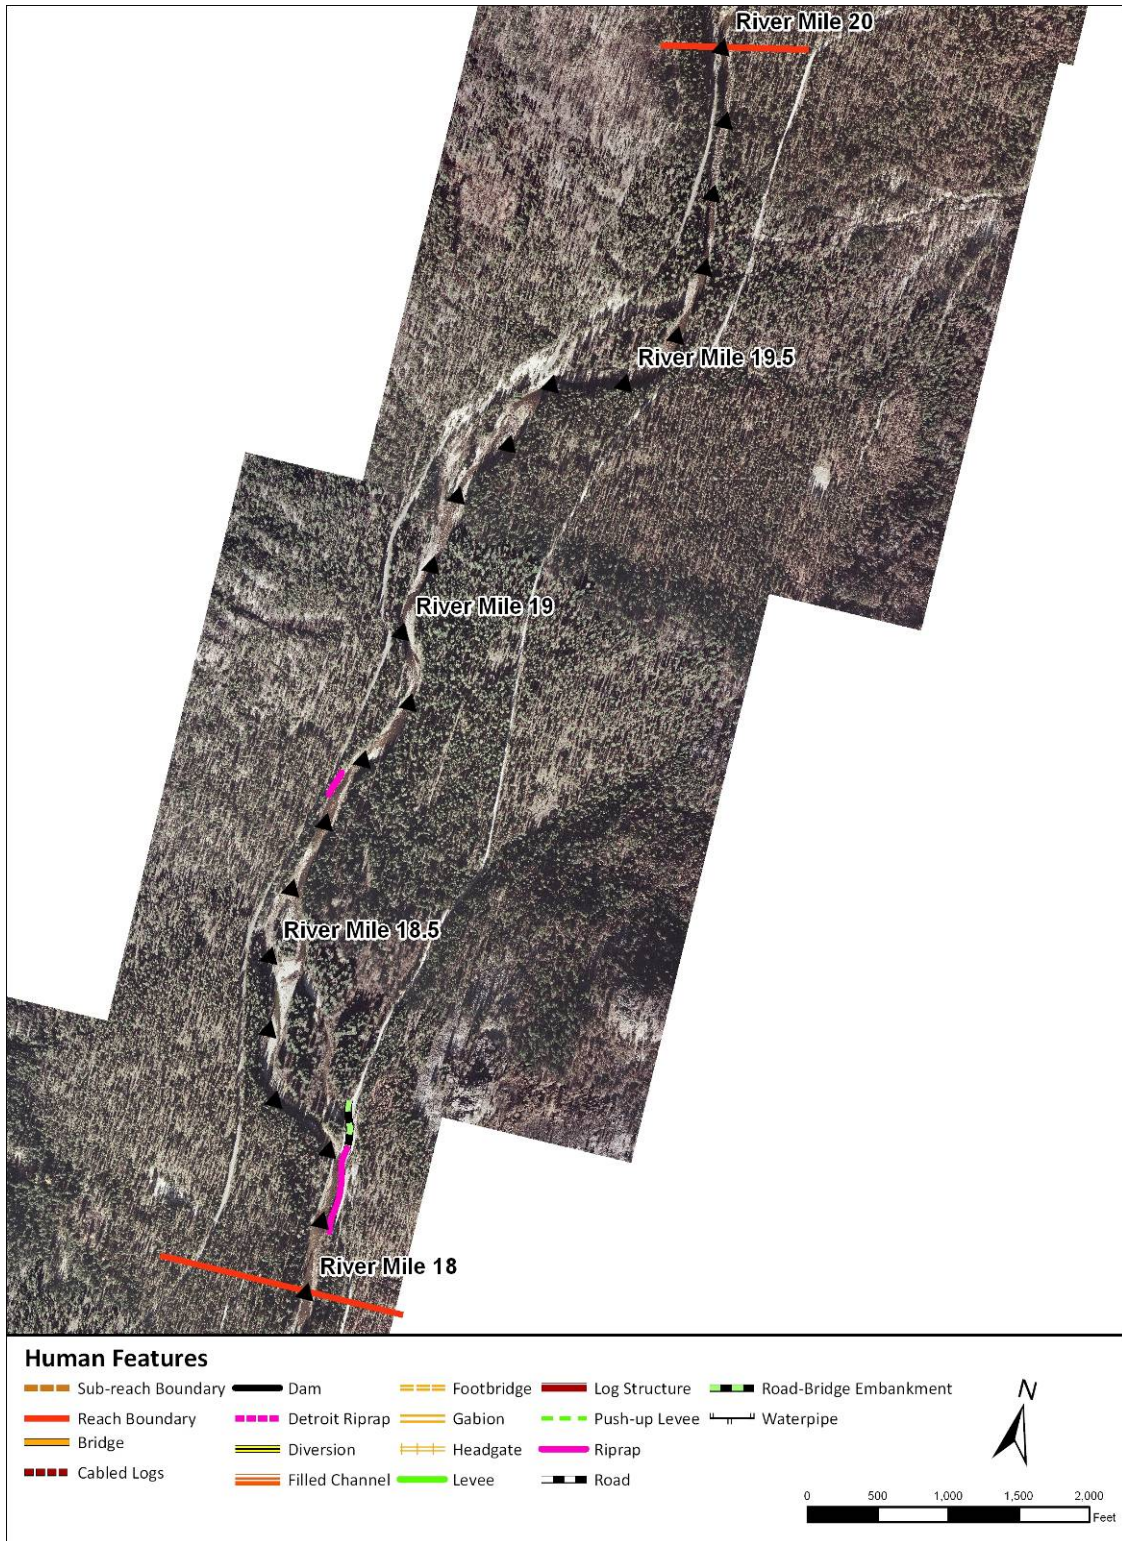
Figure 47. Aerial photo showing human features in Reach C9. Flow is from north to south.

There is little human disturbance in this reach (Figure 47). The main alteration is the road along the west side of the valley. Although the road is located on the hillslope above the channel and low surface, the embankment often forms the channel margin, creating requirements of protection and maintenance that affect channel migration, erosion, and streambank habitat.
