Entiat River Upper Stillwaters Reach Stream Corridor Assessment & Habitat Restoration Strategy

SUBMITTED TO
Yakama Nation Fisheries Program

OCTOBER 2013

PREPARED BY
Inter-Fluve, Inc.
501 Portway Ave, Suite 101
Hood River, OR 97031
(541) 386-9003

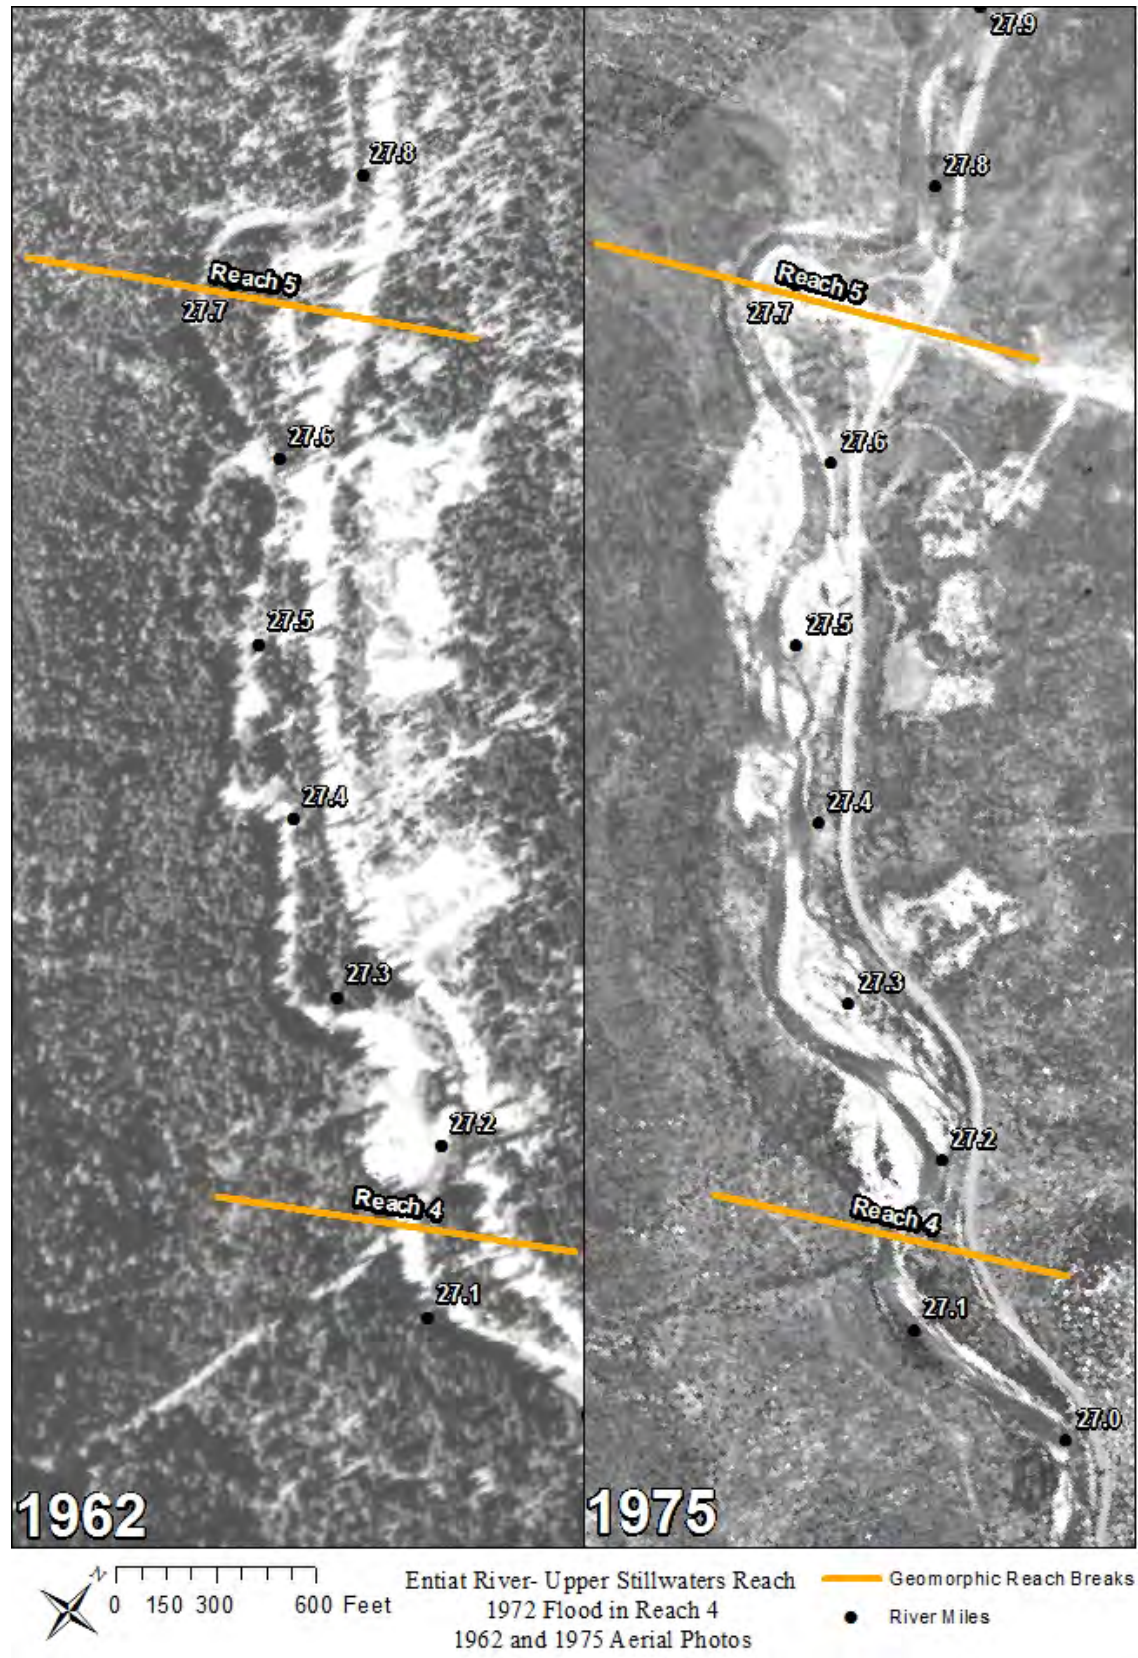
Figure 24. Aerial photo comparison of Reach 4 before (1962) and after (1975) the 1972 flood.

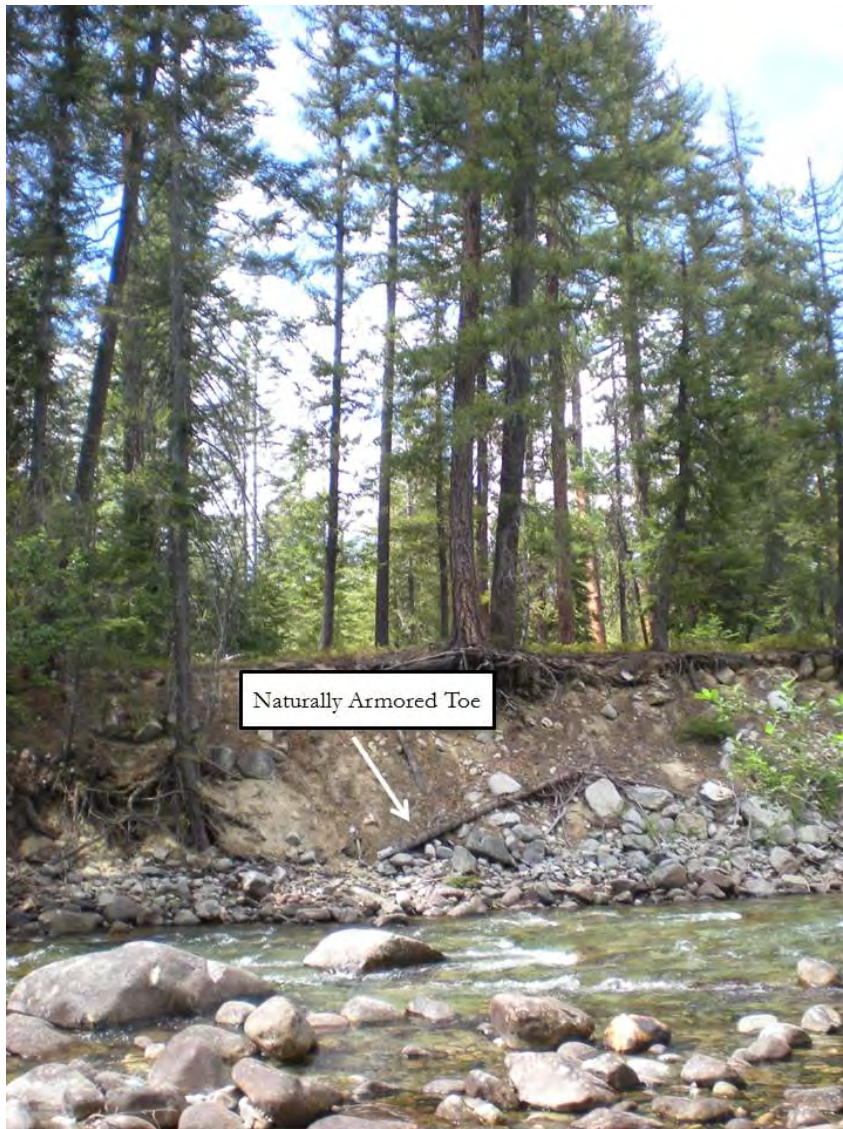
Figure 25. Naturally armored bank toe in confined portion of Upper Stillwaters Reach.

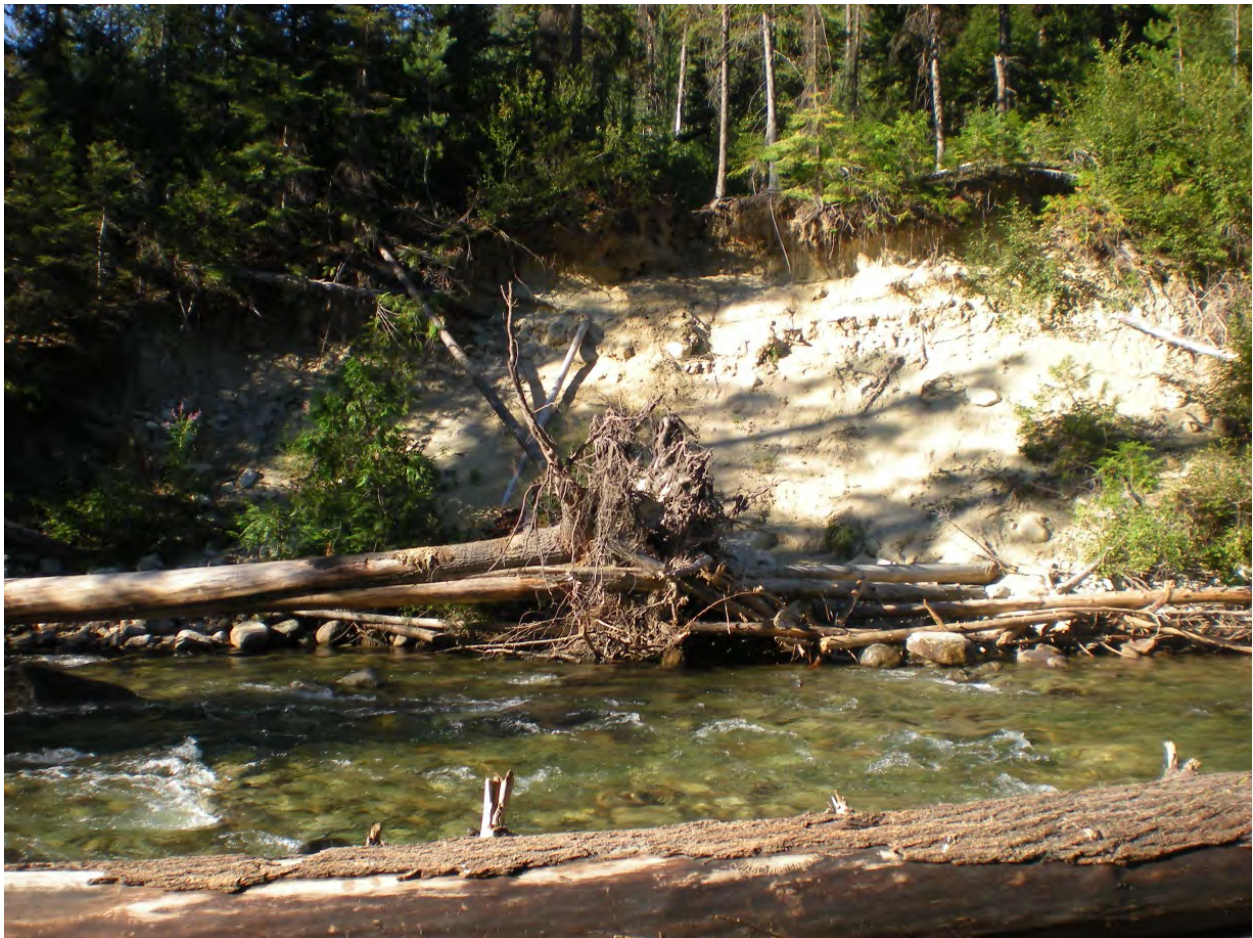
Figure 26. Example of a terrace with pumice deposits in the upper portion of the study area.

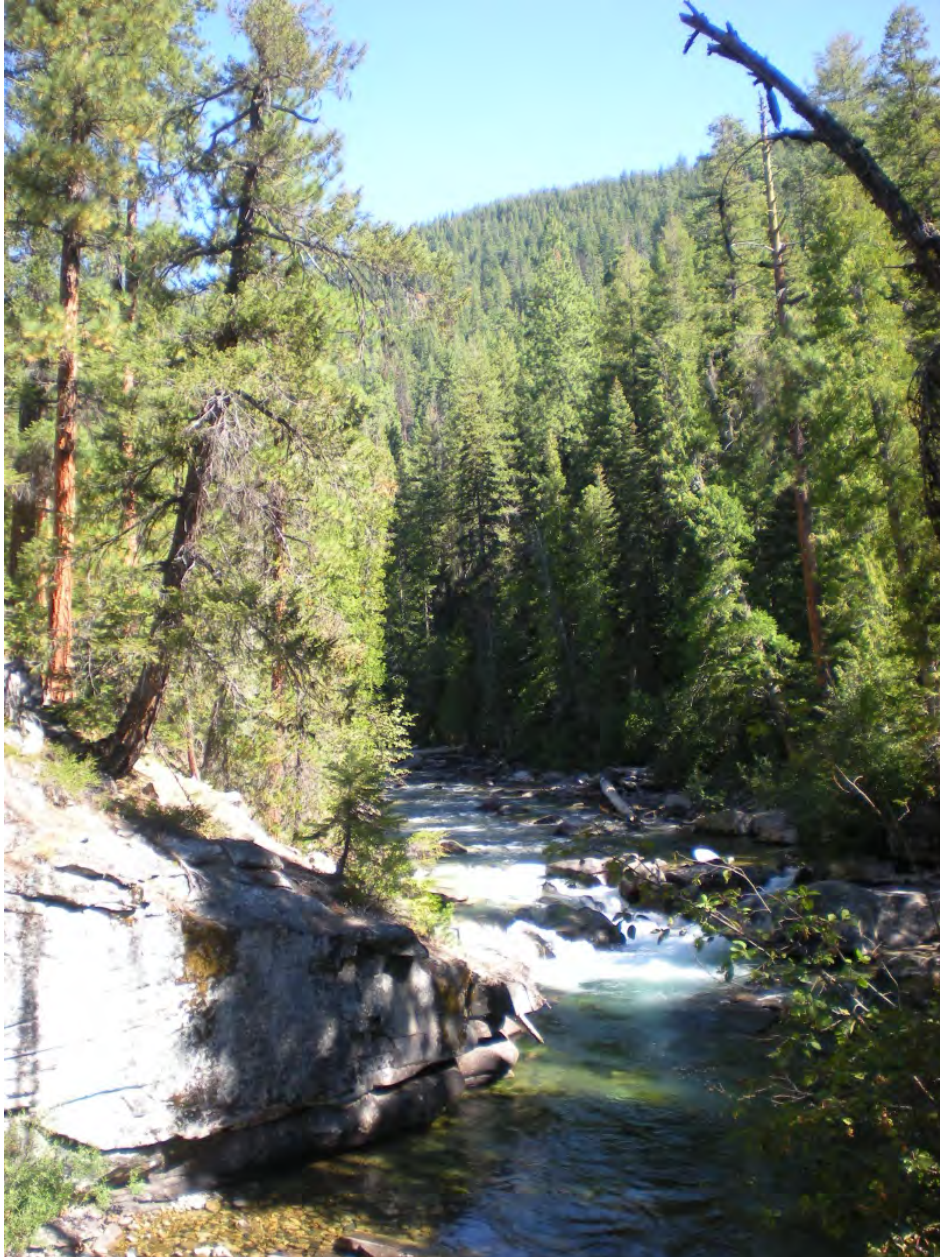
Figure 27. Bedrock outcrop along the channel in the study area providing lateral migration and vertical grade controls.

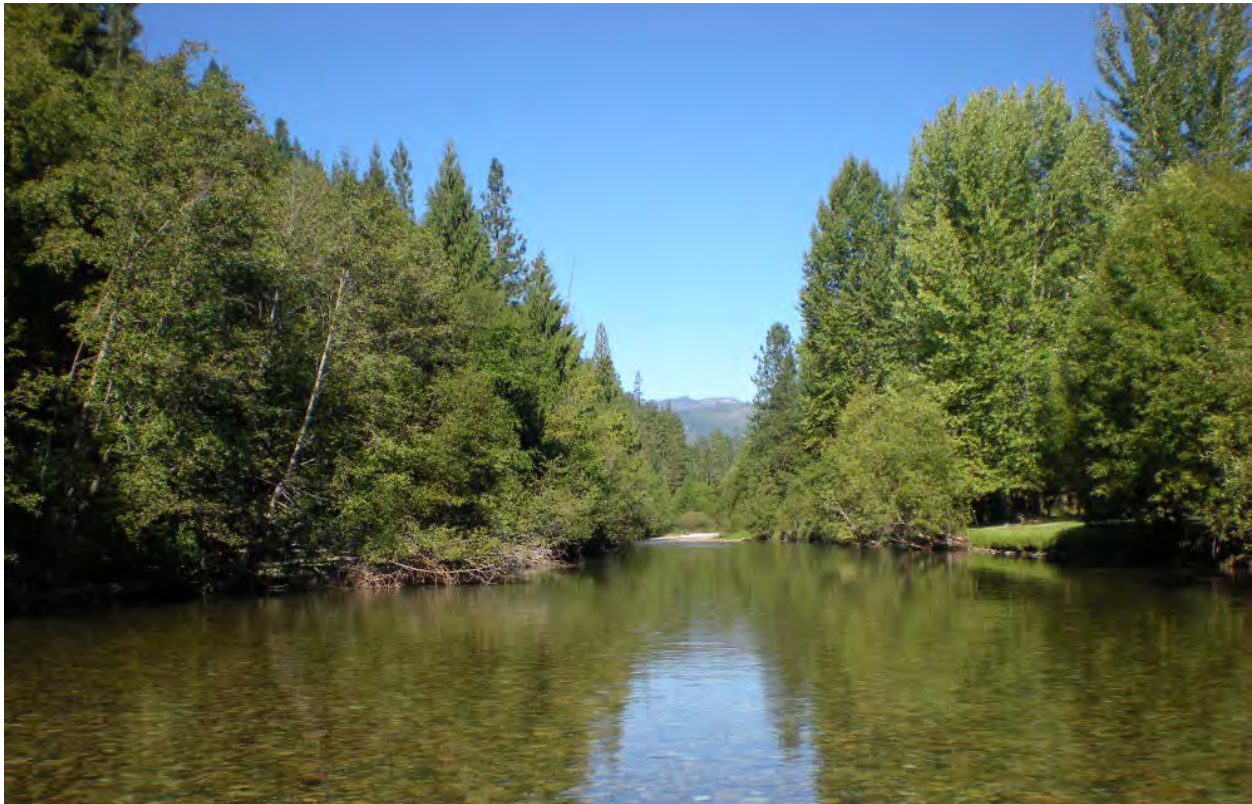
Figure 30. Representative photo of channel in the straight middle portion of Reach 0.

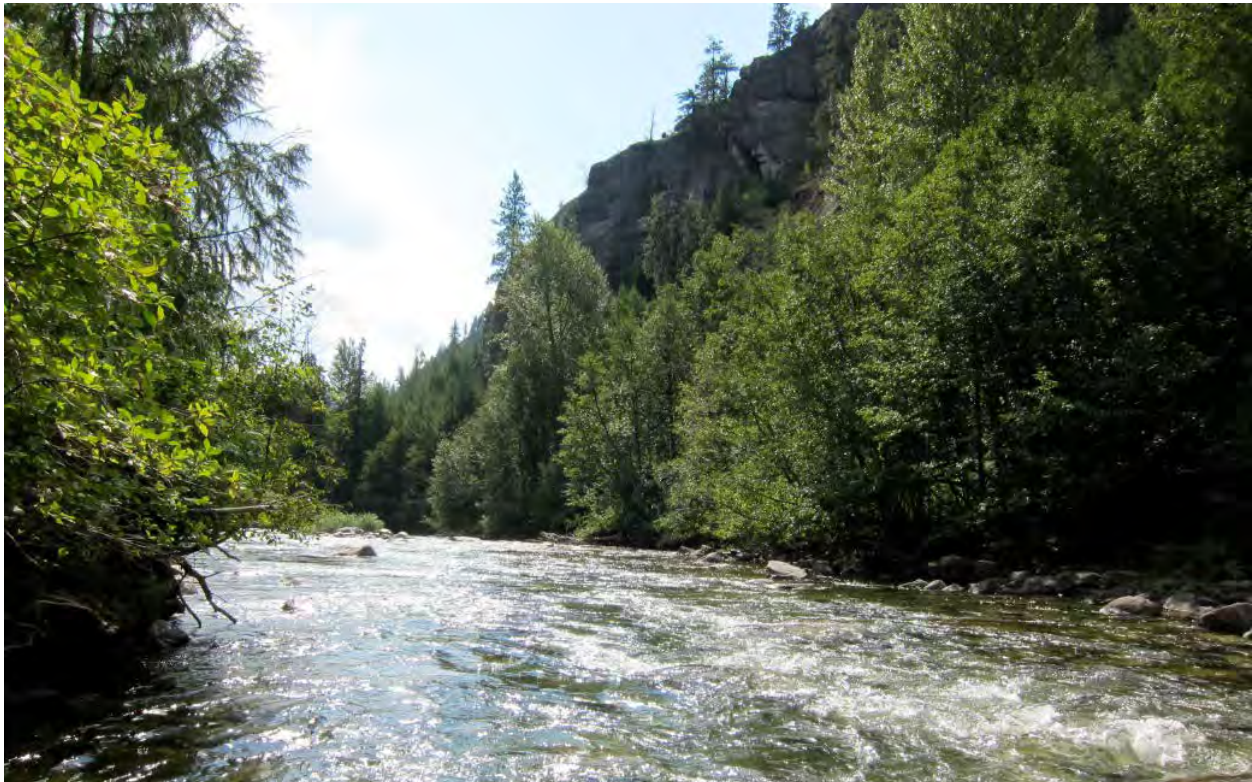
Figure 34. Representative Channel Morphology for Reach 1

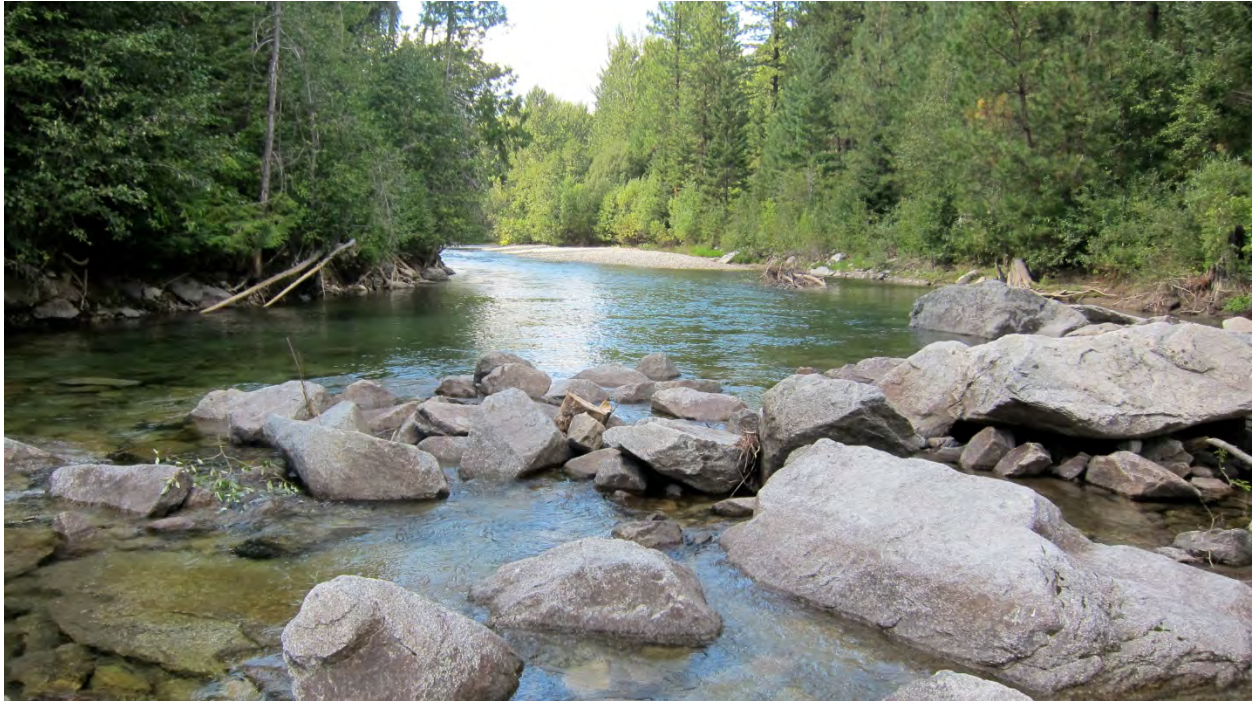
Figure 35. Large debris flow deposits originating from alluvial fans in Reach 1.

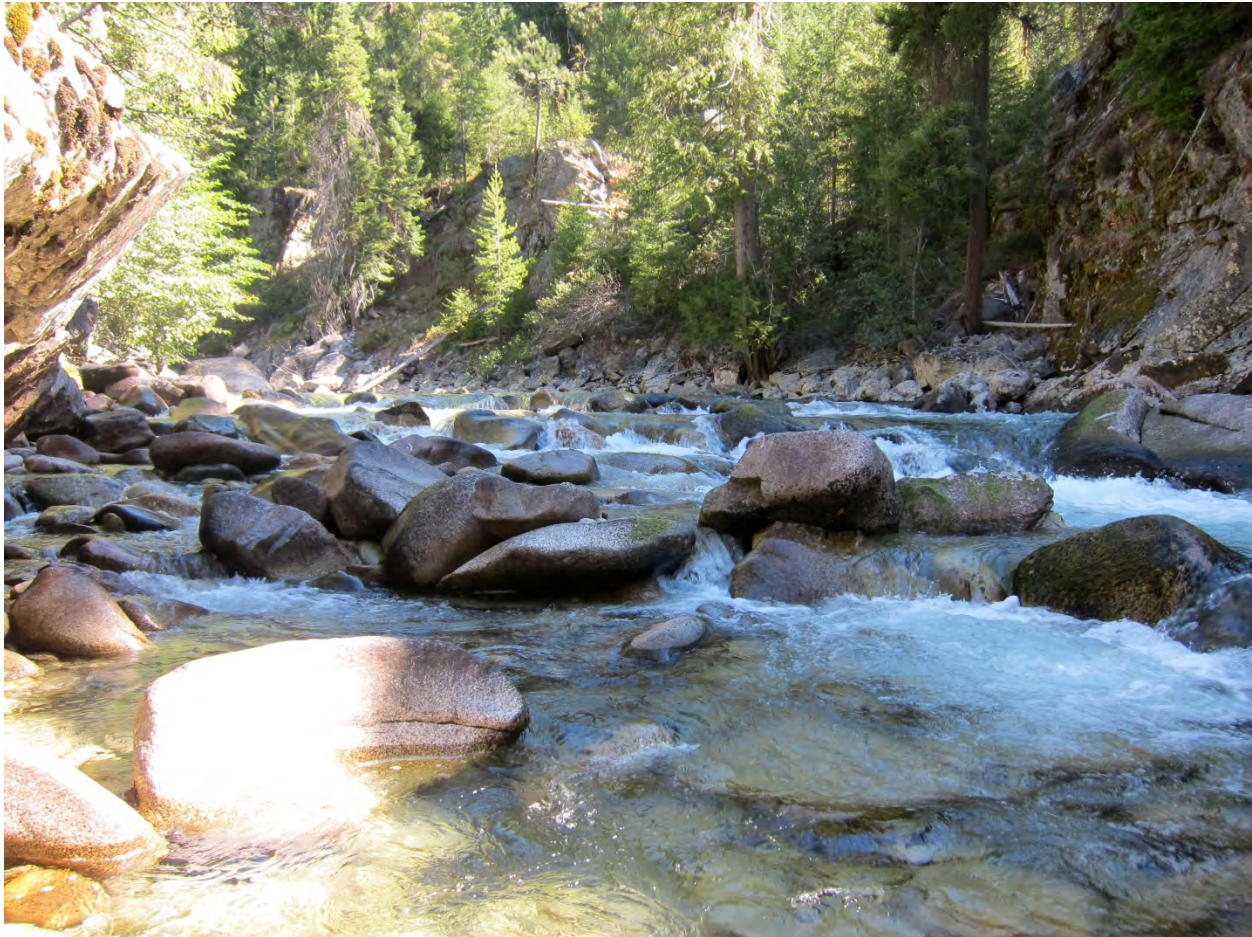
Figure 38. Representative bed morphology of Reach 3.

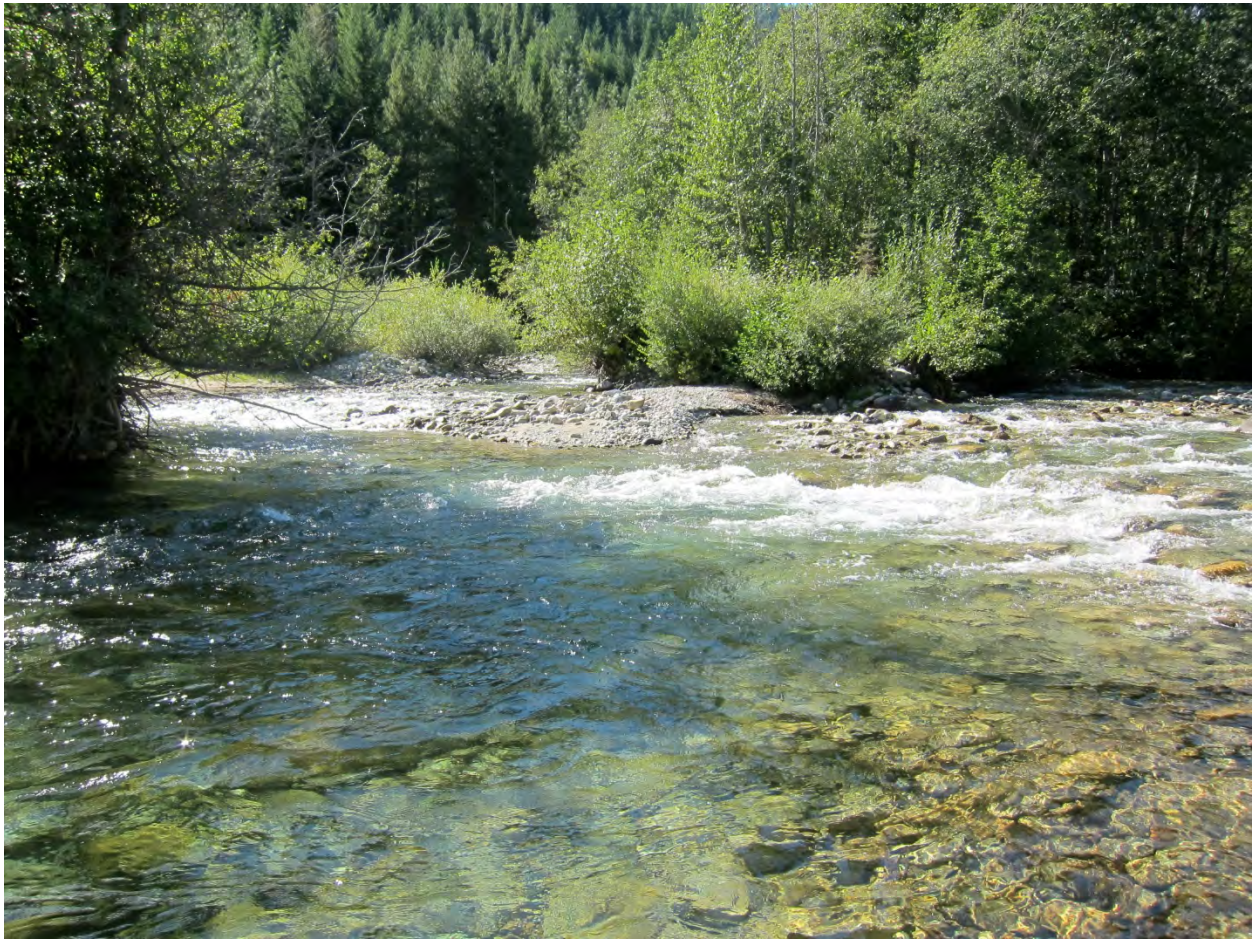
Figure 40. Representative morphology of Reach 4.

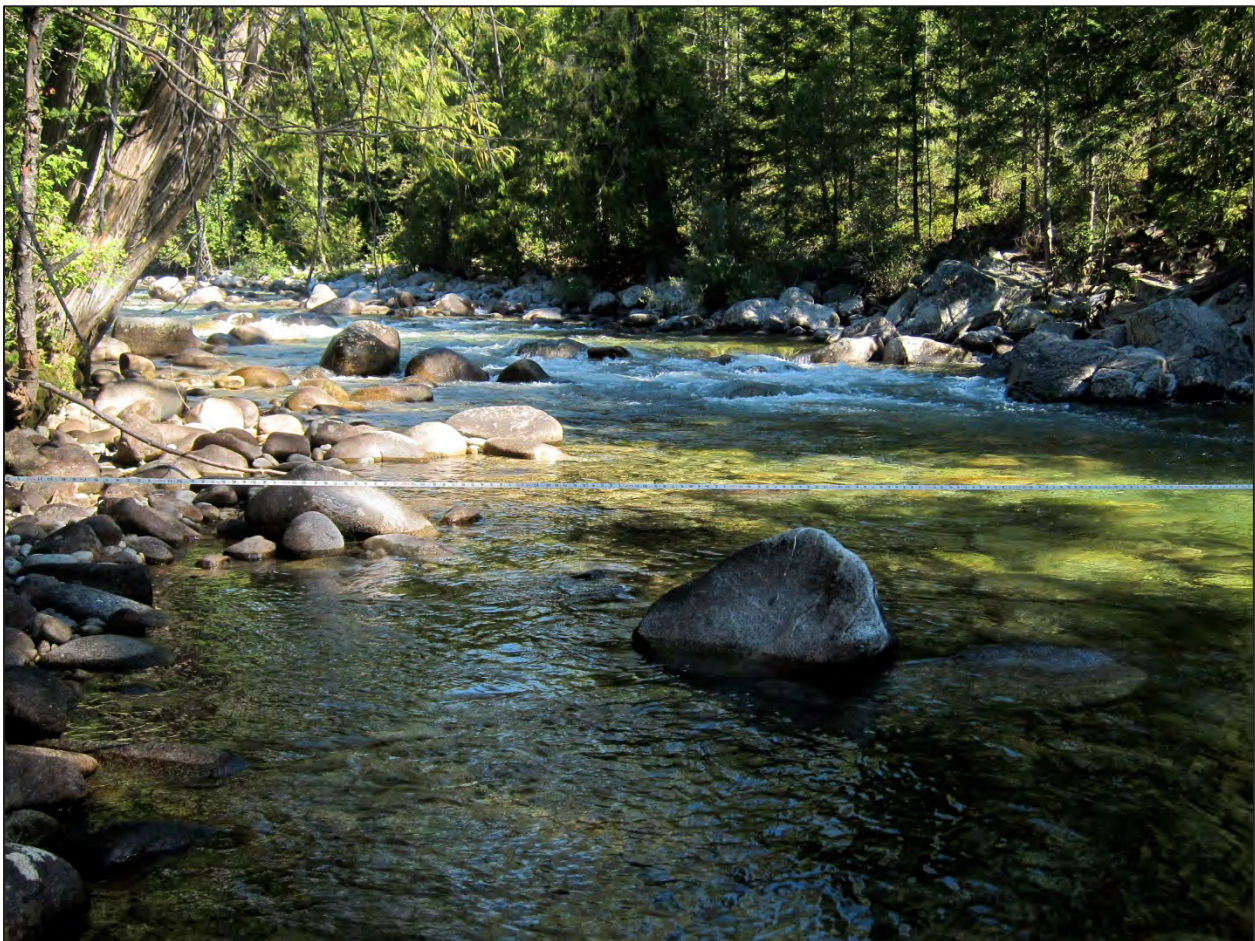
Figure 42. Representative morphology of Reach 5.

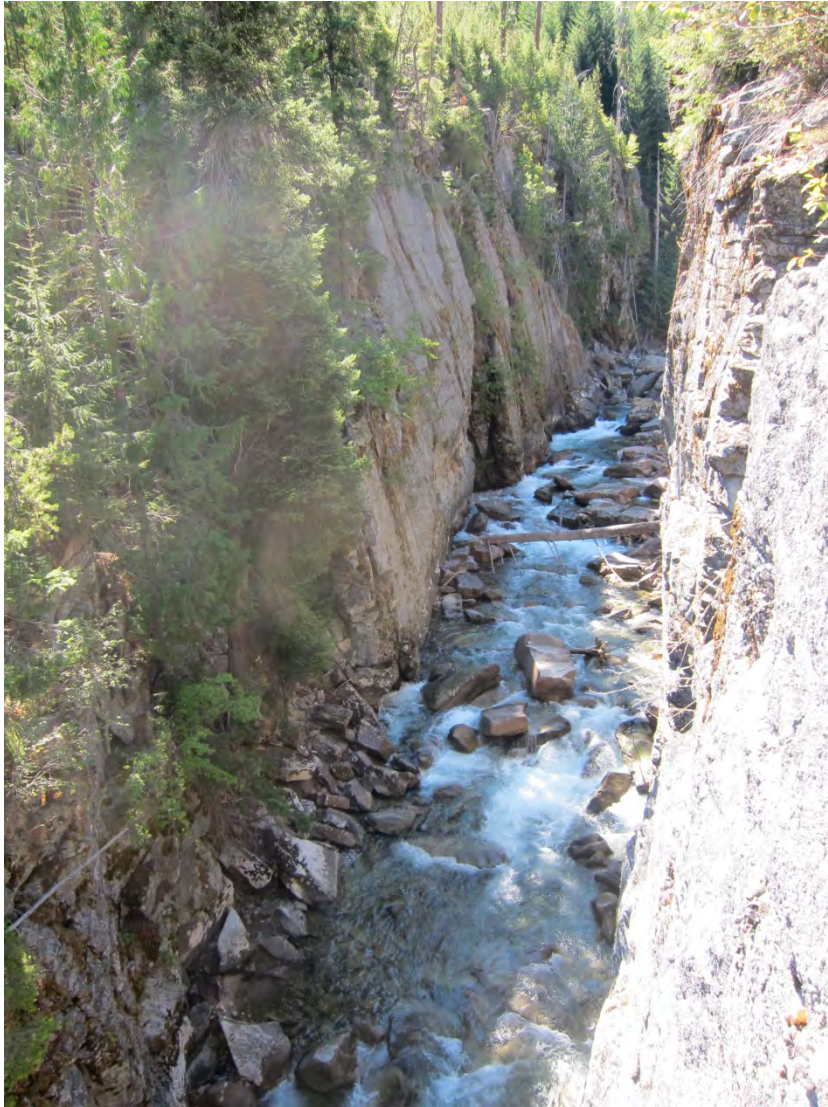
Reach 6 is a steep, confined bedrock canyon known as Box Canyon (Figure 44). Sheer bedrock walls confine the channel along both banks throughout much of the reach, and are 50 to 100 feet high. Channel units are steep and turbulent, including many cascades and steep step-pool sequences. Bed substrate ranges from gravel to bedrock, with cobble the predominant substrate type (60%). Where bedrock spans the channel and forms the bed, there are typically steep drops that transition abruptly into plunge pools creating a stepped profile. The reach has a sinuosity of 1.13.

Figure 44. Representative channel morphology of Reach 6.

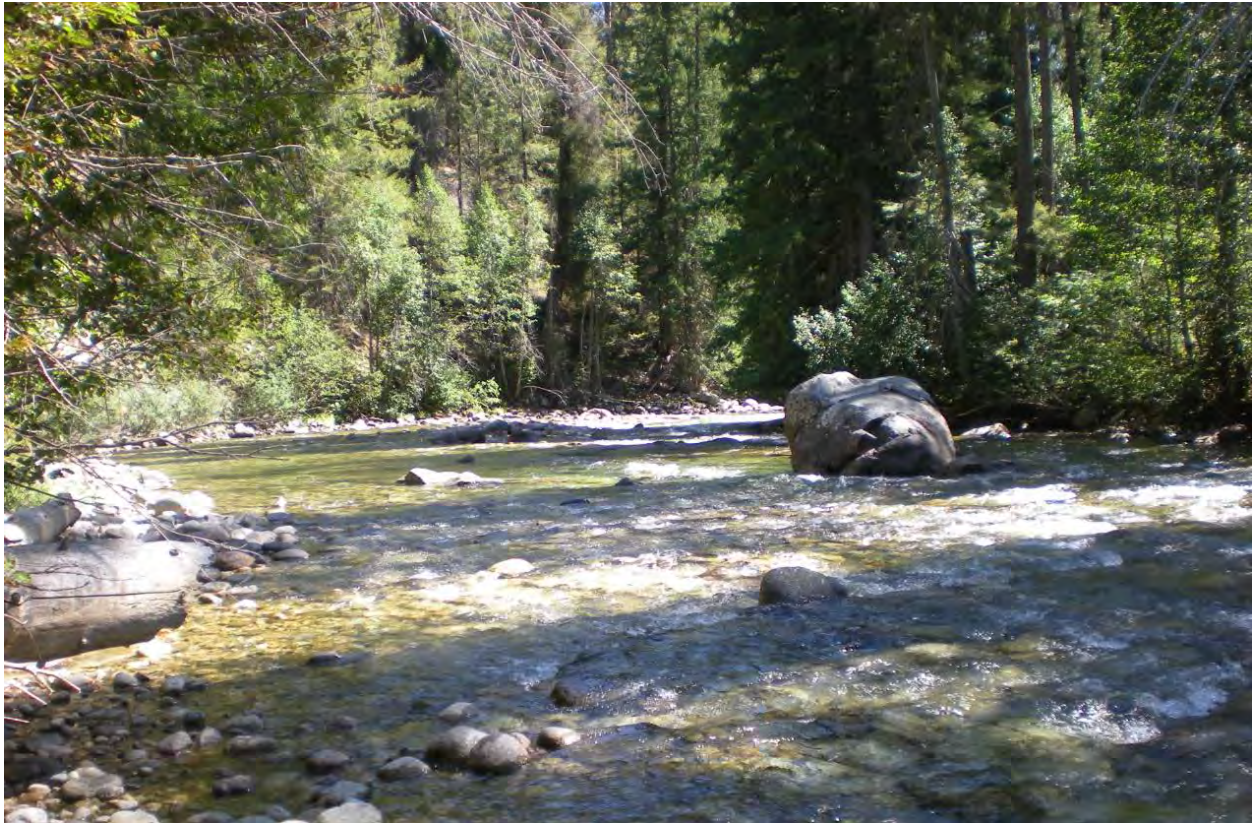
Reach 7 is a transitional reach between the bedrock-confined Reaches 6 and 8. Bed morphology in Reach 7 is extremely homogenous, and is predominantly one long riffle that is forced around an alluvial fan on river right (Figure 46). One short channel-spanning pool is interspersed within the riffle. Substrate is primarily large cobble, with occasional boulders sourced from either mass-wasting deposits, alluvial fans, or lag derived from glacial outwash deposits.

Figure 46. Representative morphology of Reach 7.

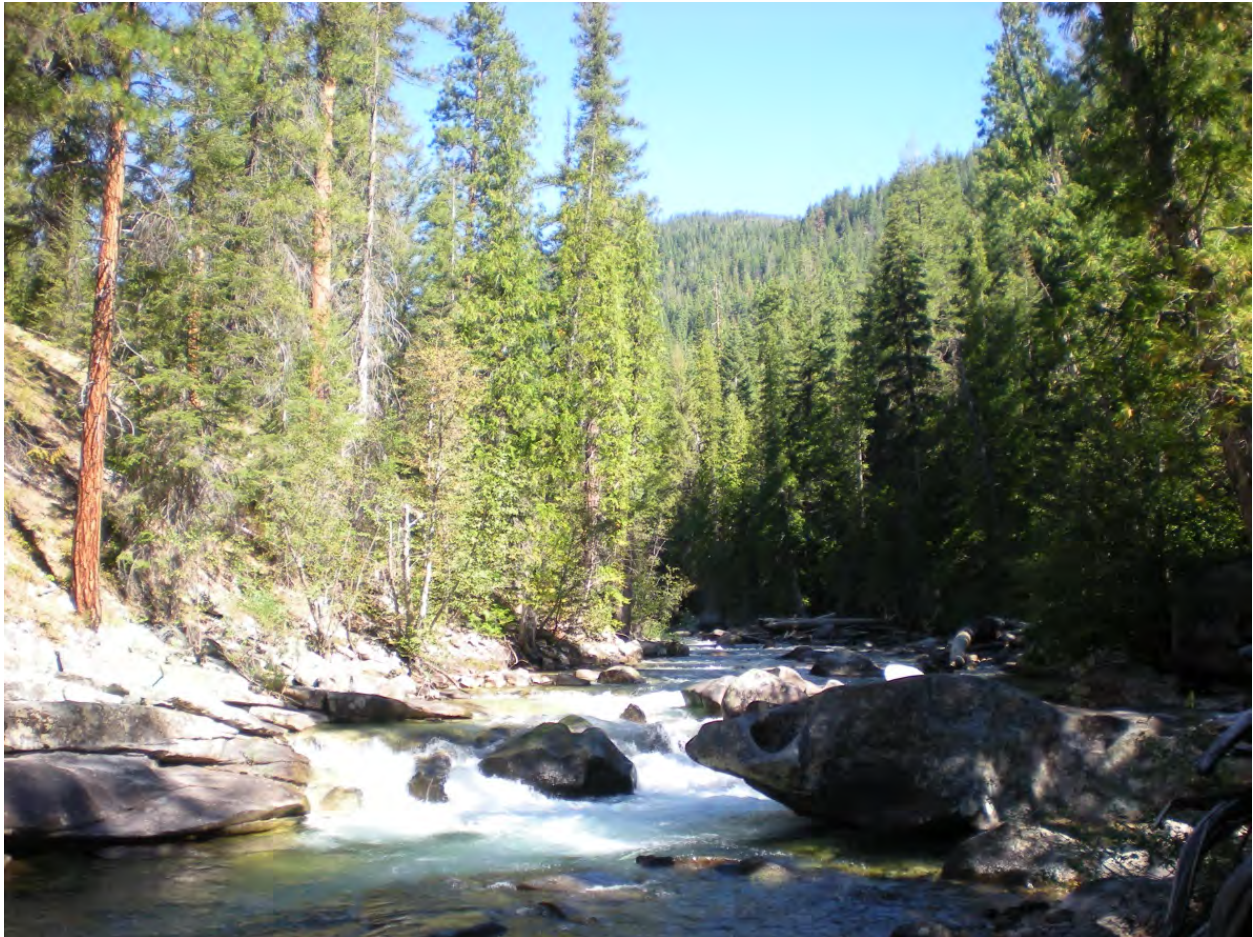
Reach 8 is a steep, confined single thread channel with a sinuosity of 1.14. Bed morphology is predominantly fast water units (riffles and rapids) with channel spanning scour and plunge pools (Figure 49). Rapids drop from one to five feet over bedrock sills, and plunge pools appear deep (greater than 9 feet), though depths were not measured due to unwadeable conditions. Large boulders and bedrock are present throughout much of the channel, with gravels and sand present in pools and eddies. Bedrock outcrops confine the channel on both sides alternating along river right and river left and in some places confining the channel on both sides creating a canyon. Canyon walls range from 10 to over 60 feet tall. At two points the bedrock walls constrict low flow discharge through narrow rock shoots (RM 30.9 and RM 29.97).

Figure 49. Representative morphology of Reach 8.

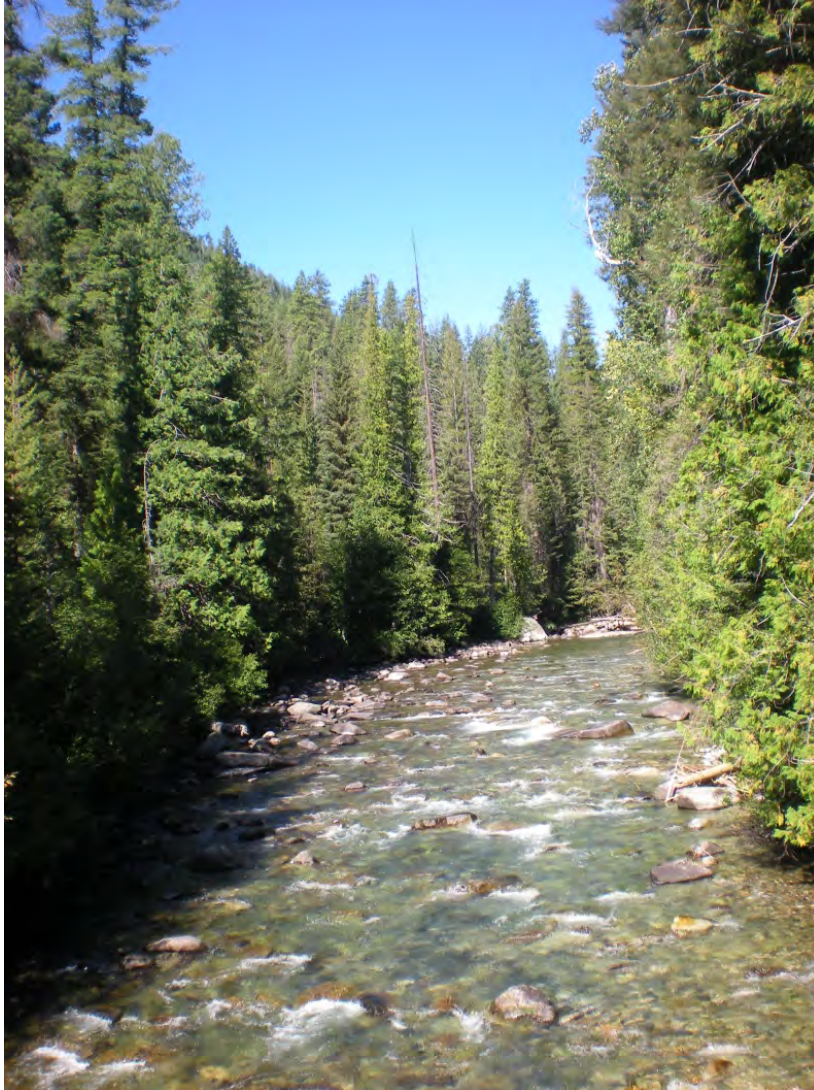
Reach 10 is primarily a long riffle complex that alternates between high gradient rapids (40%) and moderate gradient riffles (52%). In more moderate gradient segments of Reach 10, smaller coarse materials (i.e. gravels) accumulate along channel margins. Channel substrate is principally gravel (50%), followed by cobble (35%). Confined by abandoned floodplain and glacial outwash surfaces, the channel is relatively straight with a sinuosity of 1.05.

Figure 52. Representative morphology of Reach 10.

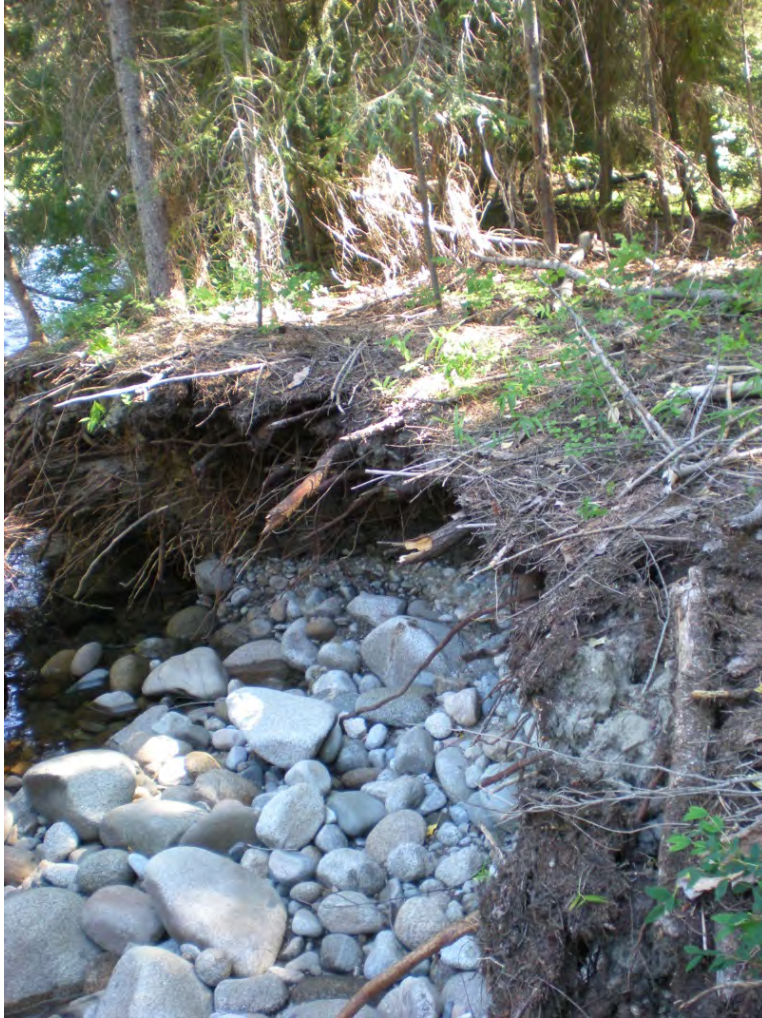
Channel migration processes are limited by the close proximity of hillslopes, bedrock outcrops, abandoned floodplain terraces on river-left, and along river-right by both abandoned floodplain terraces and an alluvial fan. Historically, confinement of the channel by mass-wasting from river-left and abandoned floodplain surfaces have dictated channel planform. Channel migration processes are ongoing in some locations, however, as evidenced by undercut rootwads (Figure 52).

Figure 53. Undercut root wads along the right bank in Reach 10.

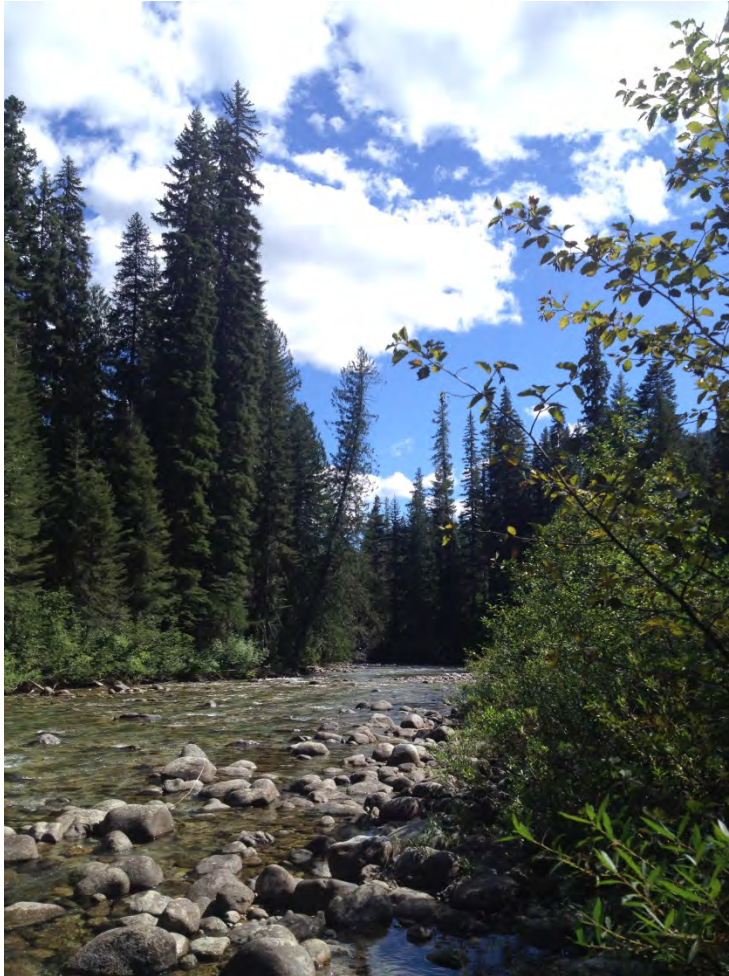
Reach 11 is a steep, single-thread channel with point and mid-channel bars active at regular high flow events (e.g. Q1 to Q3) (Figure 55). Bar surfaces are armored by a large cobble substrate. Bed substrate ranges from gravel to bedrock, with cobble the predominant substrate type (60%). Channel units alternate between long riffles and short turbulent rapids. Bedrock outcrops alternate along river right and river left throughout the reach. Similar to Reach 12, bedrock outcrops extend across the width of the channel, creating short, turbulent rapids and cascades with downstream plunge pools. Semi-confined by bedrock contacts and alluvial terraces, the reach has a low sinuosity of 1.13.

Figure 55. Representative morphology of Reach 11.

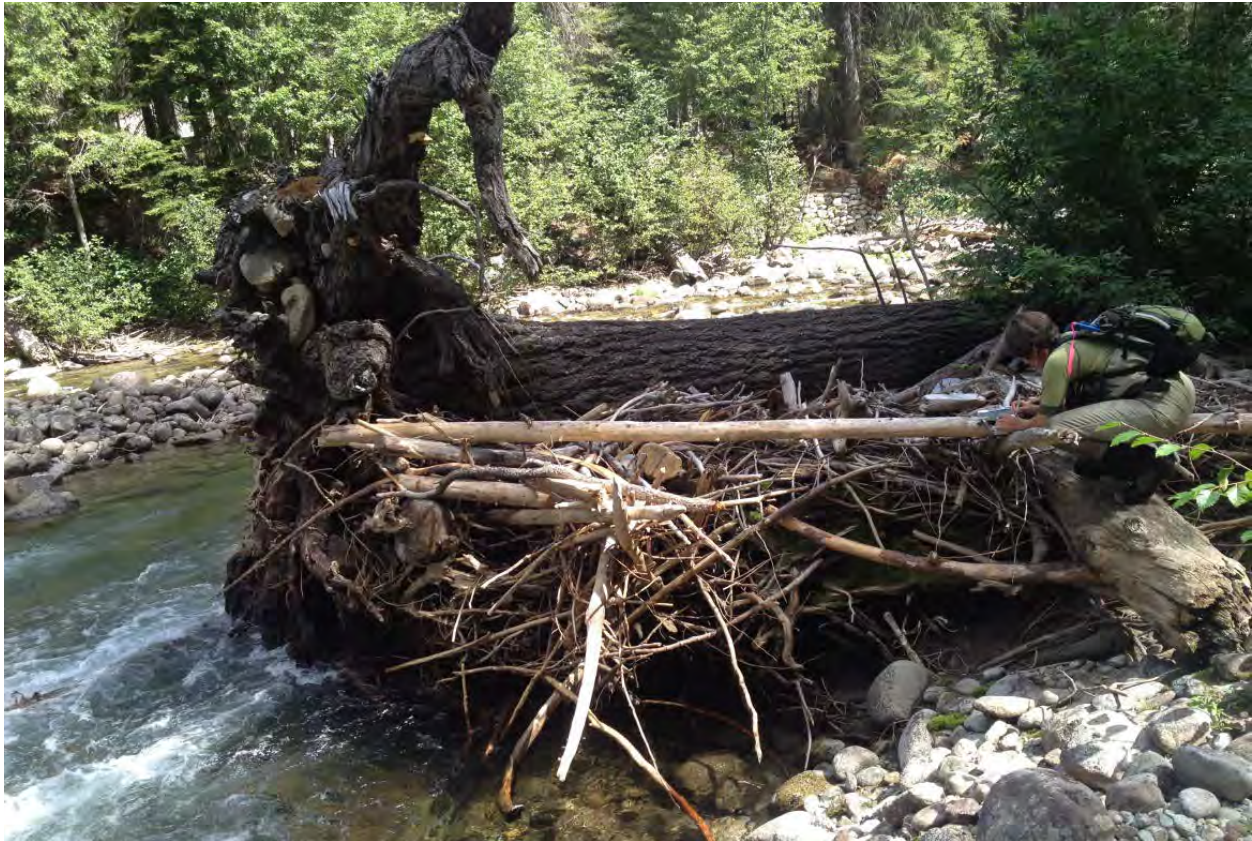
Scour around bedrock outcrops has created deep, clear pools throughout Reach 11. Erosion processes have created bedrock overhangs in many locations, providing cover and shade. Large wood complexes provide cover and complexity at multiple locations. Episodic contributions of large wood are principally sourced from undercut banks, leading riparian trees to fall into the channel (Figure 56).

Figure 56. Large wood accumulation providing cover and complexity within Reach 11.

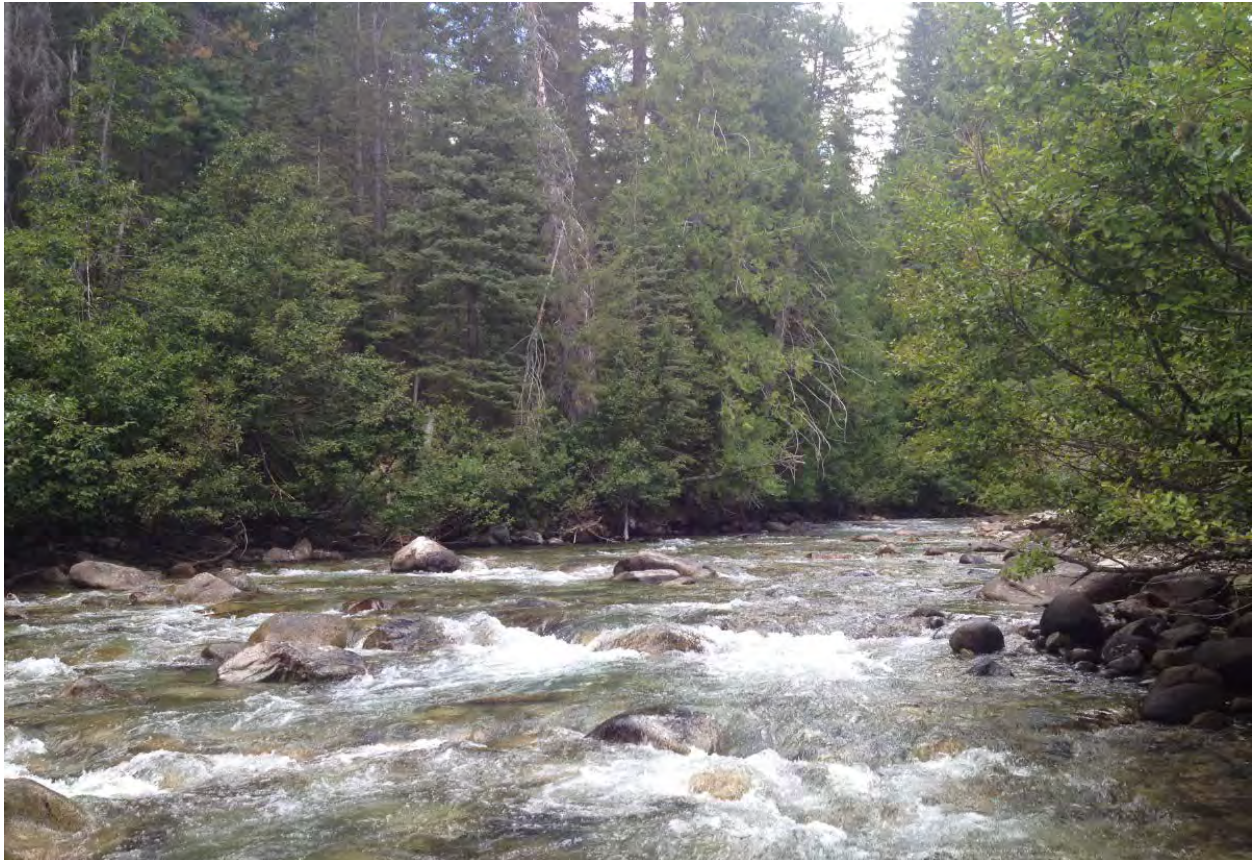
Reach 12 is a steep, single-thread channel extending from RM 32.9 to 33.19. Channel units are long rapids, with varying steepness (Figure 58). Steeper rapids occur at exposed bedrock outcrops, followed by deep plunge pools at the downstream end. Banks and bed substrate ranges from sand to bedrock, with large cobble the predominant substrate found throughout the reach (60%). Bedrock outcrops alternate along river-right and river-left, limiting both lateral migration and vertical incision throughout the reach.

Figure 58. Representative channel morphology of Reach 12.

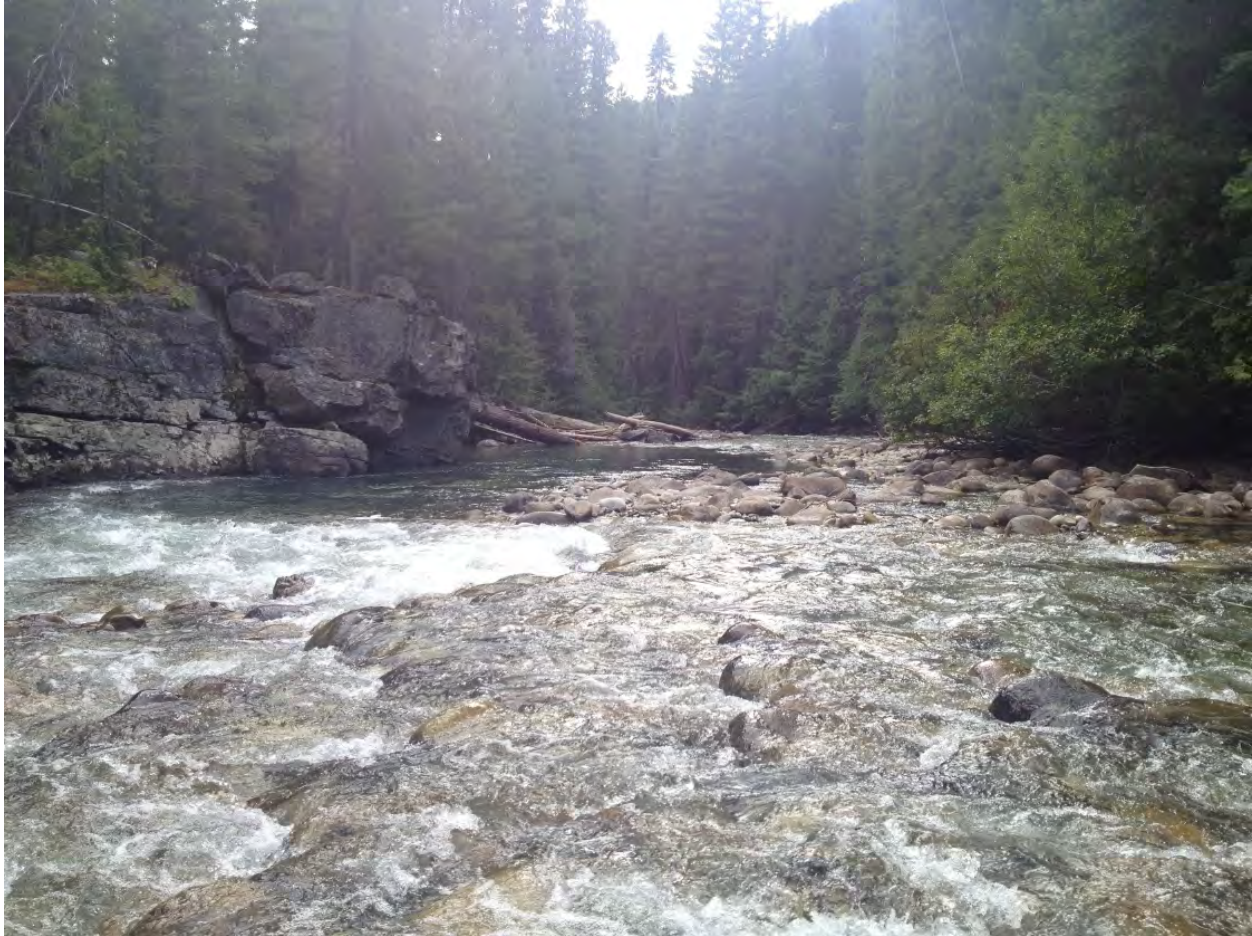
Figure 59. Steeper rapid with bedrock outcrop along river-left at downstream end.
