Entiat River Upper Stillwaters Reach Stream Corridor Assessment & Habitat Restoration Strategy

SUBMITTED TO
Yakama Nation Fisheries Program

OCTOBER 2013

PREPARED BY
Inter-Fluve, Inc.
501 Portway Ave, Suite 101
Hood River, OR 97031
(541) 386-9003

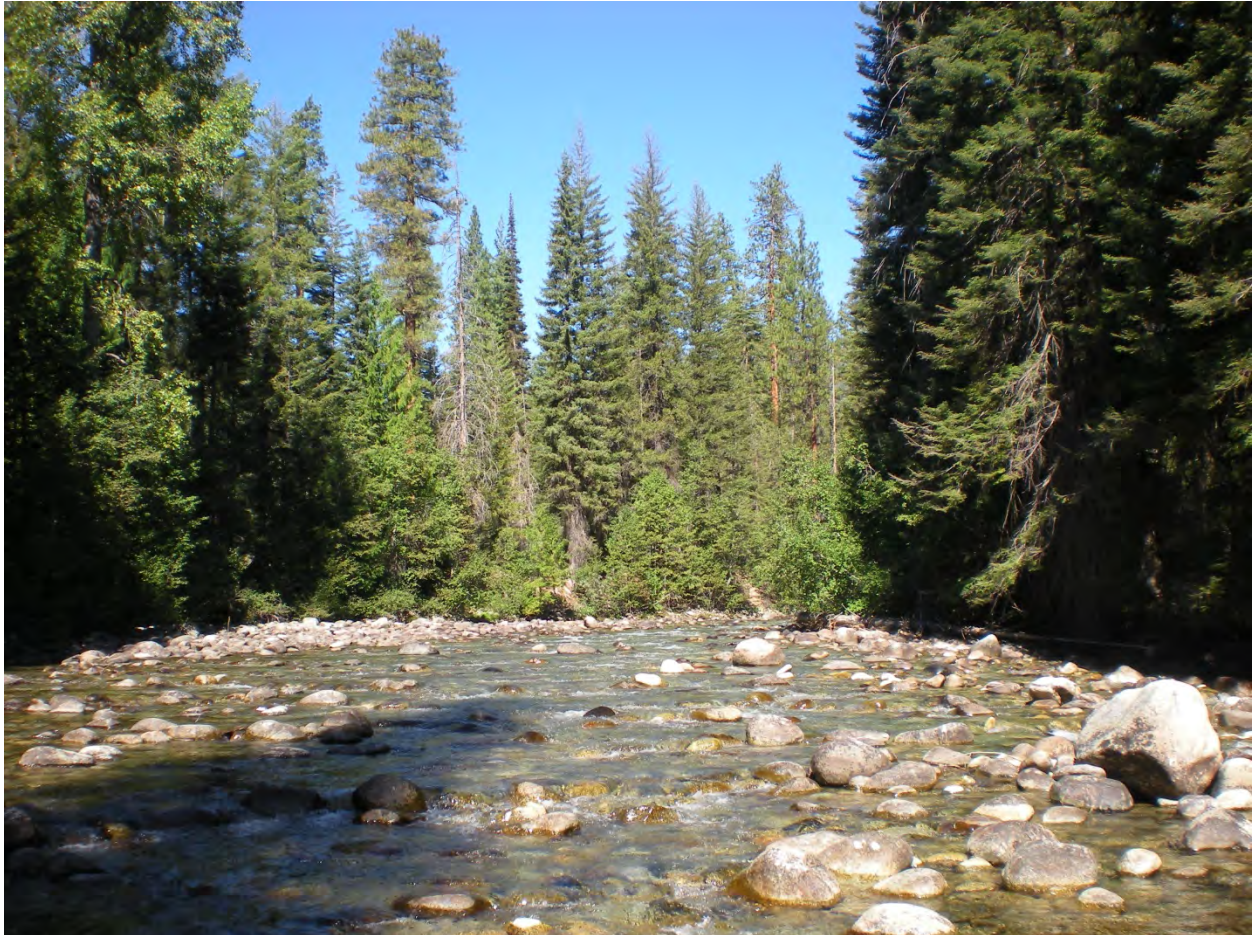
Reach 13 is a steep (2.6 % gradient), single-threaded channel with point and mid-channel bars active at regular high flow events (e.g. Q1 to Q3) (Figure 61). Channel units are primarily rapids with occasional pools. The pools throughout the reach are relatively deep (3 to 9 feet) and often channel-spanning. Scour pools are found along the channel margins where the toe of the bank has been undercut. Banks and the bed are composed of gravels, sands, and cobbles with cobbles (41-44%) and gravels (32-52%) dominating material composition. Bedrock was observed in two isolated locations at RM 35.9 and RM 37.0, and composes the end of the reach in Entiat Falls. The Reach has a sinuosity of 1.14.

Figure 61. Representative channel morphology of Reach 13.

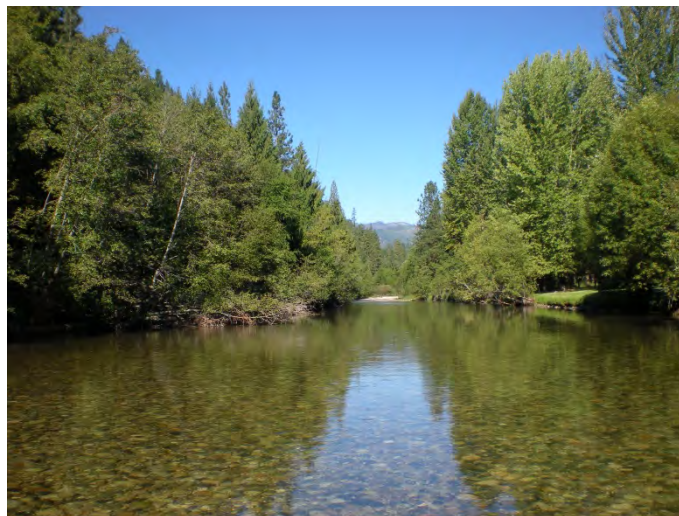
Figure 11. Upstream view of a long glide in Reach 0. Note the mowed grass along the channel margin on the right side of the photo (river-left).

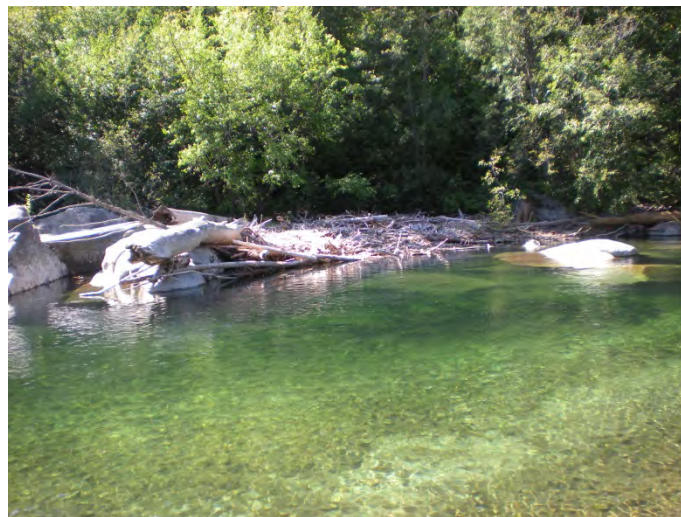
Figure 12. Deep pool located at the upstream extent of Reach 0 where a large number of adult salmonids were observed.

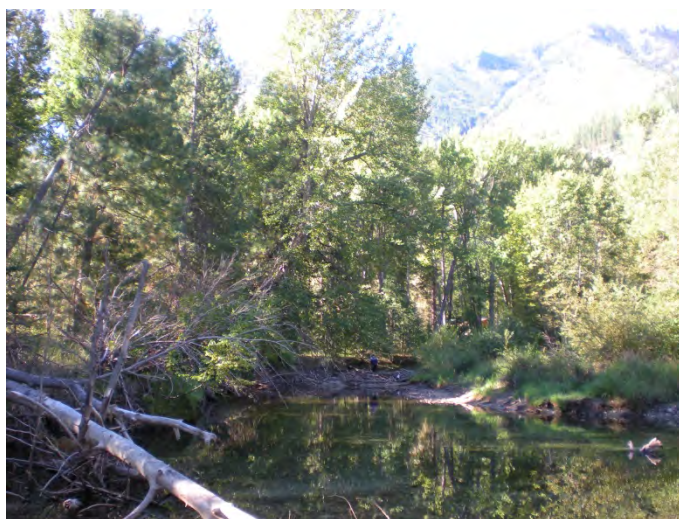
The first side channel complex is located on river right between RM 23.5 to 23.6. At low flow, the channel mouth provides a deep backwater with open connection to the mainstem. There are a series of pools upstream that had poor connectivity at low flow, much appeared to be well connected at high flows. A large log jam is located at the inlet to the side channel with at least one other high flow channel forming a part of the off-channel complex.

Figure 14. View looking upstream at a large side channel outlet near RM 23.6. A well-connected backwater is formed by the outlet.

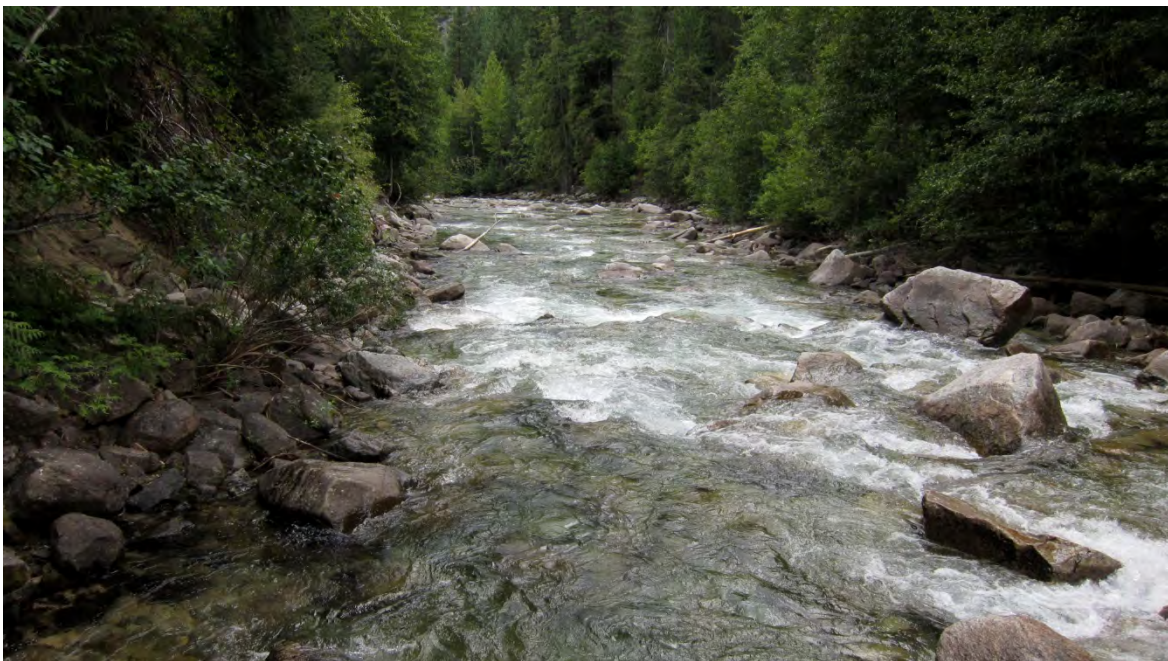
Figure 19. Photo in Reach 1 looking downstream at a long rapid which is the dominant habitat in the reach.

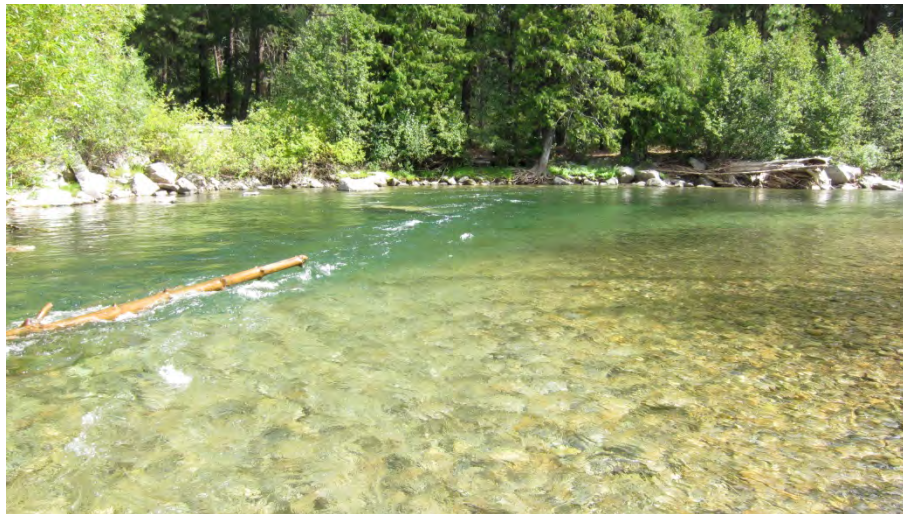
Figure 21. Downstream looking photograph of a long, deep pool providing good holding habitat in Reach 1. The pool lacks cover.

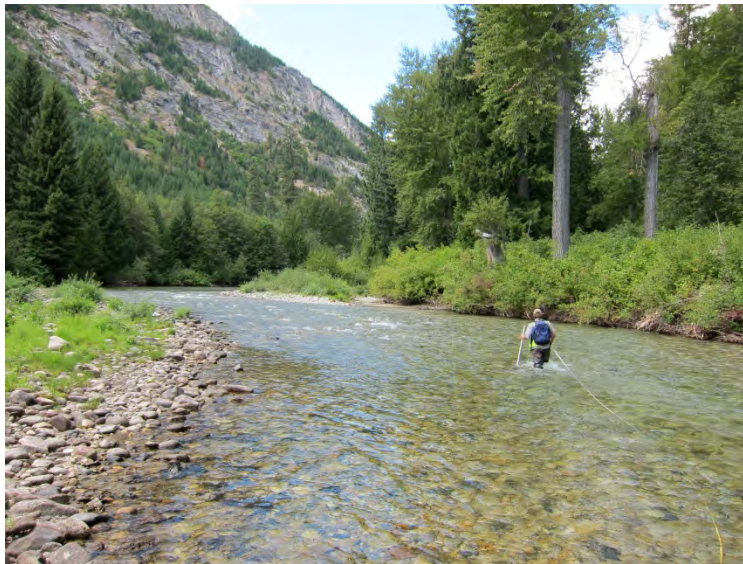
Figure 26. Upstream view of a typical riffle-pool sequence. There is a side channel outlet near the center of the photograph.

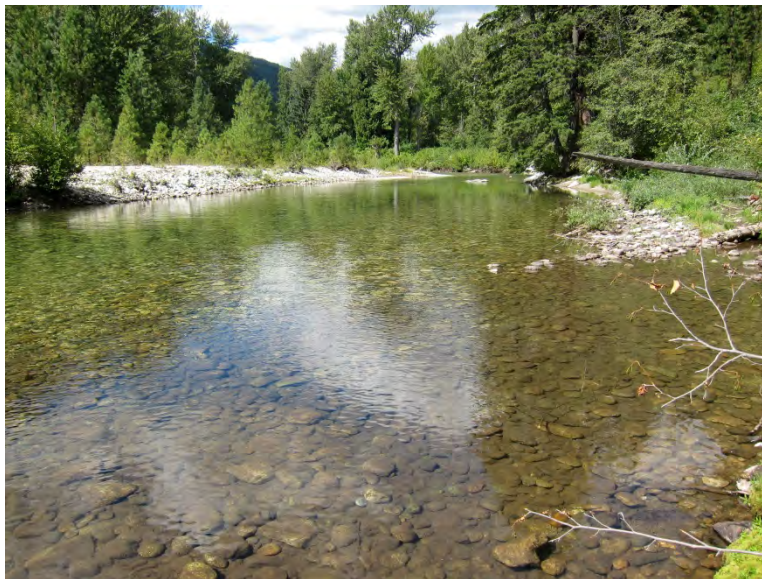
Figure 29. Upstream view of a long pool in Reach 2.

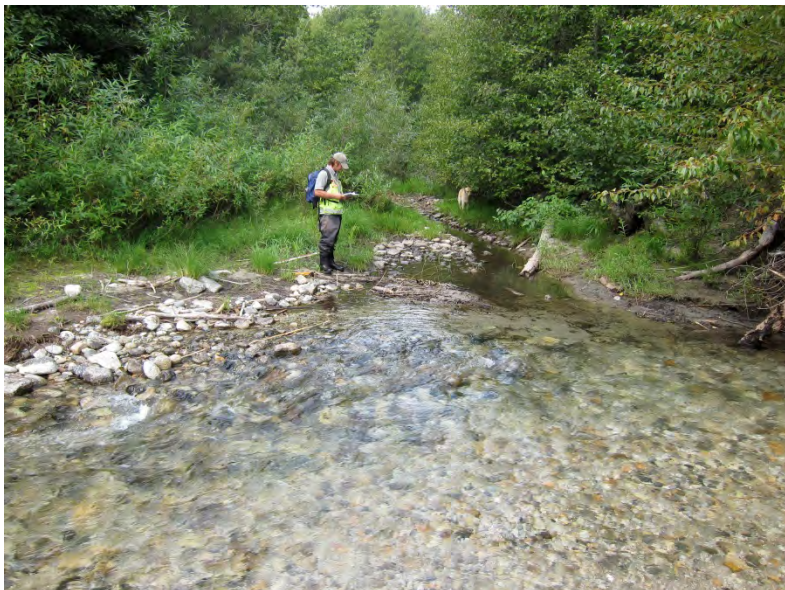
The main side channel complex is on river right between RM 25.7 and 25.85 (Figure 30). This side channel provides a small backwater alcove at its outlet, fed by hyporheic flow from upstream. The channel was dry for most of its length, but was well-defined and is likely wetted and flowing during annual high flow periods. The channel is located around a stable island vegetated by large conifers and hardwoods. The second side channel unit is a short high flow channel located on river left, and centered on RM 25.85. This channel is relatively steep over its entire length, and does not provide low flow habitat. At high flow, the channel may provide good refuge for juvenile and adults in the reach.

Figure 30. The outlet to the main side channel complex in Reach 2 near RM 25.7.

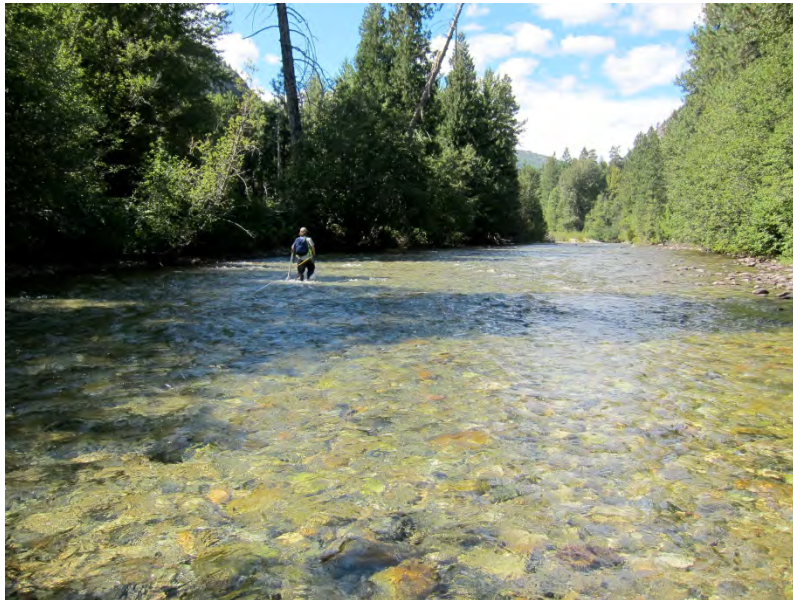
Figure 31. Upstream view of channel margin vegetation including large conifers and cottonwoods, as well as snags that will provide a source of LWM in the future.

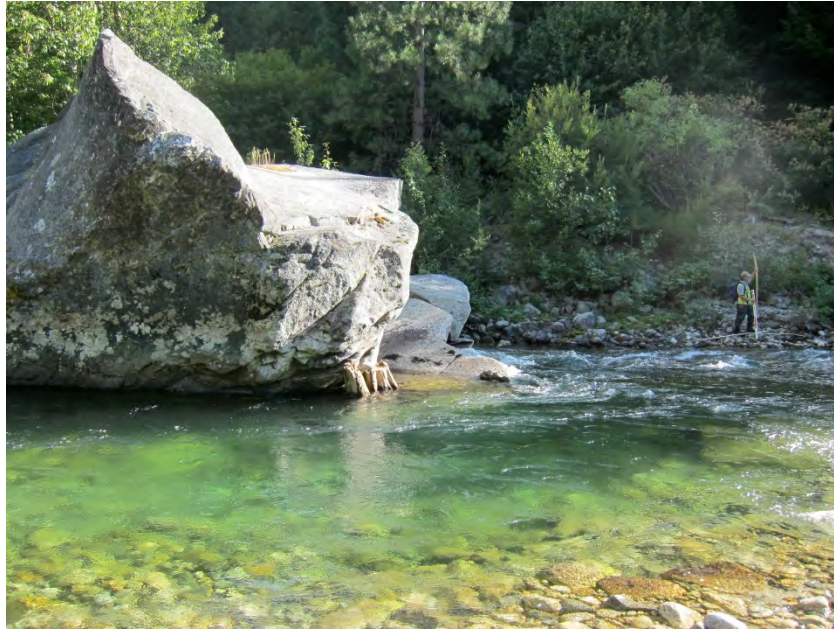
Despite the low overall area of pool habitat, Reach 3 provides the third highest pool frequency in the study area at 7.1 pools/mile. This is above the study area average of 6.4 pools/mile. Pool spacing is 8 bankfull widths per pool, the third lowest spacing in the study area. Pool length, at 98.8 ft, was amongst the shortest in the study area. Reach 3 had the second highest count of individual pools in the study area with eight total. Residual depth was over 3 ft in six of the eight pools, and over six feet in one of the pools (Figure 36, Figure 37). The average maximum depth at the time of survey was 5.5 ft, with two pools measuring at least 8 ft of maximum depth. These results suggest Reach 3 provides frequent pools with sufficient residual depth for holding and rearing habitat.

Figure 36. Photograph of a deep scour pool near RM 26.4 formed by several very large boulders obstructing the channel.

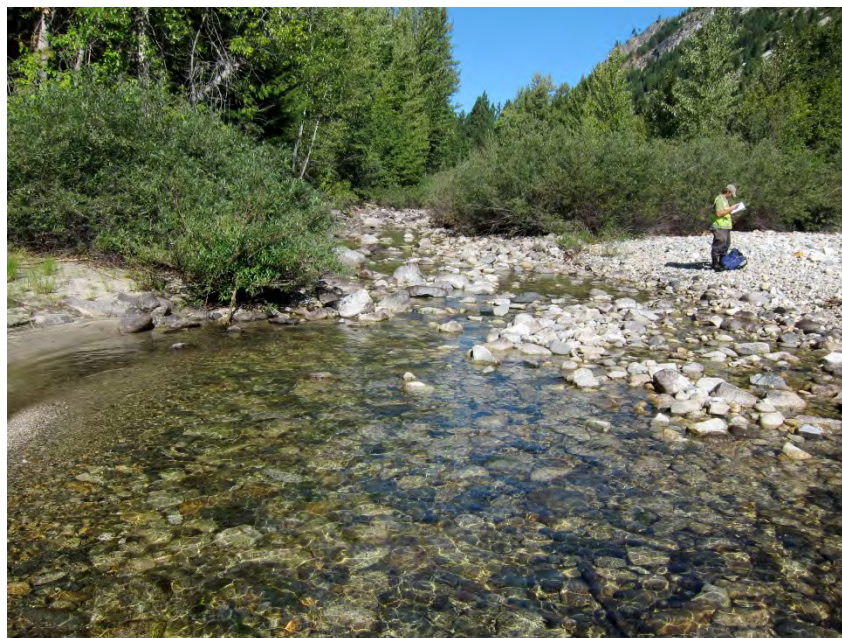
Reach 3 has four side channel units providing 6% of the total habitat in the reach. Average side channel length was about 300 ft. Side-channels in Reach 3 are mainly fast-water, essentially forming at locations of split flow of the main channel around stable, well-vegetated islands (Figure 38). All the side channels are well-connected and flow perennially. These units provide habitat similar to the main channel in terms of velocity, cover, and substrate. The upstream-most side channel near RM 27.1 is the only slow side channel, providing some velocity refuge and increased cover habitat due to its narrow width.

Figure 38. Upstream view of the outlet of a fast side channel unit.

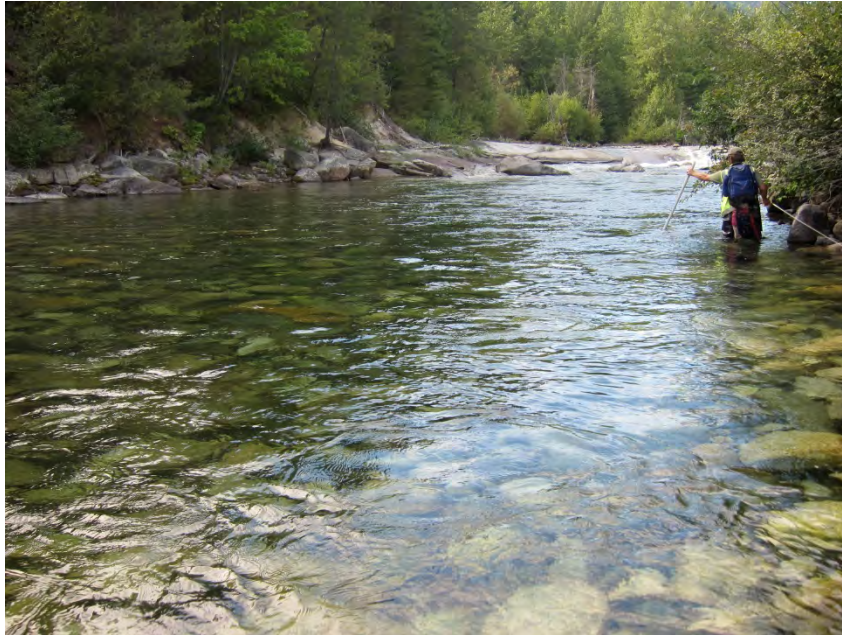
There are few pools in Reach 4 (3 pools total), and these are infrequent and widely spaced on average (Figure 42). Pool frequency was 5.0 pools/mile (6.4 pools/mile study area average), with mean pool spacing of 12 bankfull channel widths per pool (9 bankfull channel widths per pool study area average). Average residual pool depth was relatively high at 4.1 feet (study area average of 3.5 feet) (Figure 43). Average maximum pool depth was 5.7 feet.

Figure 42. Upstream view of a long pool, typical of the reach.

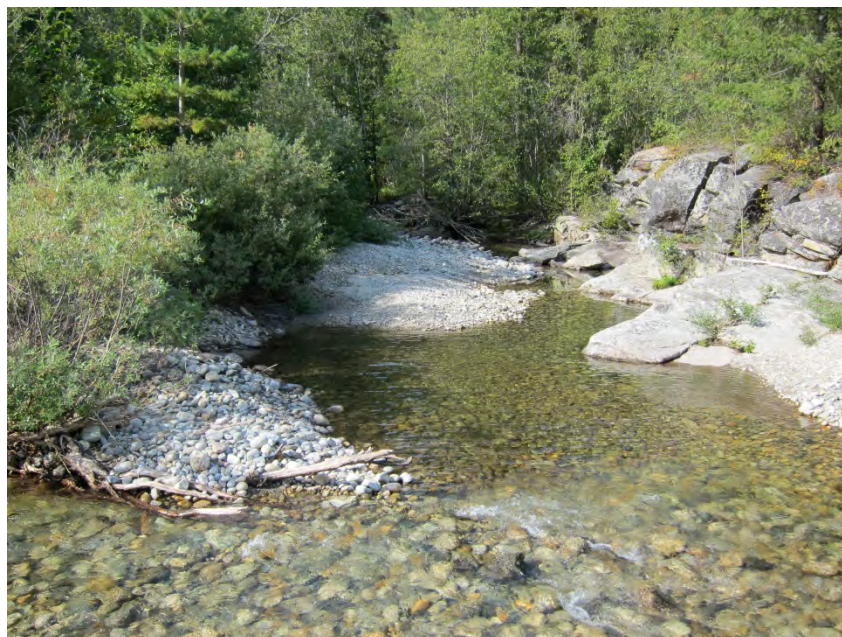
Reach 4 has the study area’s largest percentage of side channel habitat area. There are three side channel complexes, each of them long and well-connected at most flows. The downstream side channel (RM 27.2-27.4) provides complex habitat with a backwater alcove at its downstream end, and high quality pools throughout (Figure 44). It narrows considerably in its upstream half, providing greater cover to juveniles. Spawning was observed in the channel during the survey. The side channel 27.37 and 27.45 is larger than the downstream side channel, creating a split-flow condition in the main channel around a stable island. This channel is less of a velocity refuge, but does provide complexity. The upstream side channel (RM

27.45-27.55) is much narrower than either the other two, and provides good cover for juvenile rearing. There is a well-connected backwater at the downstream end.

Figure 44. Photograph of a large backwater formed at the mouth of a side channel near RM 27.4. The side channel is long and provides complex habitat.

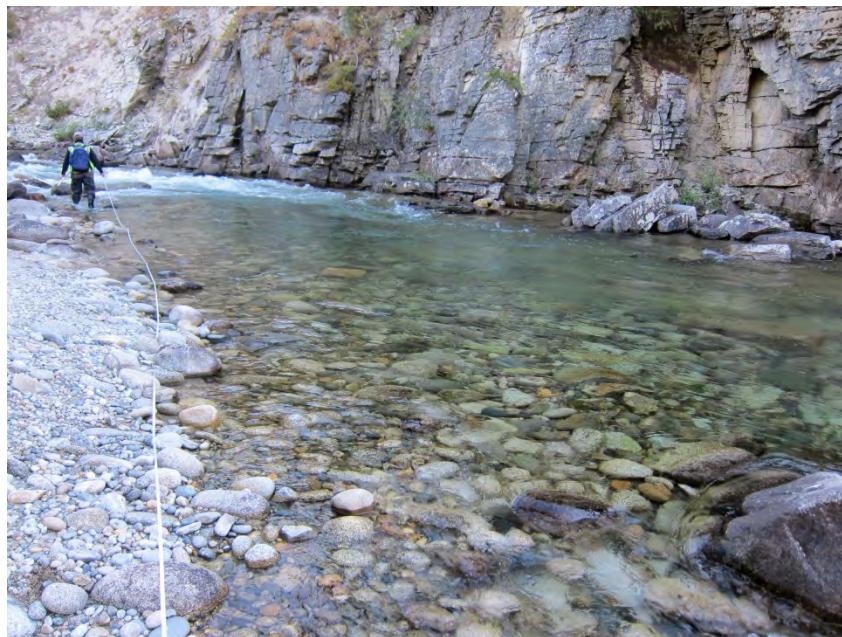
Pool frequency was 5.2 pools/mile (study area average of 6.4 pools/mile), with mean pool spacing of 11 bankfull channel widths per pool (study area average is 9 bankfull channel widths per pool) (Figure 48). Average residual pool depth was 4.8 feet with maximum residual depth of 5.9 ft (Figure 49). Average maximum pool depth was 5.8 feet.

Figure 48. Upstream view of a typical pool in Reach 5 with bedrock forming the left channel margin.

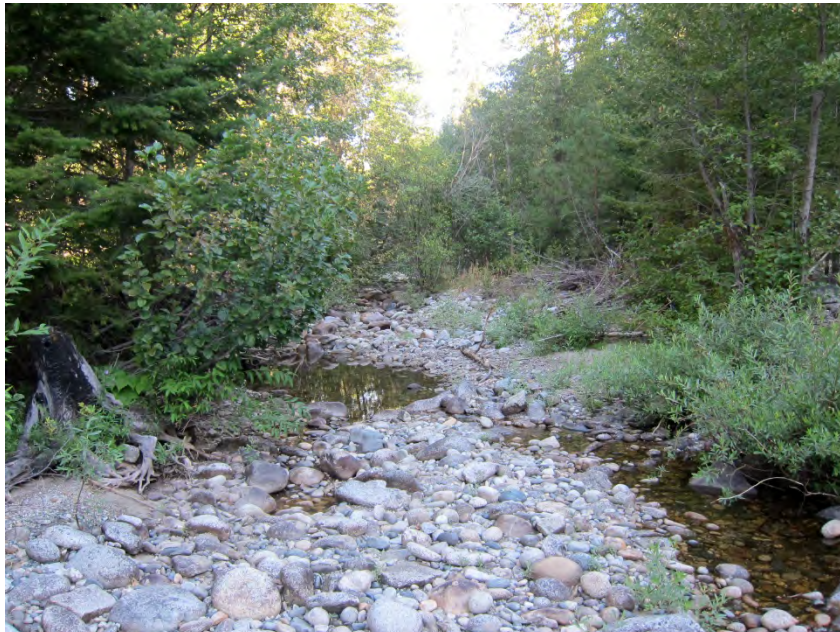
Reach 5 has one small side channel on river right near RM 27.95 (Figure 50). Morphologically the side channel resembles a chute cut-off on a point bar. However, the bar is not active, and the “chute” cuts off a stable island with mature vegetation. The side channel is about 170 ft long, has good cover.

Figure 50. Upstream view of the outlet of a short side channel near RM 27.95.

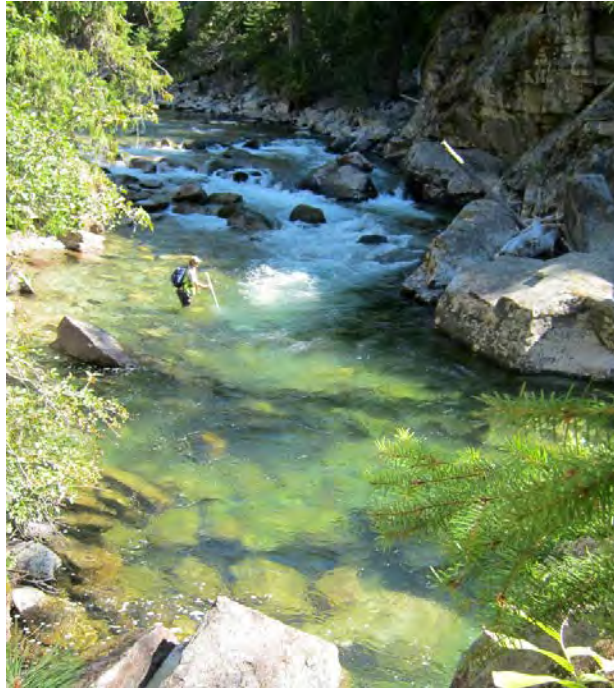
Pool frequency was 9.9 pools/mile (study area average of 6.4 pools/mile), with mean pool spacing of 6 bankfull channel widths per pool (study area average is 9 bankfull channel widths per pool). This is the highest pool frequency in the study area and the shortest average spacing. Maximum pool depths and residual depths were not measured. Most pools appeared to be deep bedrock controlled scour pools, dam pools formed by large colluvium at rapid and riffle crests, and plunge pools at abrupt riffle, rapid, and cascade tail outs (Figure 54).

Figure 54. Upstream view of a typical rapid-pool sequence in Reach 6. Though not measured, pool depths appear over 3 ft in most cases.

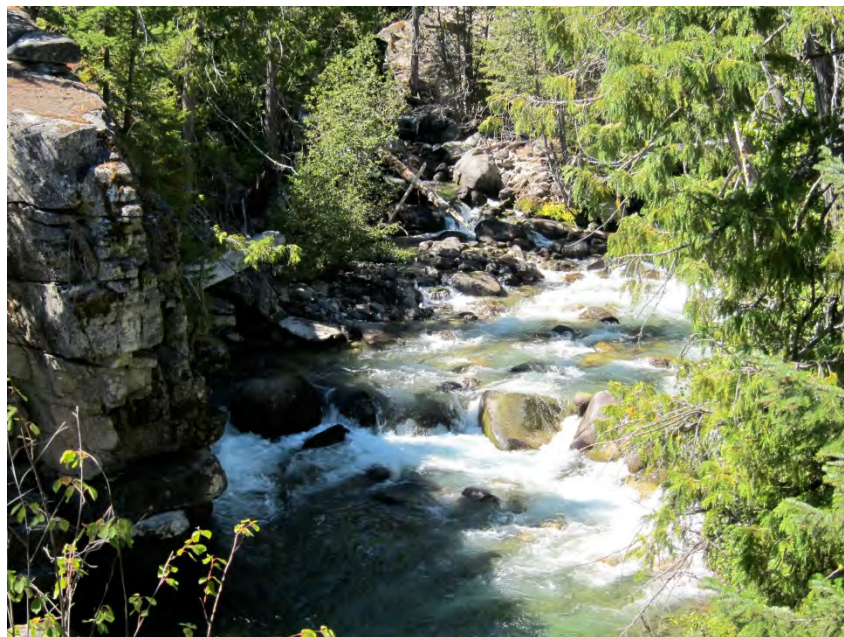
There is a single side channel that comprises all off-channel habitat in Reach 6. The channel is short and steep, as would be expected in the overall steep reach. It forms on river right in a split around a stable, vegetated island. The large substrate, steep gradient and scoured bed suggests it is an active high flow channel that provides very little hydraulic refuge during periods of high flow.

Figure 55. Upstream view of a steep side channel outlet on river right near RM 28.7. The outlet is in the upper center of the photo.

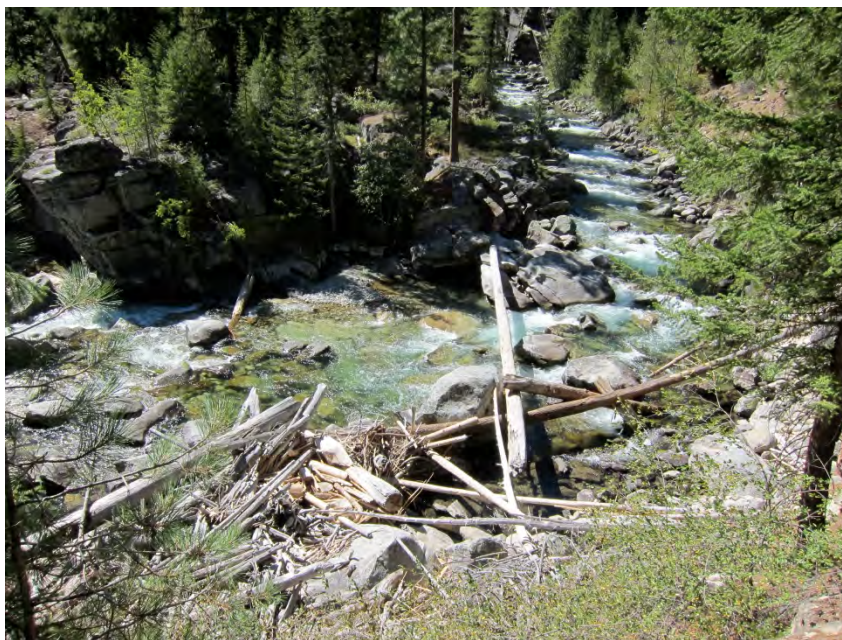
LWM quantities were not systematically counted in Reach 6 because of difficult access and safety concerns. Large wood was observed in the reach in quantities similar to other reaches where quantitative recording of LWM was completed. There were notable log jams with several large pieces in each. There was a considerable amount of wood observed high above the channel, often caught on top of large boulders or jammed into small eddies. Because of the narrow confines of the canyon, it is likely that bankfull conditions produce much deeper flows than in other reaches, and so many of these pieces of wood could be within the bankfull channel.

Figure 56. View of a log jam on river right near RM 29.1.

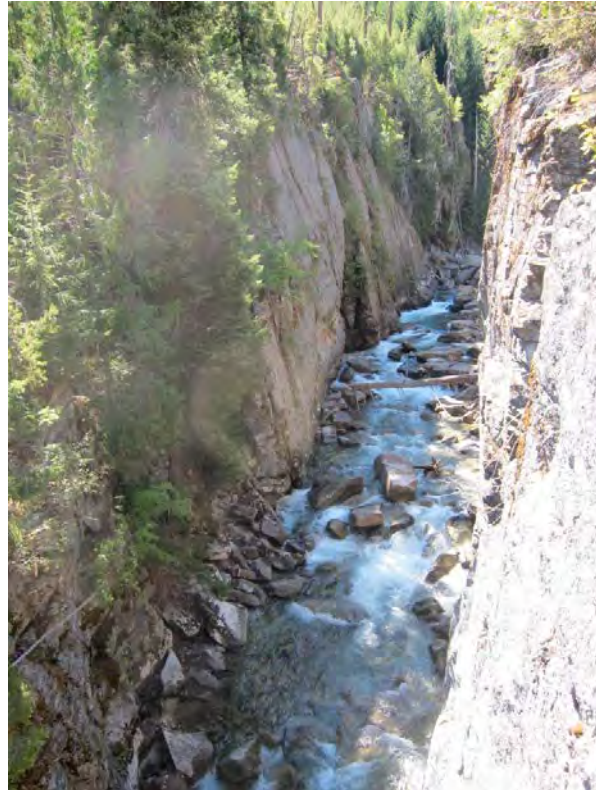
Bed substrate was not measured in Reach 6. Observations from the canyon rim, and the recognition of the steep slope, dominance of fast-water units, and confined canyon morphology support an assumption of a dominance of large bed material, primarily in the boulder and cobble size classes. Bed rock is also a larger component in this reach than in any other reach in the study area (Figure 57). Smaller material may be present on channel margins, in pools, and in eddies.

Figure 57. Upstream view of a portion of Reach 6 that is highly confined by bedrock on both sides of the channel, with large bed material forming cascade-pool sequences.

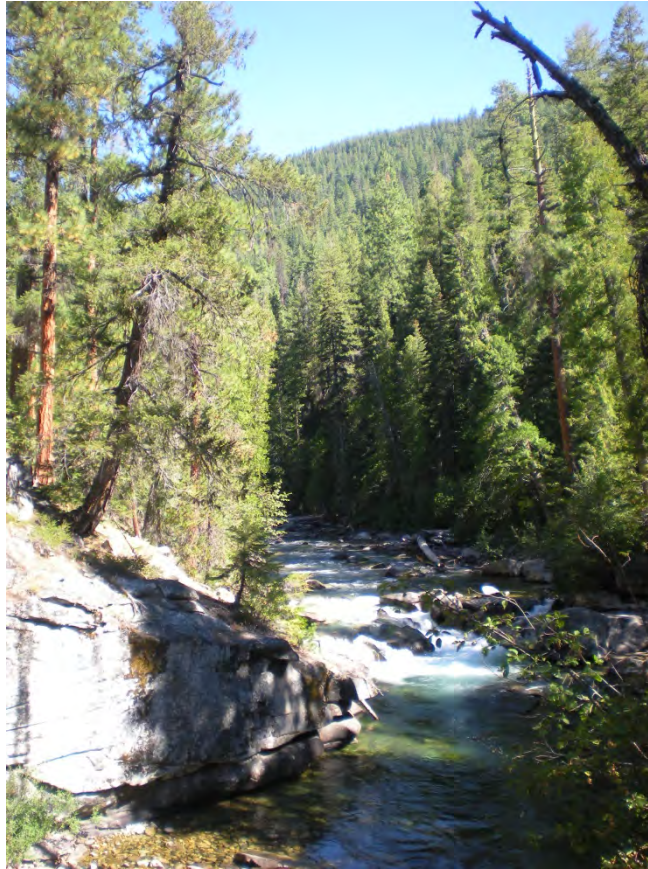
Pool frequency in Reach 8 is 8.5 pools/mile with an average spacing of 7 bankfull channel widths per pool. These are the second highest frequency and second lowest spacing in the study area. Reach 6, the other canyon reach, has higher frequency and shorter spacing. In these canyons, pools form at abrupt slope breaks at riffle or rapids tail out, or in places where cascades form plunge pools, or at locations where colluvium has dammed the channel (Figure 62). Because the reach was not walked, depth measurements were not obtained.

Figure 62. Upstream view of a typical rapid-cascade-pool sequence in Reach 8.

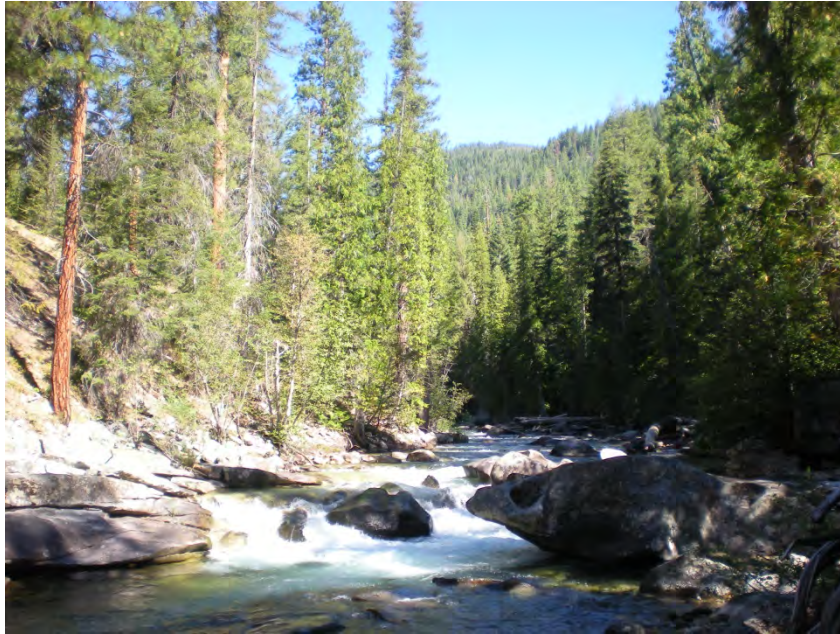
Bed substrate was not observed in Reach 8. The steep gradient and prevalence of fast water habitat units supports the assumption that bed material is dominated by cobbles and boulders with smaller percentages of gravel and sand likely in pools and eddies along the channel margin. There is a substantial bedrock component in Reach 8 as well. Fine sediment in spawning gravels has not been measured in this reach.

Figure 63. Upstream view of a visible bed substrate that include a large percentage of boulders and bedrock.

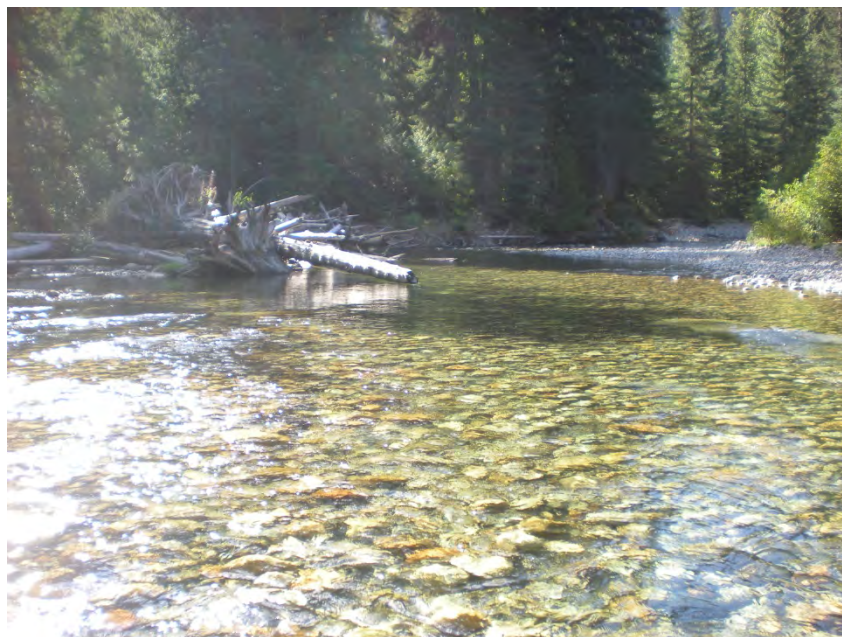
Figure 67. Upstream view of a typical pool in Reach 9. The pool is relatively shallow, but provides adequate depth and cover to be considered “properly functioning” by the USFWS (1998).

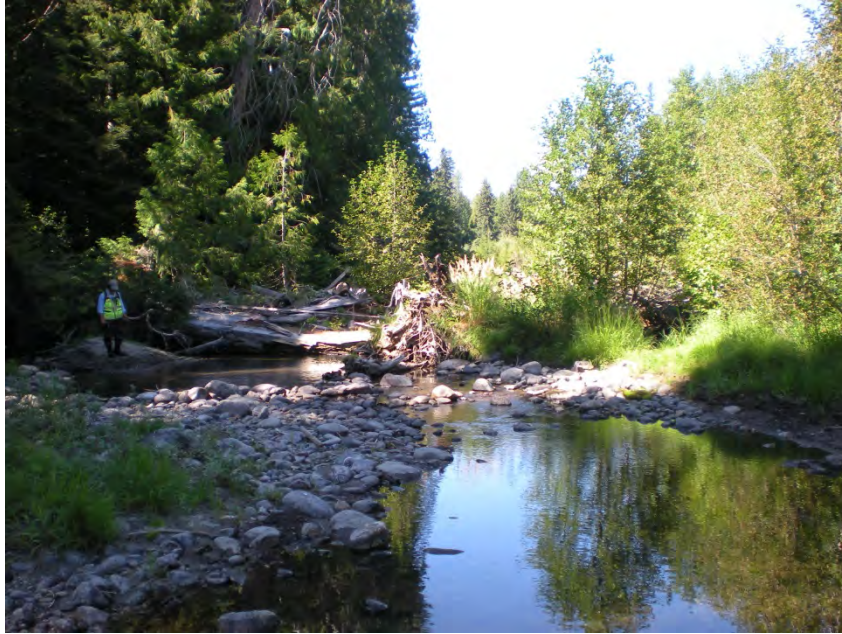
Figure 68. View of a backwater alcove at the outlet of a side channel near RM 30.7. The channel provide well-connected off-channel rearing.

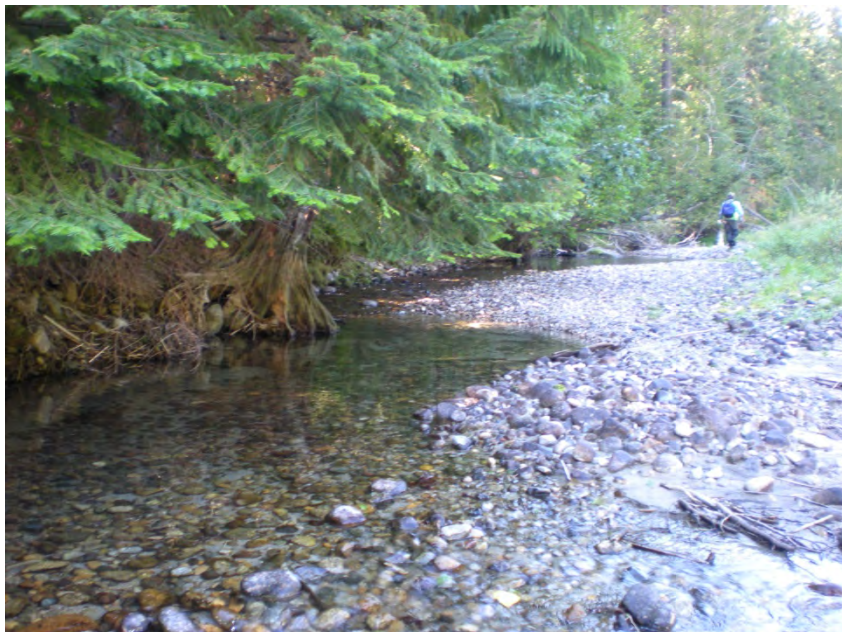
through heavily forested areas (Figure 69). These channels are not wet for their entire length, but geomorphic evidence suggests that scouring flows access these areas often. These long and complex side channels access excellent high flow refugia and rearing habitat, particularly in their perennially wet downstream portions.

Figure 69. Outlet of a long side channel near RM 31.25. This channel traverses a heavily wooded portion of the floodplain a substantial distance from the main channel.

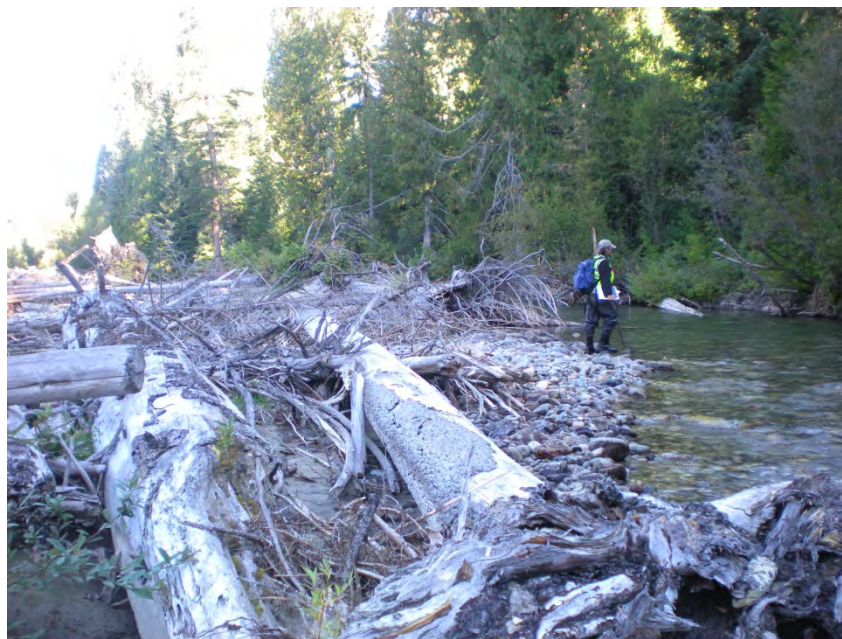
LWM recruitment potential is high. There are multiple high-flow channels and floodplain side channels that access mature riparian forests with the potential to provide LWM to the mainstem in the long-term. There are multiple log jams and large single trees recently fallen from bank erosion that are immediate sources of LWM in this reach and downstream reaches (Figure 70).

Figure 70. Several large and medium pieces of wood are rafted on a gravel bar in Reach 9. This LWM is a near-term source of wood for Reach 9 and downstream reaches.

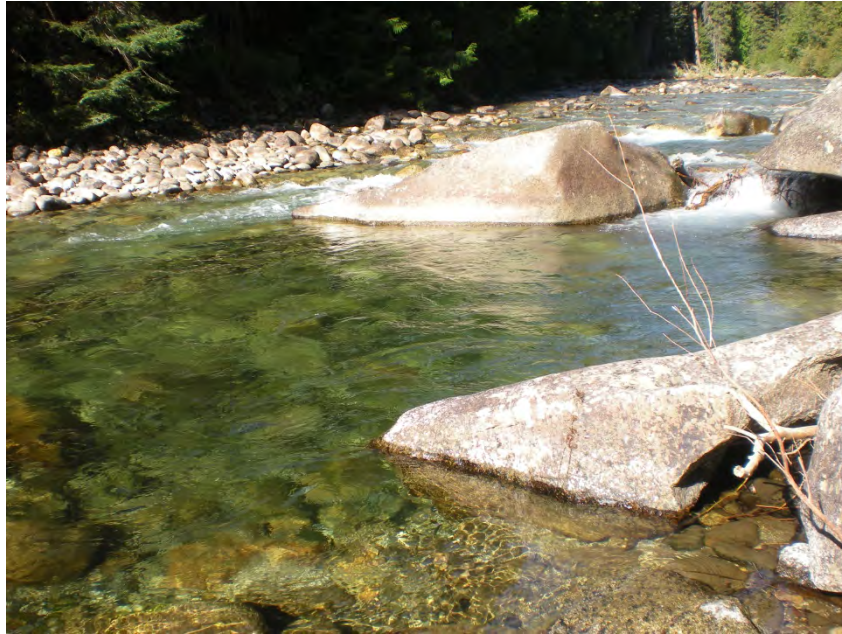
Figure 76. Upstream view of a short plunge pool in Reach 10. There is over 3 ft of residual depth just below the plunge, but residual depth quickly decrease toward to the pool tail.

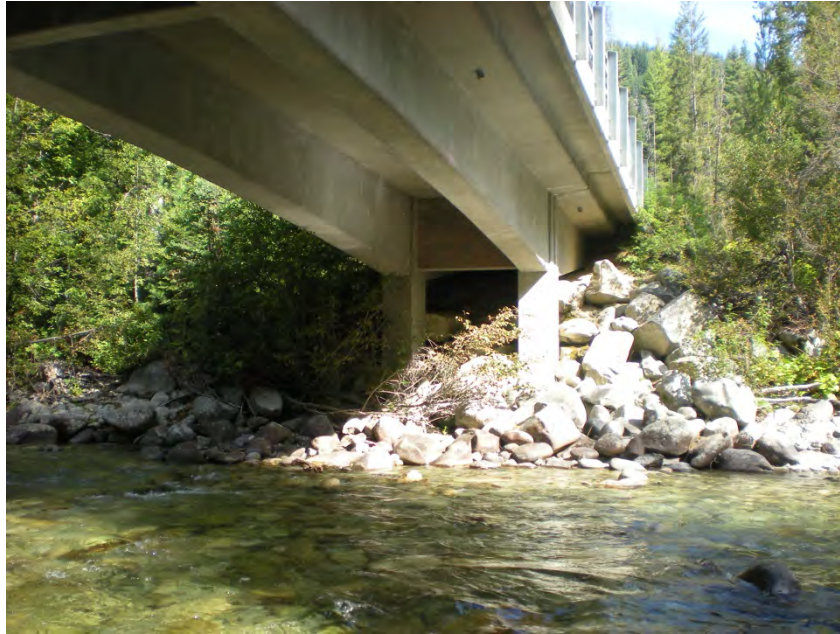
Localized channel and bank modification exists around a bridge near RM 31.85 (Figure 79). Channel modification includes abutments built in the bankfull channel cross-section, limiting bankfull width and modifying hydraulics. Bank modification includes rip-rap and bank hardening. There is some floodplain clearing near the bridge for vehicle parking and unimproved river access points. A road parallels the channel along river left for its entire length. The road is set near the toe of the hill slope and has minimum impact on floodplain or riparian function. There were no anthropogenically destabilized banks in the reach.

Figure 79. View of bridge abutment and bank hardening on river left near RM 31.85.

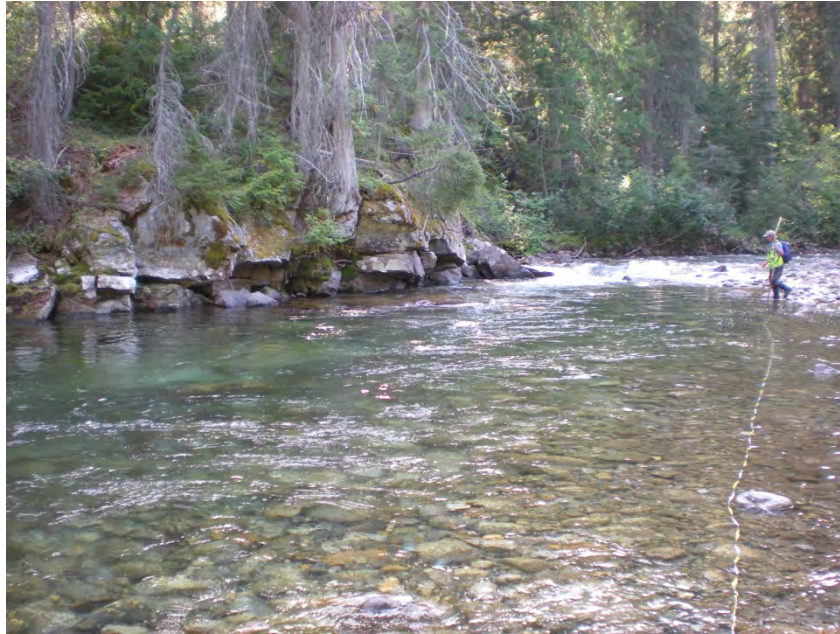
Figure 82. Upstream view of a pool in Reach 11 that occurs with an abrupt plunge at the tail of a rapid unit, with scour along bed rock on the right side of the channel. This is a typical pool configuration in the reach.

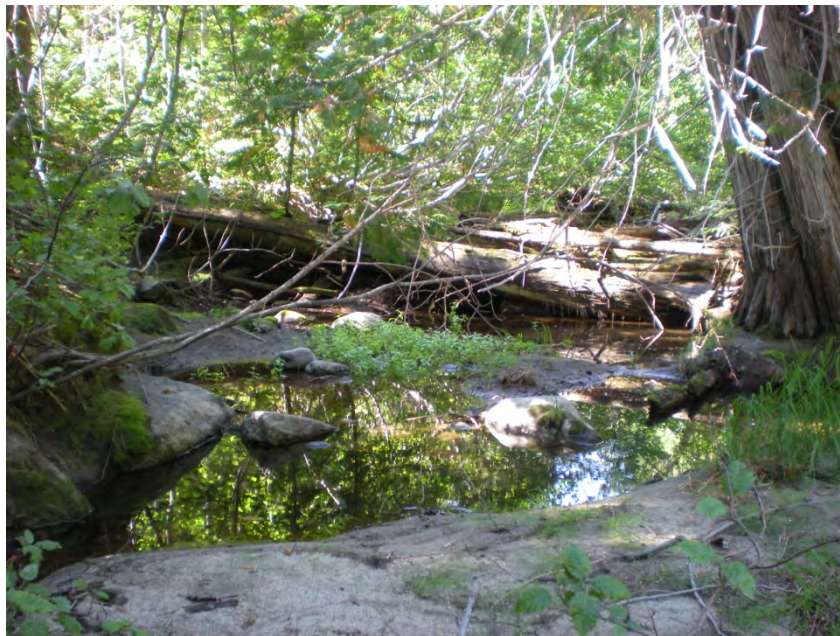
Figure 84. Slow water side channel habitat found in the floodplain of Reach 11. The habitat is well connected near the mouth of the channel and provides juvenile refugia.

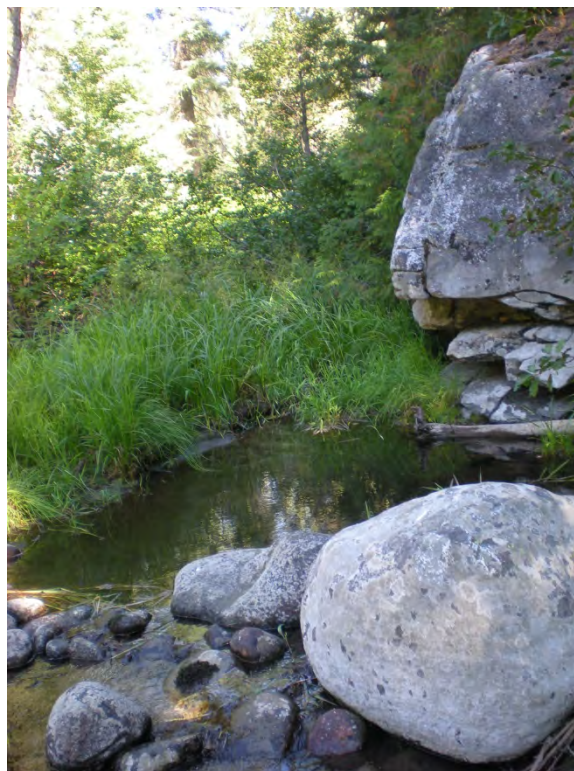
There is one large side channel complex in Reach 13. This off-channel habitat includes two distinct side channel units; one is a perennially connected split flow channel on the mainstem and the second is a narrow side channel whose inlet is off of this split flow channel. The mainstem splits around a stable island vegetated with mature conifers to form a fast-water side channel on river left. This channel is controlled at the inlet and outlet by LWM forming hydraulic refugia. A smaller floodplain side channel flows off of the main channel split, providing seasonal high flow refuge and juvenile rearing in an alcove at the outlet (Figure 93).

Figure 93. Mouth of side channel forming an alcove that provides juvenile rearing habitat.

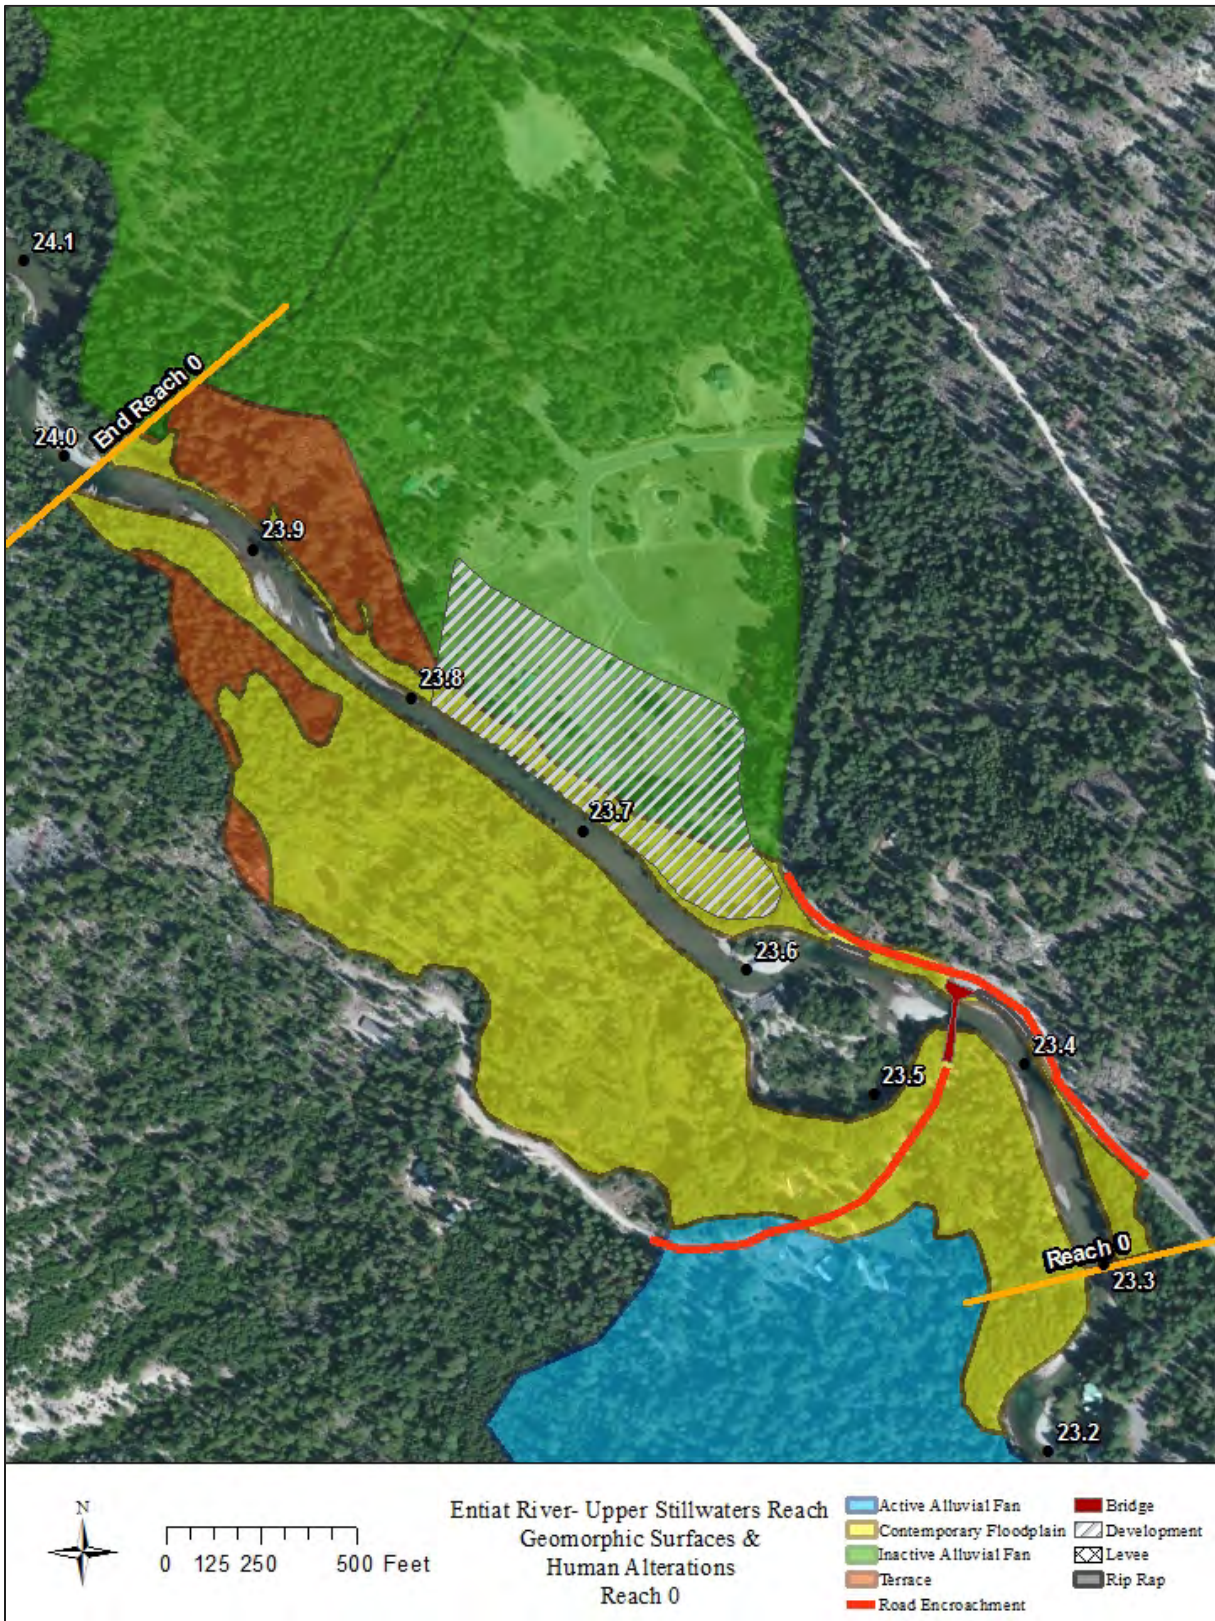
Figure 1. Geomorphic surfaces and human alterations for Reach 0. Flow is from northwest to southeast.
