Entiat River Upper Stillwaters Reach Stream Corridor Assessment & Habitat Restoration Strategy

SUBMITTED TO
Yakama Nation Fisheries Program

OCTOBER 2013

PREPARED BY
Inter-Fluve, Inc.
501 Portway Ave, Suite 101
Hood River, OR 97031
(541) 386-9003

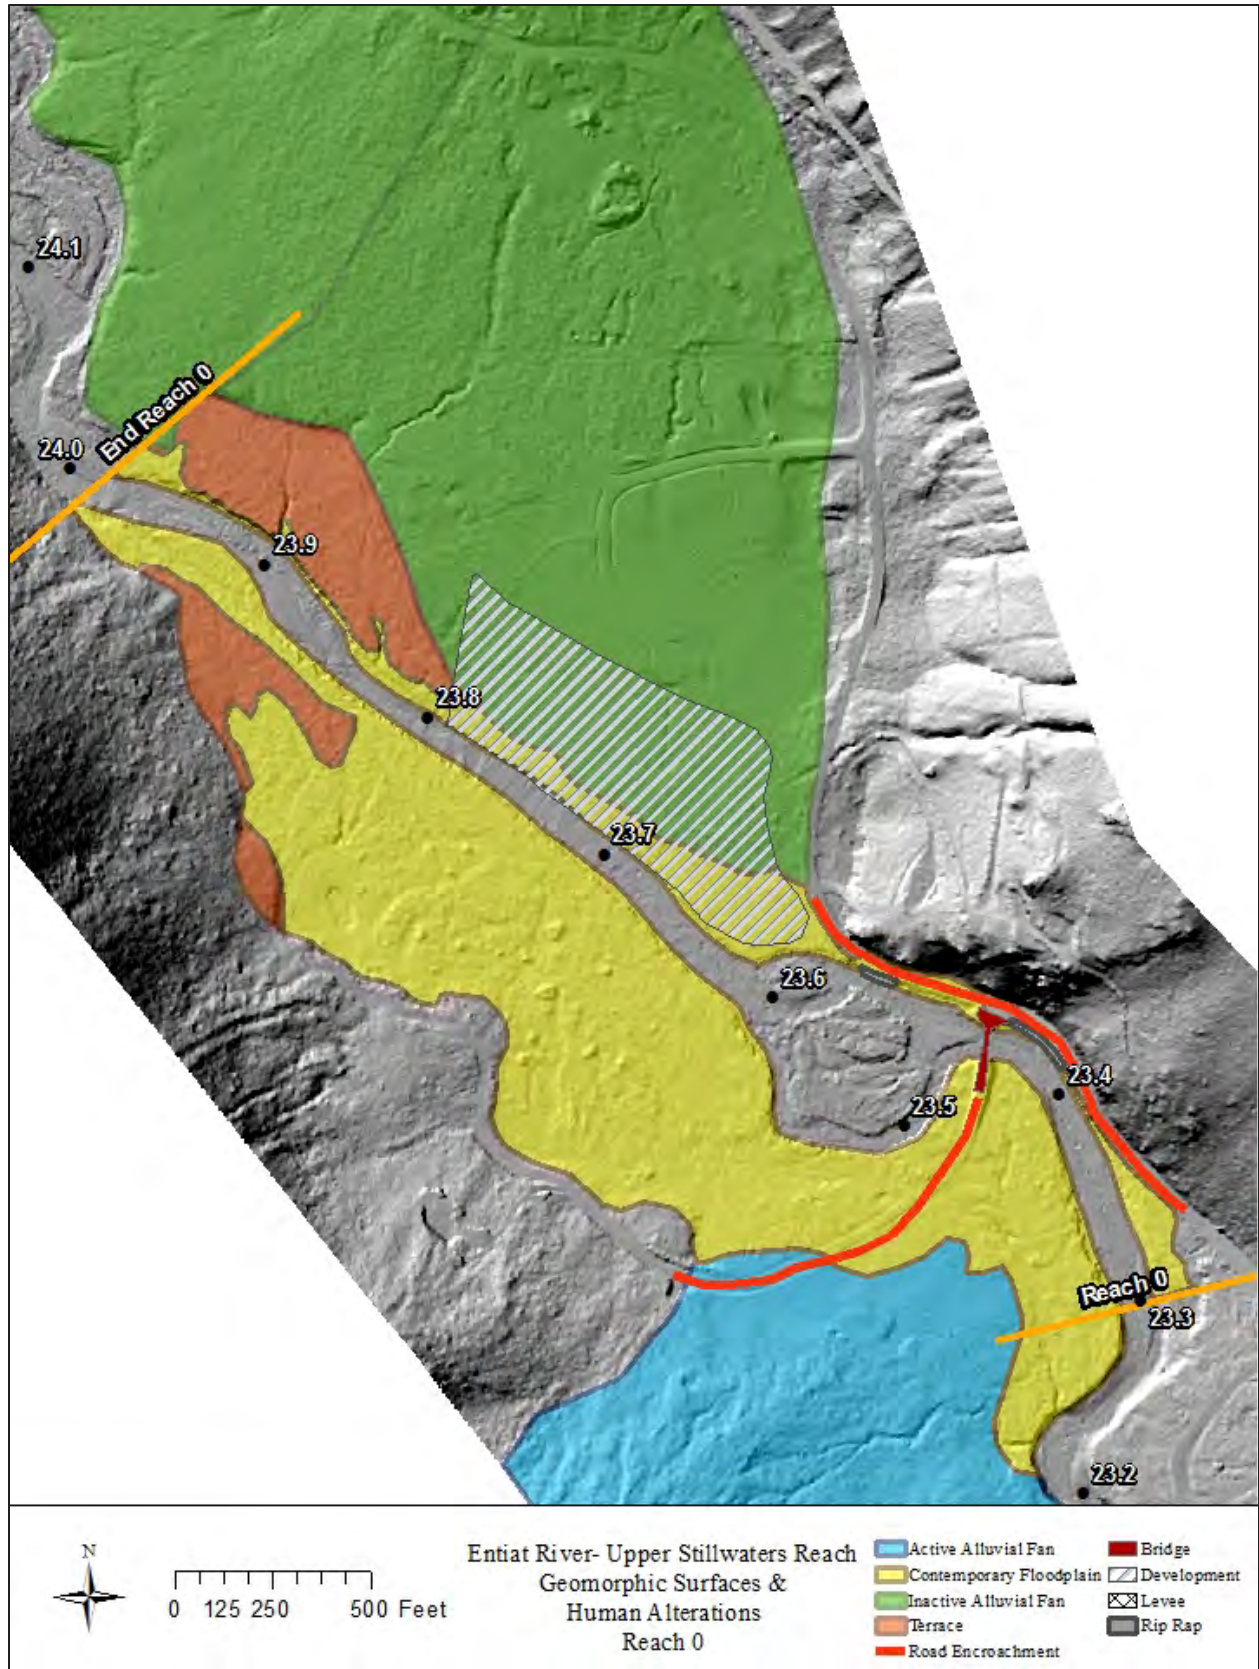
Figure 2. Geomorphic surfaces and human alterations for Reach 0 over LiDAR basemap. Flow is from northwest to southeast.

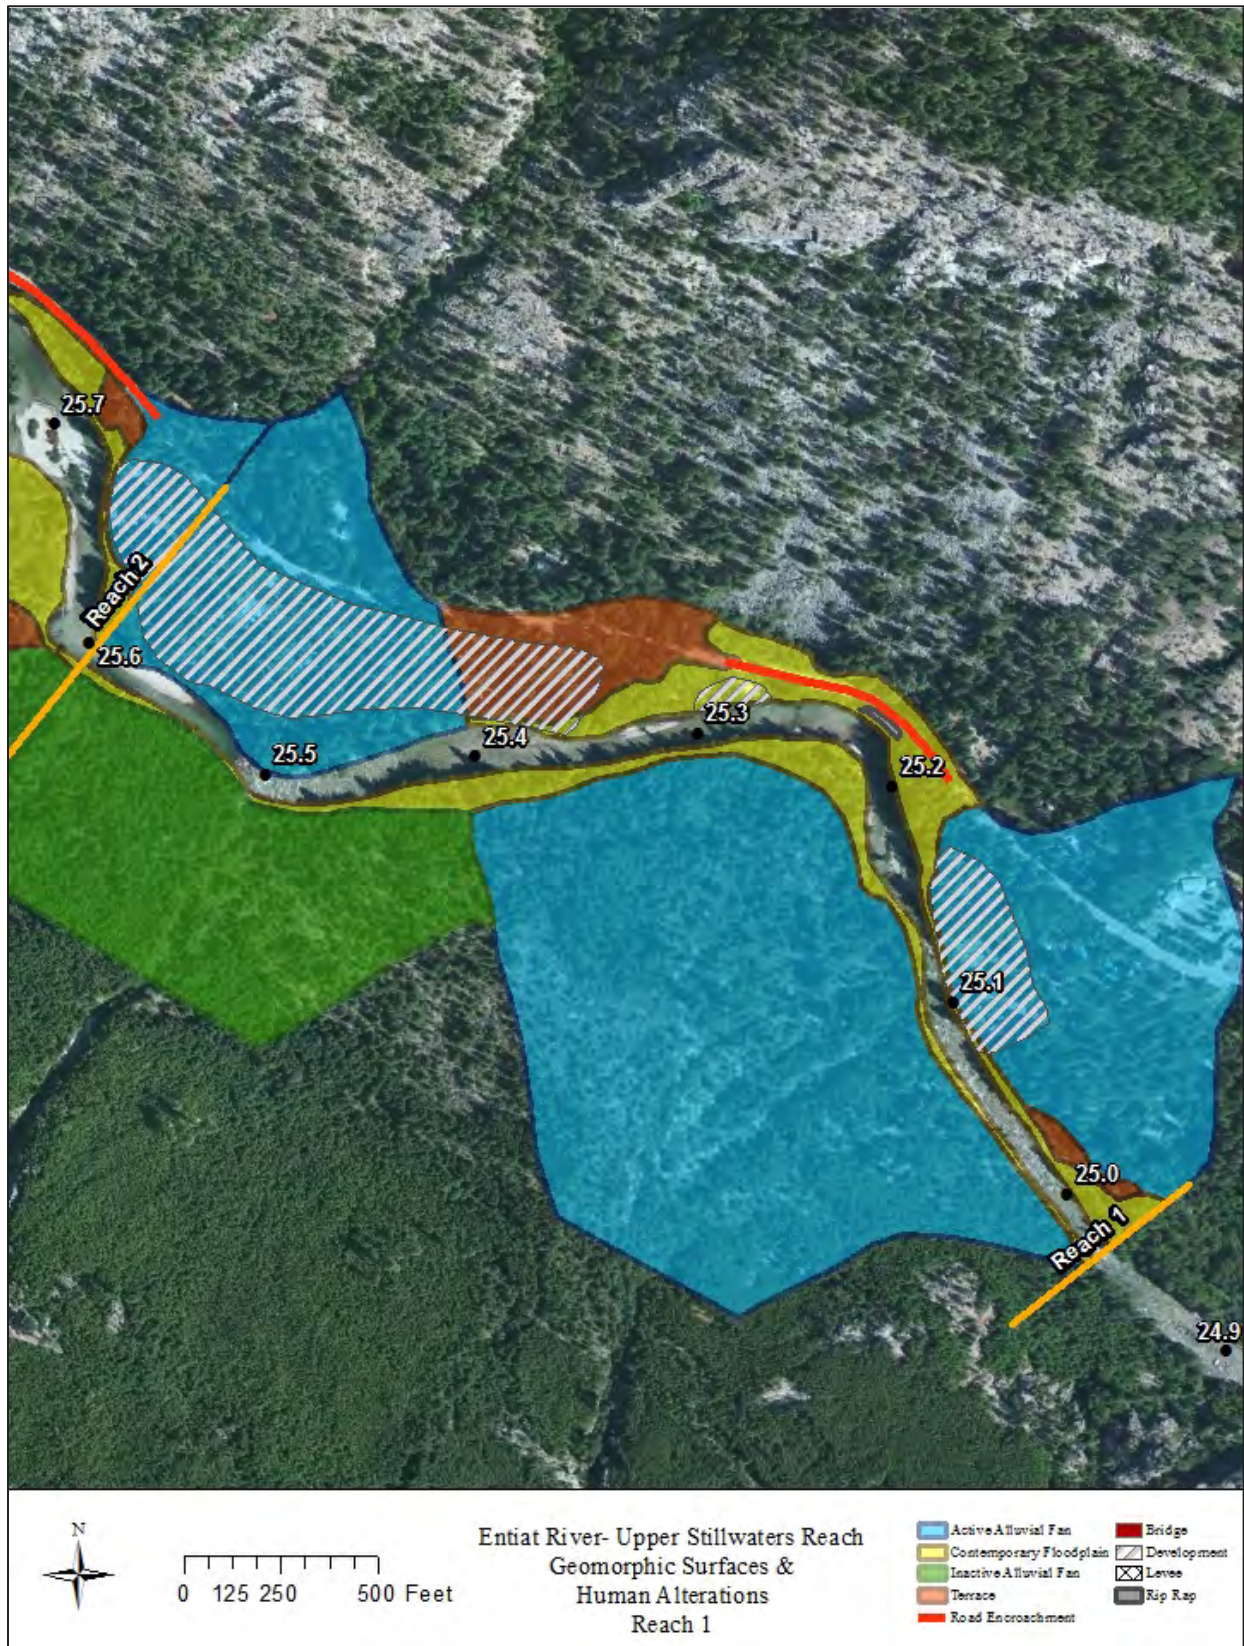
Figure 3. Geomorphic surfaces and human alterations for Reach 1. Flow is from northwest to southeast.

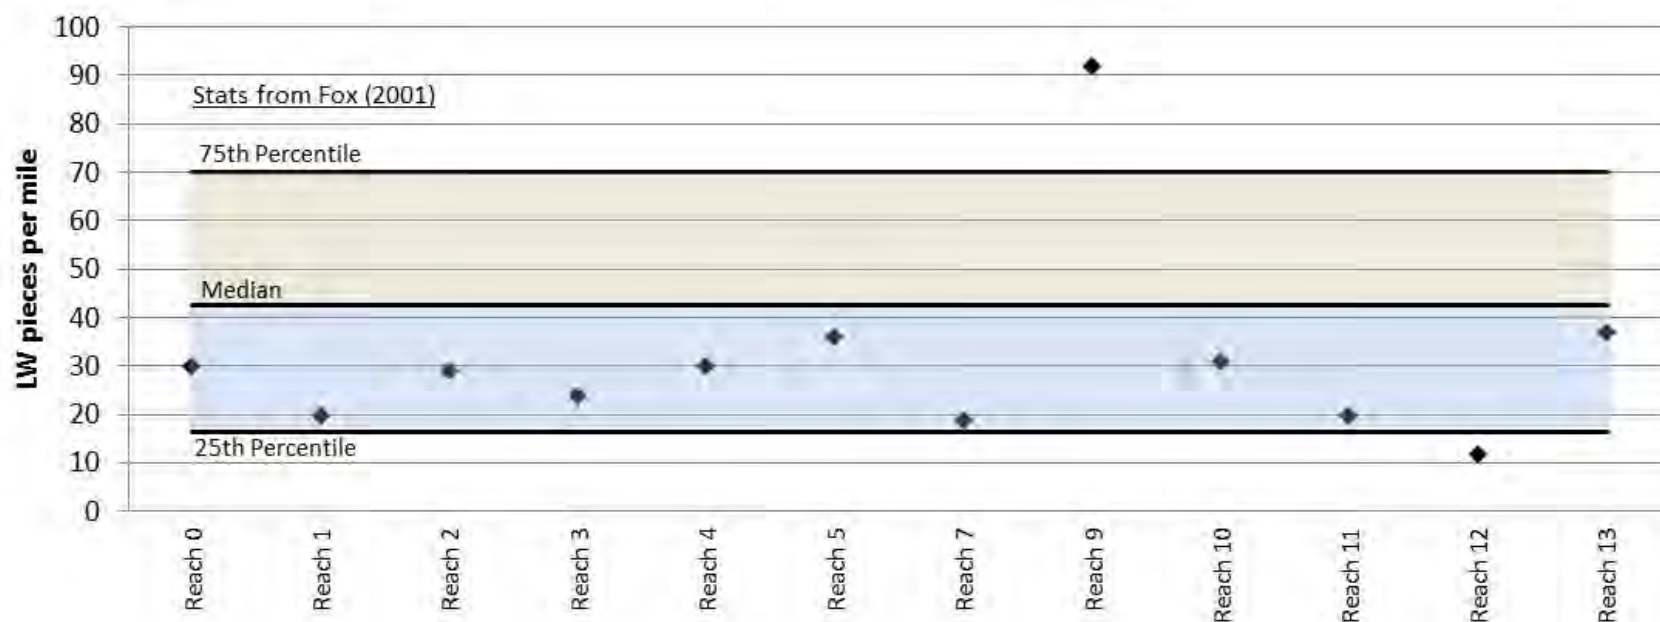
The Upper Stillwater study area as a whole currently averages 33 pieces/mile and ranges from 12 pieces/mi to 92 pieces per mile (Table 4). Log jam values ranged from 0 jams/mi in several reaches to 4.9 jams/mi in Reach 9. Figure 4 displays the reach results for pieces per mile as well as the median, 25th percentile, and 75th percentile values from Fox (2001). Only one reach, Reach 9 achieves the target of 42.5 pcs/mi and it actually exceeds the 75th percentile value as well. This reach is given an **adequate** rating since it achieves both the piece number target and the log jam target. The remaining reaches are given **unacceptable** ratings because they don't achieve either the piece number or log jam targets. Exceptions include reaches 6 and 8, which are steep canyon reaches where LWM counts were not performed. Observations during site visits suggest that these reaches would fall well short of the 42.5 pieces/mi target. However, these transport reaches would not be expected to accumulate wood to the same degree as the other, more depositional, reaches in the study area. For this reason, these reaches were given at risk ratings.

Figure 4. LW counts for the study reach compared to Fox (2001) percentile values. LW counts were not conducted on reaches 6 and 8.

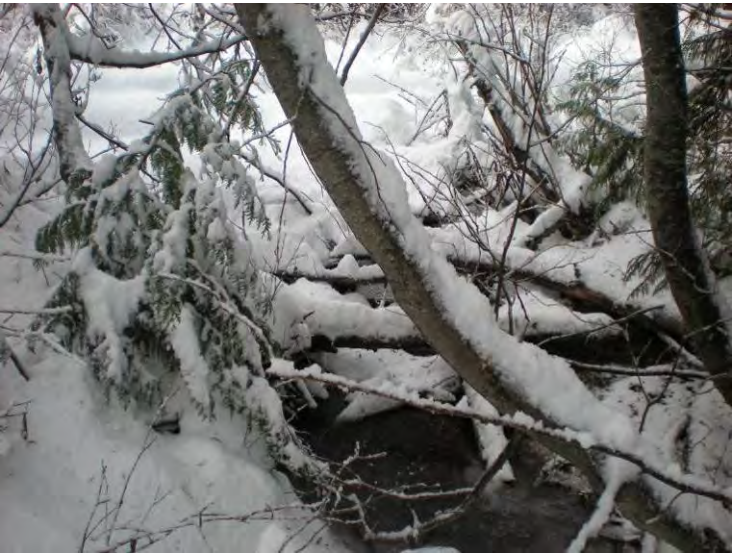
Reach	Project Number	Project Name	Action Type	Description	Photo	Caption
13	Project RM 33.2L	Upper Pope Side Channel Enhancement	Off-channel habitat enhancement Placement of structural habitat elements	There is a small high-flow side channel that branches off an active mainstem side channel near RM 33.25. Select excavation and construction of a bar apex jam could activate the side channel at lower flows and potentially allow greater connectivity of off-channel wetlands in the floodplain. Decent habitat already exists in this channel at moderate-to-high flows.

Upper end of high-flow side channel. November 2012.
11	Project RM 32.8L	Lower Pope Left Bank Side Channel Enhancement	Off-channel habitat enhancement Placement of structural habitat elements	There is a small high-flow side channel that branches off the mainstem near RM 32.8. There is only a small amount of hyporheic flow in the channel at moderately low flow. Could open upstream end by removing material and building apex jam in main channel. There are dense small trees (e.g. vine maple) and debris in the channel. Survey would determine how much deeper, if any, the channel would need to be to convey perennial surface flow or possibly to enhance groundwater flow.

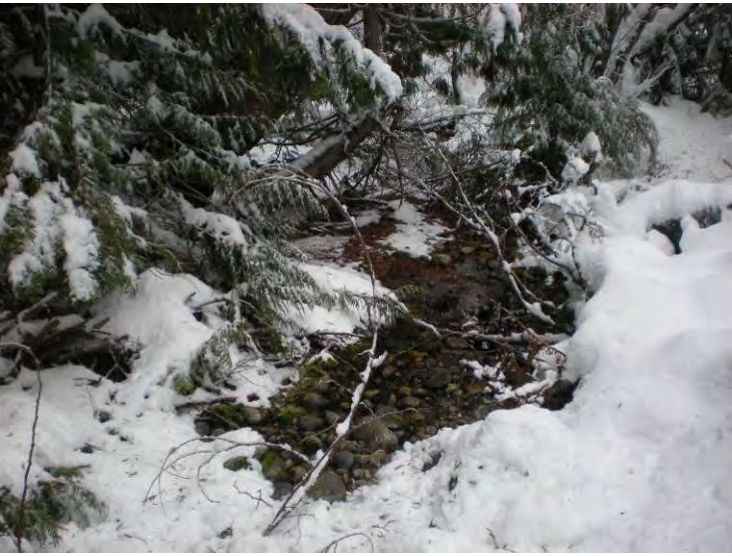
Midway down existing high flow side channel. November 2012.

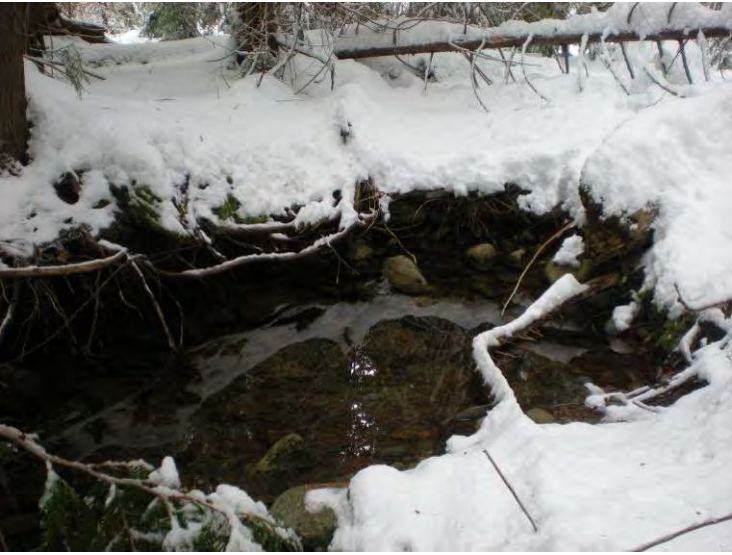
Reach	Project Number	Project Name	Action Type	Description	Photo	Caption
11	Project RM 32.7R	Lower Pope Right Bank Side Channel Enhancement	Off-channel habitat enhancement Placement of structural habitat elements	There is a high-flow side channel across the right bank bar that begins near RM 32.7. The channel only flows at fairly high flows and is likely not connected at the upstream end during typical annual high flows. There is a headcut at the downstream end. This channel could be excavated to create a more active flow-through side channel – or more likely, a backwater channel that may have hyporeic flow much of the year.

Head-cut at downstream end of high flow side channel. November 2012.
10	Project RM 31.4L	Upper Silver Falls Margin Jams	Placement of structural habitat elements	This section is composed of straight and uniform glide habitat with little cover. A channel margin logjam or jams (1-2) could be placed on river left. A large jam could be centered on an 8- to 10-yard boulder located along the channel margin. Jams here would create local pool scour and increase habitat cover and complexity.

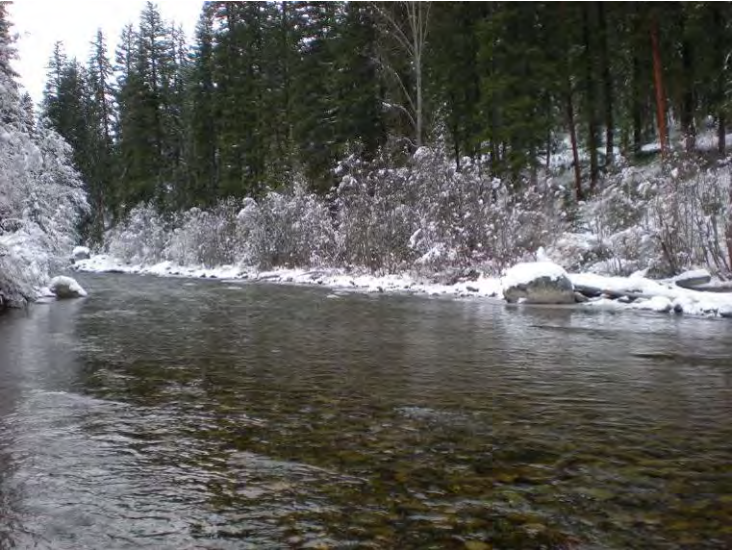
View upstream towards the river left bank where a channel margin logjam could be positioned along the upstream end of an existing large boulder. November 2012.

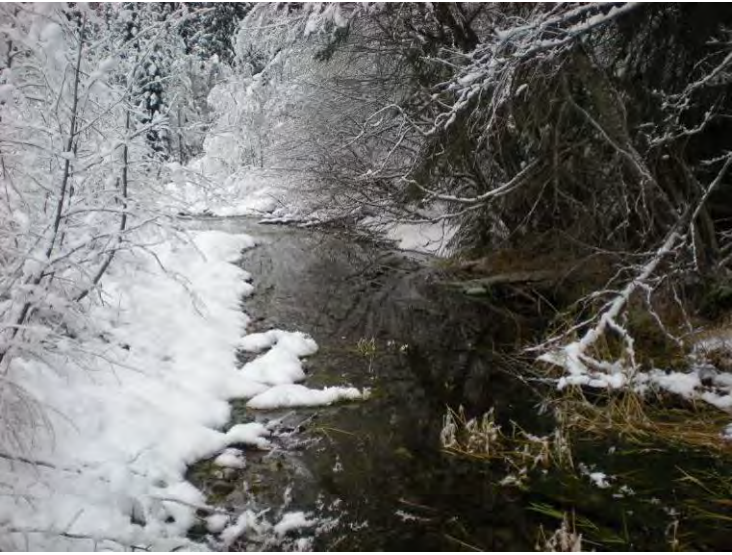
Reach	Project Number	Project Name	Action Type	Description	Photo	Caption
9	Project RM 31.4R	Silver Falls Side Channel Enhancement 1	Off-channel habitat enhancement	There is an old channel scar in the right bank floodplain that only conveys surface flows at flood flows. There is existing groundwater flow towards the downstream end. Excavation could be used to deepen and connect to the mainstem at the upstream end at a broader range of flows. Alternatively, groundwater flow could be enhanced through excavation of the downstream portion and/or placement of groundwater galleries.

View looking downstream near downstream end of groundwater-fed side channel near RM 31.3. November 2012.
9	Project RM 31.25R	Silver Falls Side Channel Enhancement 2	Off-channel habitat enhancement Placement of structural habitat elements	This is an existing right bank side channel that does not convey surface flow at low flow, but does convey flow at moderate flows (annual spring runoff). Placement/enhancement of an apex jam on the island, combined with select excavation, could help activate the channel at lower flows. A meander bend jam on the right bank at the downstream end would enhance pool scour, cover, and complexity in the side channel. Actions would need to be evaluated in the context of existing function and wood loading. It would also be possible to enhance the existing backwater at the downstream end of the island with large wood cover where it receives hyporheic flow.

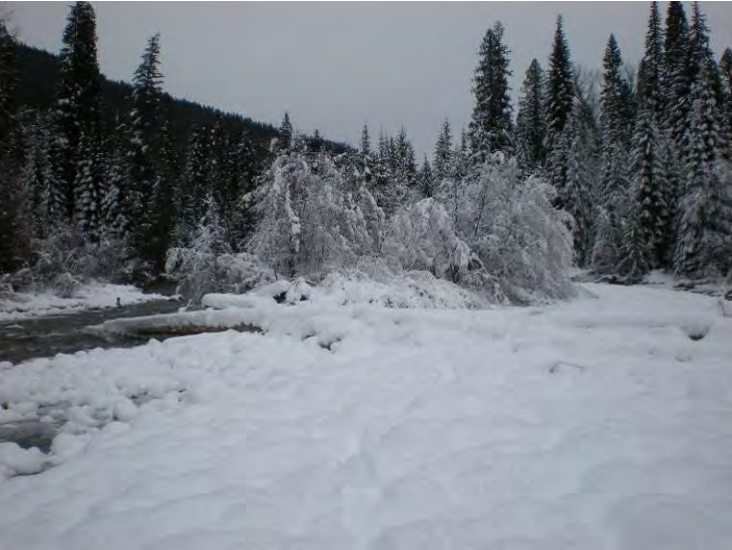
View downstream at island and split flow near RM 31.25.

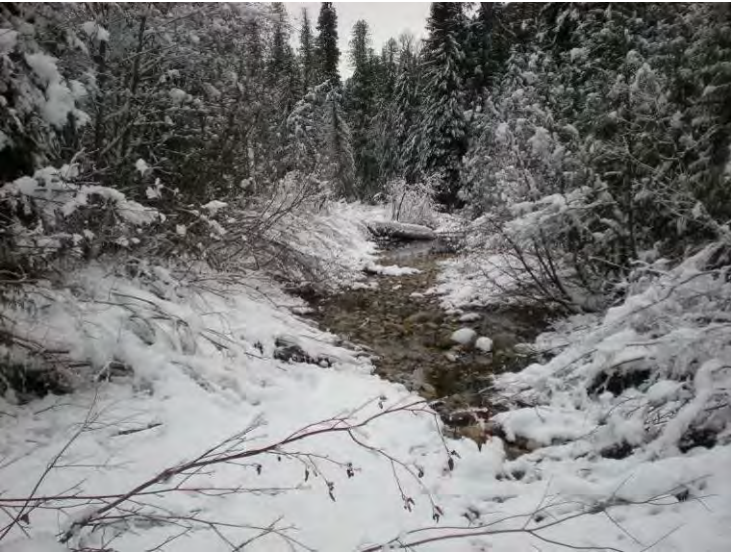
Reach	Project Number	Project Name	Action Type	Description	Photo	Caption
9	Project RM 31.15R	Silver Falls Side Channel Enhancement 3	Off-channel habitat enhancement Placement of structural habitat elements	This is an existing right bank side channel that does not convey surface flow at low flow, but does convey flow at moderate flows. Explore alternatives for increasing side channel activation at lower flows or creating a backwater channel. Actions would need to be evaluated in the context of existing function and wood loading.

View looking downstream midway down existing side channel near RM 31.1. November 2012.

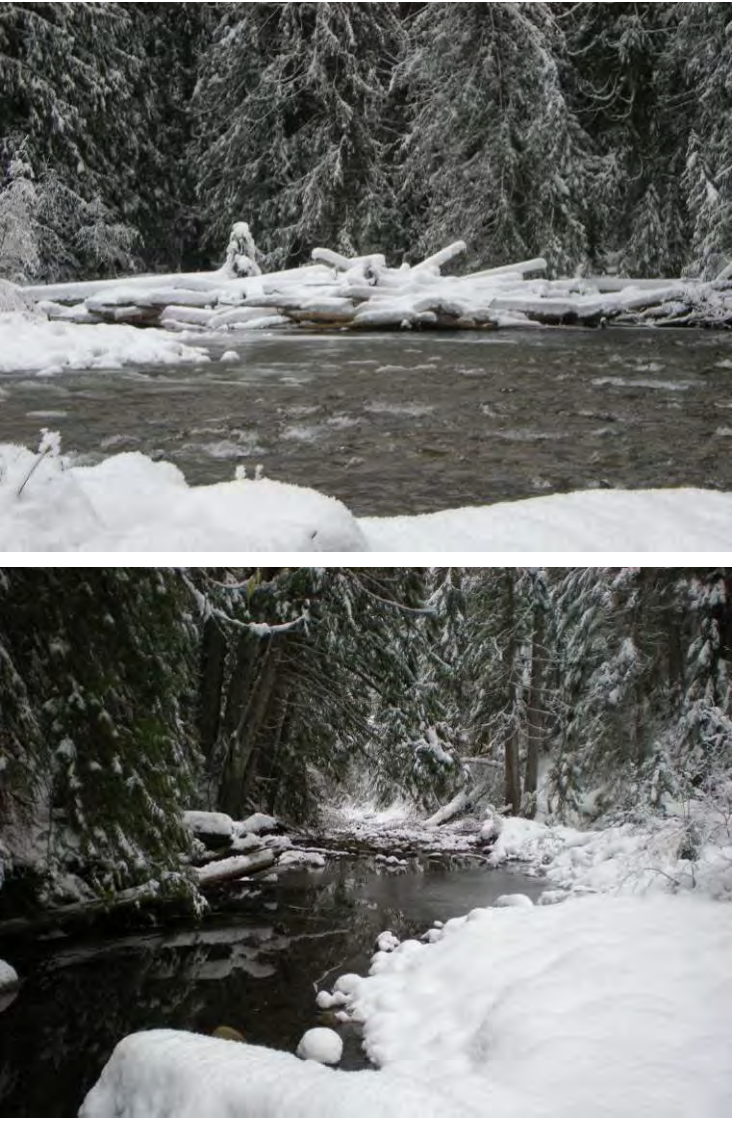
Reach	Project Number	Project Name	Action Type	Description	Photo	Caption
9	Project RM 31.0R	Silver Falls Side Channel Enhancement 4	Off-channel habitat enhancement Placement of structural habitat elements	<p>This is an existing 1,300-foot-long, 25-foot-wide, right bank side channel that branches off the mainstem at a large apex jam. Side channel is active at low flows and has good wood cover towards the upstream end. The outlet flows into a secondary mainstem side channel that is not connected via surface flow to the mainstem at low flows.</p> <p>This is a good analog for side channel enhancement projects in the study area. At the downstream end, the secondary side channel could be enhanced by placing an apex jam at the head of the island. Alternatively, the downstream end of the secondary channel could be enhanced by excavating to create backwater habitat that would be fed by the existing long side channel.</p>

<p>Top: View looking downstream at logjam that splits flow into right bank side channel near RM 31.05.</p> <p>Bottom: View looking downstream within right bank side channel.</p>

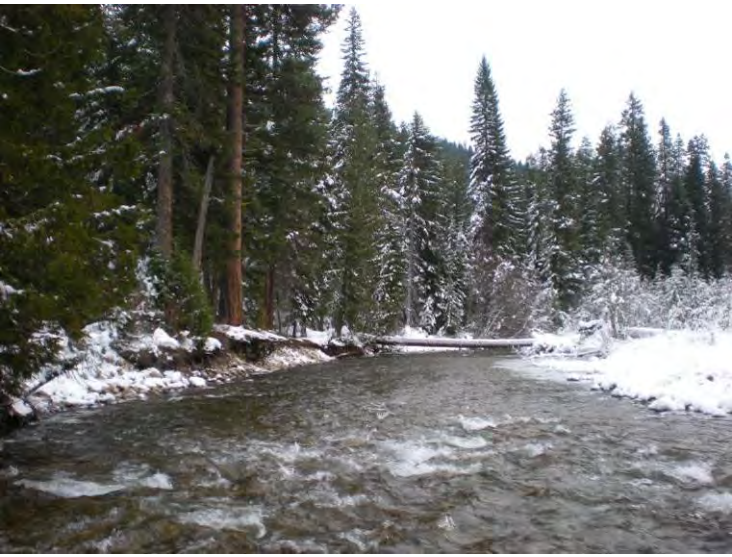
Reach	Project Number	Project Name	Action Type	Description	Photo	Caption
9	Project RM 30.7L	Lower Silver Falls Margin Jams 1	Placement of structural habitat elements	<p>This section is composed of uniform glide habitat with little cover. A channel margin logjam or jams (1-3) could be placed on river left to enhance local pool scour and increase habitat cover and complexity. Continued bank erosion may recruit large wood here soon. Another alternative would be a large bar apex jam that accelerates left bank migration-tree undermining; and natural logjam formation at the downstream bend.</p> <p>An ADA interpretive trail is located at the top of this bank. Meander-bend logjams here could serve the dual purpose of habitat creation and maintenance of trail integrity.</p>

View looking downstream at eroding river left bank near RM 30.7.
9	Project RM 30.5L	Lower Silver Falls Margin Jams 2	Placement of structural habitat elements	<p>This section is composed of uniform glide habitat with little cover. A channel margin logjam or jams (1-2) could be placed on river left to enhance local pool scour and increase habitat cover and complexity. There is no wood on top of the bank for future recruitment in the near term.</p>

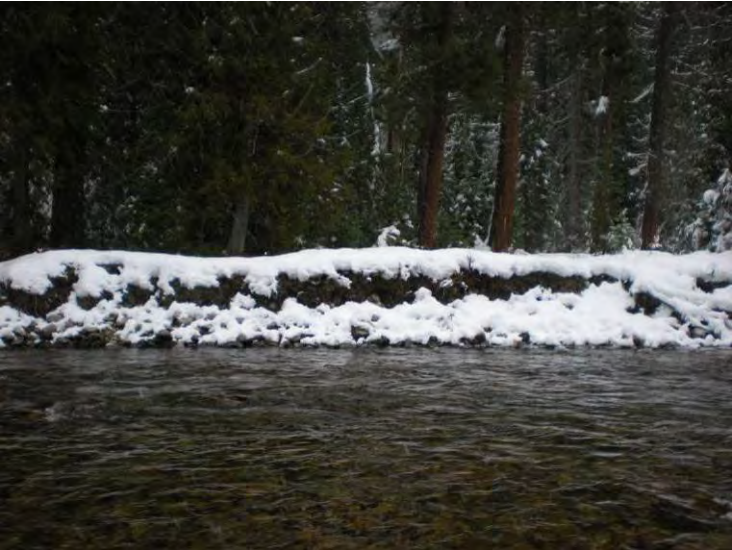
View of eroding left bank near RM 30.5.

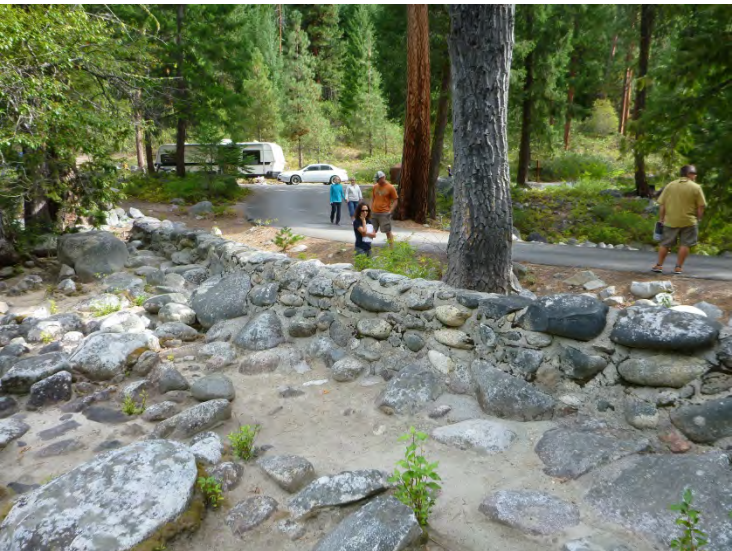
Reach	Project Number	Project Name	Action Type	Description	Photo	Caption
5	Project RM 28.2L	Fox Creek Campground Side Channel Enhancement	Habitat reconnection via infrastructure modification	At the Fox Creek Campground, there is a 700-foot-long floodplain overflow channel depression (RM 28.05-28.2) that conveys water only at flood flows but was likely more active prior to development of the campground. A stone wall, 80 feet long, obstructs the inlet to the channel, as does the campground road and associated fill. Approximately 500 feet down the channel is a road crossing with a culvert. The side channel could be enhanced as an active low-flow side channel by removing the wall; culverting or bridging the road at the upstream end; enlarging the culvert; or bridging the downstream crossing and increasing depth of the channel. The riparian structure and planform pattern would provide for a complex channel with high-quality habitat. Wood additions would increase cover and complexity. Additional riparian plantings would enhance long-term function.

Rock wall and road that obstructs the inlet to the floodplain channel at the Fox Creek Campground. August 2013.

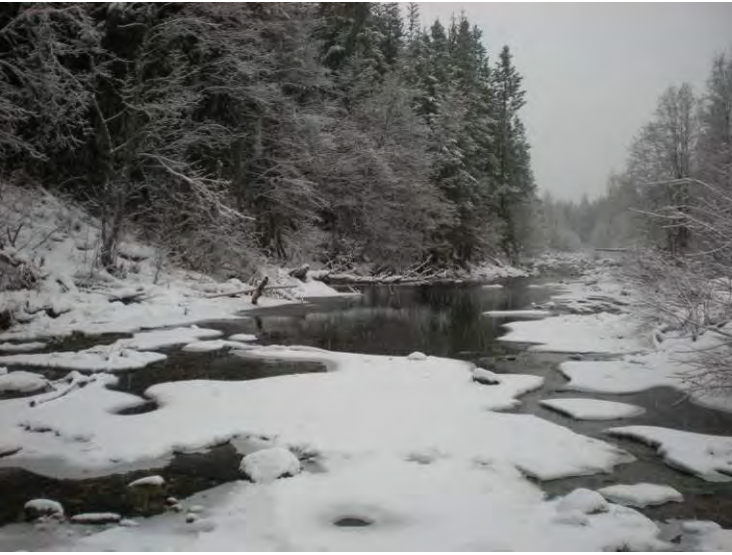
Reach	Project Number	Project Name	Action Type	Description	Photo	Caption
4	Project RM 27.4	Signal Peak Side Channel and LW Enhancement	Off Channel habitat enhancement Placement of structural habitat elements	<p>Multiple opportunities along this 0.45 mile section (27.15 – 27.6). Apex jams, margin jams, cover wood, side channel enhancement. Great opportunity to enhance moderately functioning lateral channel dynamics in an area in need of more wood.</p> <p>A spawning channel was built within this project area by the USFS. Date of construction is estimated to be in the mid-1990s. This channel currently supports high levels of spawning and should be maintained as part of any project work that occurs here.</p>

View looking upstream within right bank side channel at RM 27.4. November 2012.
3	Project RM 27.1L	Lower Signal Apex Jams	Off channel habitat enhancement Placement of structural habitat elements	<p>There are two small islands at a side channel complex on the left bank at RM 27.1. Bar apex jams at the head of the small islands could increase activation of side channels and maintain split flow conditions. Cover wood in the side channel would increase complexity.</p>

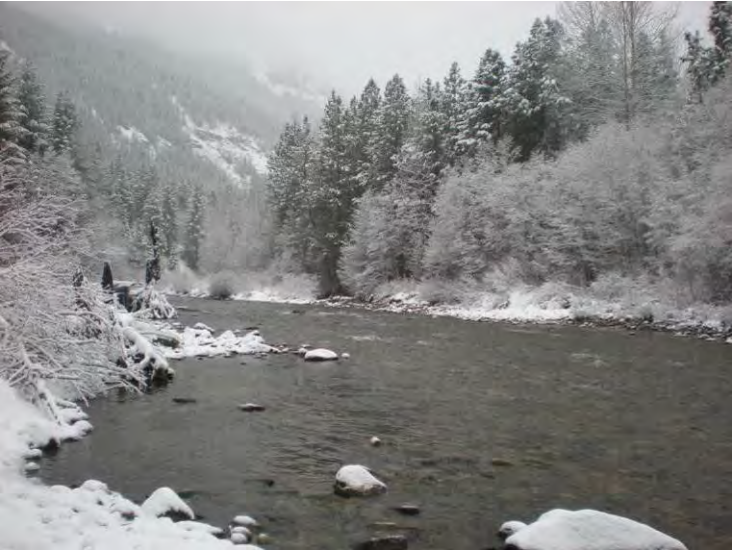
View looking upstream from RM 27 at outlet of small side channel complex on left bank (right side of photo). November 2012.

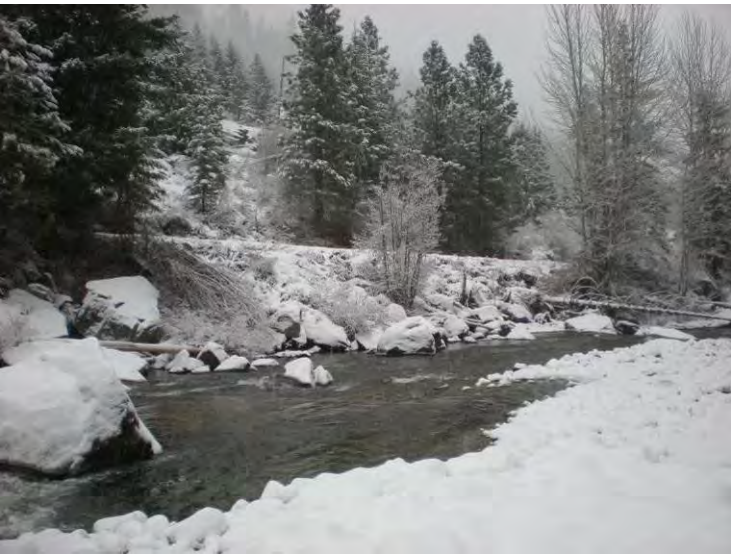
Reach	Project Number	Project Name	Action Type	Description	Photo	Caption
3	Project RM 27L	Lower Signal Road Jams	Habitat reconnection via infrastructure modification Placement of structural habitat elements Riparian restoration	Place large wood along riprap bank to enhance cover and complexity. Decent complexity is currently provided by boulders. Consider riprap removal and placement of 2-3 large jams along road corridor to shift stream away from roadway and to provide space for a forested riparian buffer.

View looking downstream at riprap bank at RM 27. November 2012.
3	Project RM 26.6	Upper Angle Point Logjams	Placement of structural habitat elements Riparian restoration	This 0.25 mile segment (RM 26.45 to 26.7) contains good locations for placement of meander bend and bar apex logjams to enhance pool scour, lateral channel dynamics, cover, and complexity. Logjams along the road near RM 26.65 could be used to shift the channel away from the road and to create room for a wider forested riparian buffer.

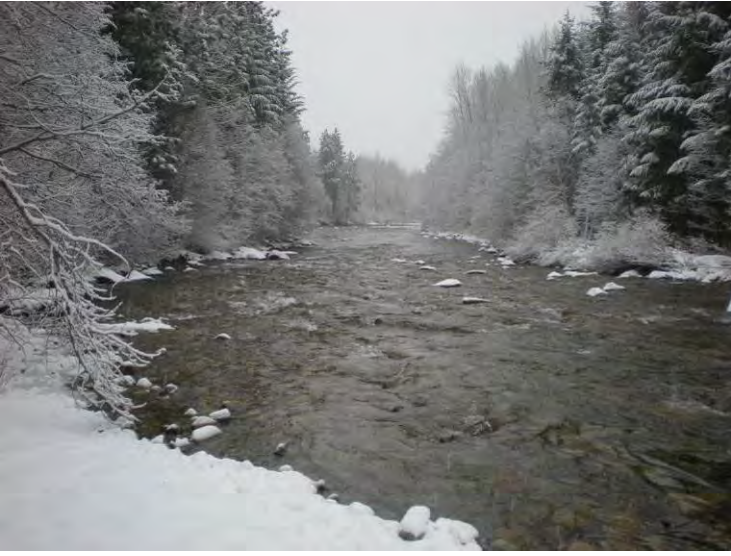
View looking downstream from near RM 26.5. November 2012.

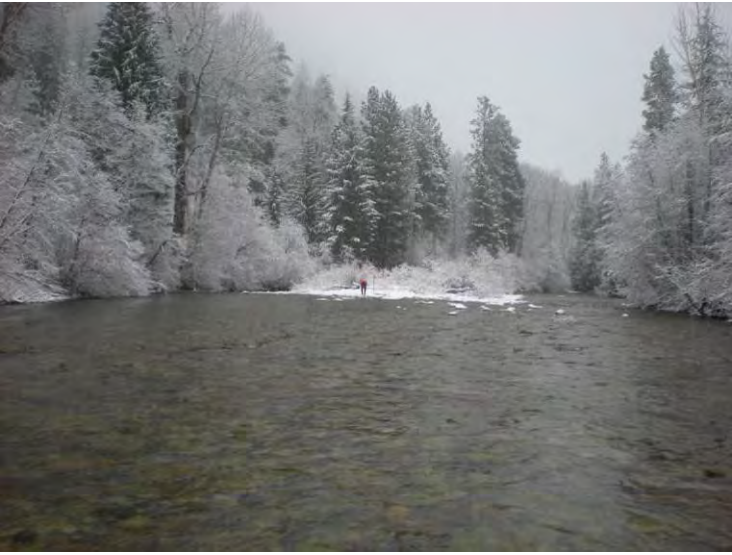
Reach	Project Number	Project Name	Action Type	Description	Photo	Caption
3	Project RM 26.1	Lower Angle Point Logjams	Placement of structural habitat elements	This 0.3 mile section (RM 25.9 to 26.2) contains good locations for placement of meander bend and bar apex logjams to enhance pool scour, lateral channel dynamics, cover, and complexity.

View looking downstream from near RM 26.1. November 2012.
2	Project RM 25.8	Upper Burns riprap enhancement	Habitat reconnection via infrastructure modification Placement of structural habitat elements Riparian restoration	There are approximately 130 feet of riprap protecting the roadway along the left bank. Place large wood along riprap bank to enhance cover and complexity. Consider riprap removal and placement of 2-3 large jams along road corridor to shift stream away from roadway and to provide space for a forested riparian buffer. This type of prescription has been used with great success on the upper Klickitat River.

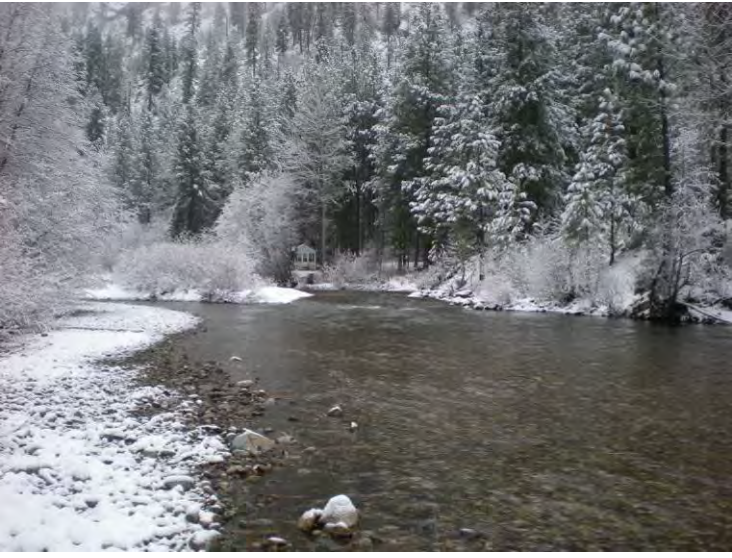
Reach	Project Number	Project Name	Action Type	Description	Photo	Caption
2	Project RM 25.7	Upper Burns LW and Side-Channel Enhancement	Off-channel habitat enhancement Placement of structural habitat elements	This 0.3 mile section (RM 25.6 to 25.9) contains good locations for placement of meander bend and bar apex logjams to enhance pool scour, cover, and complexity. Existing side channels can be enhanced through placement of large wood for pool scour, cover, and complexity. There may also be good opportunities for off-channel enhancement in the river right (south) floodplain area. Enhancements could include flow-through side channels, groundwater-fed channels, or backwater alcoves. There are nearby houses at the downstream end of this project area.

View looking upstream from near RM 25.6. November 2012.
1	Project RM 25.53L	Burns Fan Pool Jams	Placement of structural habitat elements	Existing pool has little to no wood. Placement of one or two channel margin jams at the pool would increase cover and complexity.

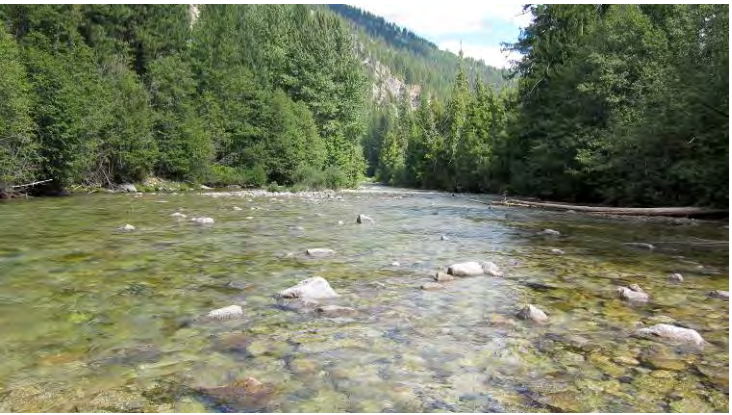
1	Project RM 25.4	Lower Burns LW Enhancement	Off-channel habitat enhancement Placement of structural habitat elements	One or two channel margin and bar apex jams located between 25.3 and 25.45 would enhance lateral channel dynamics, side channel development, and cover/complexity.

View looking downstream near RM 25.4. August 2012.

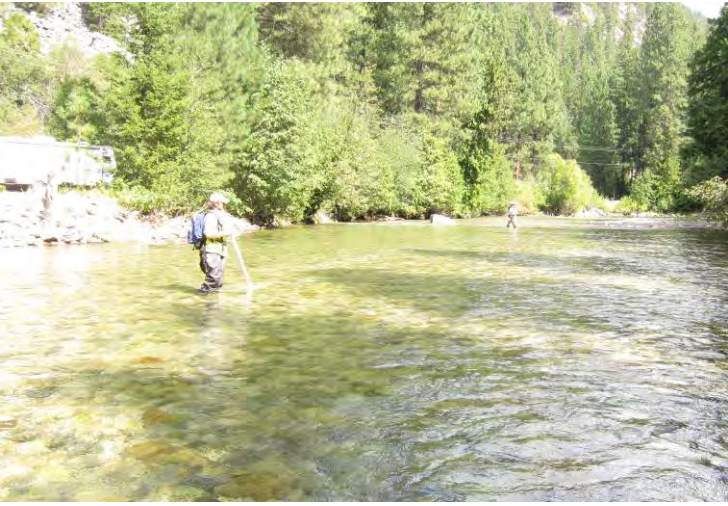
Reach	Project Number	Project Name	Action Type	Description	Photo	Caption
1	Project RM 25.3L	Grandma Fan Margin Complexity	Habitat reconnection via infrastructure modification Placement of structural habitat elements Riparian restoration	Placing one to two channel margin jams on the left bank near RM 25.3 would enhance pool scour, cover, and complexity. Consider removing or modifying a rock wall (~45 ft long) at RM 25.3. Add wood to riprap bank along road near RM 25.25, or consider replacing with one to two logjams to shift channel from bank and allow for establishment of forested riparian buffer. Houses nearby.

View looking downstream from near RM 25.3. Rock wall is in foreground on the left and riprap bank is in the distance on the left bank. August 2012.
1	Project RM 25.2	McCrea LW and Side-Channel Enhancement	Off-channel habitat enhancement Placement of structural habitat elements	Existing pool has little to no wood. Placement of one or two channel margin jams at the pool would increase cover and complexity. Place apex jam at downstream bar to activate left bank side channel.

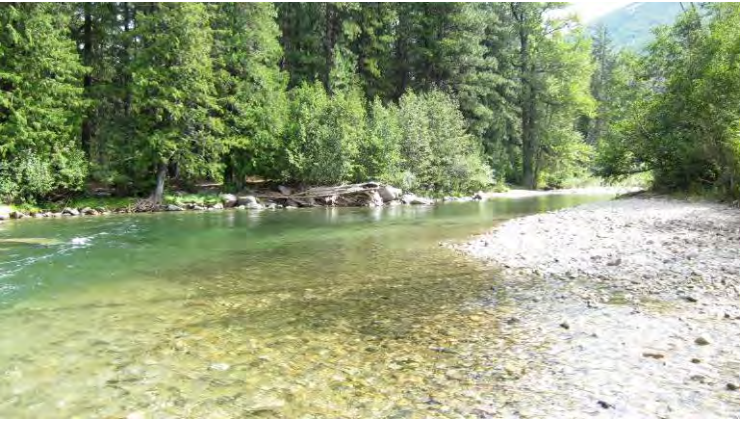
View looking downstream at pool near RM 25.2. August 2012.

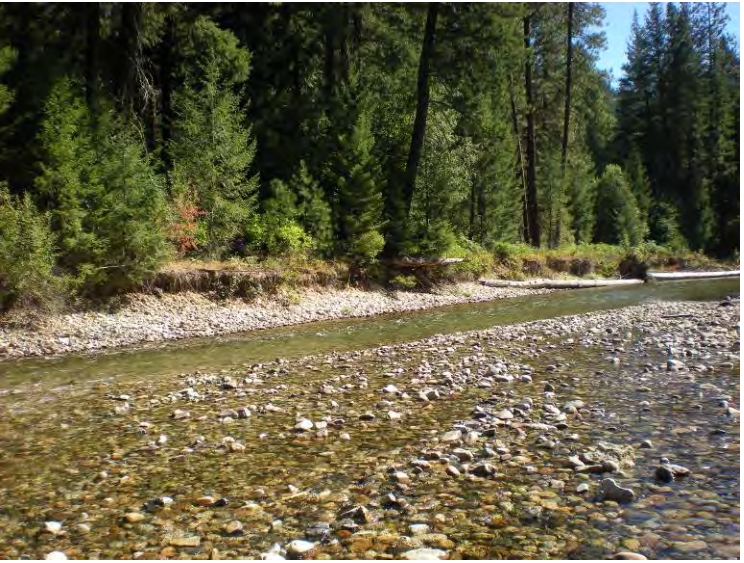
0	Project RM 23.9	Upper Jenne LW Enhancement	Off-channel habitat enhancement Placement of structural habitat elements	From RM 23.85 to 24 is a depositional area where logjams would naturally form. There is significant bar formation and split flow conditions at low flows. There is some mature riparian forest but also some impaired and rapidly eroding banks without mature trees to provide stability. Meander bend jams could be placed to protect eroding banks in some areas and to encourage erosion (and LW recruitment) in other areas with mature riparian trees. Apex jams could be placed in the main channel to enhance lateral channel dynamics and split flow conditions. Wood placements would also enhance local pool scour, cover, and complexity.

View looking downstream at left bank near RM 23.9. September 2012.

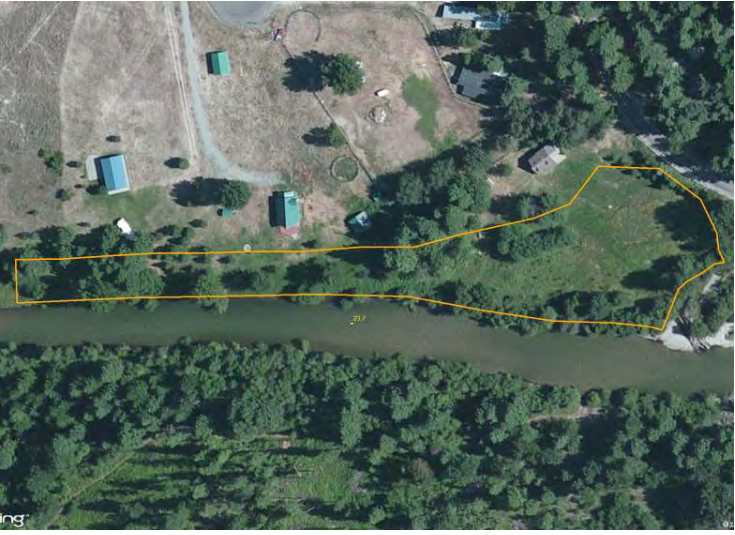
View looking upstream at straight, uniform channel from near RM 23.7. September 2012.
0	Project RM 23.65L	Reach 0 LB Riparian Restoration and Protection	Riparian restoration Protection	The left bank riparian area and floodplain from the bridge (RM 23.45) up to RM 23.8 lies within a residentially developed area where riparian clearing (lawns) and past grading has impacted riparian and floodplain processes. This area is privately-owned and continued clearing and other impacts are possible. Plant cleared areas to provide long-term riparian and floodplain function.

Aerial view of cleared riparian and floodplain area along river left bank in Reach 0.

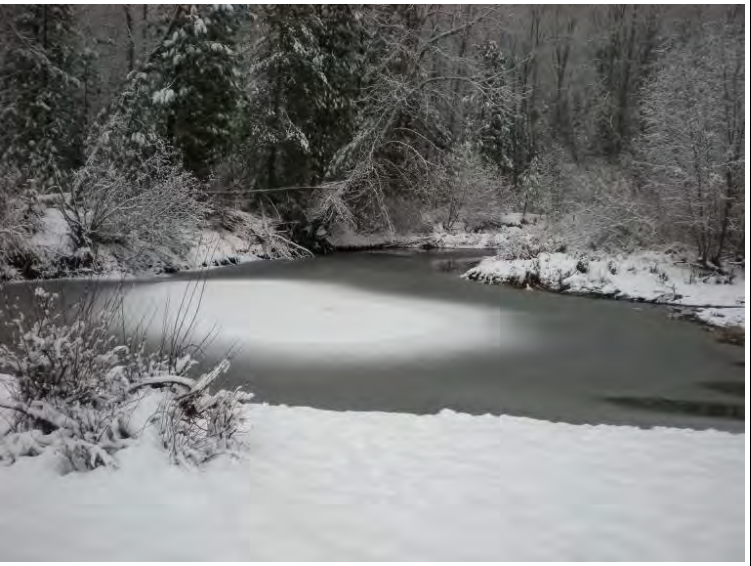
Reach	Project Number	Project Name	Action Type	Description	Photo	Caption
0	Project RM 23.5	Lower Jenne LW Enhancement	Off-channel habitat enhancement Placement of structural habitat elements	The section from RM 23.45 to 23.65 is a depositional area located above the constriction at the downstream bridge (and Mott Creek Fan) location. It is a complex area with logjams, split flows, and backwater channels with beaver activity. These backwater channels could be enhanced by adding large wood for cover (especially at beaver pond at RM 23.5). Amount of backwater habitat could potentially be increased through excavation along the river right bank, with potential for groundwater channel development in the river right floodplain. There is also potential for excavation of backwater habitat on the left bank at RM 23.6.

Beaver pond within river right side channel near RM 23.5. November 2012.
0	Project RM 23.45	Upstream of Bridge Barb Enhancement	Habitat reconnection via infrastructure modification Placement of structural habitat elements	There is a rock bank barb just upstream of the bridge on the left bank near RM 23.45. The barb could be replaced with a logjam to provide stability or wood could be added to the area to enhance cover and complexity.

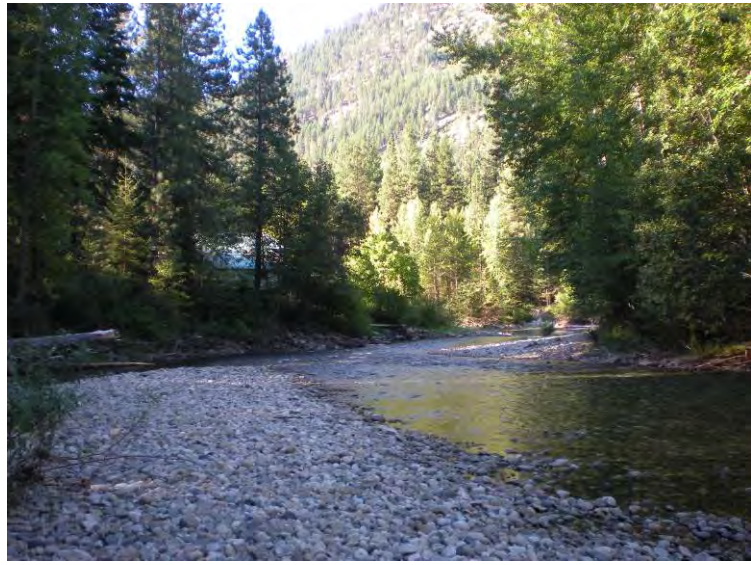
View looking upstream at riprap bank near RM 23.4. September 2012.
0	Project RM 23.3	Zerrener LW Enhancement	Off-channel habitat enhancement Placement of structural habitat elements	From 23.3 to 23.35 there is a depositional area where logjams would naturally form. There is some bar formation and split flow conditions at low flows. Apex and meander bend jams could be used to enhance cover, complexity, and lateral channel dynamics. Houses nearby.

View looking downstream near RM 23.3. September 2012.
