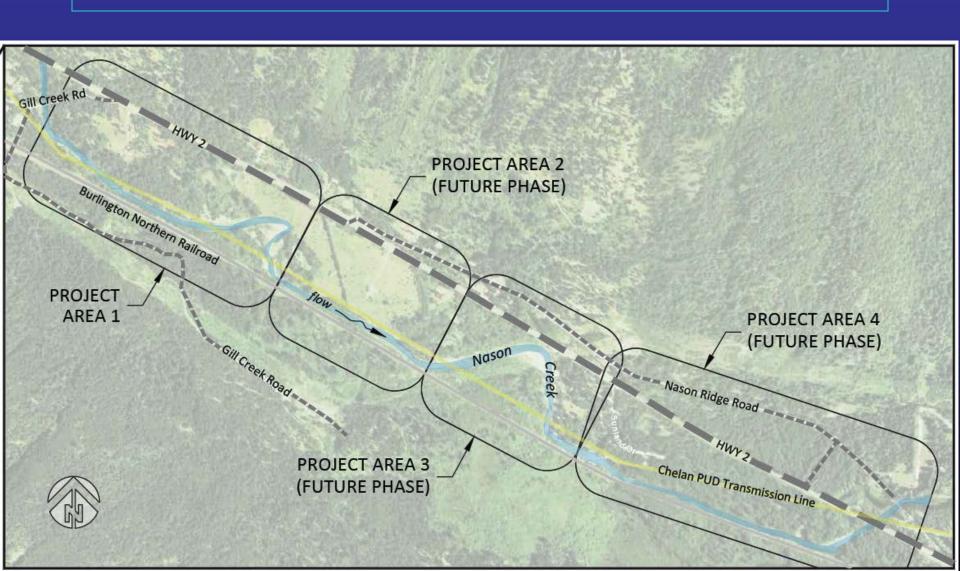
- Accelerated bank erosion
- No woody streambank or riparian vegetation
- Low floodplain roughness (in oxbow and on field)
- Log jam at downstream end of bend
- Poor margin habitat along bank

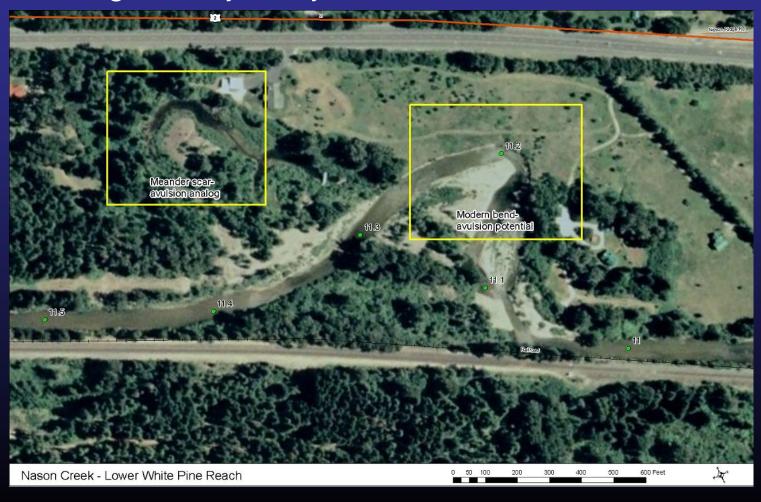
#### Other indicators of imminent avulsion

Headcut along railway embankment

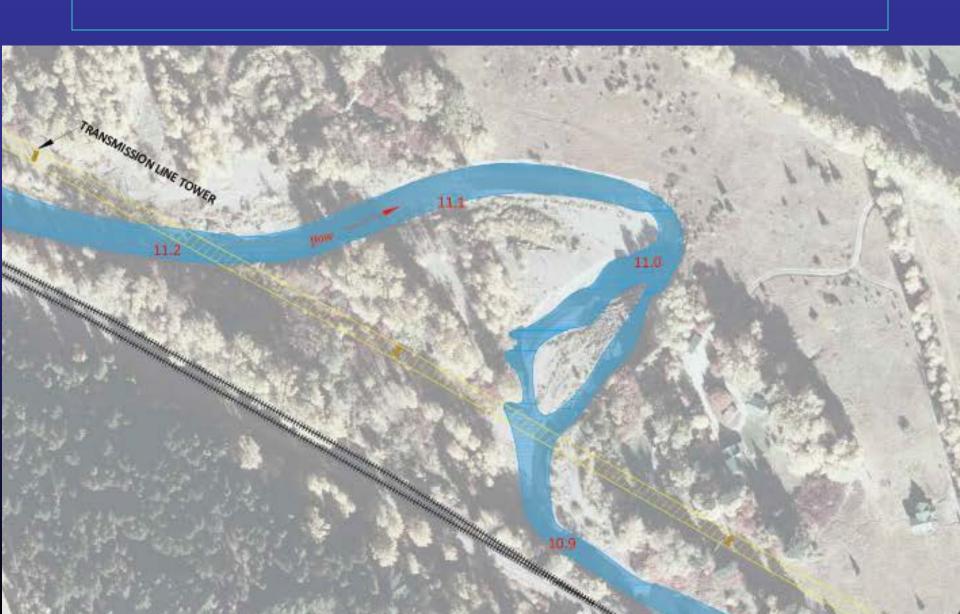
# No Action Alternative

- Created by human disturbance
  - Denuded streambank vegetation (root strength)
  - Denuded floodplain roughness (across oxbow)
  - Legacy incision
  - Sediment imbalance
- Consequences of avulsion
  - Additional straightening of reach
  - Loss of pool-riffle habitat
  - Probable stranding of existing log jam
