# Lower Twisp River Reach Assessment

Provided for:

**Yakama Nation Fisheries Program**

JUNE 2010

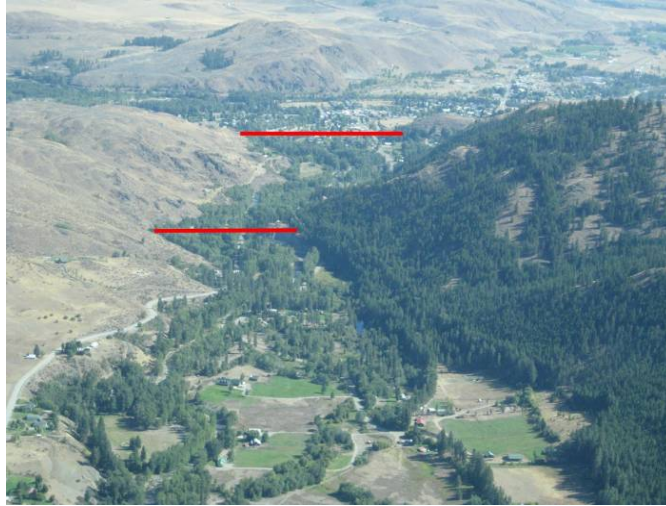
Reach T2a forms a constriction between the unconfined reach upstream and the Methow River Valley downstream (Figure 10). Hill slopes on both sides of the valley are composed of volcanic breccias inter-bedded with sandstone that can be seen in outcrops in several locations including

**Figure 10. Low elevation oblique aerial photo looking downstream to the east at the transition between reaches T2b (foreground), T2a (mid-ground), and T1a (background) (September 2009).**

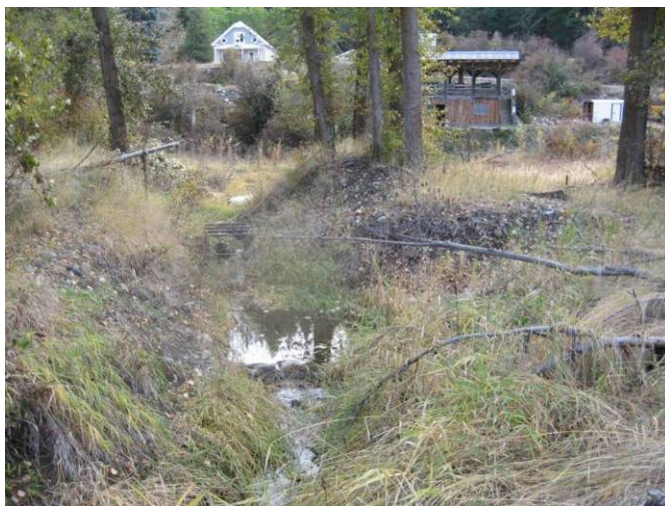
**Figure 13. Outflow of “Pond 5” which is a seasonal acclimation pond near RM 1.05 (October 2009).**

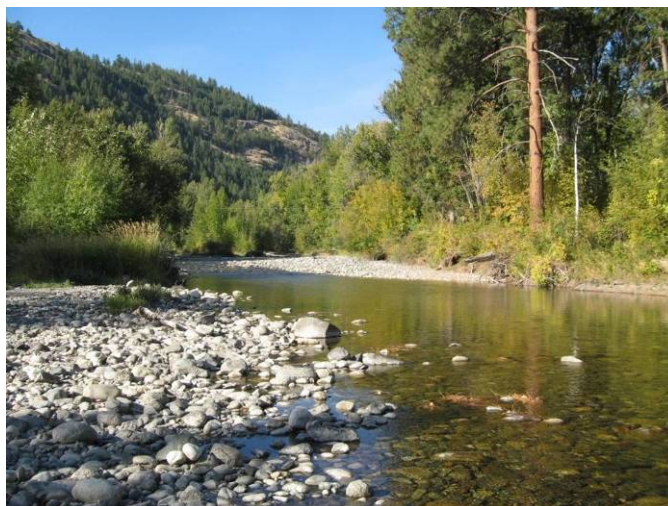
The channel has a moderate 1% grade. Bed morphology throughout the reach consists primarily of long shallow pools alternating with short riffles (Figure 14). Pools comprise about 47% of the channel area, riffles about 36%, and glides 6%. Natural streambanks through this reach are composed mainly of unconsolidated alluvial deposits and glacial outwash ranging in size from boulders to sand. Reach T2a has the highest percent length of total bank erosion in the study area at 7%. Pebble counts suggest that bed material is comprised primarily of large gravel and cobble size material (See Appendix A: Habitat Assessment).

**Figure 14. View looking east in the upstream direction at a riffle-pool transition in reach T2a (October 2009).**

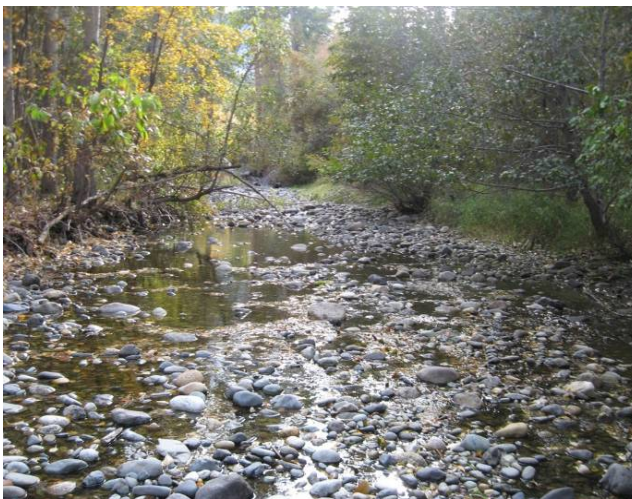
**Figure 22. Side-channel habitat formed in a laterally dynamic area of the reach near RM 3.15 (October 2009).**
