**LOWER PESHASTIN TRIBUTARY AND REACH ASSESSMENT**

**APPENDIX A    STREAM HABITAT REACH REPORTS**

**A-1 REACH 1**

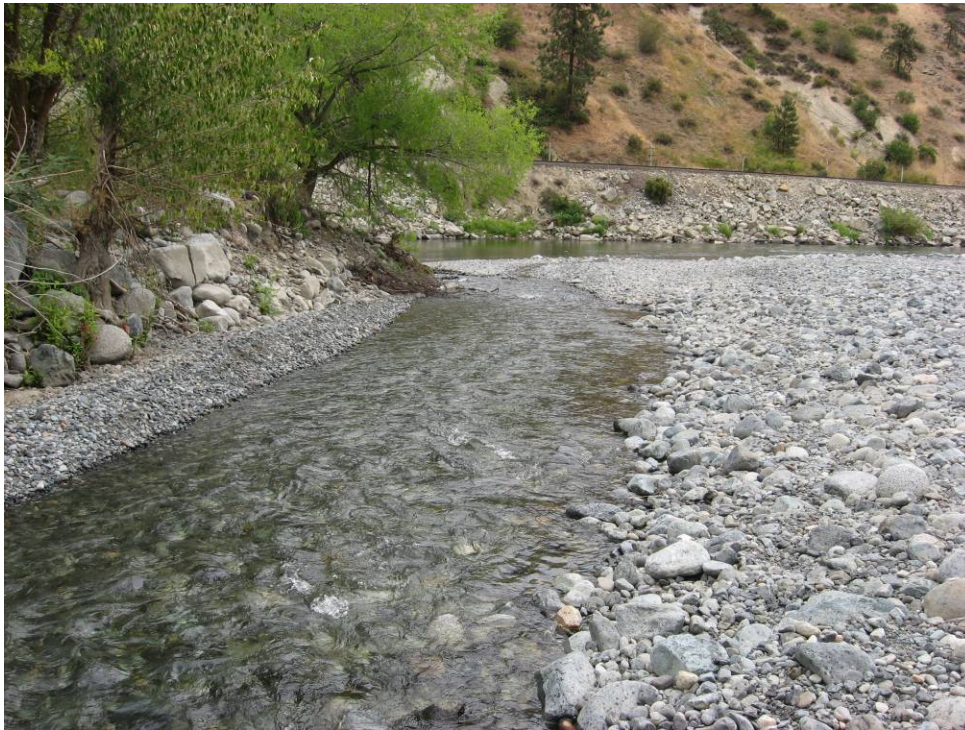
Figure 1. Downstream view of junction of Peshastin Creek with the Wenatchee River.

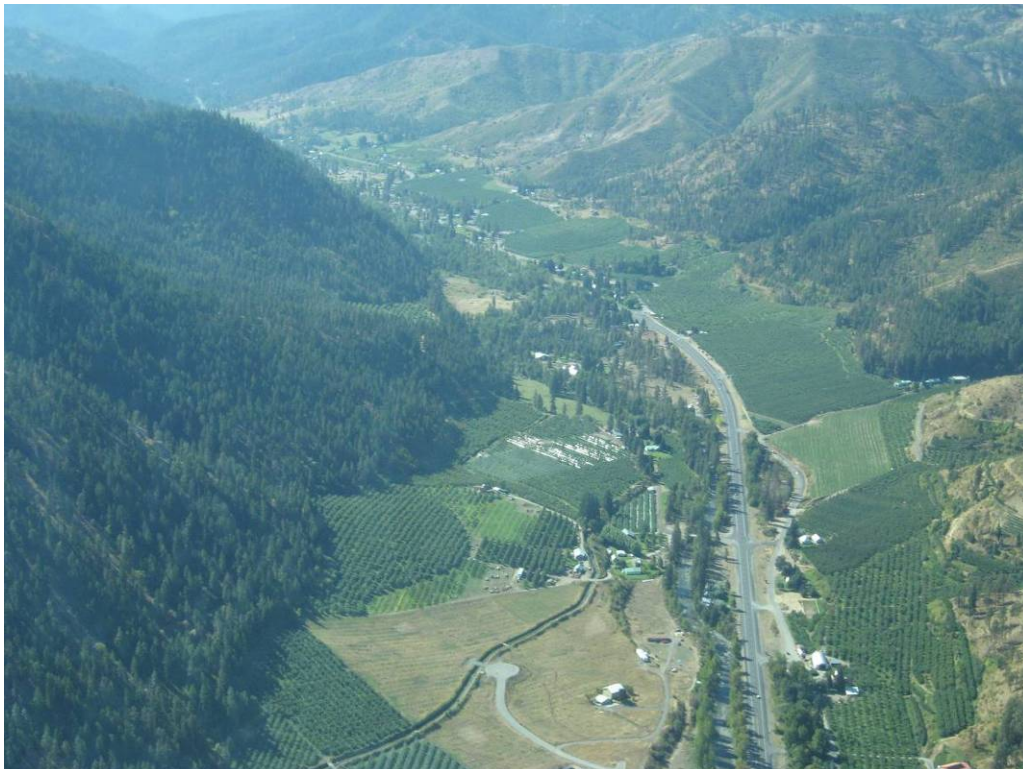
Reach 2 is the longest reach within the study area. Reach 2 lies within an unconfined valley. Highway 97 abuts the river along much of this reach and has had significant impacts on channel planform and riparian conditions. Agriculture and residential development occur throughout the valley in this reach. The largest irrigation diversion is located within this reach (river mile 2.5) and consists of a low-head dam and associated headworks. The inflow pipe from Icicle Creek crosses the channel in this reach at approximately RM 2.0. A summary of habitat characteristics for the reach can be found in Table 2 and Table 3 at the end of the Reach 2 section.

Figure 13. Aerial oblique upvalley view of Peshastin Creek Reach 2. Bottom of photo is river mile 1.6. Photo taken Sept 24, 2009.

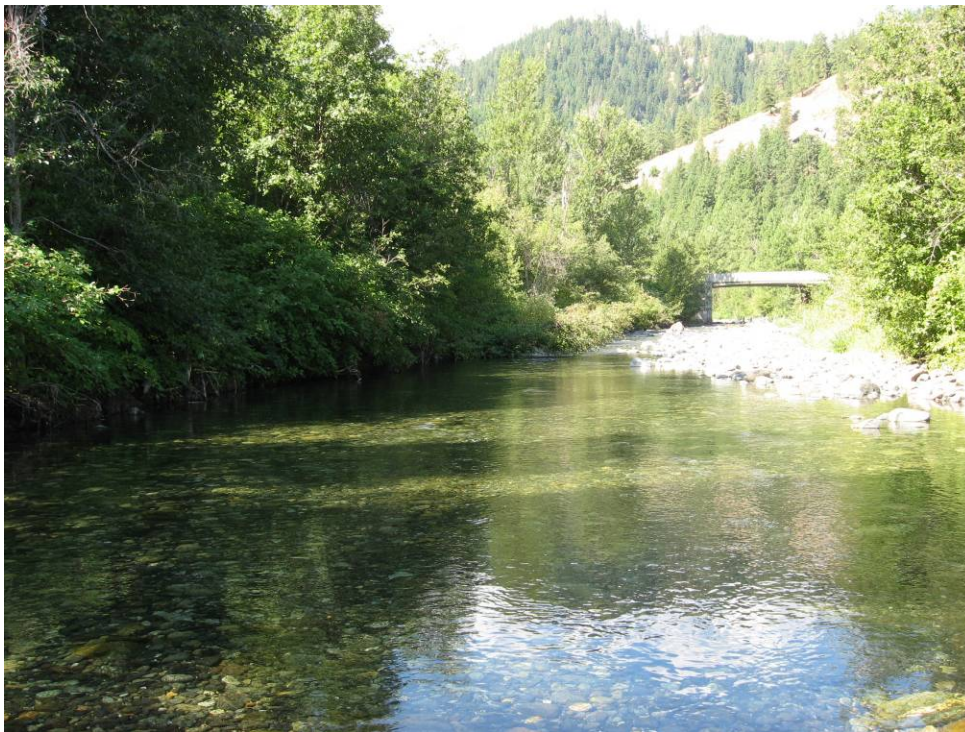
Figure 22. Long pool with good overhanging bank vegetation cover and a long tail-out with spawning-sized material. Near river mile 4.9; Highway 97 Bridge in background.

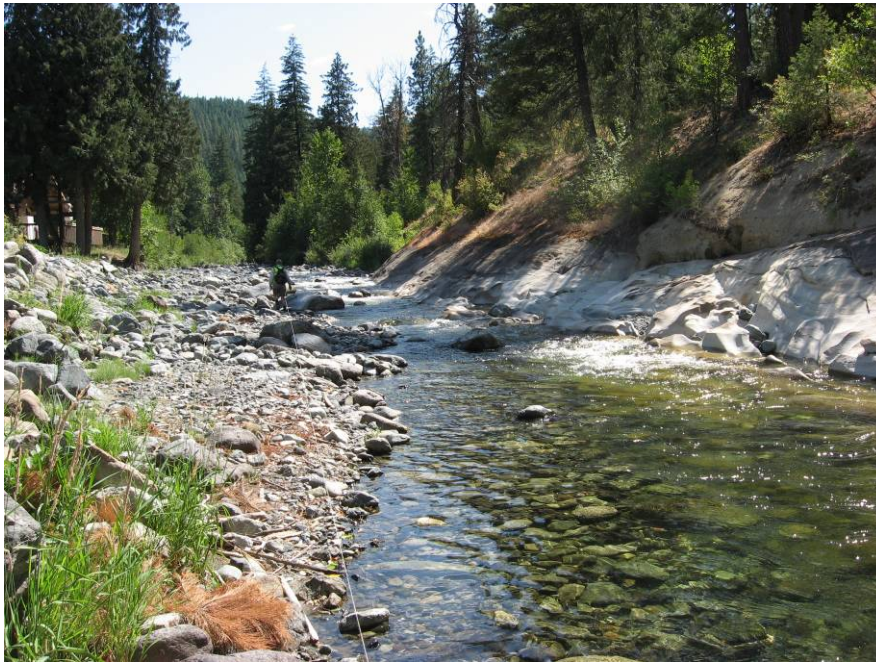
Figure 28. Step-pool sequence with bedrock on river left bank. RM 5.6.

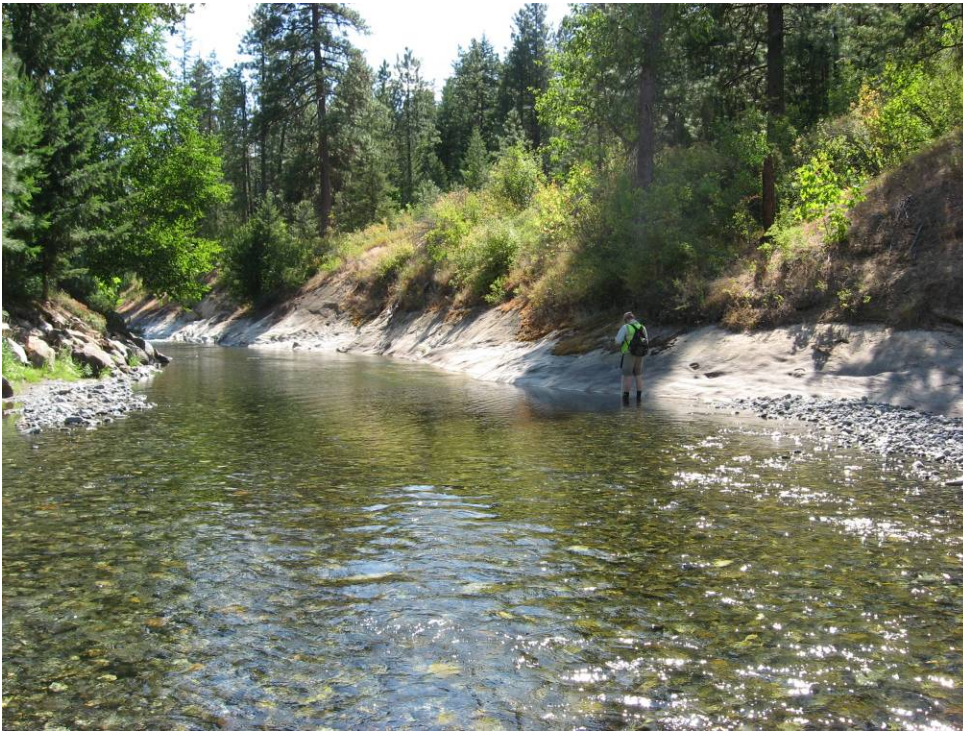
The coarse bed and high frequency of boulders provides areas of localized velocity refuge that may be utilized for rearing by juvenile steelhead and resident trout. Steelhead and Chinook spawning may occur in the handful of suitable pool tail-outs near RM 5.5. Spawning habitat is limited throughout the remainder of the reach due to coarse substrate. This reach has the greatest amount of side-channel habitat (6%) of all of the reaches in the study area, and these localized areas likely provide diverse juvenile rearing opportunities.

Figure 36. Long pool tail-out near river mile 5.5 with good spawning-sized substrate.

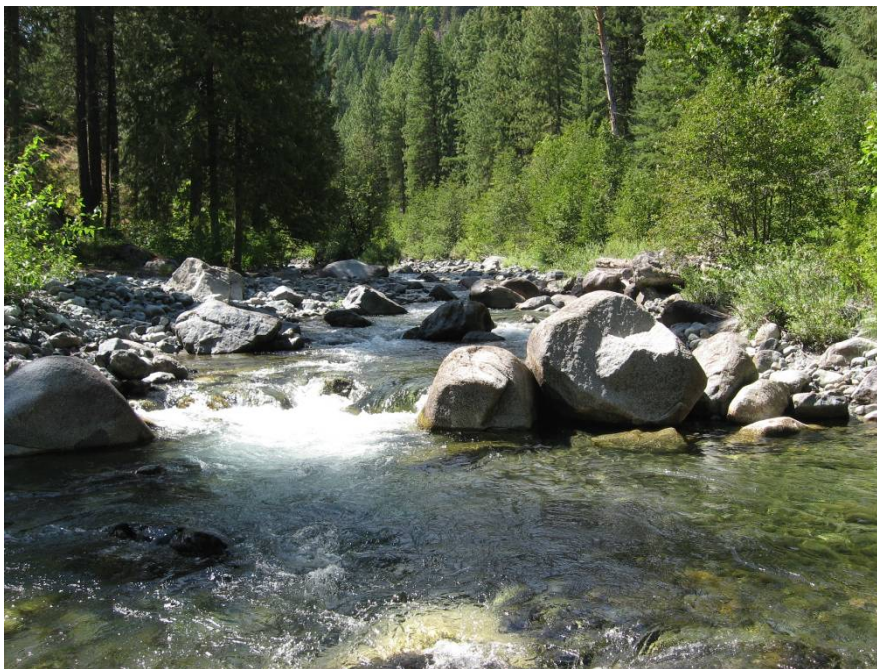
Figure 39. Step-pool channel segment near RM 7.0.

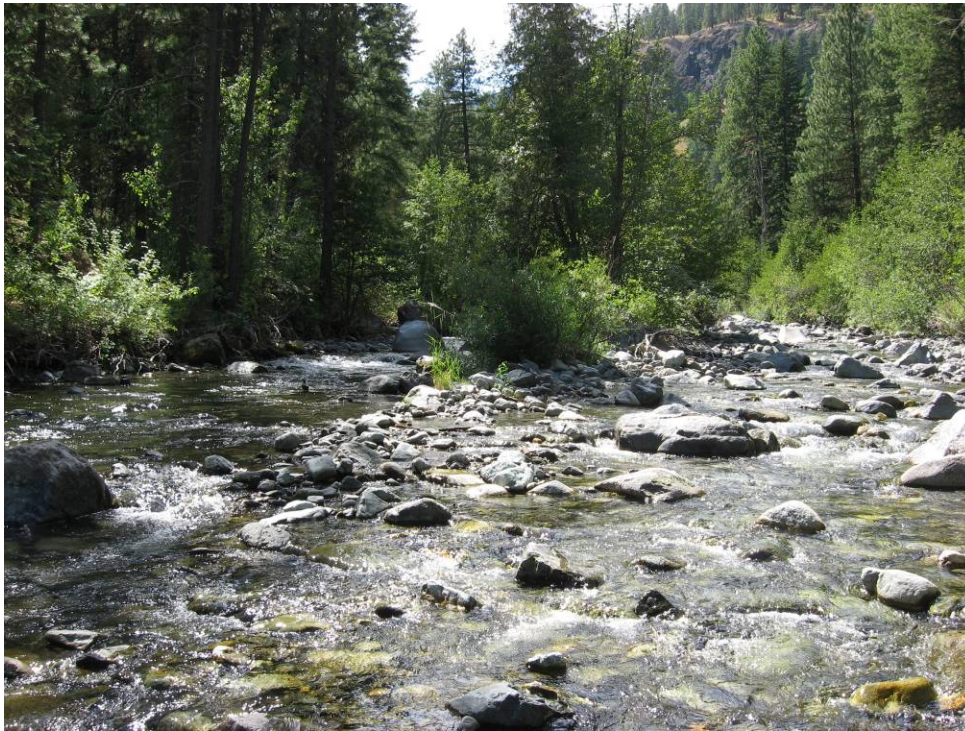
Only one side-channel, 280 ft long, was measured in this reach, accounting for 2% of the total habitat (Figure 43). No other significant off-channel habitat is available at low flow periods.

Figure 43. Side-channel confluence near river mile 7.0.

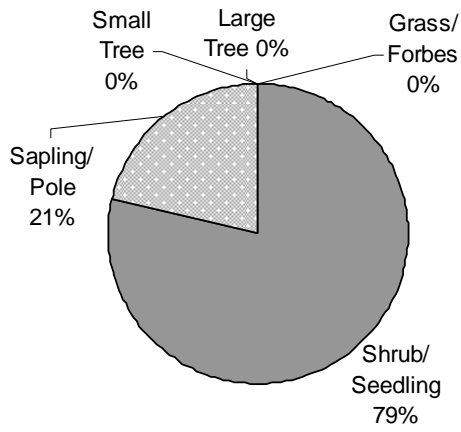
This reach has experienced some of the least amount of riparian impairments in the study area. This is partially related to the steep left bank hillslope that provides difficult access and topography for residential development or road building. The riparian inner zone is well vegetated with shrubs and sapling/pole size classes (Figure 48). The riparian outer zone has a high amount of large trees (64%, Figure 49). The remainder of the outer zone is primarily grass due to either (1) forest clearing associated with streamside residences, or (2) steep grass slope on hillsides.

Figure 48. Vegetation class by percentage in the riparian inner zone of Reach 4 of Peshastin Creek.

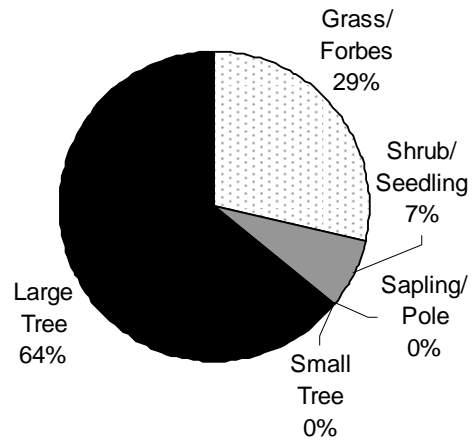
Figure 49. Vegetation class by percentage in the riparian outer zone of Reach 4 of Peshastin Creek.

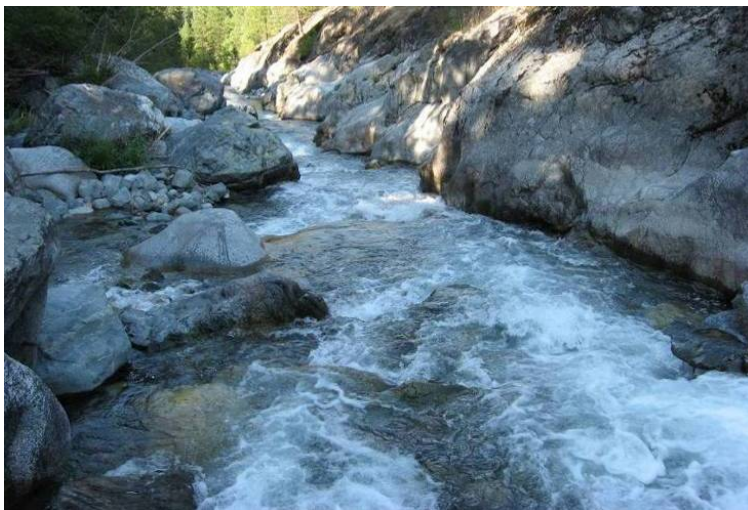
Figure 50. Bedrock canyon at downstream end of Reach 5a. River mile 7.4.

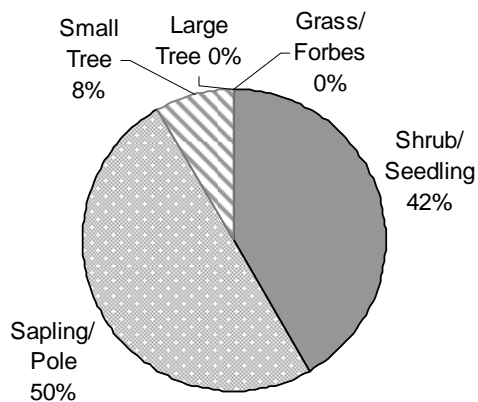
In general, the riparian inner zone is well vegetated in this reach (Figure 59). There are, however, numerous locations where residential development and associated vegetation clearing affect both the inner and outer zone riparian areas. Much of the outer zone is dominated by grass (Figure 60), which is largely attributable to streamside residential uses (i.e. view clearing and lawns). Most areas lack the large tree component necessary to provide stream shade, bank stability, and a source for LWD recruitment.

Figure 59. Vegetation class by percentage in the riparian inner zone of Reach 5a of Peshastin Creek.

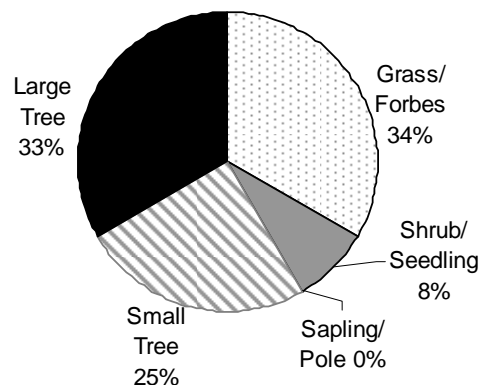
Figure 60. Vegetation class by percentage in the riparian outer zone of Reach 5a of Peshastin Creek.
