Appendix C: Lower Twisp Project Opportunities

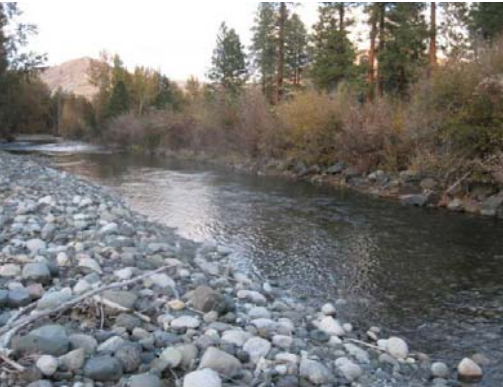
Reach	Project Number	Sub-Unit	Strategy Category	Project Name	Description	Photo
1	Project RM 0.3R	Inner Zone 1 (IZ-1)	In-stream Habitat Enhancement	LWD habitat enhancement	The bank in this area has been protected with riprap beginning at the bridge and extending down to RM 0.25. The riprap is currently protecting residences built in DOZ-3. Riprap limits geomorphic connectivity (e.g. channel migration), riparian function, and habitat complexity. Bank protection should be maintained for safety, but could be enhanced with LWD to enhance in-stream habitat cover/complexity.

<p>Looking downstream to the northeast at the river-right bank near RM 0.3 where LWD could enhance a riprap protected bank (October 2009).</p>
1	Project RM 0.53L	Inner Zone 1 (IZ-1)	Reconnect Stream Channel Processes	Side-channel habitat reconnection	In 1985, this side-channel was mapped as active split flow. Currently, the channel is scoured and contains un-vegetated alluvial material indicating a frequent high-flow connection; however, there is no active flow when water levels are low. A low-flow connection could be enhanced to provide a perennial split flow channel. Protection of adjacent residences would be a primary consideration. A small portion of riprap near the downstream outlet could be moved to the margin of the floodplain surface.

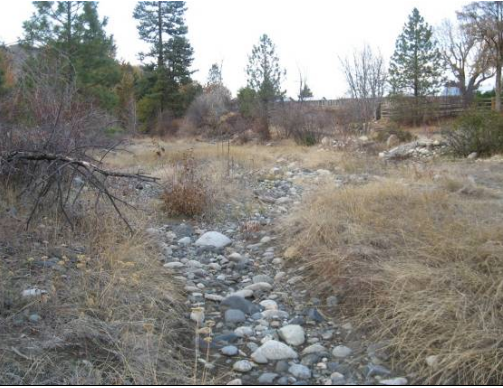
<p>View looking upstream toward the northwest at a small high-flow channel that could be enhanced to provide side-channel habitat at all flow levels (October 2009).</p>

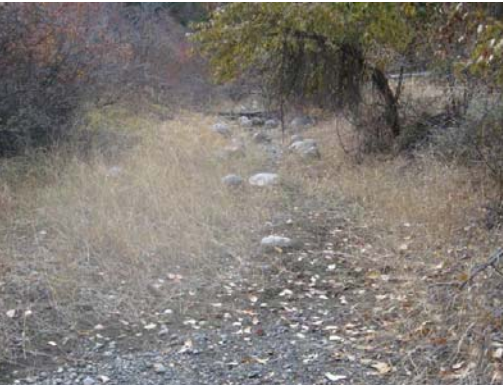
2a	Project RM 0.87R	Disconnected Outer Zone 1 (DOZ-1)	Off-Channel Habitat Enhancement	Wetland habitat enhancement	The downstream outlet of the acclimation ponds is near RM 1.05. Downstream of that point, there is topographic and vegetative evidence of a more active hydrologic connection between the channel and DOZ-1. This area is also managed by MSRF. MSRF breached the levee in several places, allowing for semi-annual flooding. Groundwater investigation by MSRF does not support a flow augmentation here. This channel could be developed with a surface connection to an active side-channel near RM 0.9, enhancing connectivity between channel and floodplain processes and habitats. There is also potential to create an active low-flow side-channel through this area in combination with Project RM 1.0R.

<p>Floodplain channel near RM 0.9. This channel is continuous across the surface but is currently not well-connected (October 2009).</p>

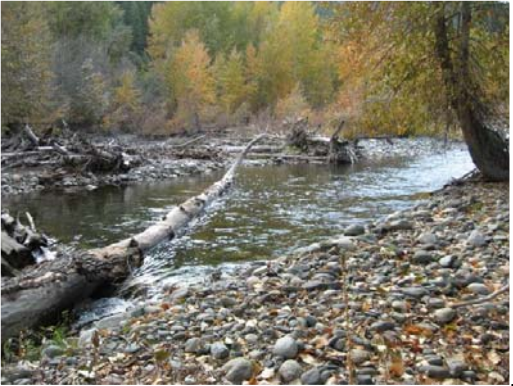
Reach	Project Number	Sub-Unit	Strategy Category	Project Name	Description	Photo
2a	Project RM 0.88L	Inner Zone 2 (IZ-2)	Reconnect Stream Channel Processes	LWD enhancement and side-channel reconnection	LWD jams at this location would enhance LWD that is naturally being deposited in this area and could enhance flows into adjacent high-flow channels. Downstream near RM 0.86, a bar apex log jam would be used to enhance a gravel bar high-flow cut-off. The cut-off channel is scoured and appears active. The purpose of the jam would be to increase scour, increase low flow discharge in the channel, and provide improve habitat.

<p>View looking upstream toward the west at LWD near RM 0.9 (October 2009).</p>
2a	Project RM 0.95R	Inner Zone 2 (IZ-2)	Off-Channel Habitat Enhancement	Alcove habitat enhancement	This wood structure would enhance an existing backwater pool that has above average residual depth, providing cover and habitat complexity.

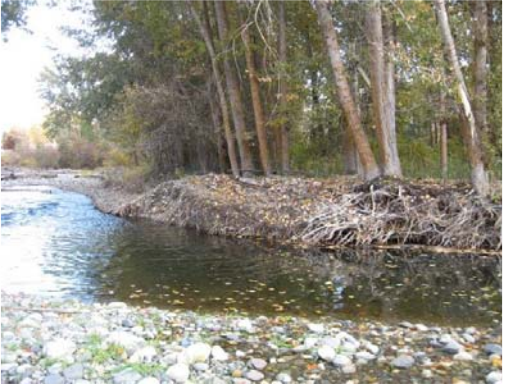
<p>View looking downstream toward the east at an alcove near RM 0.95 (October 2009).</p>

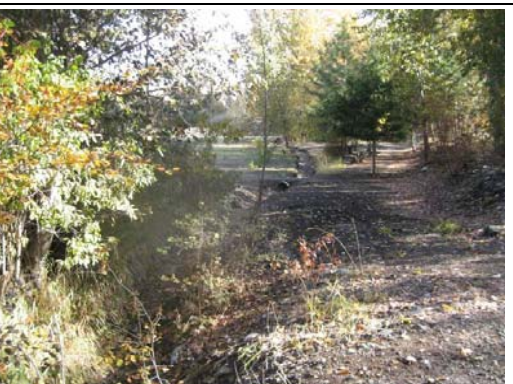
2a	Project RM 1.0R	Disconnected Outer Zone 1 (DOZ-1)	Reconnect Floodplain Processes	Levee removal	There is a 560 ft long push-up levee that creates a barrier to downstream connection to high-flow across the floodplain, and to the connectivity of off-channel and floodplain side-channel habitat. The levee does not appear to provide protection to vital infrastructure and could be removed to re-establish floodplain connectivity.

<p>View looking east in the downstream direction at an old irrigation ditch in the center of the photo protected by a levee on the right (October 2009).</p>

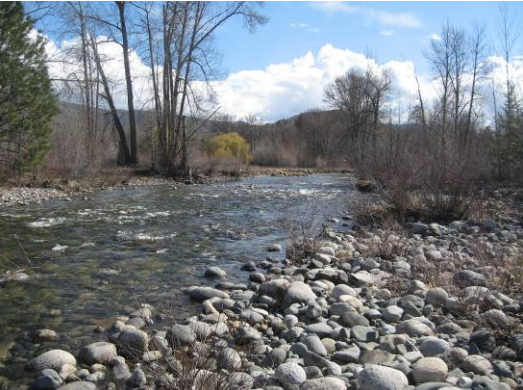
2a	Project RM 1.19R	Inner Zone 2 (IZ-2)	Reconnect Stream Channel Processes	Side-channel reconnection	An existing side-channel would be enhanced with placement of an apex wood jam. There is an existing jam at this location that would be enhanced.

<p>View looking downstream at point bar with potential for apex jam placement near RM 1.19 (October 2009).</p>

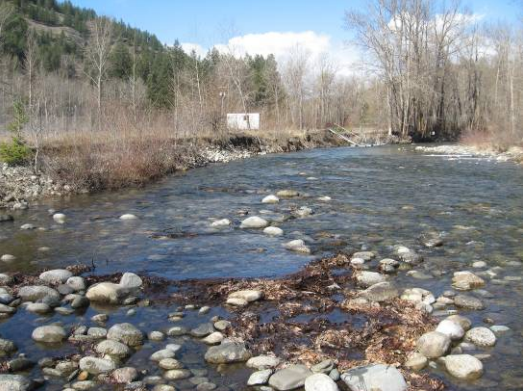
Reach	Project Number	Sub-Unit	Strategy Category	Project Name	Description	Photo
2a	Project RM 1.21R	Inner Zone 2 (IZ-2)	In-Stream Habitat Enhancement	LWD enhancement	This project includes placement of several log jams along the river right bank to control erosion and increase cover for habitat enhancement.

<p>View looking upstream at eroding bank on river-right near RM 1.21. Smolt trap in background (October 2009).</p>
2a	Project RM 1.25R	Disconnected Outer Zone 1 (DOZ-1)	Riparian Habitat Enhancement	Riparian re-vegetation	Several acres of riparian forest have been cleared on the south side of the valley for residential and agricultural development. There is no active agricultural or residential use for this cleared area, and the potential exists to re-plant native riparian vegetation to enhance habitat quality. The land is currently under protection and slated for riparian restoration.

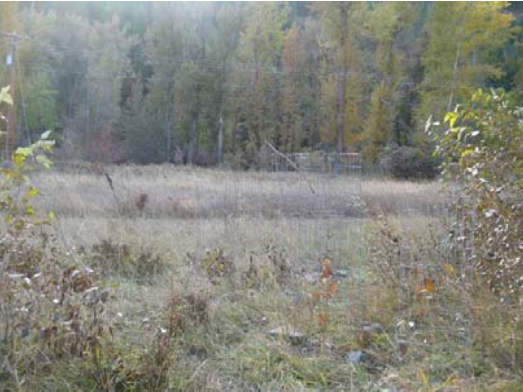
<p>View to the south at a cleared floodplain area near RM 1.25 (October 2009).</p>

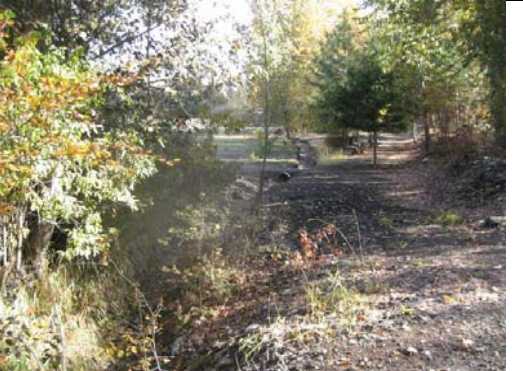
2a	Project RM 1.2L	Disconnected Outer Zone 2 (DOZ-2)	Riparian Restoration	Riparian re-vegetation	Several acres of riparian forest have been cleared north of the channel between RM 1.0 and 1.3. This clearing was originally agricultural, but now appears to be fallow. The land is under protection and is slated for riparian restoration. Re-planting native riparian vegetation would enhance habitat quality and stream processes by increasing solar shading of the channel, and eventually providing a source for large woody debris.	
2a	Project RM 1.28L	Disconnected Outer Zone 2 (DOZ-2)	Reconnect Floodplain Processes	Levee removal	Along the channel margin at the upstream end of DOZ-2, a levee protects an abandoned irrigation canal. Without the need to protect the canal, the levee could be removed to re-establish channel/floodplain connection between processes and habitat.

<p>View looking east in the downstream direction at an old irrigation ditch in the center of the photo protected by a levee on the right (October 2009).</p>

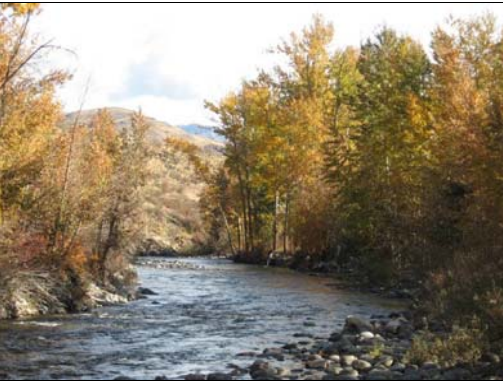
Reach	Project Number	Sub-Unit	Strategy Category	Project Name	Description	Photo
2a	Project RM 1.45C	Inner Zone 1 (IZ-1)	In-Stream Habitat Enhancement	LWD enhancement	Between RM 1.4 and 1.5 there are several opportunities for placement of LWD on both sides of the channel. These structures would increase habitat cover and complexity.

<p>View looking east in the downstream direction near RM 1.45 where both sides of the channel provide opportunities for LWD enhancement (October 2009).</p>
2a	Project RM 1.7R	Disconnected Outer Zone 1 (DOZ-1)	Reconnect Floodplain Processes	Levee removal or set-back	At the upstream end of the reach, a levee runs along the right bank of the channel for approximately 1,869 feet. Residential development does not begin for several hundred feet downstream. The levee could be set back farther on the floodplain to provide more direct protection for residential development, and re-establish a connection between channel/floodplain processes and habitats.

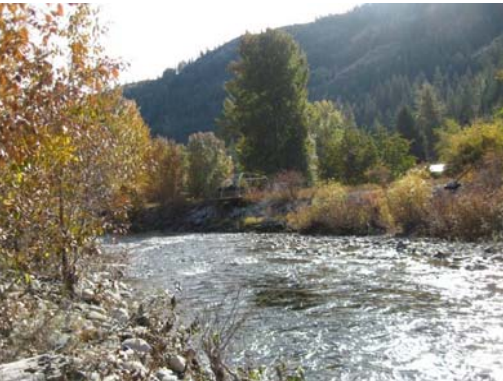
<p>View looking downstream towards the east at a levee along river-right (October 2009).</p>

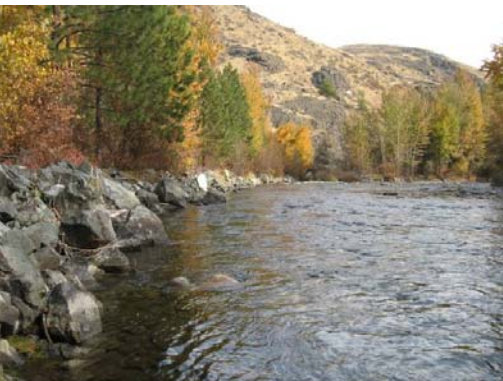
2b	Project RM 1.72L	Disconnected Outer Zone 5 (DOZ-5)	Off-Channel/Side-Channel Habitat Enhancement	Alcove habitat enhancement	This project would create an off-channel backwater/alcove at the upstream end of the north channel of the split-flow area between RM 1.68 and 1.73. The backwater would provide high-flow refugia for fish in the active channel and provide connectivity between channel and floodplain habitat.	
2b	Project RM 1.75L	Inner Zone 5 (IZ-5)	Reconnect Stream Channel Processes	Riprap removal	Downstream of the bridge at RM 1.85, the river-left channel is protected by riprap for over 700 feet. There is no residential development or other infrastructure in the adjacent floodplain. The riprap could be removed and replaced with LWD in order to reconnect stream channel and floodplain processes and to increase habitat cover and complexity. Alternatively, the riprap could remain in place and be enhanced with LWD additions.

<p>Northeast view in the downstream direction of riprap bank along river-left downstream of the bridge at RM 1.87 extending to RM 1.71 (October 2009).</p>

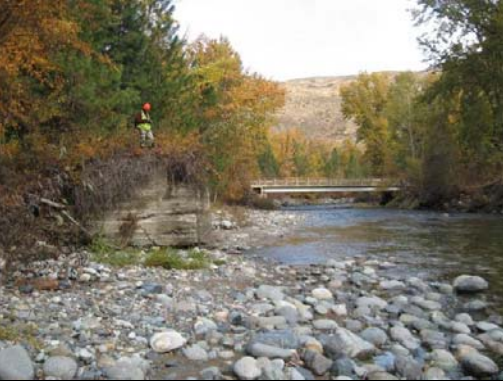
Reach	Project Number	Sub-Unit	Strategy Category	Project Name	Description	Photo
2b	Project RM 1.87L	Inner Zone 5 (IZ-5)	Reconnect Stream Channel Processes	Abutment removal	An old bridge abutment is located along the river-left channel margin. The abutment currently serves no purpose, but creates a process barrier. Removal would enhance inner zone processes.

<p>Northeast view in the downstream direction at an old bridge abutment along river-left near RM 1.87 (October 2009).</p>
2b	Project RM 2.0R	Disconnected Outer Zone 4 (DOZ-4)	Reconnect Floodplain Processes	Wetland habitat reconnection	A larger effort to reconnect habitat and process throughout DOZ-4 would require several culverts on Poorman road, multiple private roads, and multiple landowner approval. This approach is mentioned by the BOR as the “Spokane Grade” project (BOR 2008). The effort faces too many constraints to be considered here. A scaled-back approach with one culvert to connect floodplain wetlands at the downstream end is described here. This project involves replacing a culvert at RM 2.0 in order to re-connect off-channel habitat south of Poorman Road between RM 2.0 and 2.4.

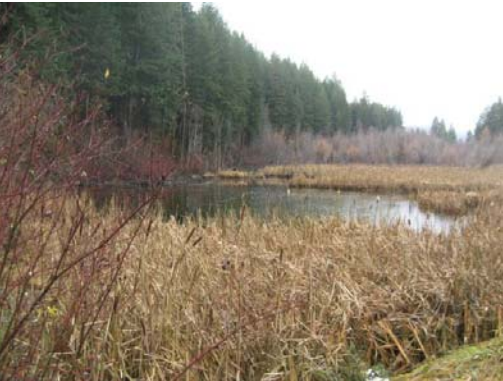
<p>View to the west in the upstream direction at wetlands south of Poorman Road in DOZ-4 (November 2009).</p>

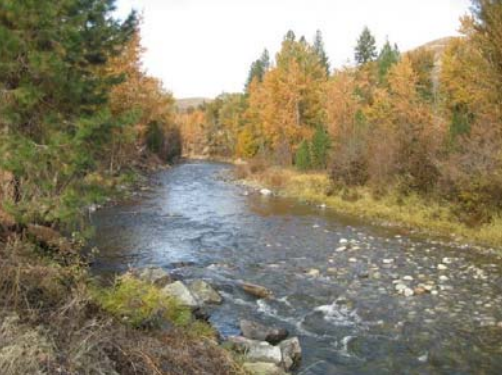
Reach	Project Number	Sub-Unit	Strategy Category	Project Name	Description	Photo
2b	Project RM 2.25R	Inner Zone 5 (IZ-5)	Reconnect Stream Channel Processes	Riprap modification or removal	This project involves incorporation of LWD along the riprap bank with the goal of increasing habitat complexity and quality. There is a backwater created by the crest of a riffle. A LWD structure could provide enhanced pool habitat in this area.

<p>Northwest view in the upstream direction at a potential LWD location along river-right near RM 2.25 (October 2009).</p>
2b	Project RM 2.3L	Outer Zone 7 (OZ-7)	Off-Channel Habitat Enhancement	Side-channel habitat enhancement	An existing meander scar could be excavated and opened up to create a floodplain channel. There is no evidence that the feature is frequently inundated. The downstream end of the channel could be widened to create a backwater/alcove connected to the active channel.

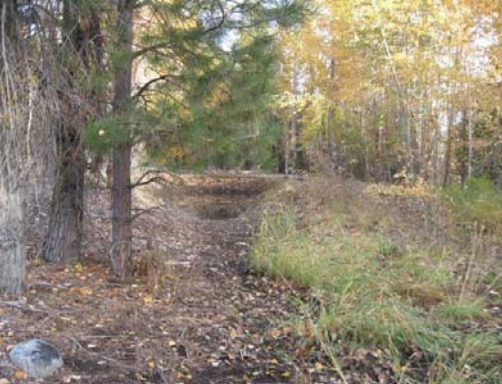
<p>Southeast view in the downstream direction at a portion of the riprap that extends along river right between RM 2.58-2.75 (October 2009).</p>
2b	Project RM 2.7L	Disconnected Inner Zone 3 (DIZ-3)	Reconnect Stream Channel Processes	Levee removal and side-channel reconnection	This project involves removing anthropogenic features to reconnect inner zone processes. A portion of the high flow channel is currently ditched, lined, and routed into a catch basin near RM 2.7. There are also two push-up levees in this area that limit connectivity of channel and floodplain processes. These features could be removed to enhance floodplain and side-channel connectivity.

<p>View to the east in the downstream direction at a catch basin that has been built to capture high-flow from a side-channel near RM 2.7 (October 2009).</p>

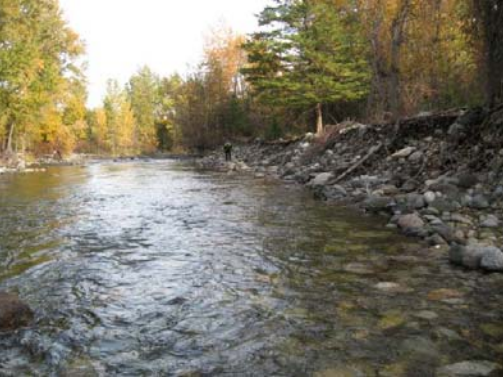
Reach	Project Number	Sub-Unit	Strategy Category	Project Name	Description	Photo
2b	Project RM 2.9C	Inner Zone 4 (IZ-4)	In-Stream Habitat Enhancement	LWD enhancement.	LWD structures on both sides of the channel would increase habitat cover, pool scour, and complexity

<p>Northeast view in the downstream direction at a potential LWD location along river-right near RM 2.9. The left side of the channel provides a similar opportunity (October 2009).</p>
2b	Project RM 2.93L	Inner Zone 4 (IZ-4)	In-Stream Habitat Enhancement	LWD enhancement	This is a location where LWD could be added to the channel along river-left near RM 2. This project is located in an active side-channel. The log jam would provide habitat complexity in the side channel.

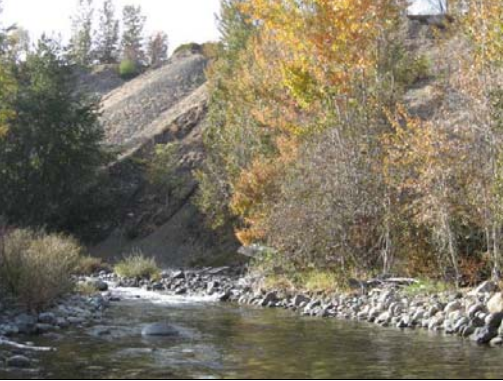
<p>View to the northwest in the upstream direction at a side channel near RM 2.93 (October 2009).</p>
2b	Project RM 3.0R	Disconnected Outer Zone 4 (DOZ-4)	Reconnect Floodplain Processes	Levee removal, side-channel reconnection	Habitat actions proposed for this project would re-connect several floodplain sub-units and the active channel. Currently a large levee extends 550 ft between RM 3.1 and 3.2. The levee creates a process and habitat barrier between DOZ-3, DOZ-4, and OZ-4. High-flow channels and wetlands occupying older channel scars intersect the levee and terminate, with the water entering the levee prism and going sub-surface. LiDAR data suggests that these high flow channels historically extended beyond the levee connecting with wetland features in DOZ-4. The levee does not appear to serve a protection purpose; there is no residential development or transportation corridor nearby. In addition to removing the levee, high flow channels and off-channel habitat would be enhanced to re-establish historical floodplain connections and functions in the system.

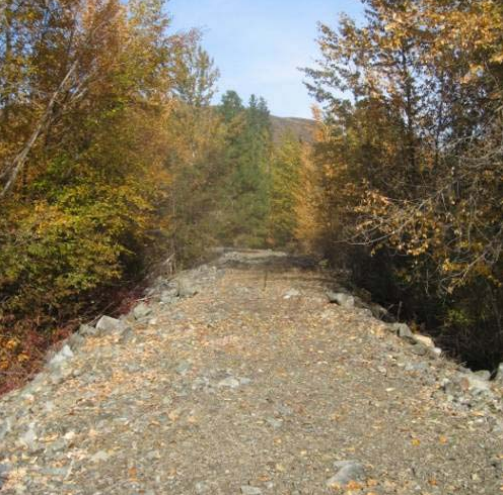
<p>Northeast view along the top of the levee near RM 3.2 that creates an ecological and physical barrier between multiple floodplain sub-units (October 2009).</p>

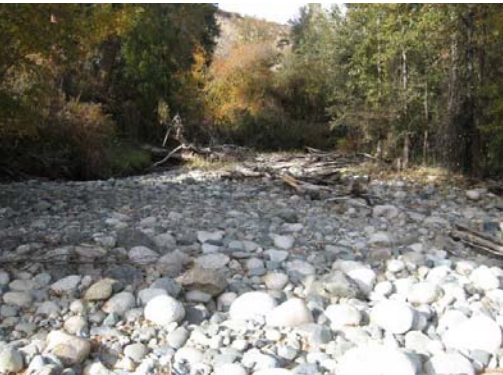
Reach	Project Number	Sub-Unit	Strategy Category	Project Name	Description	Photo
2b	Project RM 3.13C	Inner Zone 4 (IZ-4)	Reconnect Stream Channel Processes	Re-establish channel LWD dynamics	This project entails enhancing an existing apex jam in order to increase channel complexity, and enhance an existing side-channel by encouraging split-flow at all flow levels. The side-channel currently sees active flow during annual high-flow events. Creating a split-flow condition would increase habitat complexity. Habitat features could be installed throughout the side-channel as well.

<p>View to the northeast in the downstream direction at a side-channel near RM 3.13 (October 2009).</p>
2b	Project RM 3.25R	Inner Zone 4 (IZ-4)	In-Stream Habitat Enhancement	LWD enhancement	A LWD meander bend jam would improve local habitat and cover. Existing riparian vegetation is in good condition along the bank and enhancing lateral channel adjustment processes could drive future LWD recruitment

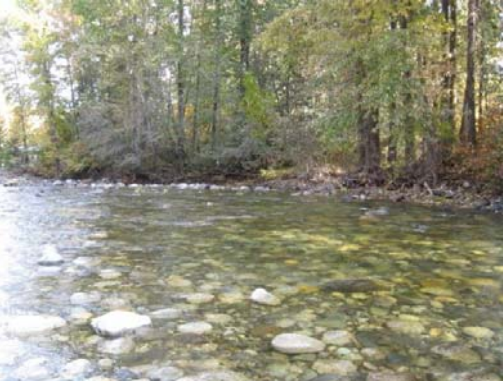
<p>Northeast view in the downstream direction at a potential LWD jam location on river-right near RM 3.25 (October 2009).</p>

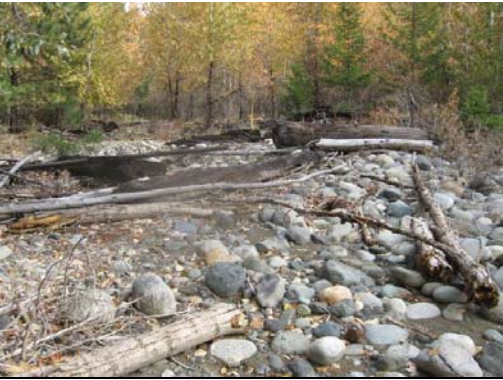
2b	Project RM 3.35L	Inner Zone 4 (IZ-4)	Reconnect Stream Channel Processes	Levee removal and side-channel reconnection	This project involves enhancement of a river-left side-channel that runs between RM 3.22 and 3.38. This side-channel was the active channel location in 1954 and 1964 aerial photos. Geomorphic and vegetative evidence suggests an active connection to inner zone processes that could be enhanced through a combination of actions. Enhancement of an existing bar apex jam would encourage flow into the side-channel. The existing jam is limited by current wood recruitment levels. A 200 ft long push-up levee currently creates a flow barrier between the main channel and the side-channel at the downstream end. Removing this levee would allow inner zone processes to proceed unimpeded.

<p>Northeast view in the downstream direction at a small LWD jam at a bar apex near RM 3.38 (October 2009).</p>

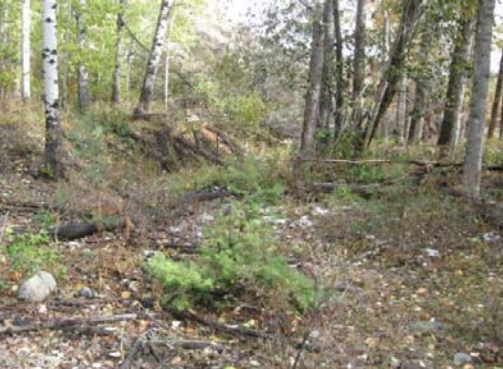
2b	Project RM 3.5L	Outer Zone 3 (OZ-3)	Off-Channel Habitat Enhancement	Side-channel habitat enhancement	This project involves re-activating a high-flow channel between RM 3.3 and 3.6. Currently, the channel does not appear to be regularly inundated, but cross-section geometry suggests that moderate flows were historically accommodated in this channel. Excavation would be required to lower the upstream end of the channel and activate flow at a 1.5-2 yr frequency. The channel is well defined in its upstream half and would require minimal mechanical enhancement to accommodate flow. Excavation is needed to construct a channel and outlet at the downstream end of the project. Dry ground and upland vegetation suggest that groundwater would not be a significant contributor to flow in this channel.

<p>Northeast view in the downstream direction at the historical high-flow channel found between RM 3.3 and 3.6 in OZ-3 (October 2009).</p>

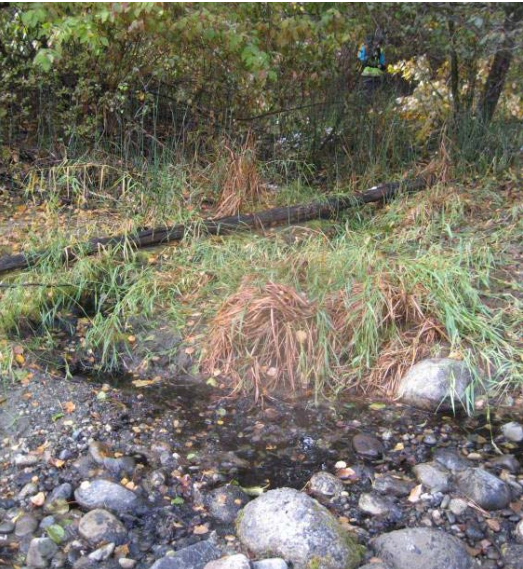
2b	Project RM 3.9R	Disconnected Outer Zone 3 (DOZ-3)	Off-Channel Habitat Enhancement	Alcove habitat enhancement	At RM 3.9, there is a low area on the channel margin that forms the drainage point for the upstream end of the “Chain of Lakes” (Figure 20). Despite the berms that surround the wetlands, and the lack of natural drainage, there is a small surface discharge into the channel. This topographic low point could be excavated into the floodplain to create an off-channel alcove that connects channel and floodplain habitats.

<p>View to the southwest toward the outlet of the upstream end of the "Chain of Lakes" near RM 3.9 (October 2009).</p>

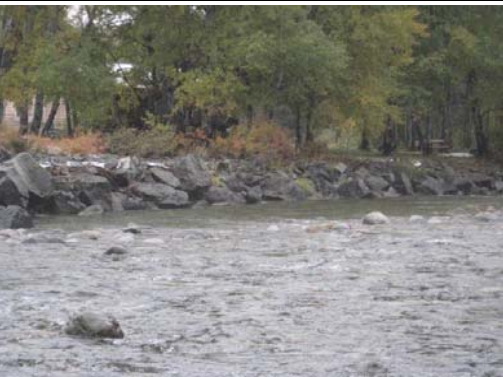
<p>Looking east in the downstream direction at riprap along river-left near RM 4.25 (October 2009).</p>
2b	Project RM 4.3L	Disconnected Outer Zone 1 (DOZ-1)	Reconnect Floodplain Processes	Wetland Habitat Reconnection	This project involves reconnecting wetland habitats to inner zone habitats, and re-establishing channel/floodplain connection. Groundwater fed wetlands provide potentially valuable off-channel habitat, but lack passable fish access. The outflow channel is blocked by fill, garbage, and riprap at the channel margin creating a steep fall into the channel that is impassible except at very high flows. The outflow channel could be opened up to allow fish passage into off-channel habitat. The wetlands themselves could be enhanced to provide increased quality of fish habitat

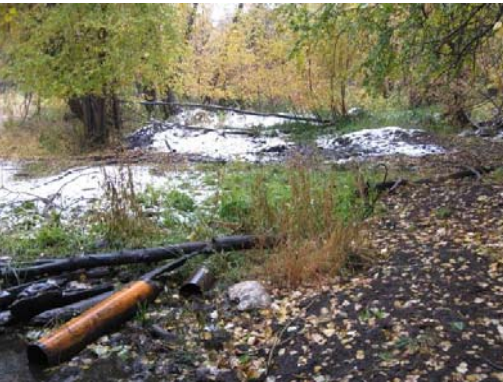
<p>Wetland outflow channel that has been altered with floodplain fill behind riprap. The channel does not currently provide habitat connection at any flow level except high flows (October 2009).</p>

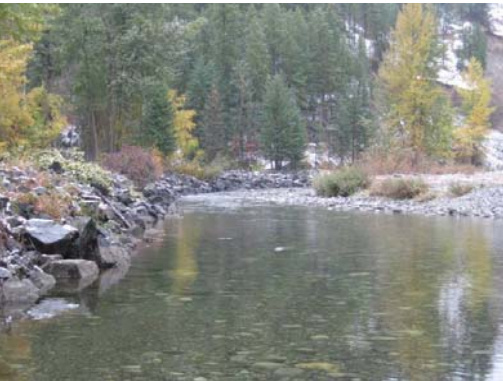
<p>Looking southwest in the upstream direction at a levee that is a process and habitat barrier for DOZ-2 (October 2009).</p>
2b	Project RM 4.55L	Disconnected Inner Zone 1 (DIZ-1)	Reconnect Stream Channel Processes	Levee removal, side-channel reconnection	This project involves removing or modifying the push-up levee between RM 4.75 and 4.85. LWD enhancement near inlet locations of disconnected side-channels could direct high-flow into high flow channels, re-establishing process and enhancing habitat connection. Downstream outlets of the high flow channels are unimpeded, and would not require and mechanical enhancement.

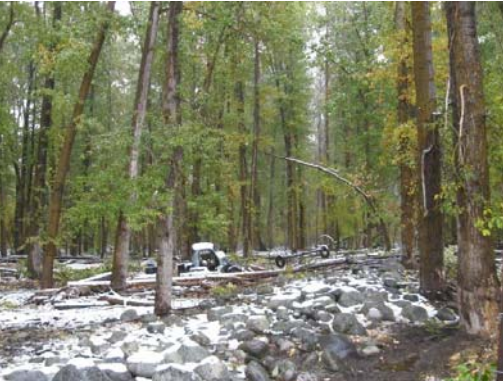
<p>Southeast view of DIZ-1 looking across a push-up levee into the thinned riparian forest (October 2009).</p>

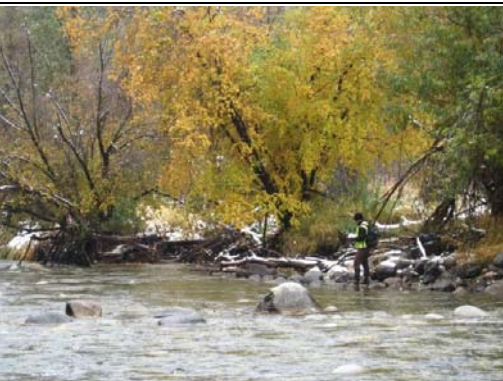
<p>Potential LWD location along river right near RM 4.75. Existing woody bank structure could be enhanced to provide increased habitat quality (October 2009).</p>

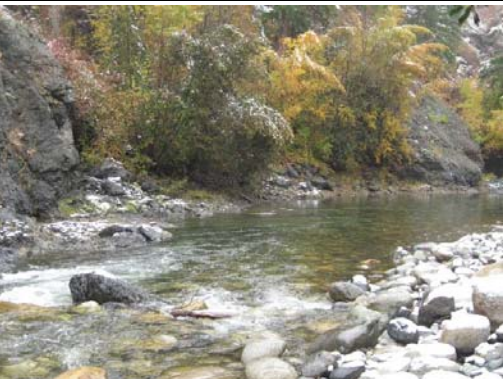
<p>View to the northeast in the downstream direction at a deep bedrock pool near RM 5.23 (October 2009).</p>

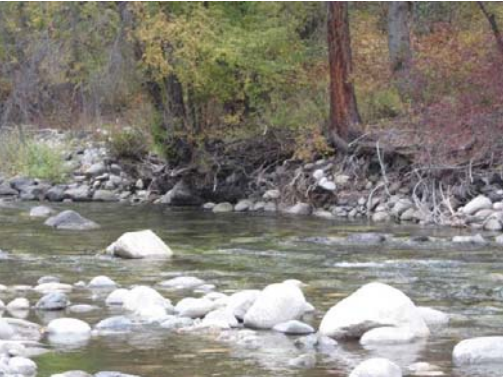
Reach	Project Number	Sub-Unit	Strategy Category	Project Name	Description	Photo
3b	Project RM 5.45L	Inner Zone 3 (IZ-3)	In-Stream Habitat Enhancement	LWD enhancement	Similar to Project RM 5.7L, this is a location where an existing root mass and pool could be enhanced with a LWD meander-bend jam.

<p>View to the west in the upstream direction at an overhanging root mass on the left bank near RM 5.45 (October 2009).</p>
3b	Project RM 5.5R	Inner Zone 3 (IZ-3)	Reconnect Stream Channel Processes	Side-channel reconnection	A high-flow channel between RM 5.4 and 5.6 appears to be inundated and scoured on an annual recurrence. This channel could be enhanced to provide side-channel habitat at a wider range of flows. LWD structures and select excavation would be used to provide low-flow access to the side-channel and to increased habitat complexity and quality.

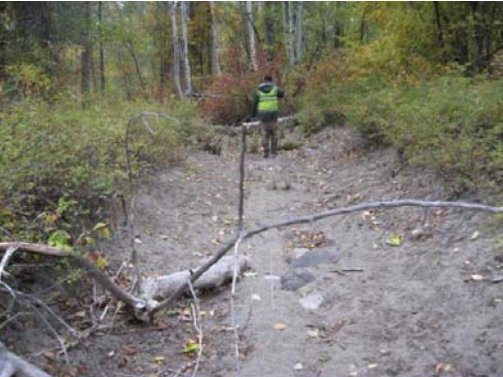
<p>View to the east in the downstream direction at an active high-flow channel near RM 5.5 (October 2009).</p>

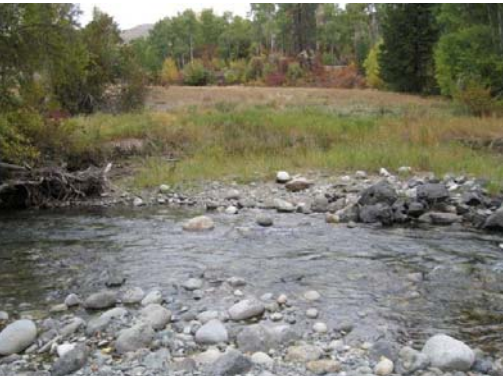
<p>View to the north at the river-left bank near RM 5.7 (October 2009).</p>

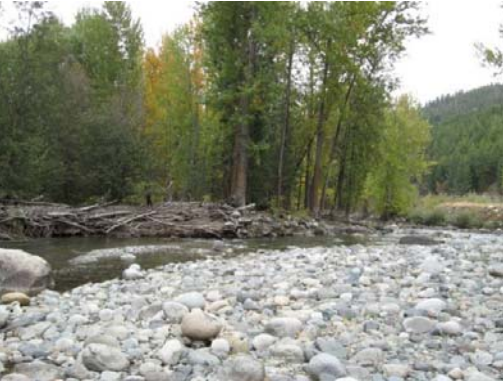
Reach	Project Number	Sub-Unit	Strategy Category	Project Name	Description	Photo
3b	Project RM 5.8L	Inner Zone 3 (IZ-3)	Reconnect Stream Channel Processes	Side-channel reconnection	This project involves enhancing the active side-channel and high-flow channels that have developed in the re-worked deposits of an alluvial fan between RM 5.7 and 5.9. LWD apex jams near the upstream end at RM 5.9 would enhance inundation of high-flow channels. Select excavation could be used to create a low flow side-channel. High-flow channel outlets could be enhanced to allow for habitat connection throughout the project area.

<p>View to the southeast in the downstream direction at the upstream inlet to a network of high flow channels located along river-left between RM 5.7 and 5.9 (October 2009).</p>
3b	Project RM 5.9R	Disconnected Outer Zone 2 (DOZ-2)	Riparian Restoration	Riparian re-vegetation	There is only a narrow forested riparian buffer (10 – 50 ft wide) on river-right between RM 5.8 and RM 6.2. This project would involve reforestation of the riparian zone up to 100 feet (or greater if possible) from the channel. Address livestock access if it is an issue on this parcel.

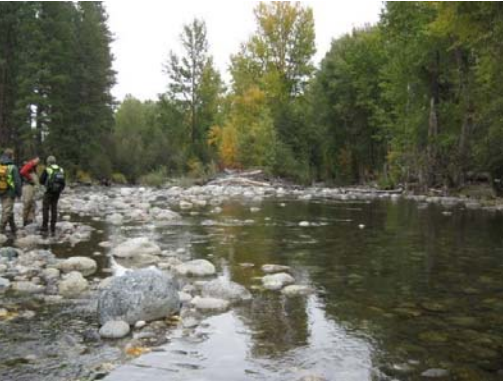
3b	Project RM 6.0C	Inner Zone 2 (IZ-2)	Reconnect Stream Channel Processes	LWD placement to enhance lateral dynamics	This location is just upstream of the transition from IZ-2 to IZ-3 where the channel width begins to expand and flow splits around a mid-channel bar. This project would involve placing LWD jams on point bars and mid-channel bar apexes to enhance split flow conditions.

<p>Downstream view to the east at an apex log jam on a mid-channel bar. LWD jams in this area would enhance lateral channel dynamics and improve habitat cover and complexity (October 2009).</p>
3b	Project RM 6.08C	Inner Zone 2 (IZ-2)	Reconnect Stream Channel Processes	Bridge modification	The bridge at RM 6.08 creates a hydraulic constriction at high flows. An improvement of the bridge with a wider span could alleviate hydraulic effects of increased energy in the channel during high flows.

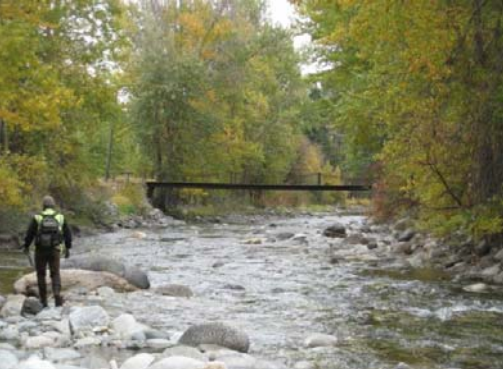
<p>View to the east in the downstream direction at a bridge crossing near RM 6.08. As stage increases, the bridge becomes a hydraulic constriction (October 2009).</p>

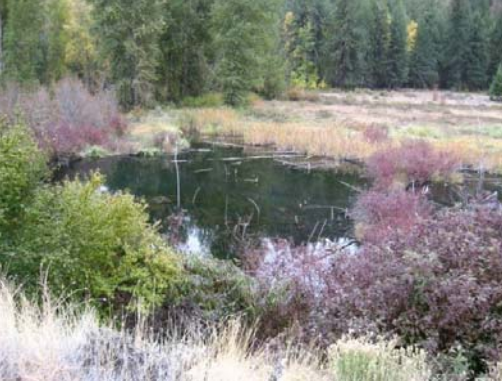
<p>Floodplain wetlands located in DOZ-1 that could be re-connected to inner-zone processes and habitat (October 2009).</p>

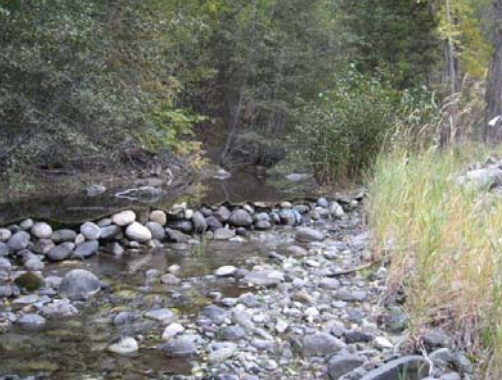
<p>View to the southwest in the upstream direction at the diversion dam near RM 6.51. Removal of the dam would enhance side-channel habitat (October 2009).</p>

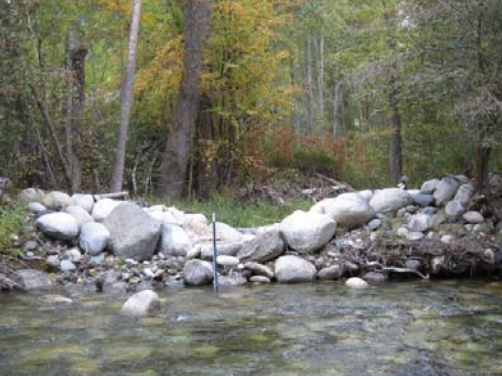
<p>View to the southeast in the downstream direction at a push-up levee near RM 6.4. The levee has been breached / lowered as part of an enhancement project (October 2009).</p>

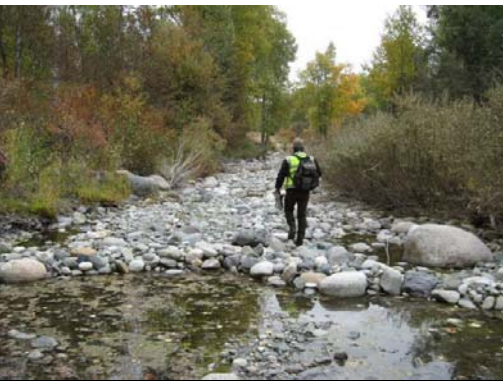
<p>View to the east in the downstream direction at a high-flow side-channel near RM 6.8 (October 2009).</p>

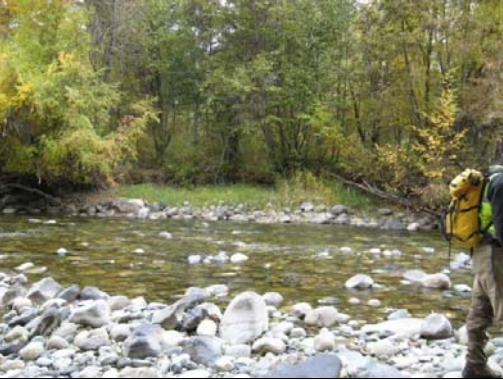
3c	Project RM 6.89R	Inner Zone 2 (IZ-2)	In-Stream Habitat Enhancement	LWD enhancement	There is another good location for LWD enhancement on river-left at RM 6.89. Construction of a meander-bend log jam would increase pool scour, cover, and habitat complexity.

<p>View to the north at river-left near RM 6.89 where LWD would enhance in-channel habitat (October 2009).</p>
3c	Project RM 6.95R	Inner Zone 2 (IZ-2)	In-Stream Habitat Enhancement	LWD enhancement	This project opportunity involves placement of LWD along the margins of an existing bedrock pool to increase habitat cover and complexity.

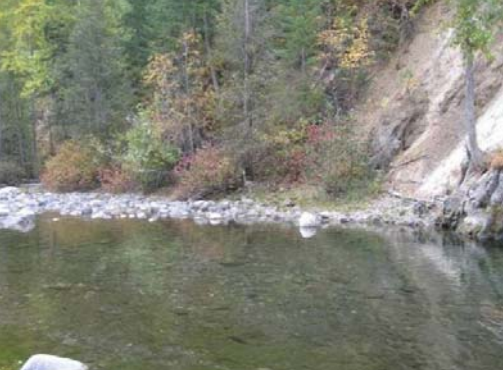
<p>View to the southeast in the downstream direction at a potential LWD placement location along river-right near RM 6.95 (October 2009).</p>

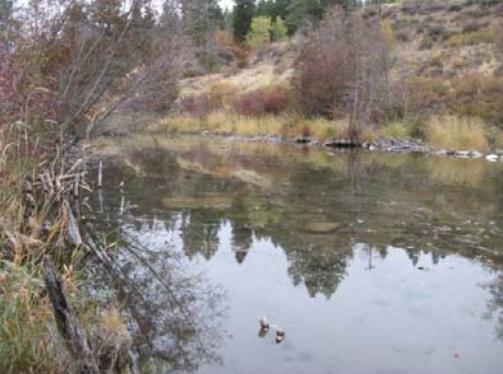
<p>View to the east in the downstream direction at riprap along the river-left bank near RM 7.05 (October 2009).</p>
3c	Project RM 7.15L	Disconnected Inner Zone 1 (DIZ-1)	Off-Channel Habitat Enhancement	Off-channel habitat enhancement	The oxbow wetlands in this sub-unit provide the potential for valuable habitat that is rare in Reach T3c. This project would re-establish/enhance the connection between the wetlands and main channel habitats while maintaining protection of the irrigation diversion, fisheries facilities, and residential access. Improved culverts at the upstream road crossing could provide a stronger high-flow connection with the main channel. Culverts under the access road are either completely overgrown or non-existent. The downstream outlet could be enhanced to ensure low flow fish access to the ponds.

<p>Oxbow pond located near RM 7.15 that provides valuable, although largely disconnected, off-channel habitat (October 2009).</p>

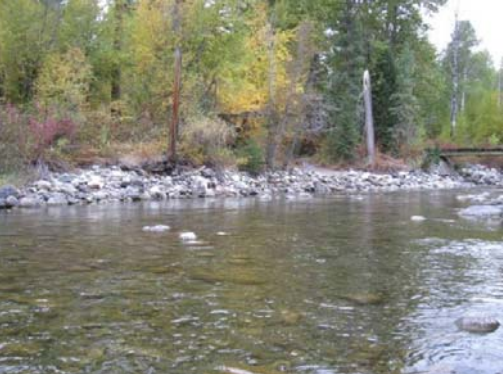
3c	Project RM 7.15R	Inner Zone 2 (IZ-2)	In-Stream Habitat Enhancement	LWD enhancement	This location is just downstream of the bridge crossing at RM 7.15. Installation of LWD would enhance cover and habitat along the right bank. Currently, the bank is protected with riprap and large alluvial material. LWD would increase pool scour, cover, and habitat complexity.

<p>View to the west in the upstream direction at a potential LWD jam location along river-right near RM 7.15 (October 2009).</p>
3c	Project RM 7.3L	Disconnected Inner Zone 1 (DIZ-1)	Reconnect Stream Channel Processes	Levee removal	This project involves removing 150 ft of push-up levee that has been constructed out of local alluvium. The levee may provide some protection for the TVIP canal. The levee could be set-back to provide more direct protection to the canal while re-connecting inner zone processes.

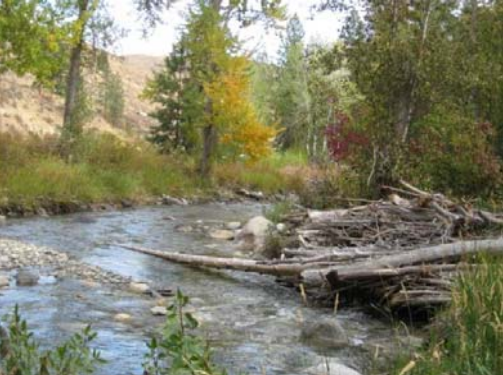
Reach	Project Number	Sub-Unit	Strategy Category	Project Name	Description	Photo
3c	Project RM 7.5L	Inner Zone 1 (IZ-1)	Reconnect Stream Channel Processes	Re-establish channel LWD dynamics	There are several LWD jams along the banks and at island apexes near RM 7.5 in the north split-channel. This project would enhance existing and create new jams to enhance active channel dynamics including split-flow and pool scour.

<p>View the east in the downstream direction near RM 7.5 (October 2009).</p>
3c	Project RM 7.5R	Inner Zone 1 (IZ-1)	In-Stream Habitat Enhancement	LWD enhancement	This project involves constructing a LWD jam along the right bank of the south split-channel near RM 7.5. The location is in a backwater just upstream of a riffle crest where the grade breaks and steepens. LWD would provide cover in the pool and increase local habitat complexity.

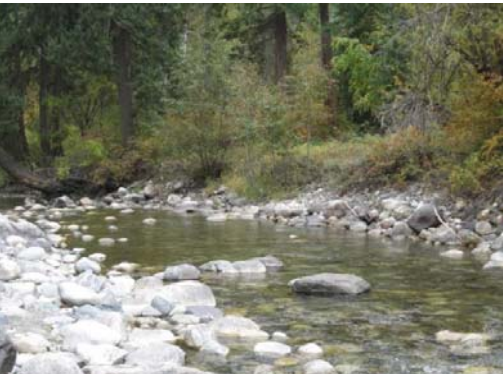
<p>View to the east in the downstream direction at a potential LWD jam location along river-right near RM 7.5 (October 2009).</p>

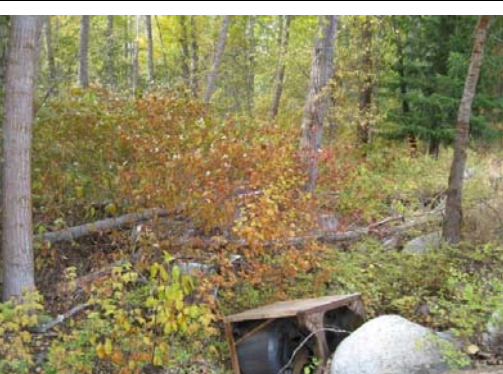
3c	Project RM 7.6L	Inner Zone 1 (IZ-1)	Reconnect Floodplain Processes	Levee removal	An older push-up levee starts at the edge of the active channel near RM 7.58 and extends about 190 ft. along the inner/outer-zone margin. Removal of the levee would enhance floodplain connectivity to DOZ-1. Appliances have also been dumped in this area and could be removed as part of enhancement work.

<p>View of an older, vegetated push-up levee near RM 7.6 that could be removed to re-connect channel/floodplain processes (October 2009).</p>
3c	Project RM 7.7R	Inner Zone 1 (IZ-1)	In-Stream Habitat Enhancement	LWD alcove enhancement	This project involves placing LWD along river-right near RM 7.7. The placement is in a backwater just upstream of a break in slope where the channel steepens. Some large trees have been cut down and cleared along the stream edge. Installing LWD could replace some of the bank stability and habitat complexity lost by the riparian clearing.

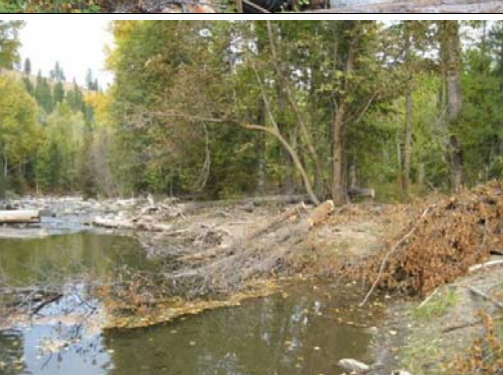
<p>View to the northeast in the downstream direction at a potential LWD structure location along river-right near RM 7.7 (October 2009).</p>
